**RE: LAND IN FRONT GARDEN OF 42 ELSWORTHY ROAD LONDON NW3 3DL**

**Engineering Assessment Report**  
**40 Elsworthy Road**

**Author: Nick Maclean**

**24 Sept 2015**

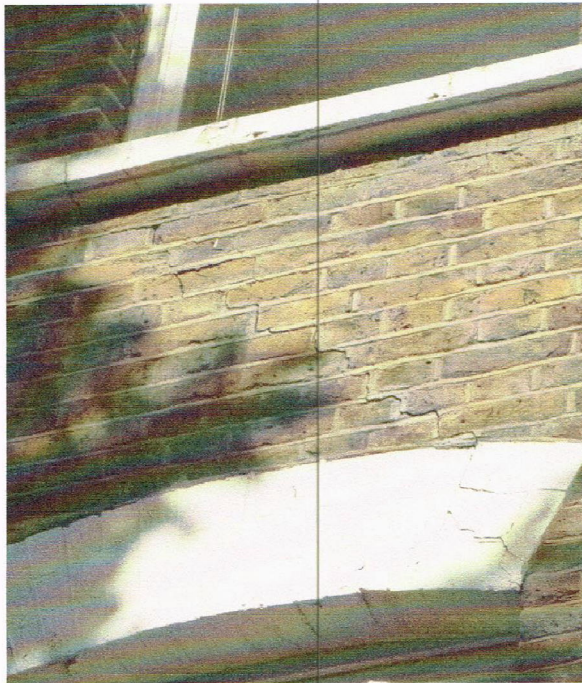
There are clear signs of vertical movement of the front corner of the building which are associated with the foundations, and resulted in the diagonal crack of 3-4mm under the top floor window near the corner and of not more than 5mm we estimate because it has been repointed. Also, the diagonal cracking in the flanks of the stairs up to the front door also point to relative vertical movement of the front corner of the house. (See photo 1-3) These signs of recent cracking are clear signs of settlement due to foundation movement as a consequence of subsoil desiccation.

Photo 1 the diagonal crack under the top, corner window – clearly subsidence.

The extent of the subsidence is *slight* and relatively recent compared with the maturity of the trees and so reducing the subsoil moisture desiccation by removal of the trees will, in our opinion, reduce the subsidence problem to a magnitude which avoids the need for expensive and disruptive underpinning. There will undoubtedly be some heave (soil swelling) movement as the subsoil recovers, but as the vertical movement is small at present, this heave recovery will also be small, and of course only occur once unlike subsidence which would have recurred every drought cycle.

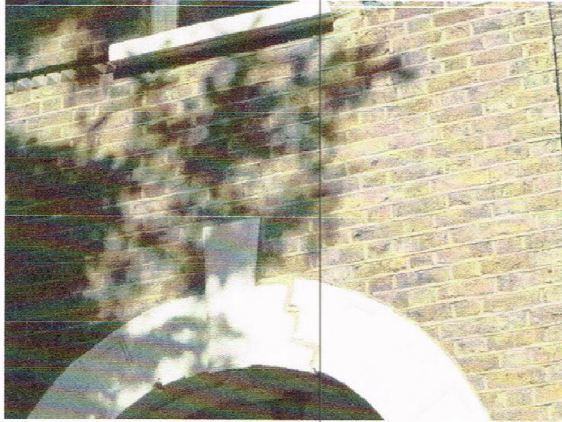
Photo 2. The cracking over the front door – further evidence of subsidence.

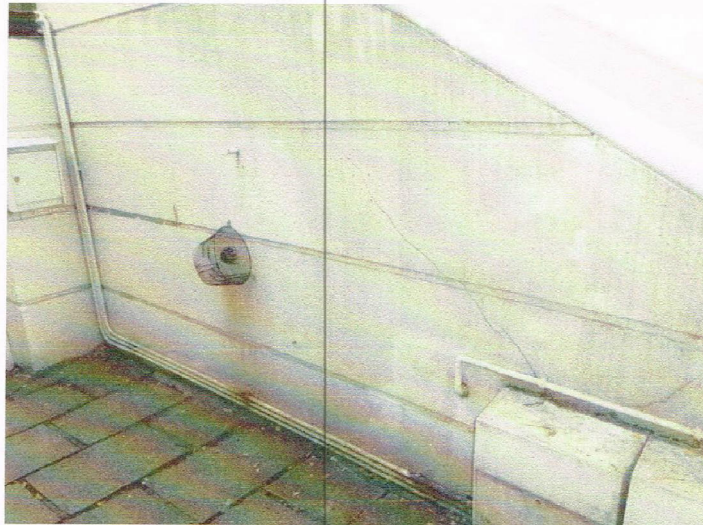
Photo 3. Cracking in the flank of the steps up to the front door.
