Kidderpore Avenue, Hampstead

Engineering Note: Unreinforced clinker concrete floors to Maynard Wing

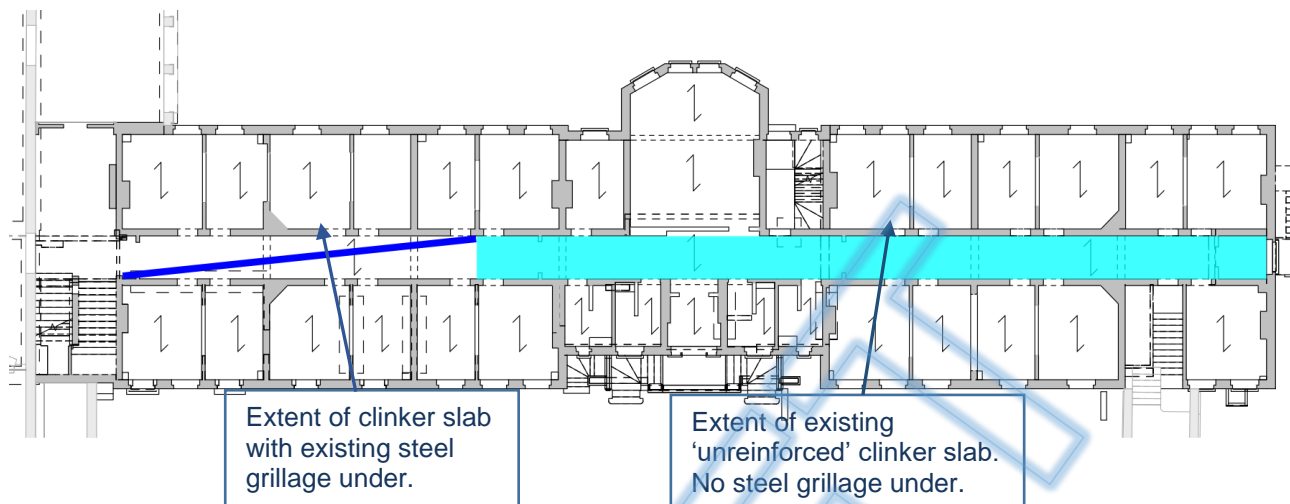
Key Plan – Upper Ground Floor – Existing Plan

- 1.1 This report is in regard to the 'clinker' concrete construction of some corridor floors in Maynard Wing. It was observed during site visits that numerous longitudinal cracks were becoming evident to the underside of the floor. Propping has been put in place as a precautionary temporary support measure. The locations affected are at upper ground and first floor level as indicated on the key plans in the appendix (section 4) of this Engineering Note.

- 1.2 Local opening up of the floor has shown that there is no reinforcement or any other form of steel support to the areas affected. The span of the floor in these locations is approximately 1800mm. It was also observed that the floor appears to be formed of a number of regular square sections. This suggests a form of precast unit that was then grouted in place. This means that the floor has limited overall structural integrity compared to casting the slab fully insitu. The longitudinal crack observed along the centre of the corridor coincides with a joint in the above noted units.

- 2.2 The form of construction encountered is very unusual and is not something that we have seen previously from our extensive experience of refurbishment projects. For the slab to work effectively it has to arch across the corridor. The resulting arch is too flat to support the imposed loads safely as localised point loads. The resulting thrust lines will likely be outside the profile of the slab which leads to the type of cracking seen in the soffit. We would therefore be unable to prove that the existing construction can span the corridor with acceptable factors of safety for its ongoing use as residential property.

- 3.1 The floor is currently considered unstable and must remain propped until replaced or re-supported.
- 3.2 We consider that the most appropriate remedial action would be to remove the existing clinker concrete and replace with a timber joist construction as used elsewhere in the building.

- 2.3 In view of the above we consider that there are two basic options available regarding making the floor both structurally adequate and safe:
1. Provide a new framing under the existing floor to fully support the existing unreinforced floor.

- 2.5 The second option requires the existing unreinforced clinker concrete slab to be removed and replaced with a new structure. Options here are either a new reinforced concrete floor or traditional timber joists and boarding. Both will require the wall to be made good where the clinker concrete is removed. The concrete option will be heavier than the current clinker concrete and it will be difficult to place wet concrete in the confines of the existing building, also significant temporary propping would be required to support the wet concrete until it hardens. Timber joisted floors are used elsewhere in the building and
