PRE-DEVELOPMENT ARBORICULTURAL SURVEY

CAMDEN GOODSYARD, CAMDEN

**PRE-DEVELOPMENT
ARBORICULTURAL SURVEY**

Report No: RT-MME-122107-01 Rev E

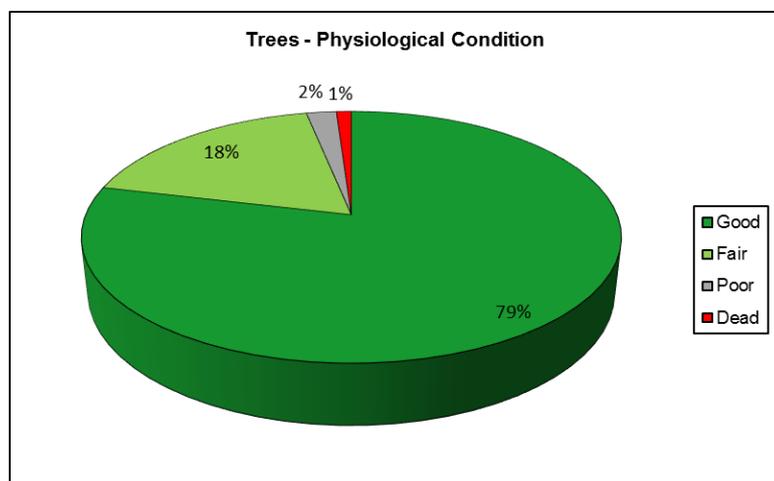
Chart 4.1: Tree Physiological Condition

Chart 4.1 summarises the distribution of tree physiological condition across the study area.

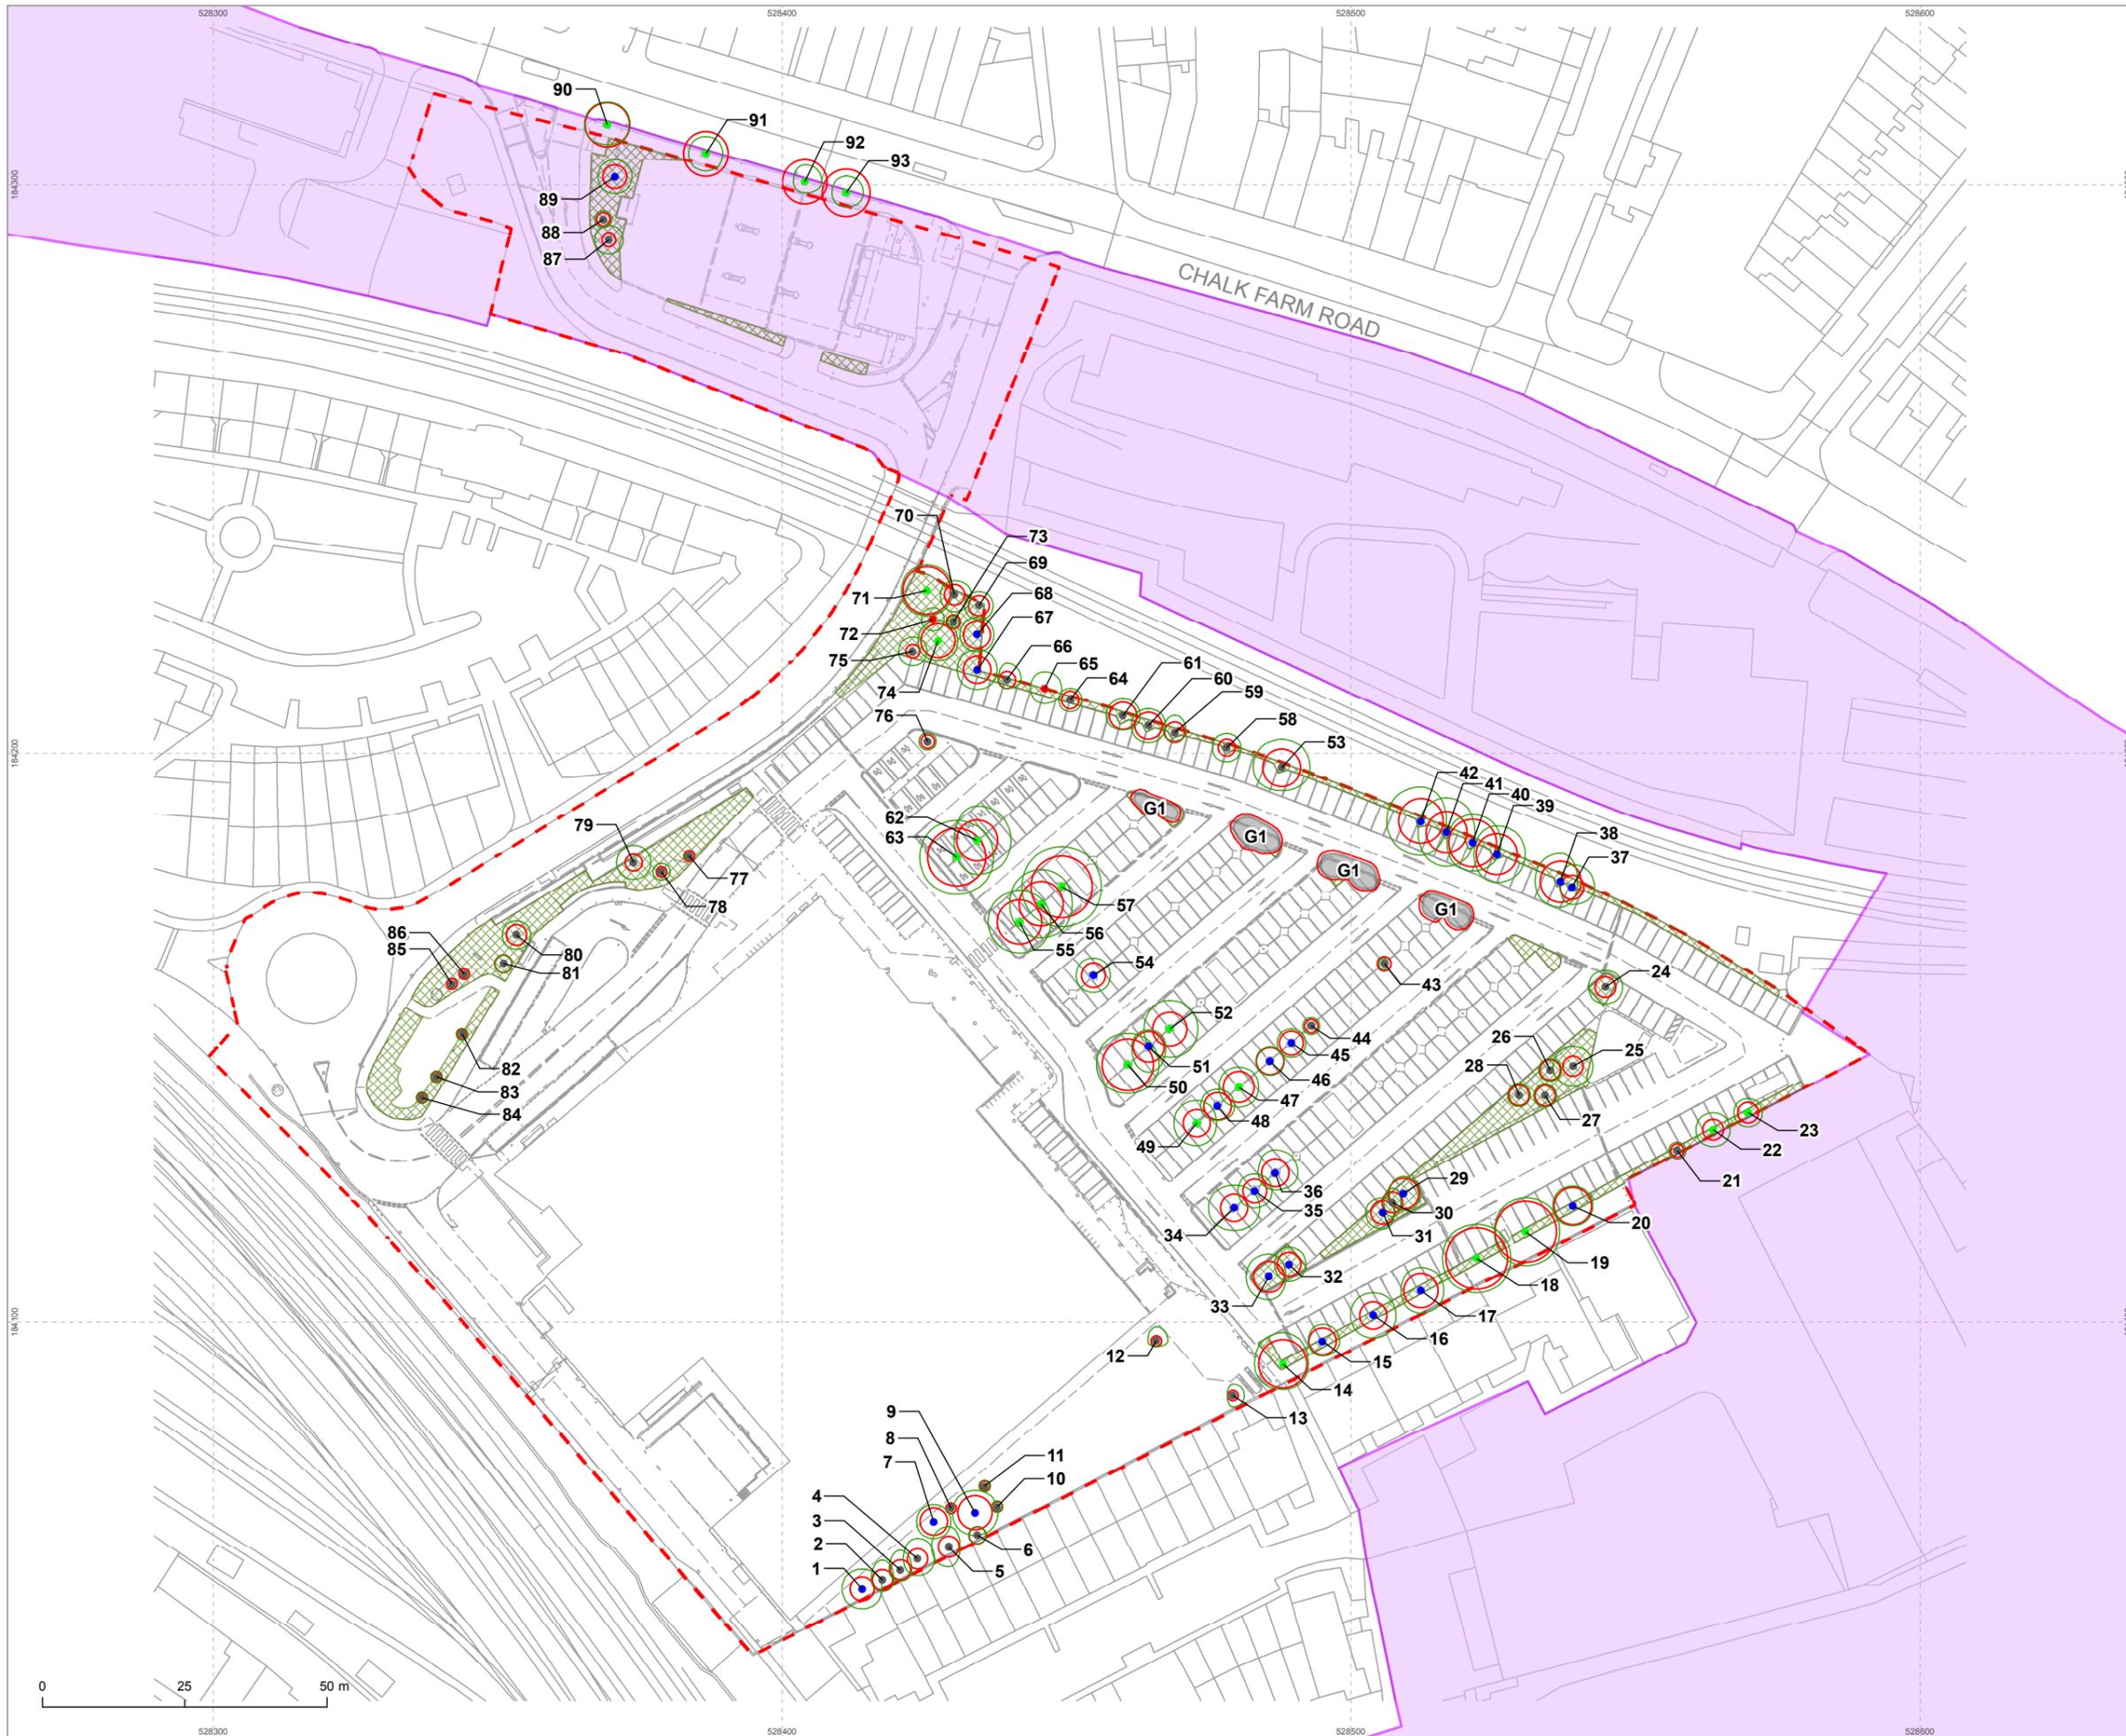
Project		Camden Goodyard, Camden	
Drawing		Tree Constraints Plan	
Client		Safeway Stores Limited and BDW Trading Limited	
Drawing Number	C122107-01-01_RevB	Revision	Rev B
Scale @ A3	1:1100	Date	November 2016
Approved By	BJ	Drawn By	RP

The Tree Constraints Plan (Drawing Number C122107-01-01 Rev B, contained within Section 7 of this report) is designed to show the influence that the trees have upon the site by virtue of their size and position. The plan seeks to act as a design tool that shows both the above and below ground constraints presented by the trees. The plan shows the initial Root Protection Area (RPA) which may be modified dependent on site conditions.
