Landmark Trees

## ARBORICULTURAL IMPACT ASSESSMENT REPORT FOR:

The Waterhouse  
Millfield Lane  
London N6 6HT

Ref: UKE/WHS/AIA/01

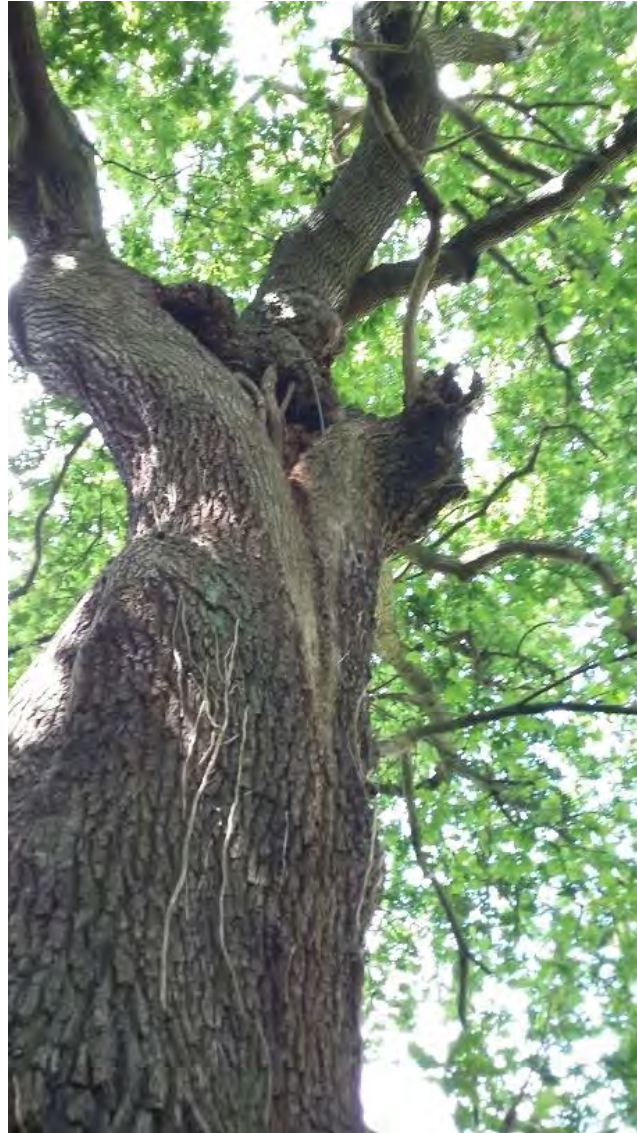
Photograph 1: T5

This tree is situated in the south part of the garden, 8 metres from the boundary. The tree has a large open cavity at 1.5 metres to the south (shown in Photograph 2 below), with further cavities at ground level, 4 metres and 6 metres. The crown appears in good health, with some minor deadwood throughout. There are currently no indications of fungal brackets.

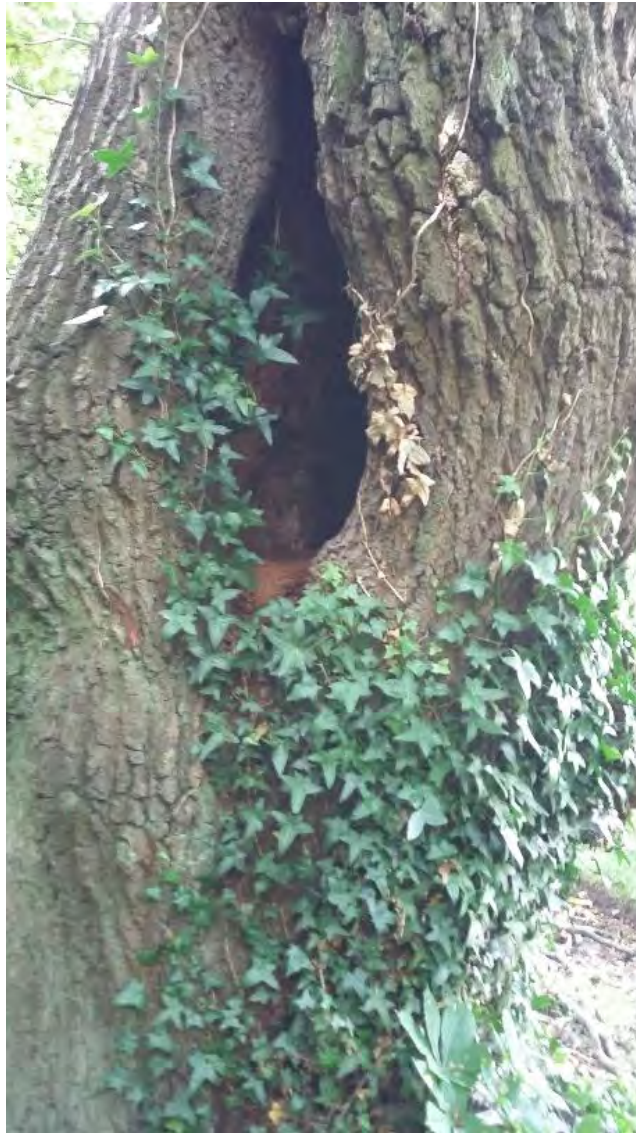
Photograph 2: Cavity at 1.5m height

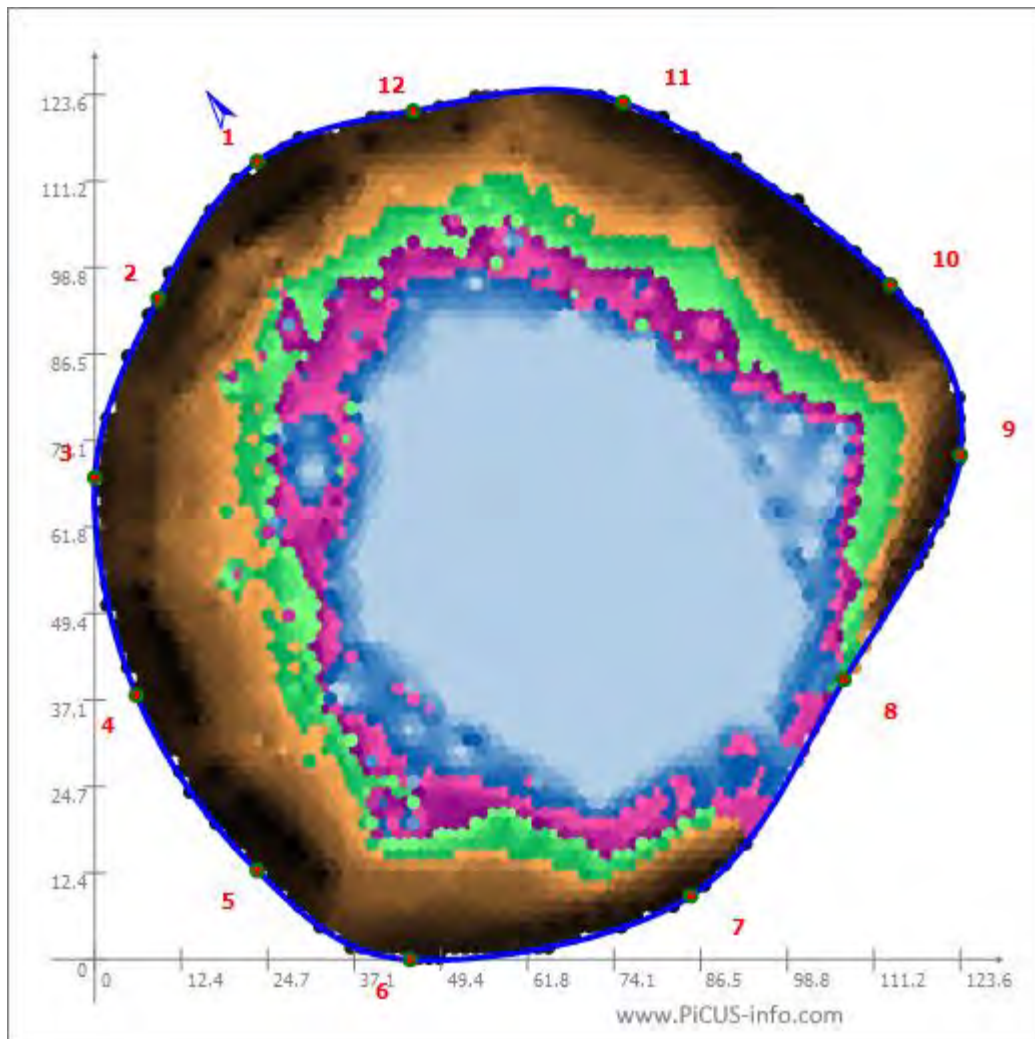
1 PICUS tomograph was undertaken at 100cm above ground level, the results of which can be seen overleaf. The tomograph shows an area of decay with a cavity shown in blue, advanced decay coloured pink/purple and the incipient or early decay coloured green.

Figure 1: Tomograph taken at 100cm above ground level

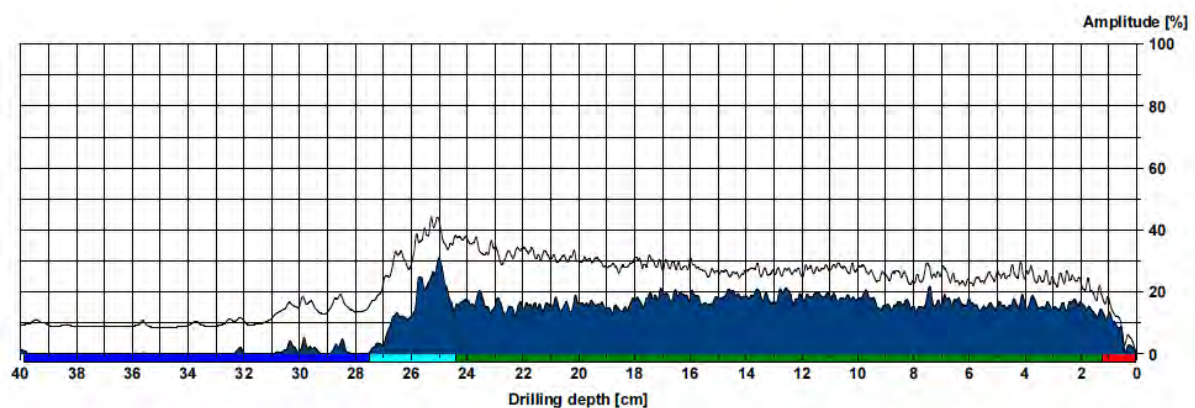
Measurement no. : 17	Needle speed : 2500 r/min	Diameter : 10.0 cm
ID number : WATERHOUSE HORNBEAM E10	Needle state : —	Level : 10.0 cm
Drilling depth : 40.00 cm	Tilt : —	Direction : East
Date : 09.06.2017	Offset : 66/271	Species : Hornbeam
Time : 15:13:12	Avg. curve : off	Location : Waterhouse
Feed speed : 50 cm/min		Name : Kim Dear

From 0.0 cm to 1.2 cm : Bark
From 1.2 cm to 24.4 cm : Good wood
From 24.4 cm to 27.5 cm : Decay
From 27.5 cm to 39.9 cm : Cavity
From 0.0 cm to 0.0 cm :
From 0.0 cm to 0.0 cm :

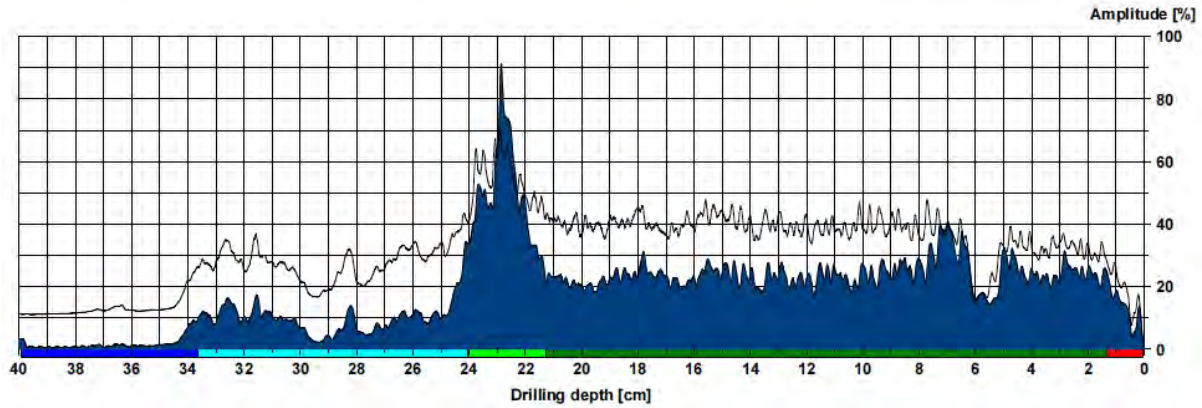
Measurement no. :	18	Needle speed :	2500 r/min	Diameter :	
ID number :	WATERHOUSE HORNBEAM N10	Needle state :	---	Level :	10,0 cm
Drilling depth :	40,00 cm	Tilt :	---	Direction :	North
Date :	09.06.2017	Offset :	62/294	Species :	Hornbeam
Time :	15:14:58	Avg. curve :	off	Location :	Waterhouse
Feed speed :	100 cm/min			Name :	Kim Dear

From	0,0 cm	to	1,4 cm	:	Bark
From	1,4 cm	to	21,3 cm	:	Good wood
From	21,3 cm	to	24,0 cm	:	Barrier zone
From	24,0 cm	to	33,7 cm	:	Decay
From	33,7 cm	to	39,9 cm	:	Cavity
From	0,0 cm	to	0,0 cm	:

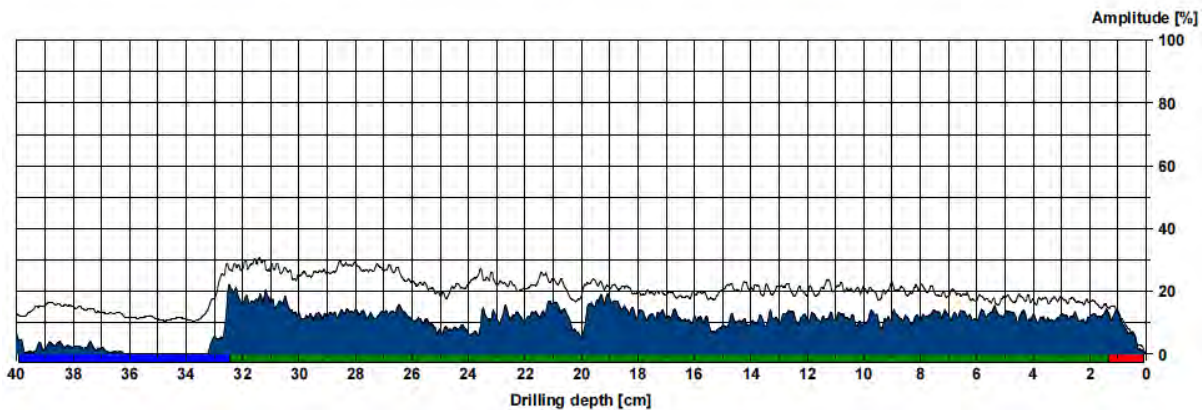
Measurement no. :	16	Needle speed :	2500 r/min	Diameter :	
ID number :	WATERHOUSE HORNBEAM S10	Needle state :	---	Level :	10,0 cm
Drilling depth :	40,00 cm	Tilt :	---	Direction :	South
Date :	09.06.2017	Offset :	58/284	Species :	Hornbeam
Time :	15:10:19	Avg. curve :	off	Location :	Waterhouse
Feed speed :	25 cm/min			Name :	Kim Dear

From	0,1 cm	to	1,4 cm	:	Bark
From	1,4 cm	to	32,4 cm	:	Good wood
From	32,4 cm	to	39,9 cm	:	Cavity
From	0,0 cm	to	0,0 cm	:	
From	0,0 cm	to	0,0 cm	:	
From	0,0 cm	to	0,0 cm	:
