Tree Hazard Assessment

West Hill Court
Millfield Lane
London
N6 6JJ

Survey Date: 26th October 2015
Report Date: 11th November 2015
Project no: 675

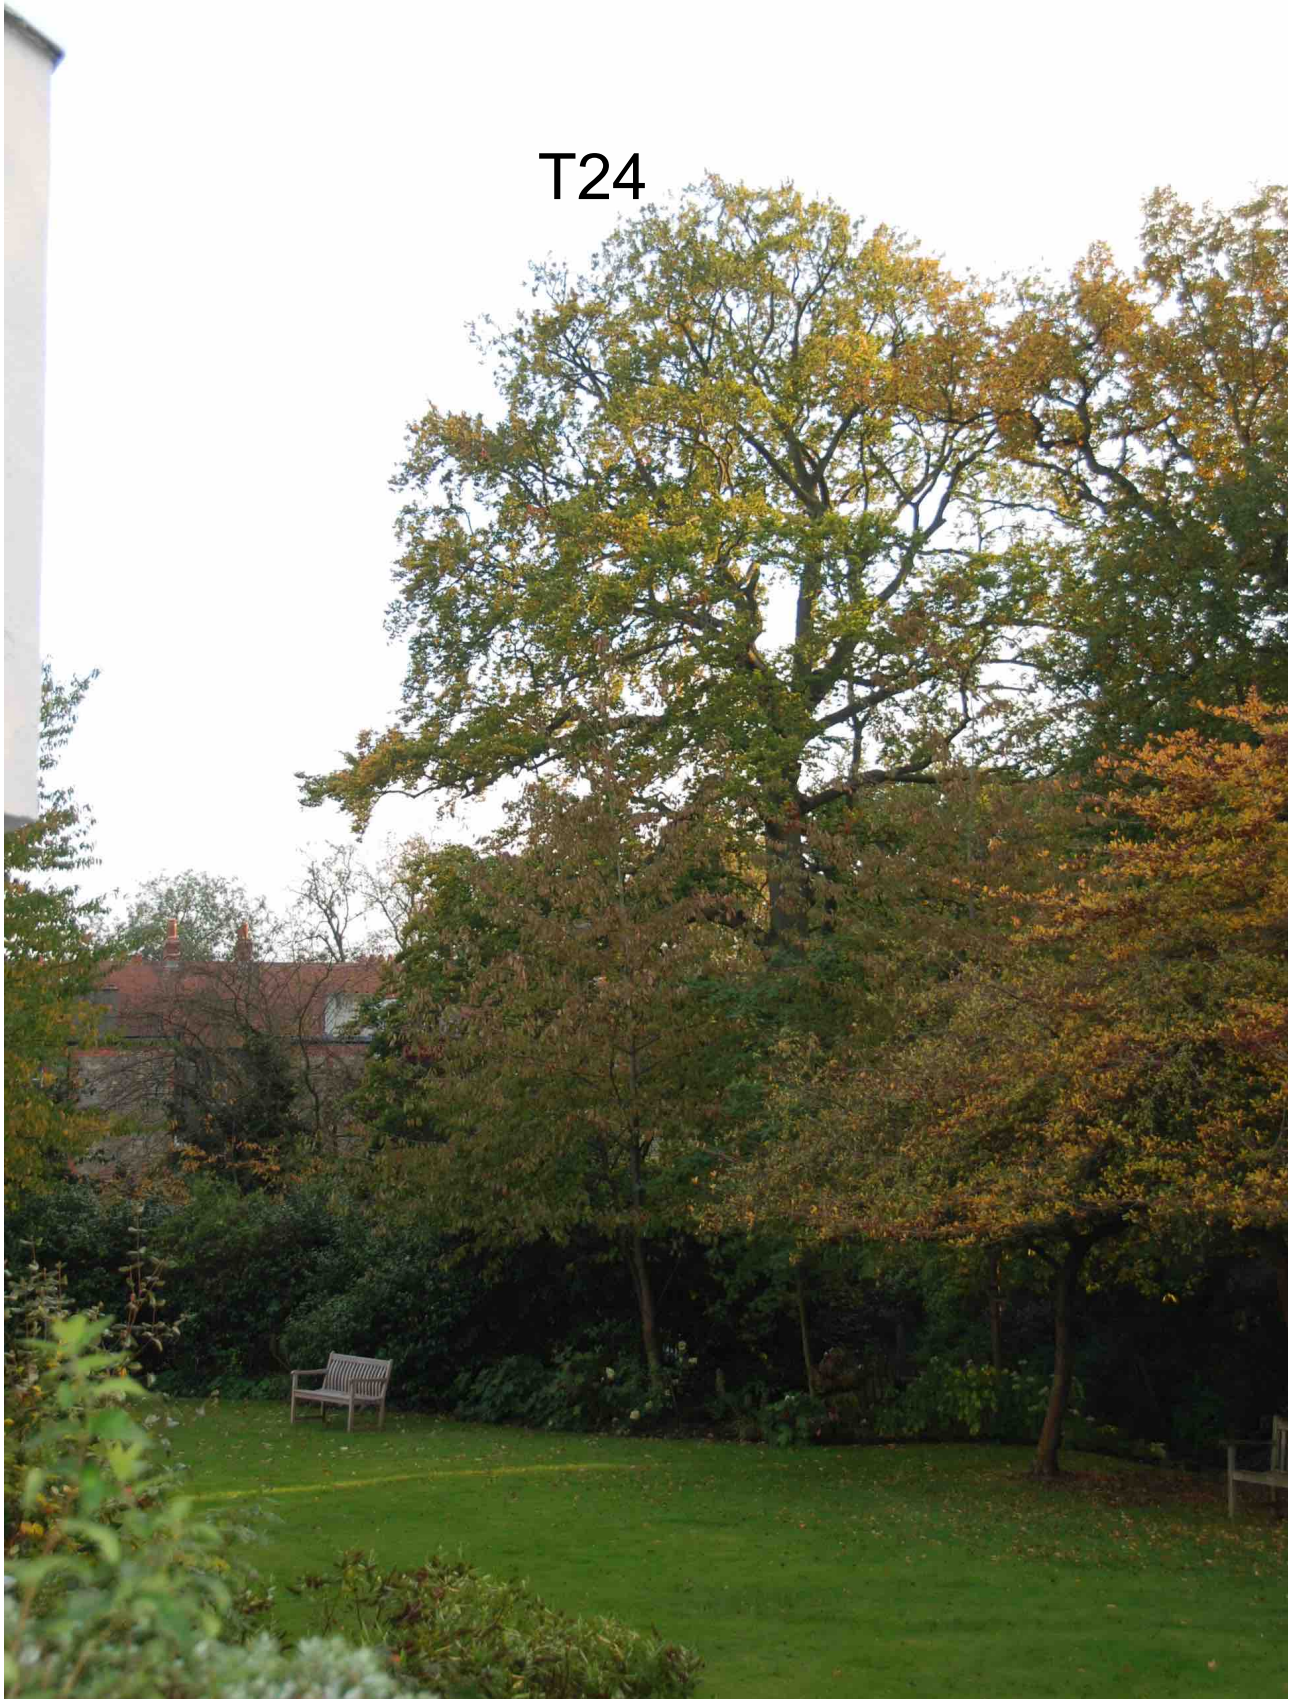
Tree/Group No.	Species	Height (m)	Stem Diam. at 1.5m (mm)	Crown Spread (m)	Age Class	Observations	Management Recommendations	Estimated Remaining Contribution (years)	BS 5837 Category Grading	Priority	Gang hours
T24	Beech	22	920	16	Mature	Only moderate vigour. Crown reduced since last inspection in September 2014, as per recommendations. Tar spots to south side of main stem from ground to 3m. Weighted to north. Area underneath fenced off.	Continue to monitor and prevent access underneath canopy.	15-30	B		
T27	Thorn	8.0	300	6	Mature	Ivy to upper crown. Crown thinning.		10-20	C		
T28	Cherry	12.5	250	8	Semi-Mature	Ivy to mid crown. Good crown shape.		20-40	B		
T30	Yew	14.0	400	12	Early mature	Foliage somewhat sparse. Possible, but vigour appears to be improving.		>40	B		
T31	Gleditsia	11.0	200	8	Early mature	Good form, structure and vigour.		20-40	B		
T32	Portugal laurel	4.0	150	5	Early mature			15-30	C
