# Arboricultural Appraisal Report

## Subsidence Damage Investigation at:

38 Steele's Road  
Hampstead  
London  
NW3 4RG

CLIENT:	Crawford & Company
CLIENT REF:	SU1605138
MWA REF:	SUB170425-1360
MWA CONSULTANT:	Mark Bisley (BSc Hons)
REPORT DATE:	08-06-2017

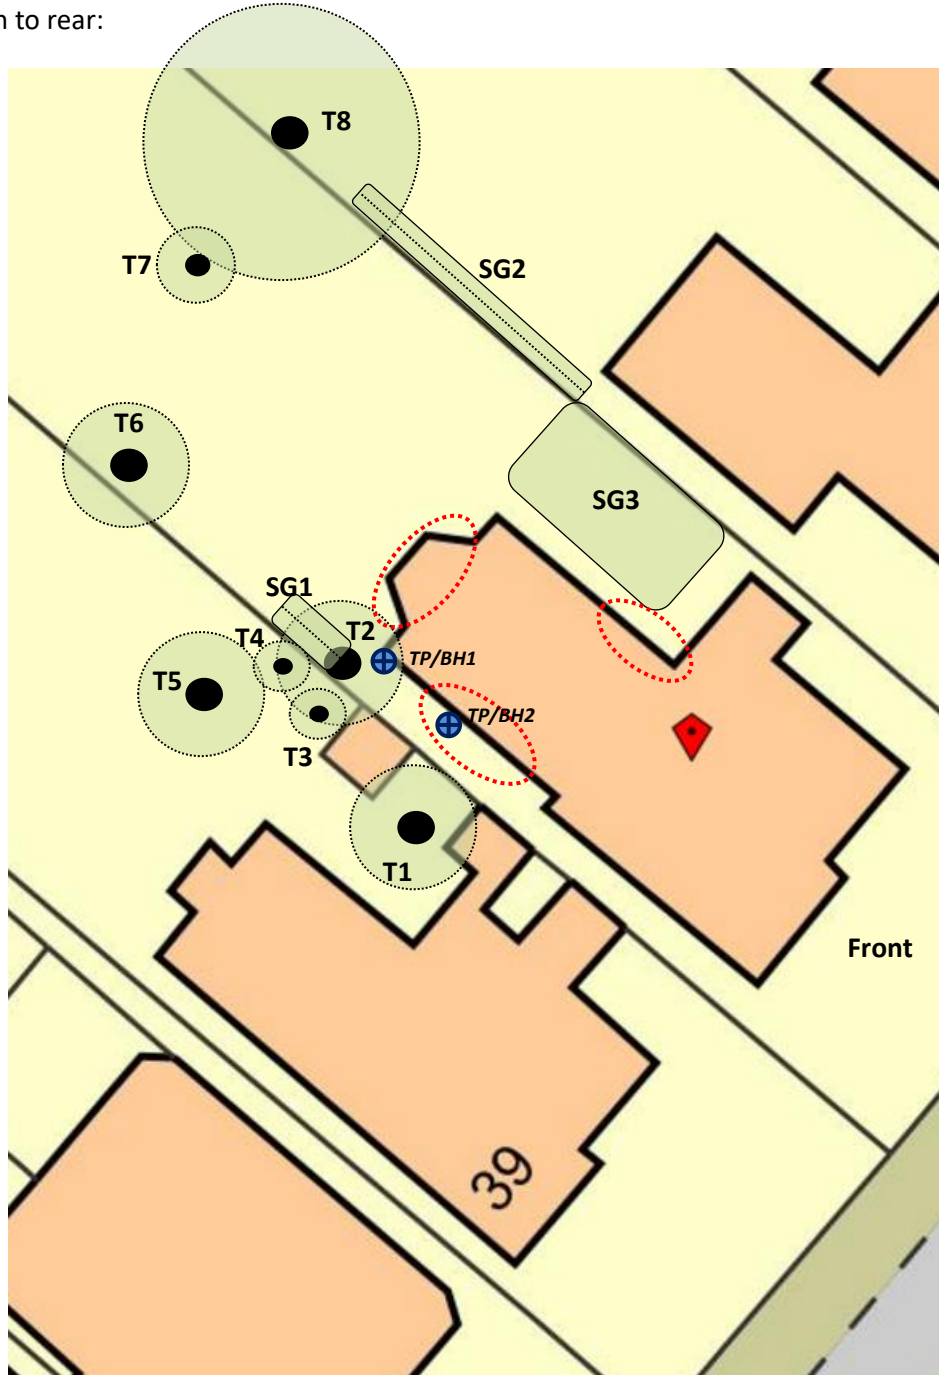
Vegetation to rear:

Approximate areas of damage

If an arboricultural solution is to be implemented to mitigate the current damage and allow the soils beneath the property to recover to a position such that an effective repair solution can be implemented we recommend that T1, T2 and part of SG3 are removed. T8 should be reduced and maintained at this reduced size.

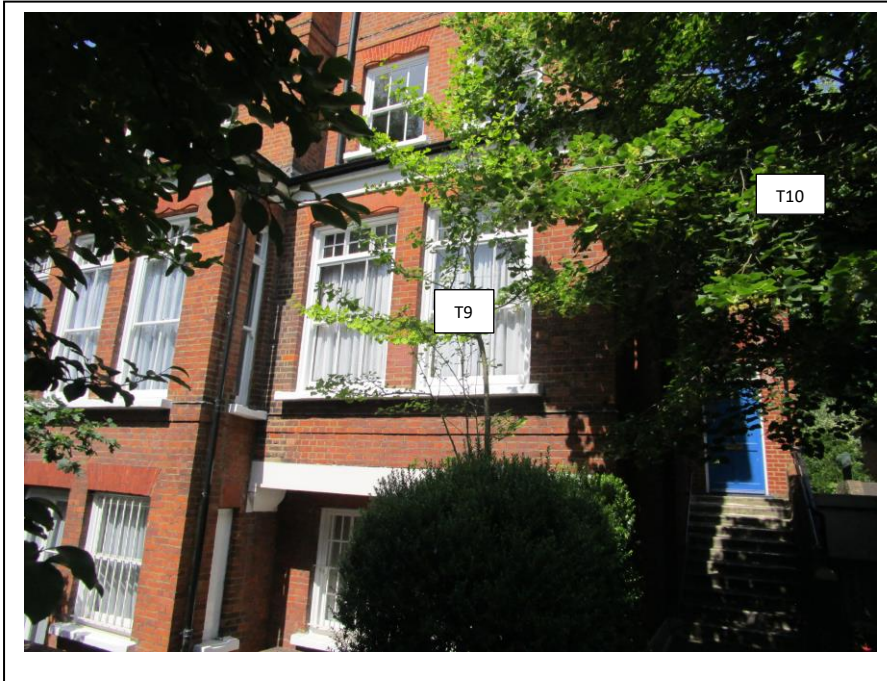
View of T9

Tree No.	Species	Ht. (m)	Dia. (mm)	Crown Spread (m)	Dist. to building (m)	Age Classification	Ownership
T9	Maidenhair Tree	6	65	3	1.75	Younger than property	Policy Holder
Management history		Growing through short length of hedge. Lifted.					
Recommendation		Remove.					
T10	Lime	12	350*	8	3.5	Younger than property	3 <sup>rd</sup> Party:- 37 Steele's Road
Management history		Heavy Ivy cover in scaffold. Reduced and lifted in the past.					
Recommendation		Do not allow to exceed current dimensions.					
T11	Holly	9	250*	5	8.1	Younger than property	3 <sup>rd</sup> Party:- 37 Steele's Road
Management history		Leans steeply away from property. Regularly crown reduced.					
Recommendation		Do not allow to exceed current dimensions.					
T12	London Plane	14	1000	6	17	Younger than property	Local Authority
Management history		Recently pollarded.					
Recommendation		Repeat pollarding on 3 year cycle.					
T13	Lime	20	370	8	11.2	Younger than property	Local Authority
