Arboricultural Appraisal Report

Subsidence Damage Investigation at:

Flats 2, 3 and 5
30 Eton Avenue
London
NW3 3HL

CLIENT:	Crawford & Company
CLIENT REF:	SU1603271
MWA REF:	SUB170323-1251
MWA CONSULTANT:	Mark Bisley (BSc Hons)
REPORT DATE:	05-04-2017

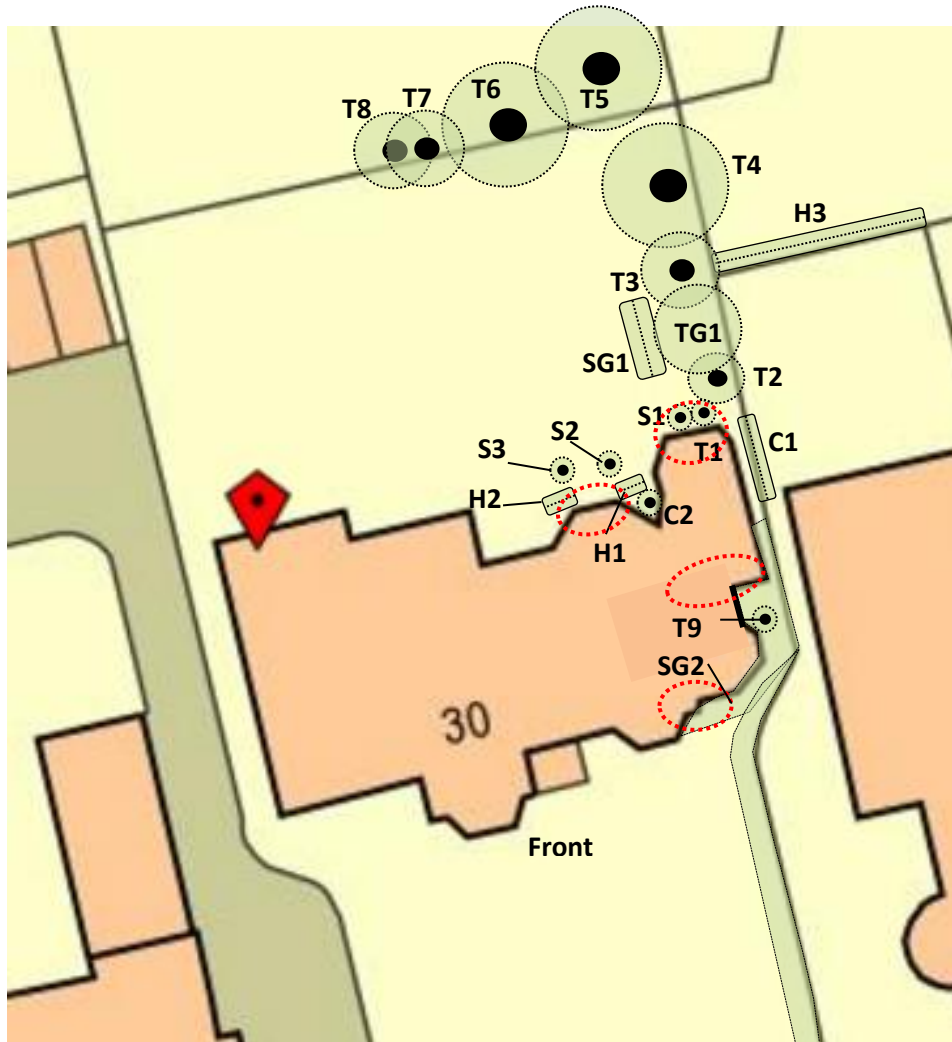
SITE PLAN

Approximate areas of damage

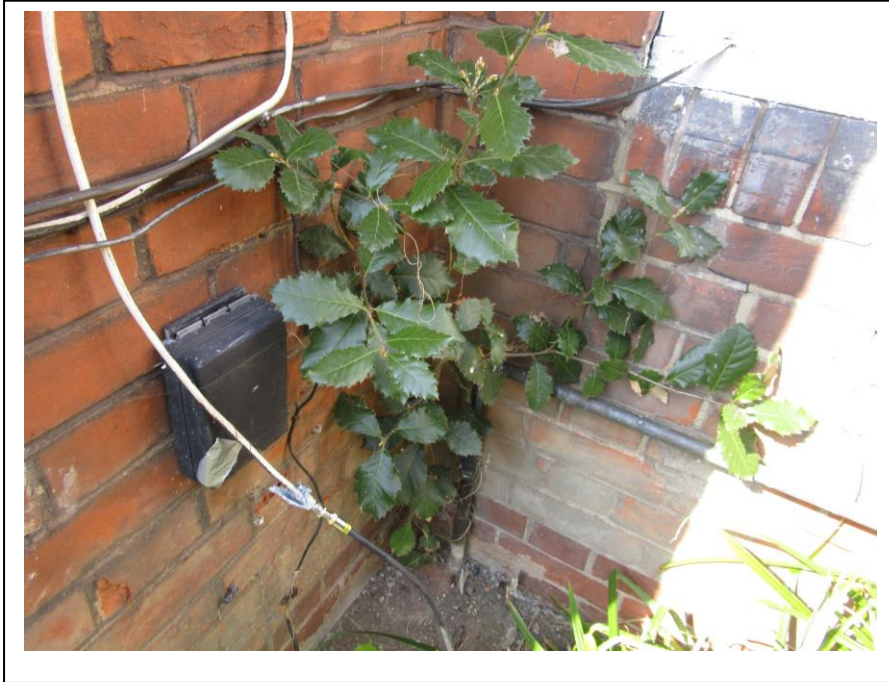
View of self-seeded tree within SG2

Having considered the available information, it is our opinion that should clay shrinkage subsidence be confirmed as the cause of subsidence, the combined influence of C2, T2, TG1 and SG2 is the principal cause of the damage. If an arboricultural solution is to be implemented to mitigate the current damage and allow the soils beneath the property to recover to a position such that an effective repair solution can be implemented we recommend that C2, T2, TG1 and SG2 are removed.
