St Giles Circus

26 Denmark Street

Temporary Removal of Timber Panelling

July 2017

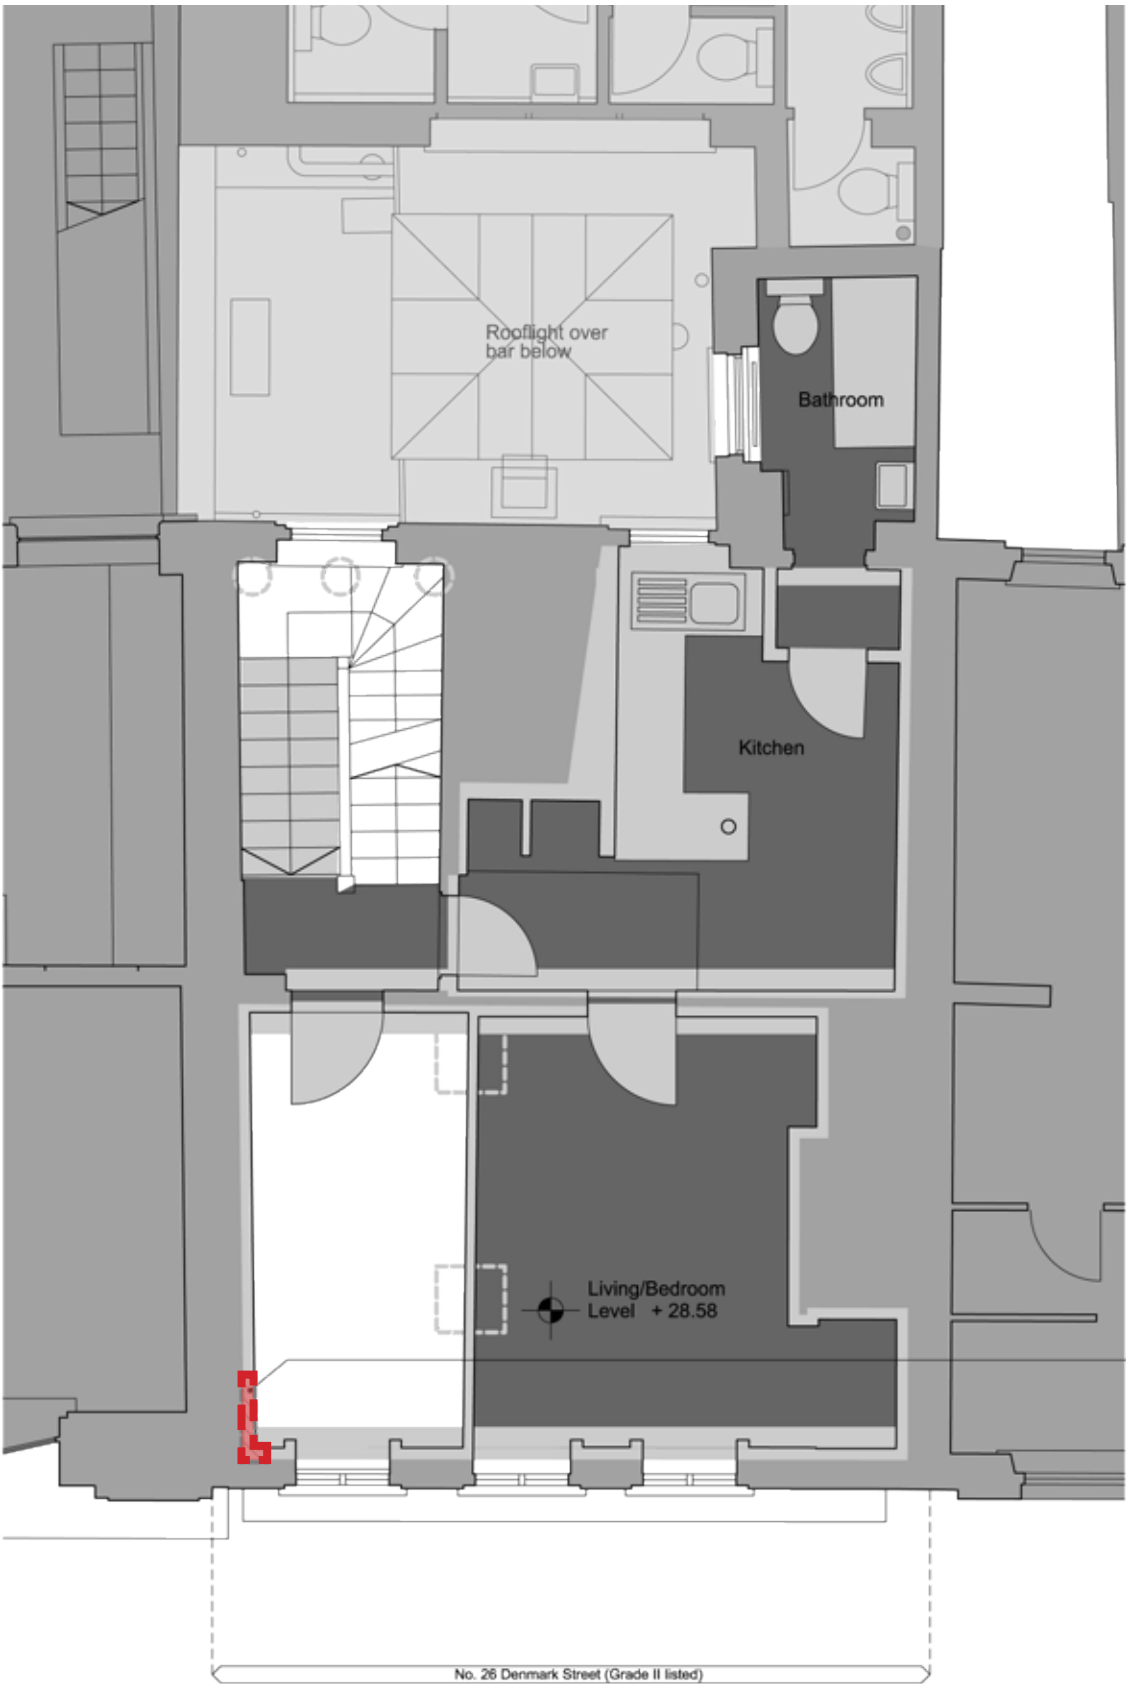
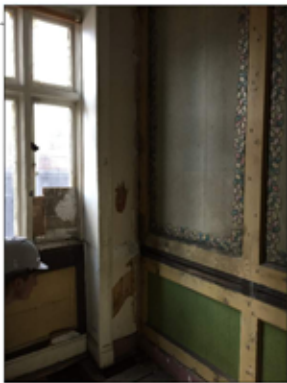
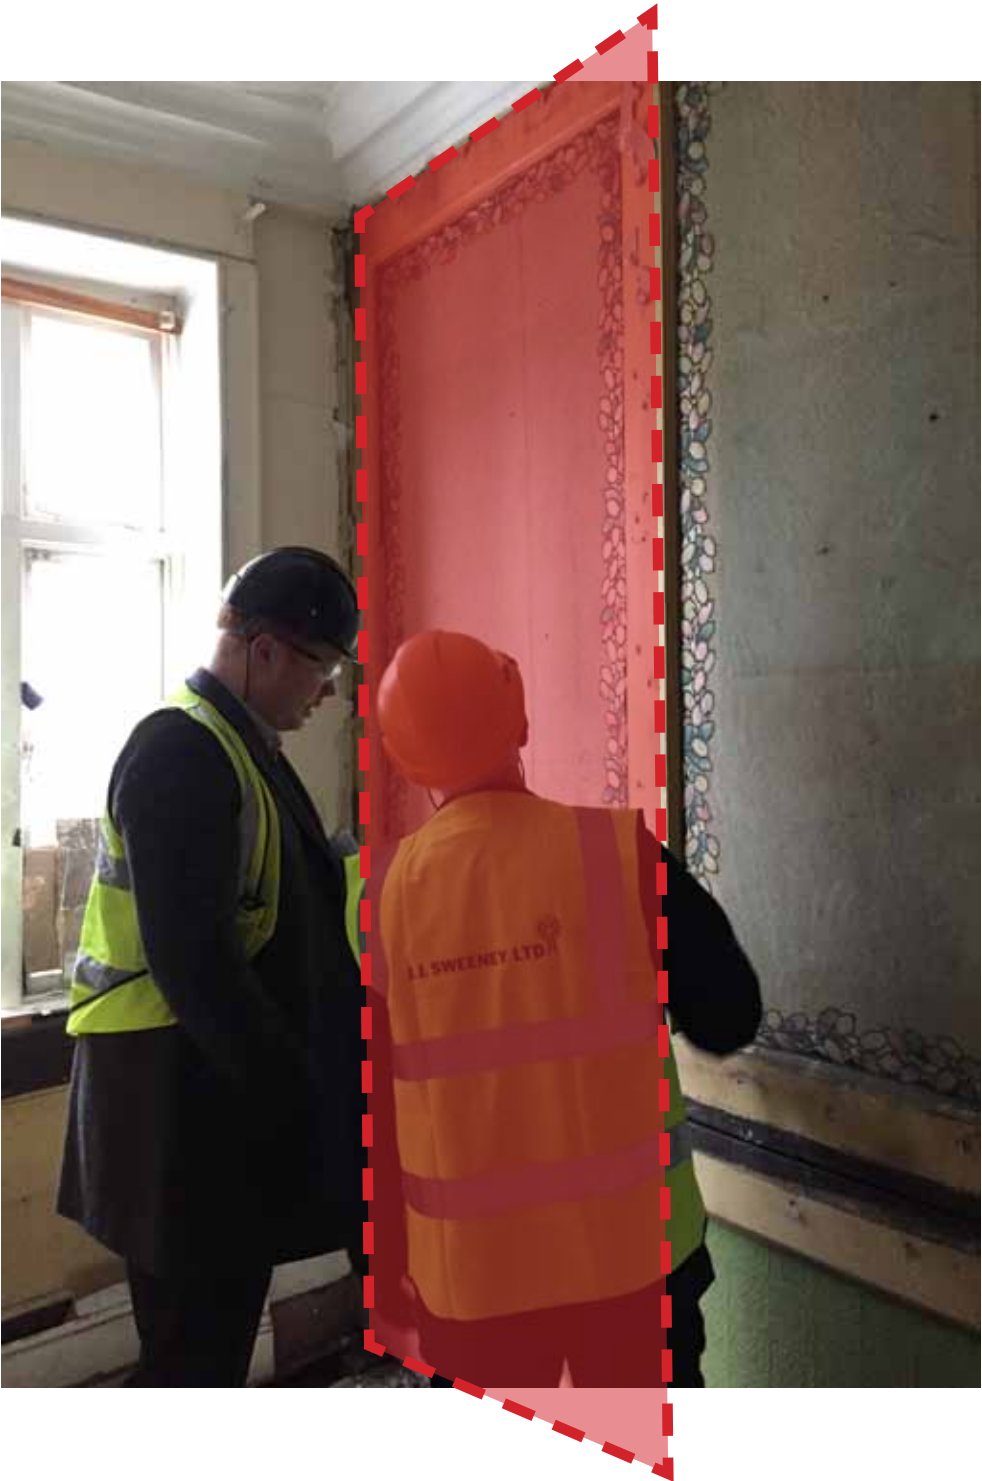
Extent of timber panelling to be temporarily removed - 1st Floor

Remove panelling (over full height) locally to expose masonry corner interface

To remove Panel A full height to expose masonry corner interface. See attached layout and photographs 1 and 2 for information. Joinery to be labelled up as it is removed and photographs taken. An 'as removed' drawing to be produced.

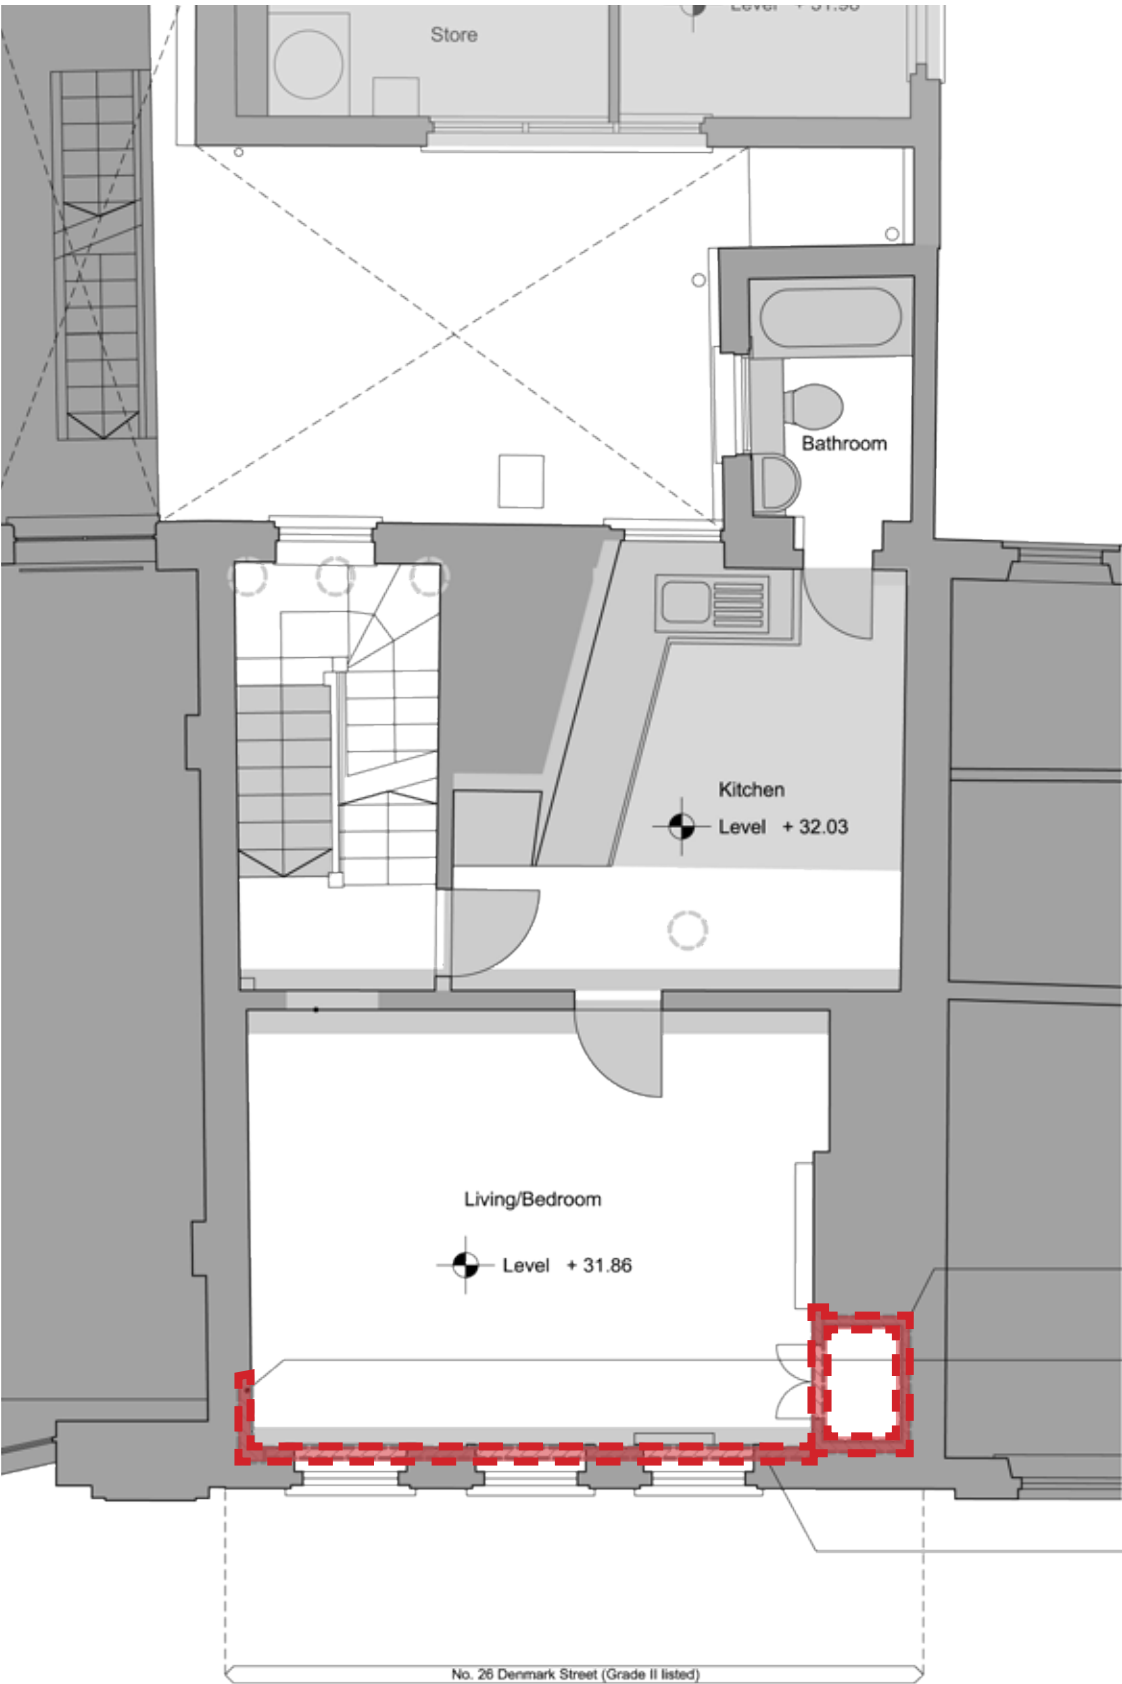
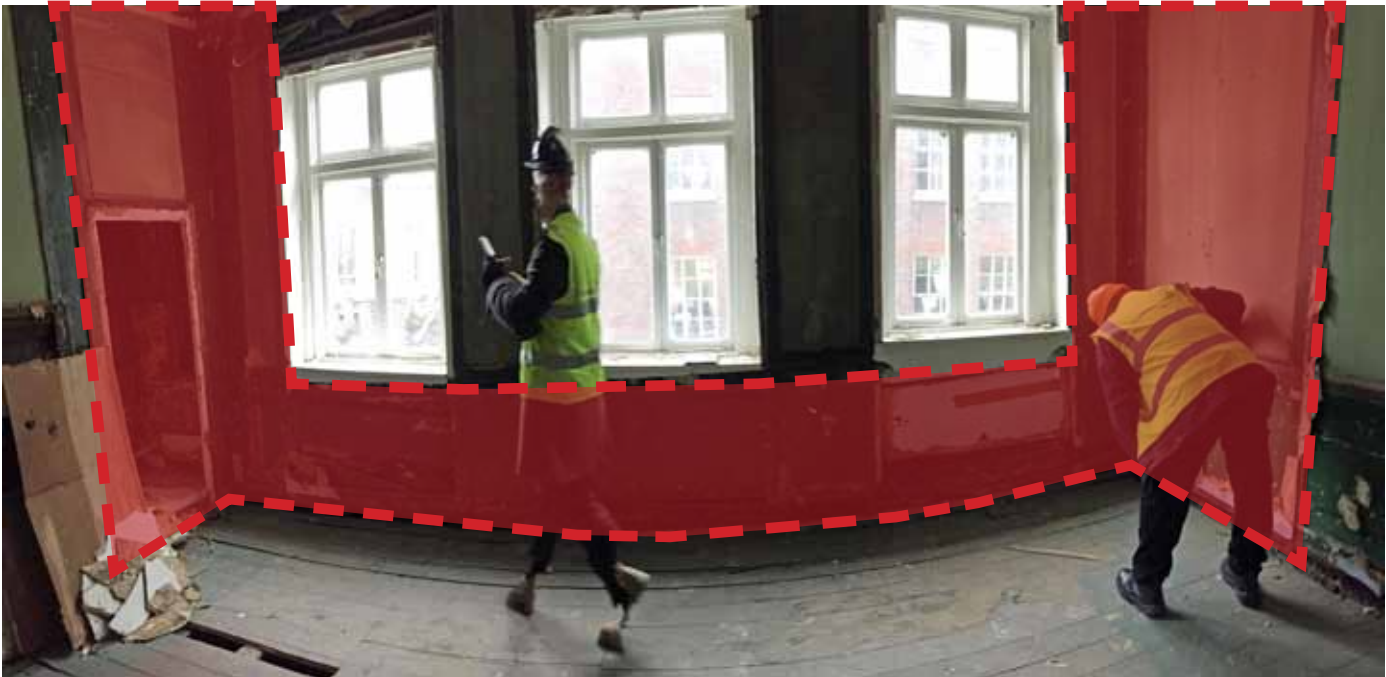
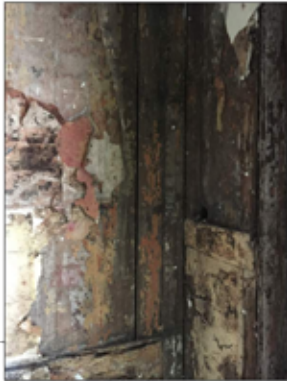
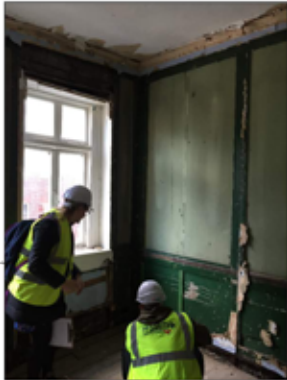
Extent of timber panelling to be temporarily removed - 2nd Floor

Scope of timber panelling to be temporary removed to allow for structural investigative works to be carried out

To remove Panels B and C and to remove all elevations within the cupboard. See attached layout and photographs 3, 4 and 5 for information. Joinery to be labelled up as it is removed and photographs taken. An 'as removed' drawing to be produced.

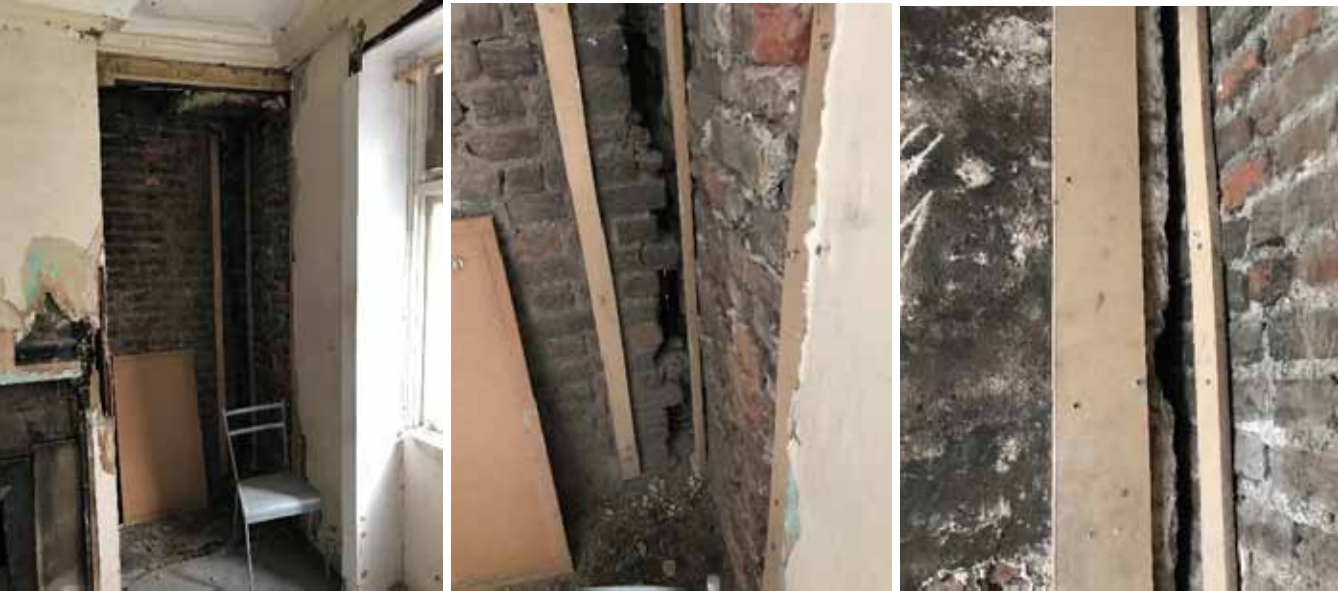
- 2.1 As noted in Alan Baxter's report on No. 26 Denmark Street, the front facade of No. 26 Denmark Street is thought to have been previously rebuilt to provide today's shop front.
- 2.2 On the recent removal of a contemporary back panel to a cupboard at first floor level, the interface between the front facade and the perpendicular Party Wall was exposed. At this location a crack of approximately 50mm width was observed, with free view in to the adjacent property.

- 2.3 Directly adjacent to this, the chimney breast to the Party Wall was also observed and seen to be separated from the wall.
- 2.4 This movement and separation of the masonry is a cause of serious structural concern. Should the defect be shown to be general to the front façade and not just local, the front façade will in effect be unsupported by flank walls and therefore reliant on the very limited structural restraint of the floor joists, or central bressummer beam.

- 2.5 Historically, this wall has shown a great deal of movement, as expressed in the slopping of the front lintels. This delamination could be the reason for this movement. Although no new movement has been recorded from the monitoring of the façade over the past few years, the lack of restraint of the masonry wall could lead to its ultimate and catastrophic failure.

- 2.6 Both the front façade and the chimney breast will be required to be tied back to their adjacent Party Walls, without this repair the wall is potentially unstable.

- 2.7 However, prior to repair, the full extent of this issue should be surveyed. To do this, the historic panelling to the walls must be removed to provide full access and view.
