Asbestos Survey Report
Project Ref. No: 112972
Kiln Place
Demolition survey

Kiln Place

Survey Type: Demolition survey

Project Reference Number: 112972

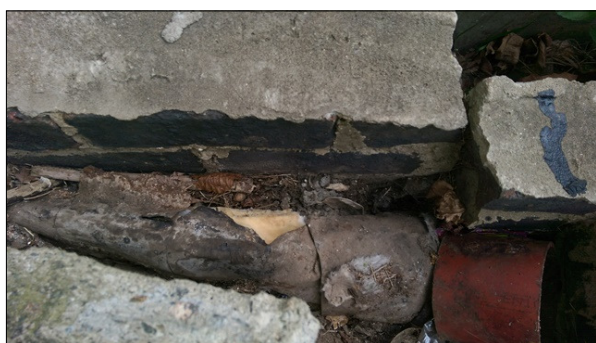
Asbestos Sample Record - 01a

Non asbestos insulation to pipes. (<2 sqm.)

| Action required: | None | | |

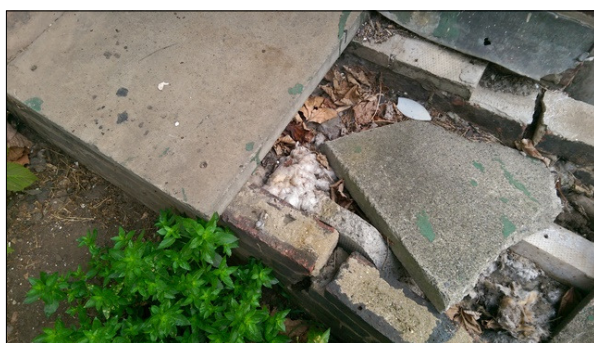
Non asbestos insulation to pipes. (<2 sqm.)

| Remedial / Management Action Required | | | |
|---|---|---|--|
| Action required: | None | | |

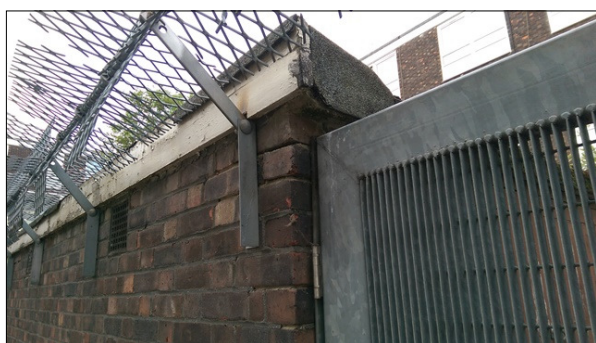
Non asbestos bitumen roof. (20 sqm.)

| Action required: | None | | |

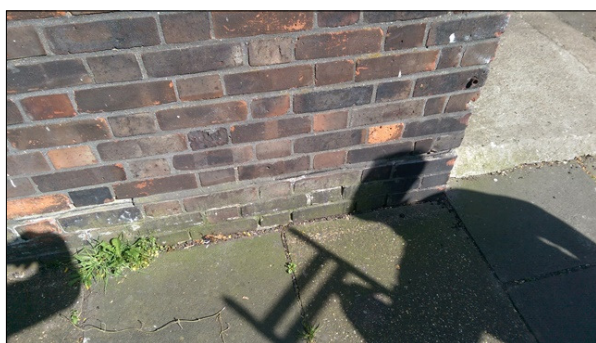
Non asbestos damp proof course. (20 sqm.)

| Action required: | None | | |

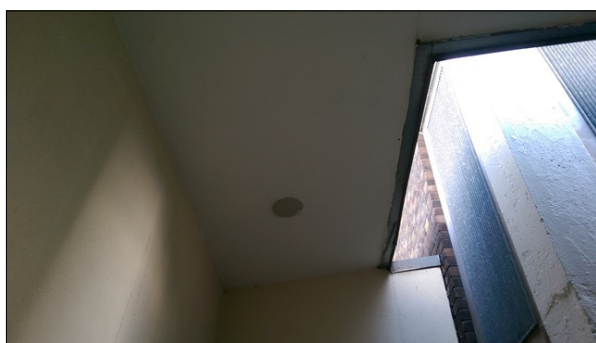
Non asbestos sandtex to ceiling. (20 sqm.)

| Remedial / Management Action Required | | | |
|---|---|---|--|
| Action required: | None | | |

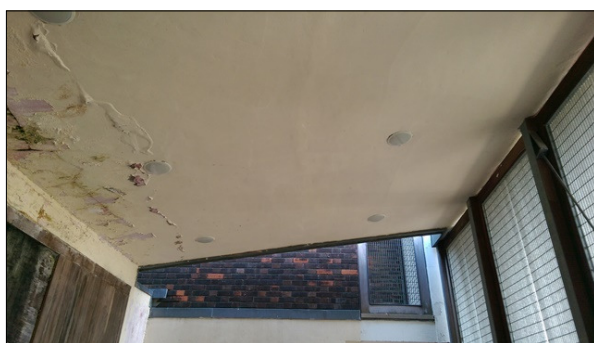
Non asbestos sandtex to ceiling. (20 sqm.)

| Action required: | None | | |

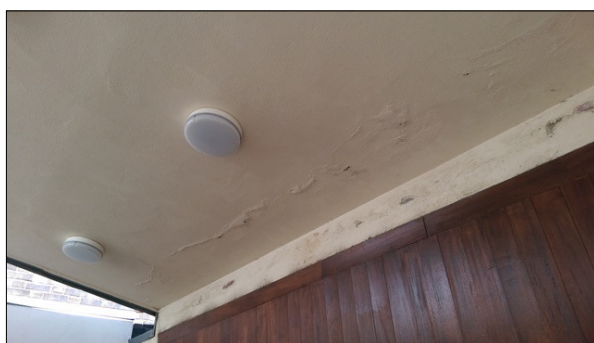
Non asbestos sandtex to ceiling. (20 sqm.)

| Action required: | None | | |
