TECHNICAL REPORT ON A SUBSIDENCE CLAIM

Crawford Reference: SU1605138

Society of Inner Light
38 Steele's Road,
Hampstead,
London
NW3 4RG

SUBSIDENCE CLAIM

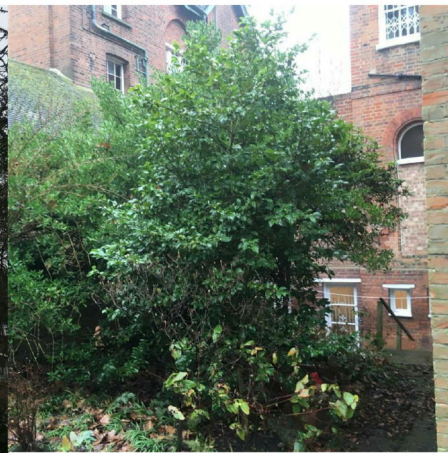
Insured's vegetation close to the right hand flank wall of the meeting room
