## **TECHNICAL REPORT ON A SUBSIDENCE CLAIM**

**Crawford Reference: SU1605138**

**Society of Inner Light  
38 Steele's Road,  
Hampstead,  
London  
NW3 4RG**

**SUBSIDENCE CLAIM**

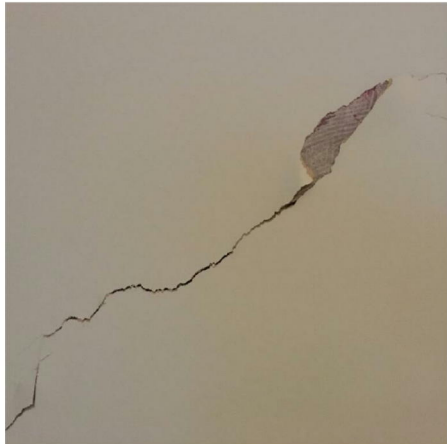
Crack to left flank wall of the meeting room

3mm diagonal cracks to the left flank wall, with 1mm parallel crack below. The focus of movement of these cracks is the mid-length of the wall

The pattern and nature of the cracks is indicative of an episode of subsidence. The cause of movement appears to be clay shrinkage.

The timing of the event, the presence of shrinkable clay beneath the foundations and the proximity of vegetation where there is damage indicates the shrinkage to be root induced. This is a commonly encountered problem and probably accounts for around 70% of subsidence claims notified to insurers.

Although the cause of the movement needs to be dealt with, we note the vegetation is located within a conservation Area. It is very likely that investigations will be required to support a planning application to remove the offending trees.

Typically, these investigations would involve trial pits to determine the depth and type of footings, boreholes to determine the nature of the subsoil/influence of any roots and monitoring to establish the rate and pattern of movement. The monitoring data provided must be sufficient to show a pattern of movement consistent with the influence of the vegetation and therefore it may be necessary to carry out the monitoring for up to a 12 month period.

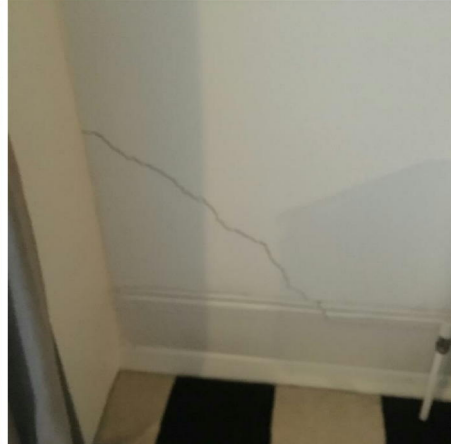
Crack to the right flank wall of the meeting room

3mm diagonal crack to the right flank wall below the window

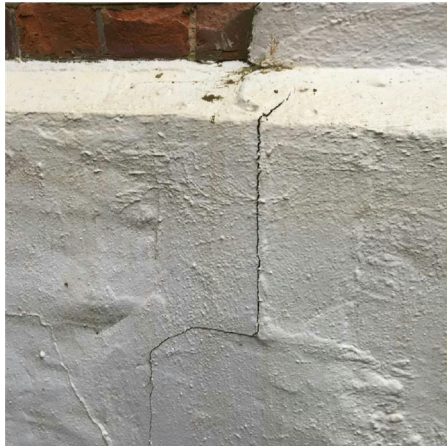
Crack to tight flank wall of the rear projection

2mm vertical crack, with 1mm diagonal crack to the right flank wall, close to the rear wall of the main building

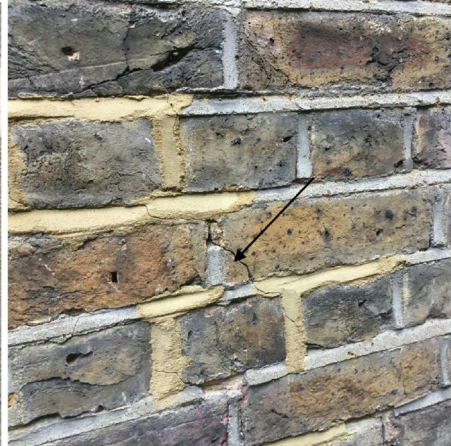
Crack to the left flank wall of the rear projection

1mm diagonal cracks to the left flank wall with evidence of repointing

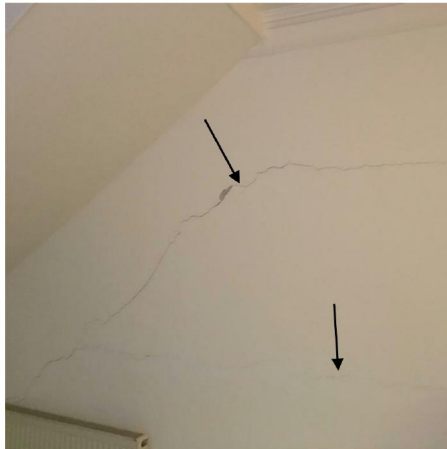
Cracking to the left flank wall of the meeting room

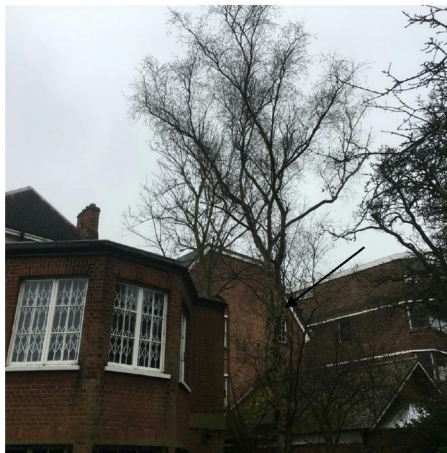
| Type | Height | Distance | Ownership |
|---|---|---|---|
| Birch | 12 m | 1 m | Owners |

Insured's tree close the rear corner of the meeting room

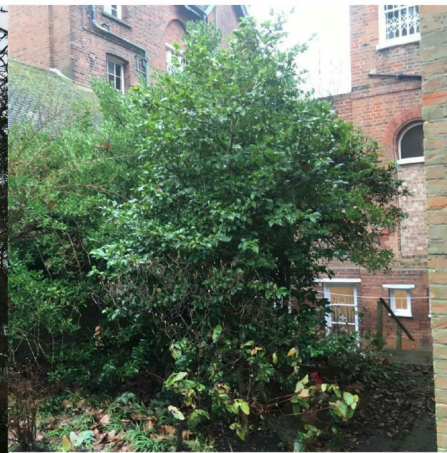
Insured's vegetation close to the right hand flank wall of the meeting room

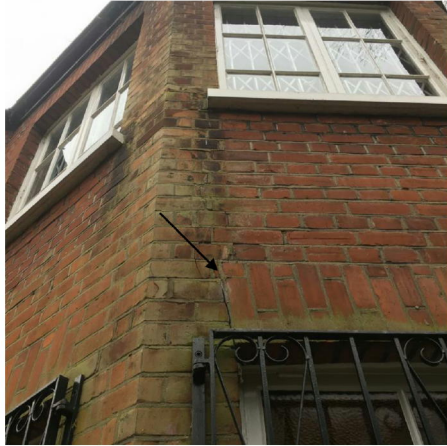
3mm crack over, and 1mm vertical crack below the windows to the right hand splay of the rear bay.

Cracks over the rear bay windows

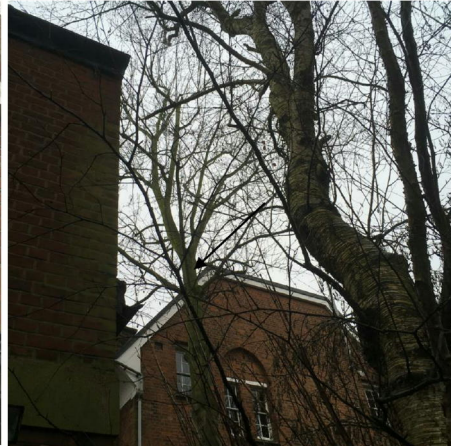
| Type | Height | Distance | Ownership |
|---|---|---|---|
| Deciduous | 12 m | 3 m | No 38 Steels Road |

Tree (arrowed) in no 38 Steels Road

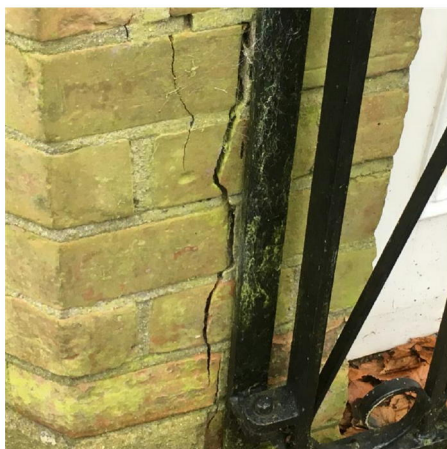
2 no 2mm vertical cracks to the rear wall of the rear bay, extending from ground to upper floor window

Cracking at the foot of the rear bay
