Figure 1. Roof Plan
23 Macklin Street

23 MACKLIN STREET
A Brickwork Report by T.J. Shepherd

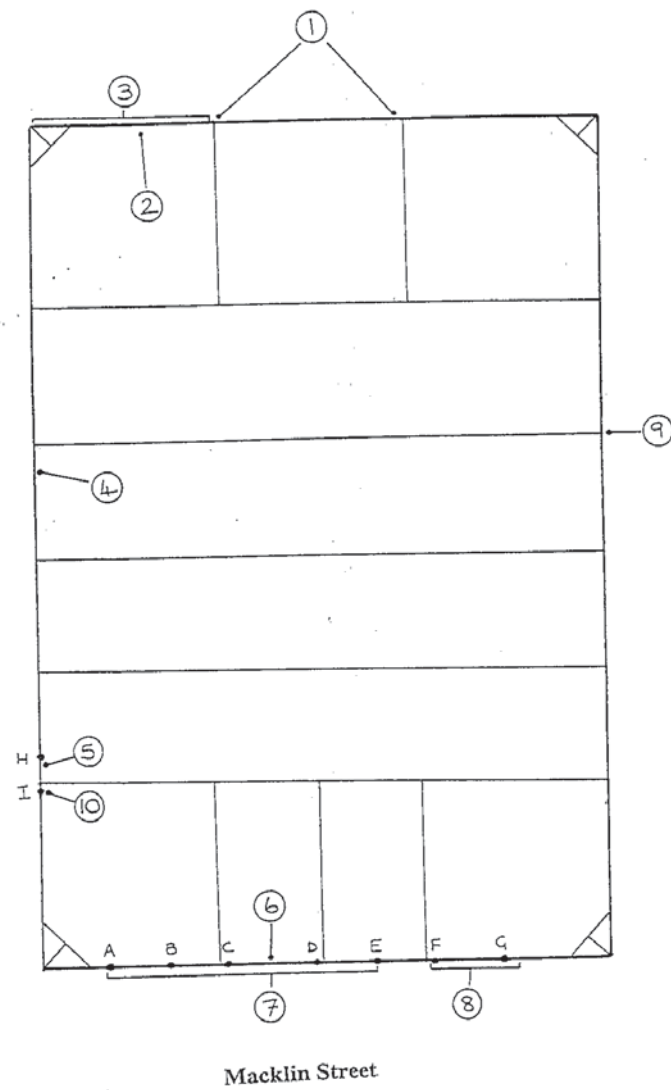
The locations of our observations are identified as points 1-10 in figure 1. These are detailed as follows:

1. Tie beam bearings embedded into the brickwork. Bearing sound as far as accessible.
2. Rafter badly fractured.
3. Considerable water ingress, but no significant decay.
4. Considerable water ingress. One rafter foot slightly decayed by a white resupinate fungus. Back of wall plate decayed by a white rot. Damage superficial. Currently dry.
5. Rafter plate fractured.
6. Large plant root/stem (approximately 20mm diameter) penetrating masonry.
7. Undersurface and back of wall plate decayed.
8. Wall plate appears compressed.
9. Small patch of wet rot decay in beam end. Bearing not decayed.
10. Wall plate decayed at back adjacent to tie beam.

Sites of drillings are located as points A to I in figure 1. All drillings were made into the wall plate. At each of the sites A to G, three drillings were made horizontally into the vertical face of the wall plate. The first (1) at a height of 30mm from the top of the wall, the second (2) at 70mm, and the third (3) at 150mm. This enables us to begin to estimate the extent of the decay at the back of the plate. Our findings are as follows:

- A1. Decayed to 25mm, sound to 70mm, then decayed to full extent of timber (150mm).
2. Decayed to 25mm, sound to 65mm, then decayed to full extent of timber (150mm).

3. Decayed to 35mm, then sound.
- B1. Decayed.
2. Decayed.
3. Decayed to 30mm, sound to 140mm, then decayed to full extent of timber (150mm).
- C1. Decayed to 20mm, sound to 40mm, then decayed to full extent of timber (150mm).

2. Sound to 70mm, then decayed to full extent of timber (150mm).
3. Sound to 80mm, then decayed to full extent of timber (150mm).
- D1. Decayed to 15mm, sound to 35mm, then decayed to full extent of timber (150mm).

2. Decayed to 15mm, sound to 55mm, then decayed to full extent of timber (150mm).
3. Decayed to 15mm, sound to 50mm, then decayed to full extent of timber (150mm).

- E1. Sound to 70mm, then decayed to full extent of timber (150mm).
2. Sound to 115mm, then decayed to full extent of timber (150mm).
3. Sound to 135mm, then decayed to full extent of timber (150mm).

- F1. Sound to 75mm, softened to 115mm, then decayed to full extent of timber (150mm).
2. Sound to 95mm, then softened to full extent of the timber.
3. Sound and dense to 110mm, soft to 140mm, then sound and dense to 150mm.

- G1. Sound to 110mm, then decayed to full extent of timber (150mm).
2. Sound to 105mm, then softened to full extent of timber (150mm).

3. Sound and dense to 55mm, then sound to full extent of timber but with much reduced density.
- H. Sound to full extent of timber (200mm), though reduced density from 150mm to 200mm.
- I. Decayed to 30mm, sound to 90mm then decayed to full extent of timber (200mm).

There has been considerable water ingress at roof level, but comparatively little decay. We would attribute this to the high quality and natural durability of the timbers. Where timber is in contact with damp masonry, particularly on more than one face, then the likelihood of decay is high. The most significant decay by far is restricted to the wall plate on the Macklin Street elevation where large sections are decayed at the back.

It may be necessary to replace the wall plate on this elevation. We would suggest that good quality Douglas Fir be used as replacement, and that this should be isolated from the wet masonry with a damp proof membrane. Alternatively, repairs could be made using reclaimed timbers of similar age and quality.
