**55 FITZJOHNS AVENUE,
LONDON NW3 6PH**

REPORT on CONDITION OF ROOFS

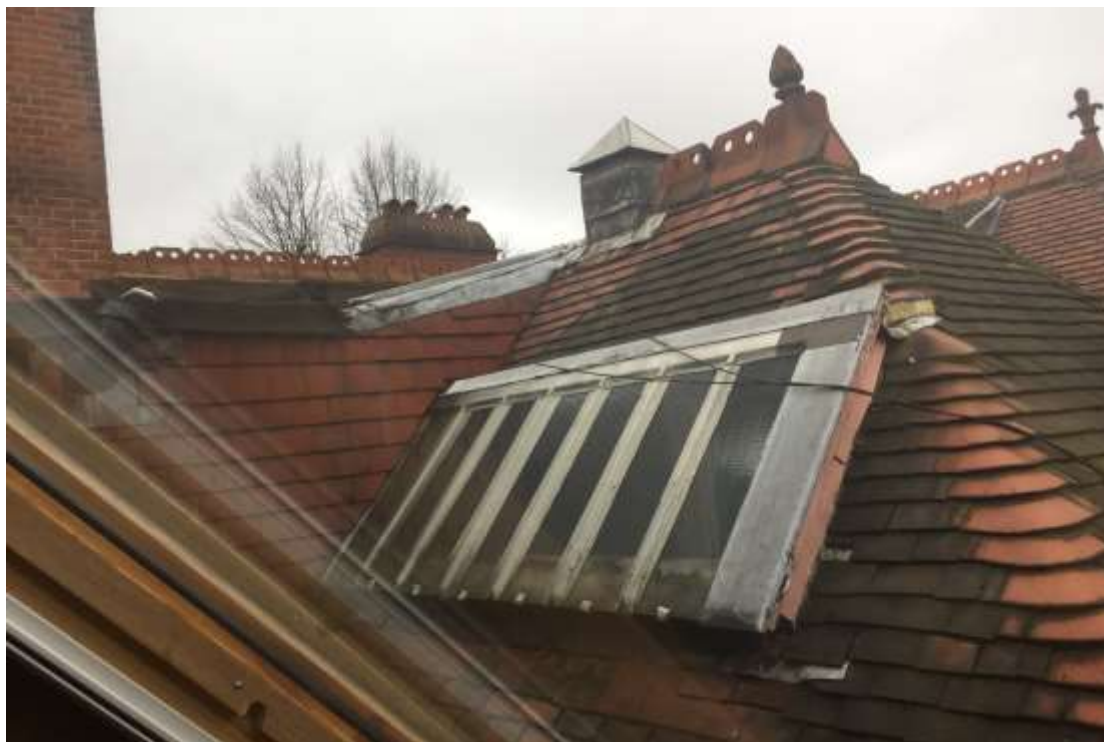
VIEW OF PART ROOF – ITEM a)

- a) In the central section either side of a tiled pitched roof are two rooflights which are in a timber frame clad with lead flashings and 6No. panes of glass within each rooflight and glazing bars between. Looking at the condition of the flashing details around the timber frame to the rooflight it does appear that the flashing details may not be sufficiently waterproof and especially where the flashing is tucked into some of the adjacent tiles and there appears to be some missing ridge tiles where the rooflight meets an angled ridge between the pitched slope and an adjacent hipped slope.
- b) Where a pitched slope to the hip end and encloses to the rooflights referred to above there is evidence of displacement of tiles, slipped tiles, and tiles having been poorly refitted possibly the result of piecemeal repairs.

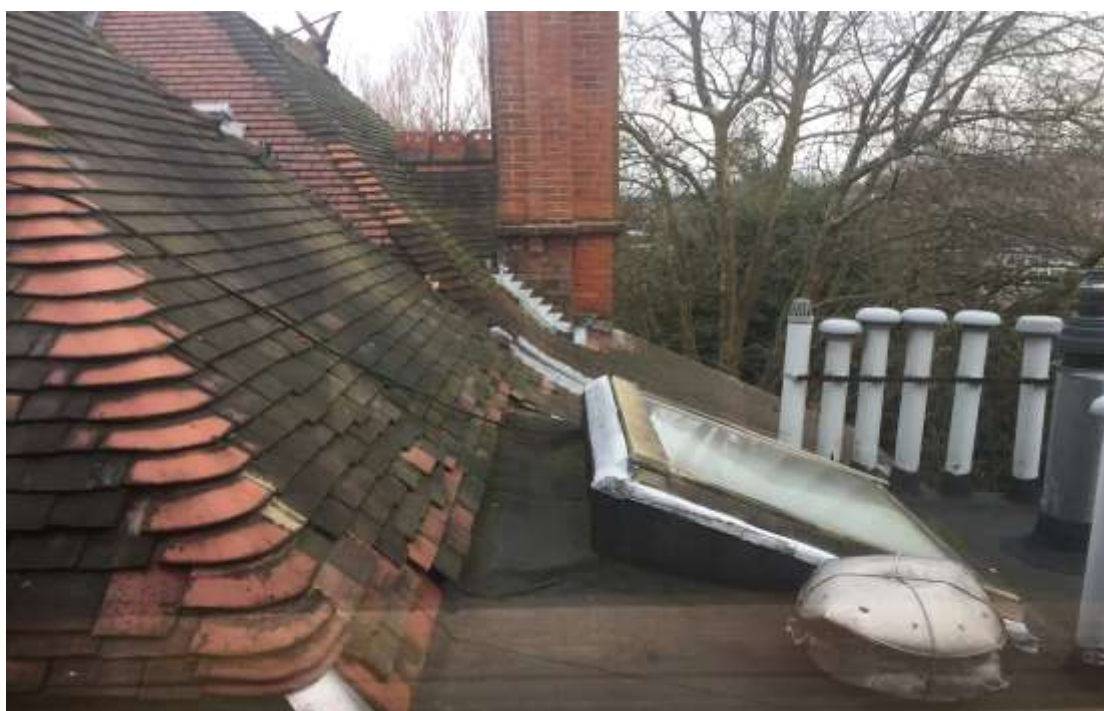
VIEW OF PART ROOF - ITEM b)

When carrying out piecemeal repairs to tiles it is impossible for the repaired tile to be properly secured and as a result the tile has to be inserted and held by the self-weight and in place by adjacent tiles which often is not satisfactory long term repair.

Also adjacent to this tiled surface is another rooflight which appears to have lead flashing detail drips around it. The rooflight is raised on a timber plinth which should be waterproofed with bitumen felt. Looking at the lead flashing detail this again does not appear to be satisfactory or could be at risk of water penetration occurring

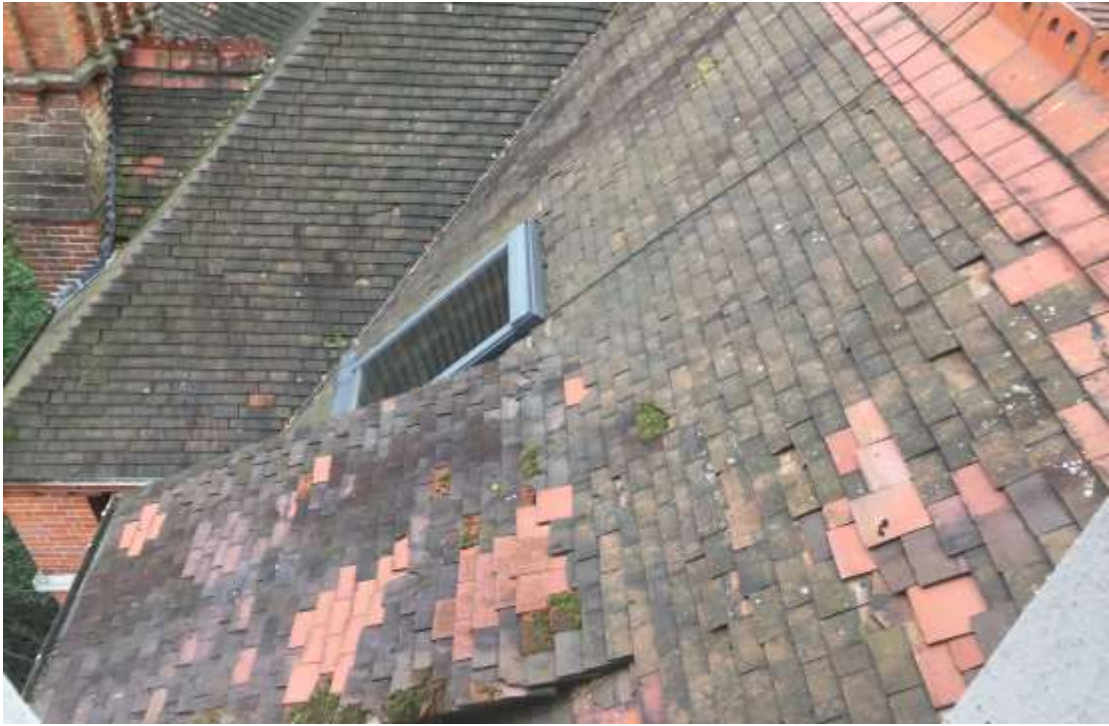
VIEW OF PART ROOF - ITEM c)

- c) On the main south facing slope to the side of the property there were large number of tiles which have been both replaced and a large number of tiles which have become slipped and are breaking. This slope has reached the end of its natural life and would require stripping and re-covering. (See comments below with regard to remedial work).
- d) The front part of the roof which is the east side of the property is a double pitched roof with partial hipped ends north and south. The slope of the roof which does not face the front of the property but actually faces towards the

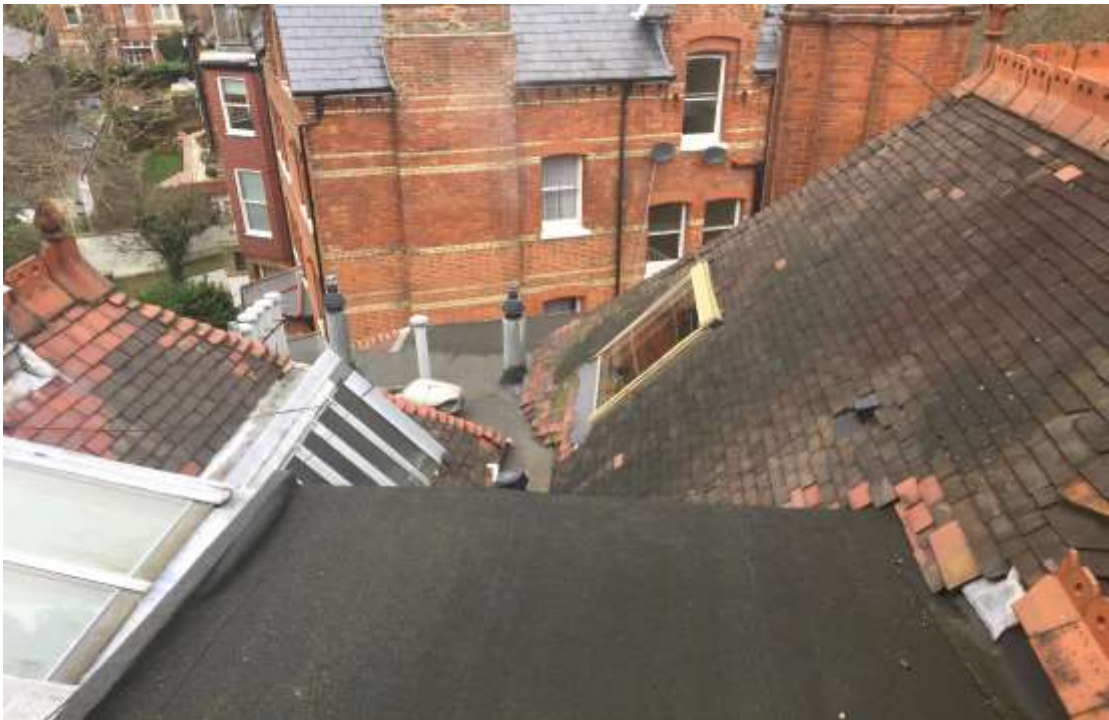
VIEW OF PART ROOF - ITEM d)

rear is not in good condition. A number of slates have become dislodged and piecemeal partial repairs have already been carried out. Some of the tiles to the ridge have become broken.

When undertaking remedial works it should be noted that some of these ridge tiles might be difficult to obtain and it may be necessary to approach appropriate heritage providers and/or possible architectural reclamation specialist.

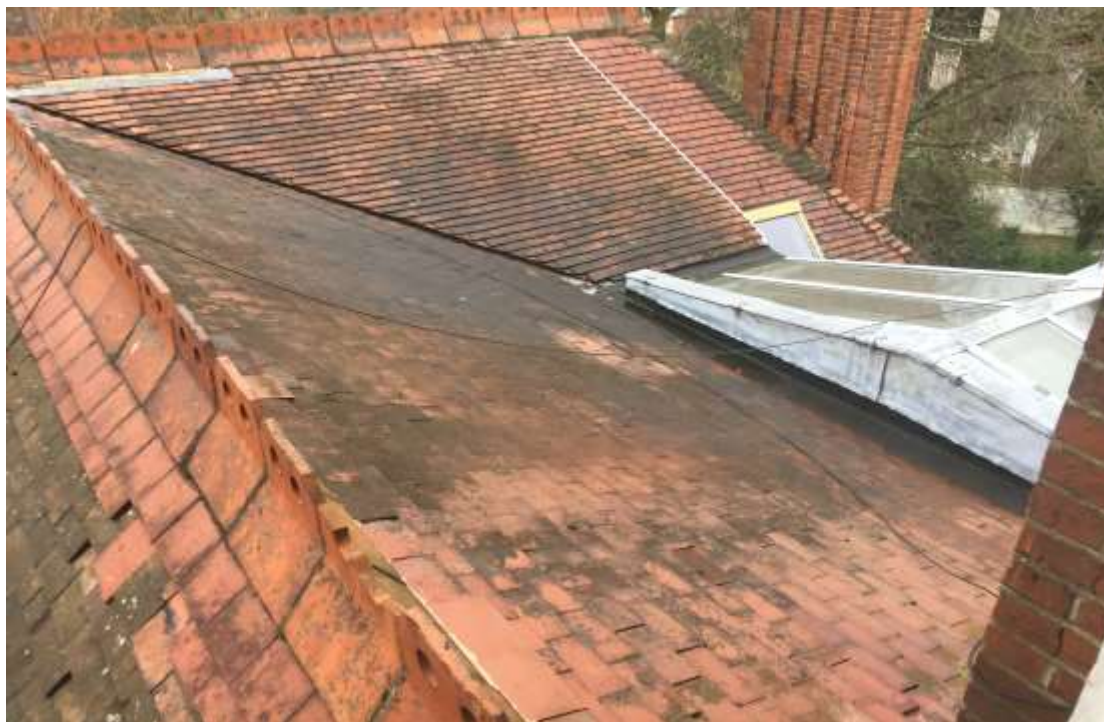
VIEW OF PART ROOF - ITEM e)

- e) To the rear of the property there is also a double pitched roof with two hipped ends and again on the slope of the roof which is towards the rear and close with the apex to the defective roof described earlier in item c) above there is a section of roof to the apex where there appears to be a metal flashing which has been inserted underneath the apex. There could be no reason why metal work has been inserted underneath a tiled apex other than somebody wanted to carry out a piecemeal repair, did not have the appropriate tools and materials, and as a result effectively carried out a “botched” repair.

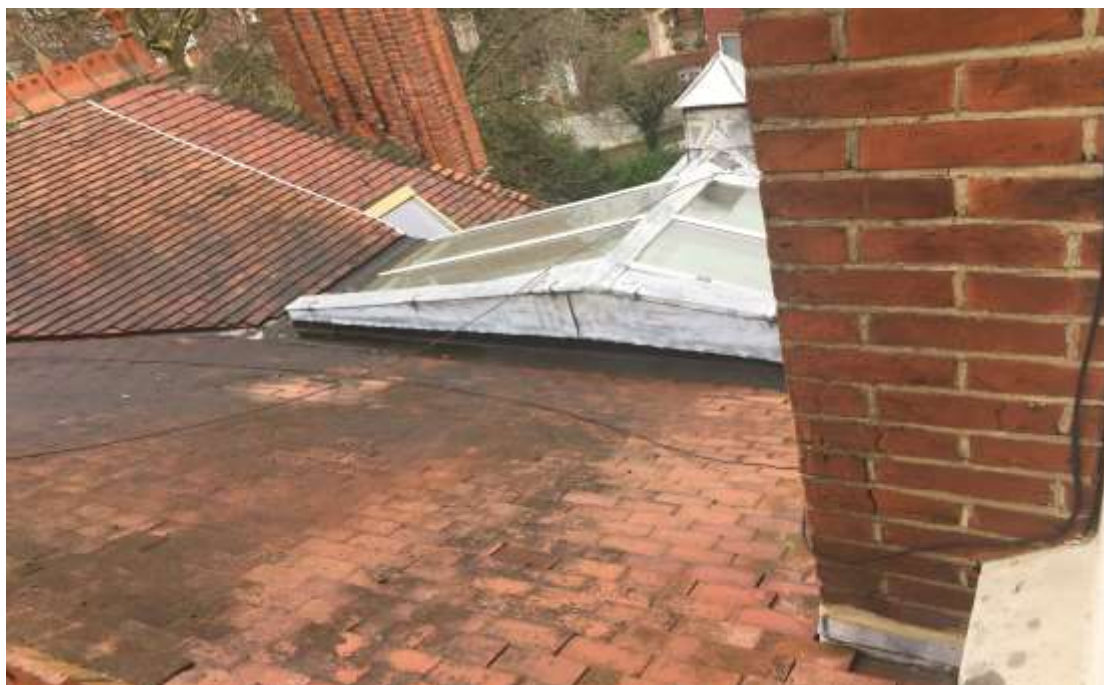
VIEW OF PART ROOF - ITEM f)

- f) On area above the rooflights described in Item a) above there is a further skylight. Unfortunately the view of the skylight itself which is of four panes was limited however there appears to be lead flashing details around it which appeared to be reasonable but closer examination may be necessary.

However to the tiled slope which is the rear of the slope which is defective as described in Item c) above runs down into a valley gutter which goes around the rooflight. Firstly there are some tiles on this rear slope which are defective and secondly there also appears to be an extension of the defective apex described in Item E above and thirdly the valley itself appears to have been coated possibly even with felt and being this is a valley which is hidden has potential for rainwater to run down the slope and to hit the end of the wall which is the end of the rooflight and there is a significant potential for rainwater to become a problem and to enter the property unless the detail of both tiles, the covering to the valley parapet, the valley gutter detail and the end of the rooflight are all properly watertight. It is recommended that this is more closely examined and appropriate repairs carried out.

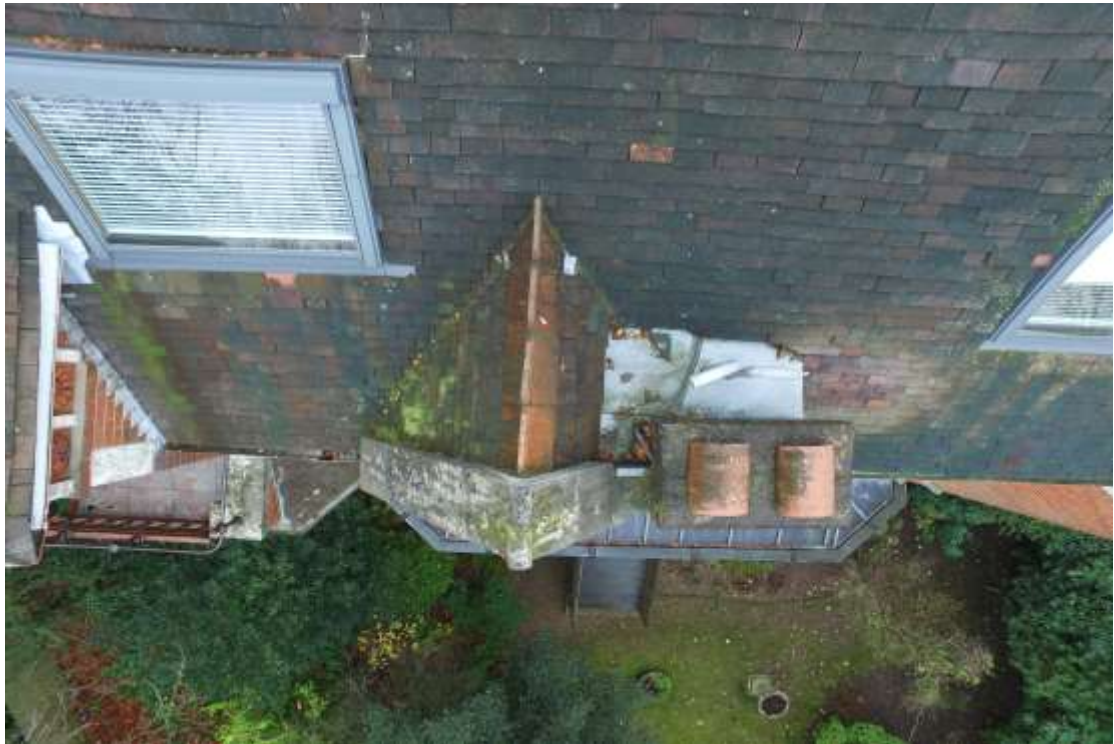
VIEW OF PART ROOF - ITEM g)

- g) Towards the rear of the property there is a small chimney stack abutting a small gable and a small flat roof is created. At the time of my inspection leaves had gathered in this area and clearly this would become prone to causing water damage to occur. There also appears to be a small area of possible defective tiling to the roof which is probably caused due to rainwater runoff from the small flat roof saturating and causing the tiling to become badly weathered.
- h) The tower has four main sides which are tiled and generally the tiling appears to be in reasonable condition apart from one or two isolated areas on one of

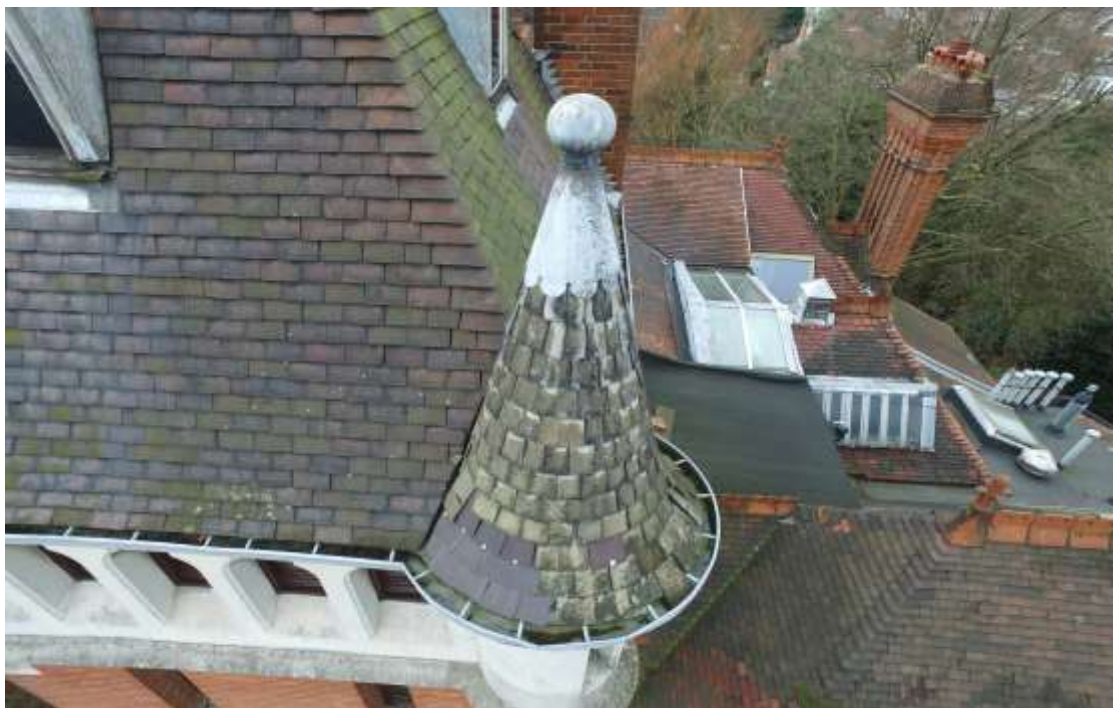
VIEW OF PART ROOF - ITEM h)

the rear slopes. This may indicate that the tiling to the tower is beginning to become defective.

Within the top of the tower there is to each side a projecting small dormer which are lead covered. The lead work is of some age. It was noticeable that rainwater runoff around these projecting dormers is causing the clay tiling to become stained and worn.

We have not been able to inspect closely even with a drone because of safety concerns the condition of the lead covered spire which is the centre of the tower. It should be noted it does appear to exhibit significant weathering and although leadwork can survive for many years it can certainly suffer from fatigue, tearing of joints, pinholes can be formed especially during any areas of corrosion or pollution and as a result if access was possible more closely the leadwork around the tower detail might become defective and prove to be requiring replacement or at the very least lead repairs.

To the front of the tower are two smaller spires which are covered in slates as far as we could ascertain. Again through the use of the drone we are able to advise that the slates are not in good condition and the slates are slipping and being dislodged. Water penetration is therefore likely to occur. These slates probably are suffering from nail sickness. This is when the nails fixing the slates which are often copper will corrode with time and will then become defective and when this happens the slate slips becomes loose and falls. Because the slates to these spires are almost vertical they should have been double fixed however probably because they date from the time the building was built it is unlikely the slates were fixed to comply with current standards.

If the decision is made to re-slate or to extensively overhaul these two spires which are slate covered then it should be noted that the lead capping and ball which sits on the top is likely to require to be either remoulded or to be recovered or replaced for the simple reason that would become disturbed by the work to the slates and the leadwork is probably weathered might even be thin and therefore capable of being easily torn during the course of any remedial repairs. It would therefore make sense for it to be replaced at the time of any roof works.

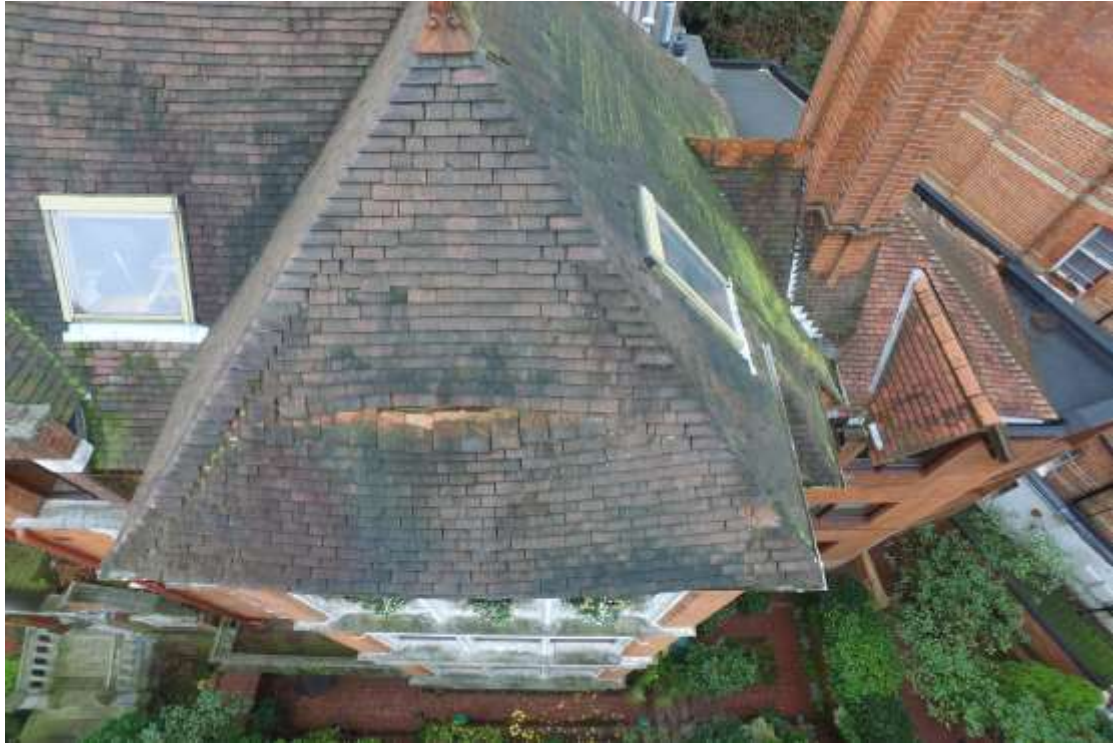
VIEW OF PART ROOF - ITEM i)

- i) This is a front slope over a projecting bay and here the tiles are not in good condition with a section which appears to have dropped and in my opinion the whole slope of this particular part of the roof would need to be stripped and renewed. (See comments below regarding remedial works).
- j) There is a small area of defective clay tiling around a ridge also on part of the front slope.
- k) On one of the rear slopes around some of the apex and just immediately below the apex there is a possible defective tiling and ridge tiles.
