Window Schedule

Project: **British Museum Perimeter Projects 1-1A MS : Window Schedule**
 Job No: **P2007246**
 Issue: First Issue
 Date: 17/03/2017
 28/04/2017 Rev A
 01/06/2017 Rev B

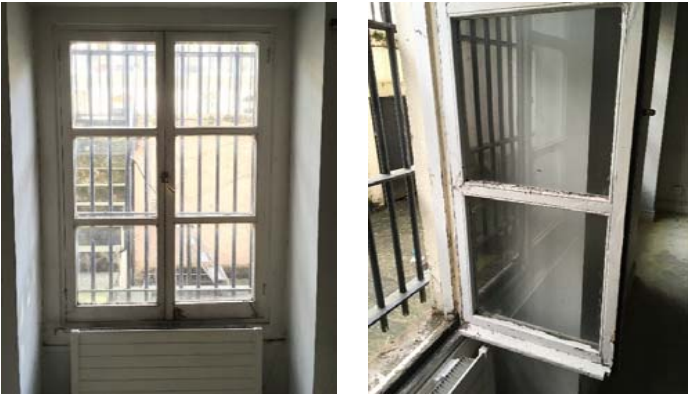
| Window Number | Location | Window Construction | Window Finish | | Nominal Window Size | | Security | Current condition | Notes / Scope of Works |
|---|---|--|---|---|---|---|---|---|--|
| 1-LG-W01 | 1MS/1/014 | Solid timber framed double opening, side hinged casement window | Paint | Paint | Existing | Existing | External security bars | | <ul style="list-style-type: none"> Existing ironmongery in good condition |

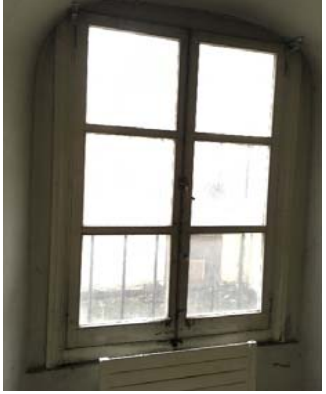
| Window Number | Location | Window Construction | Window Finish | | Nominal Window Size | | Security | Current condition | Notes / Scope of Works |
|---|---|--|---|---|---|---|---|---|--|
| 1-LG-W03 | 1MS/1/012 | Solid timber framed, double opening, side hinged casement window | Paint | Paint | Existing | Existing | External security bars | | <ul style="list-style-type: none"> Existing ironmongery in good condition |

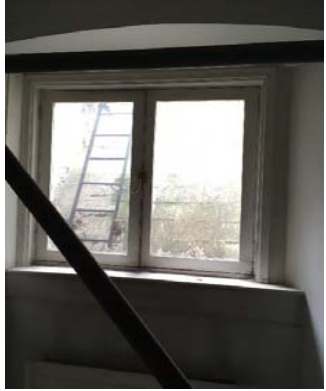
| Window Number | Location | Window Construction | Window Finish | | Nominal Window Size | | Security | Current condition | Notes / Scope of Works |
|---|---|--|---|---|---|---|---|---|--|
| 1-LG-W04 | 1MS/1/015 | Solid timber framed Georgian double opening, side hinged casement window | Paint | Paint | Existing | Existing | | | <ul style="list-style-type: none"> Existing ironmongery in good condition |

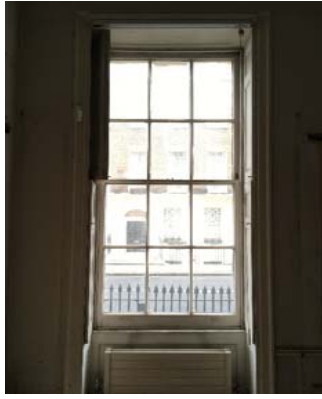
| 1-G-W01 | 1MS/2/005 | Solid timber framed Georgian sash window with top and bottom shutters. Floor to cill and reveal timber panelling. | Paint | Paint | Existing | Existing | | | <ul style="list-style-type: none"> • Shutters in good working order • Some ironmongery missing |

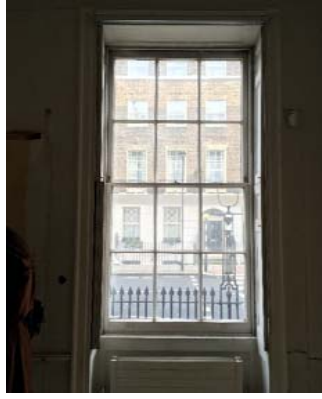
| 1-G-W02 | 1MS/2/005 | Solid timber framed Georgian sash window with top and bottom shutters. Floor to cill and reveal timber panelling. | Paint | Paint | Existing | Existing | | | <ul style="list-style-type: none"> • Shutters in good working order • Some existing ironmongery has been replaced with unmatching ironmongery. |

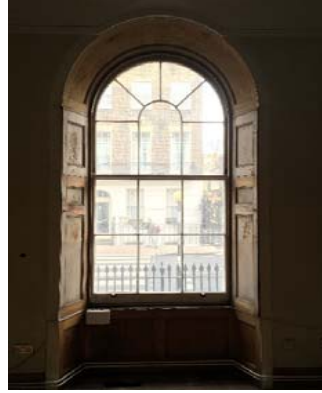
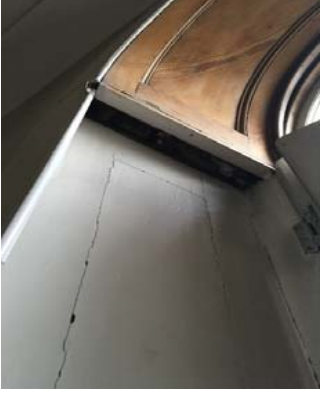
| 1-G-W03 | 1MS/2/004 | Solid timber framed Georgian arched sash window with top and bottom shutters. Timber floor to cill and reveal panelling | Paint | Paint | Existing | Existing | | | <ul style="list-style-type: none"> • Existing gap at top of wall panelling behind shutters. Repair work required. • Some damage to window architrave. Repair work required. • Evidence of dampness on shutters. Further assessment required to ascertain cause of dampness. Repair work to be carried out accordingly. • Paint cracks on shutters. Repair work required. |

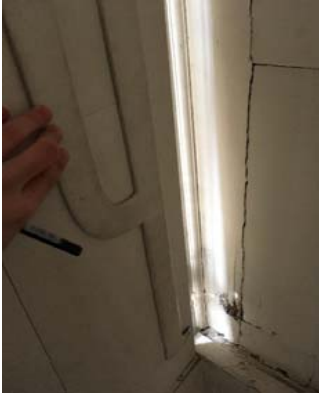
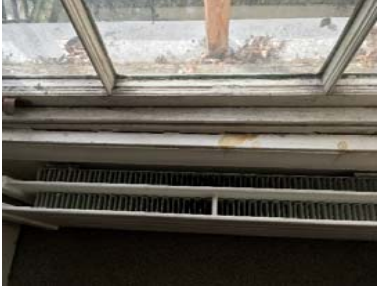
| 1-G-W04 | 1MS/2/006 | Solid timber framed Georgian sash window with top and bottom shutters. Timber floor to cill and reveal panelling. | Paint | Paint | Existing | Existing | | | <ul style="list-style-type: none"> • Dropped window head prevents top shutters from opening. Adjustments required. • Shutter bar to be restricted to prevent further damage to shutters. • Paint cracks on shutters. Repair work required. • Damage to floor to cill wall panel. Repair work required. |

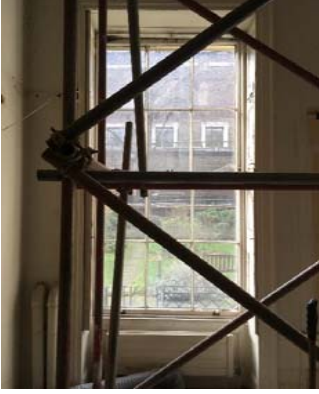
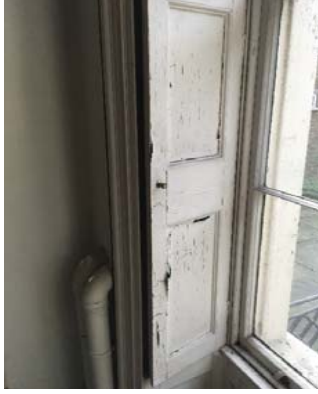
| 1-G-W05 | 1MS/2/006 | Solid timber framed Georgian sash window with top and bottom shutters. Timber floor to cill and reveal panelling. | Paint | Paint | Existing | Existing | | | <ul style="list-style-type: none"> • Left shutters don't fully fold. Adjusting required. • Shutter bar to be restricted to prevent further damage to shutters. • Paint cracks on shutters. Repair work required. |

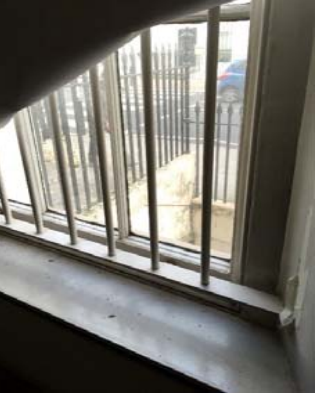
| 1A-G-W01 | 1AMS/2/013 | Solid timber framed Georgian sash window | Paint | Paint | Existing | Existing | Internal security bars | | <ul style="list-style-type: none"> • Unable to fully access window • Existing draft seal proofing to be replaced |

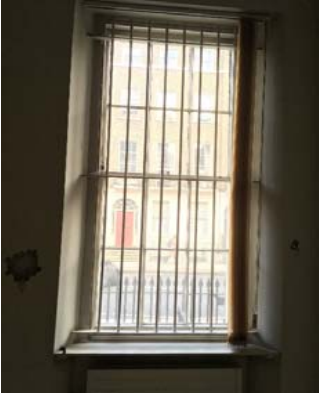
| 1A-G-W02 | 1AMS/2/013 | Solid timber framed Georgian sash window | Paint | Paint | Existing | Existing | Internal security bars | | <ul style="list-style-type: none"> Existing draft seal proofing to be replaced |

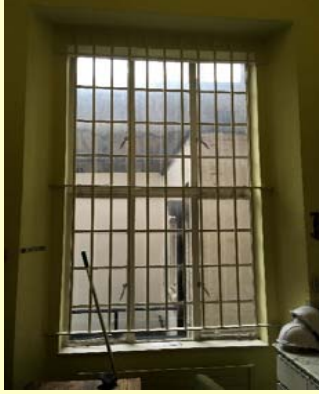
| 1A-G-W03 | 1AMS/2/013 | Solid timber framed Georgian sash window | Paint | Paint | Existing Opening | Existing Opening | | | <ul style="list-style-type: none"> Existing metal framed window to be removed and replaced. Making good works to window surround required. Refer to (31)AD002. |

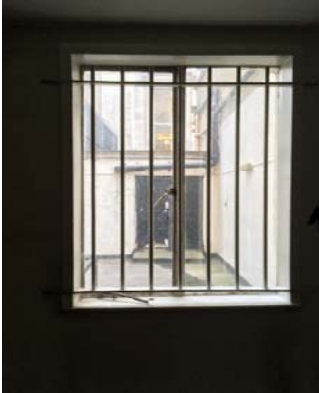
| 1A-G-W04 | 1AMS/2/015 | Metal framed casement window with single side hinged opening | Metal | Metal | Existing | Existing | Internal security bars | | <ul style="list-style-type: none"> Existing drop in window opening. Ease and adjusting required. |

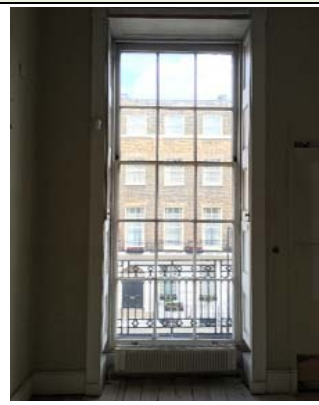
| 1-1-W01 | 1MS/3/002 | Solid timber framed Georgian sash window with top and bottom shutters and top timber reveal panelling | Paint | Paint | Existing | Existing | | | <ul style="list-style-type: none"> Existing shutters have been cut short to accommodate radiators. Shutter bar to be restricted to prevent further damage to shutters. |

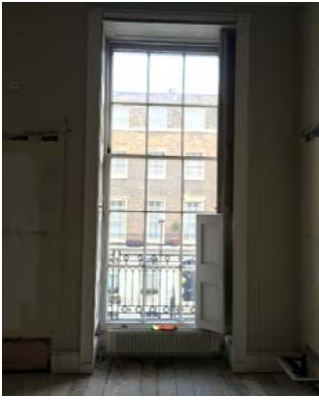
| 1-1-W02 | 1MS/3/002 | Solid timber framed Georgian sash window with top and bottom shutters and top timber reveal panelling | Paint | Paint | Existing | Existing | | <ul style="list-style-type: none"> Existing shutters have been cut short to accommodate radiators. Shutter bar to be restricted to prevent further damage to shutters. Sash cord missing from both sides of window. Replacements required. |

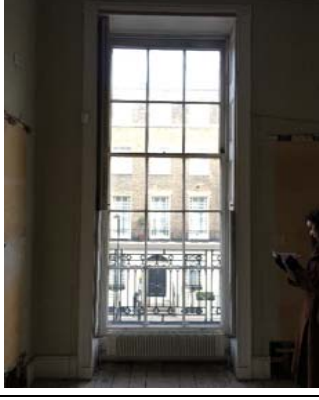
| 1-1-W03 | 1MS/3/003 | Solid timber framed Georgian sash window with top and bottom shutters and top reveal timber panelling | Paint | Paint | Existing | Existing | | <ul style="list-style-type: none"> Existing drop in top sash window. Ease and adjusting required. Existing shutters have been cut short to accommodate radiators. Shutter bar to be restricted to prevent further damage to shutters. Sash cord missing from both sides of window. Replacements required. |

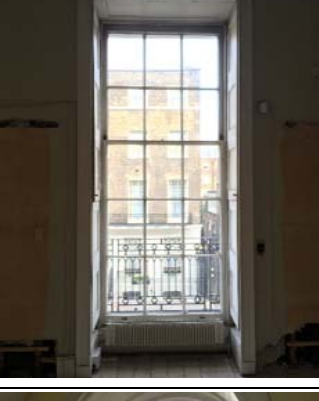
| 1-1-W04 | 1MS/3/003 | Solid timber framed Georgian sash window with top and bottom shutters and top timber reveal panelling | Paint | Paint | Existing | Existing | | <ul style="list-style-type: none"> Existing drop in top sash window. Ease and adjusting required. Existing shutters have been cut short to accommodate radiators. Shutter bar to be restricted to prevent further damage to shutters. Sash cord missing from both sides of window. Replacements required. Existing cracks in wall panelling. Repair works required. |

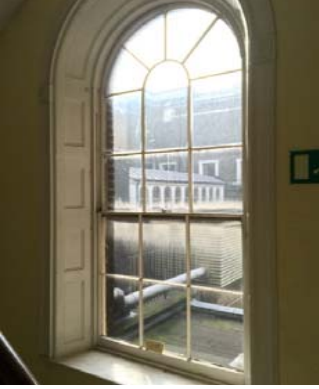
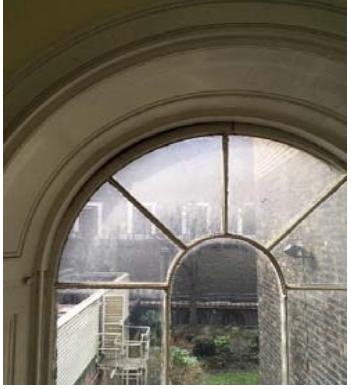
| 1-1-W05 | 1MS/3/S01 | Solid timber framed Georgian arched sash window with timber reveal panelling | Paint | Paint | Existing | Existing | | <ul style="list-style-type: none"> Existing gap between window and inside lining to be addressed. |

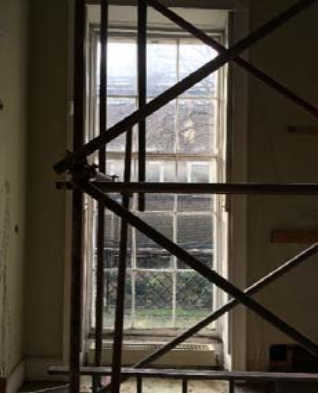
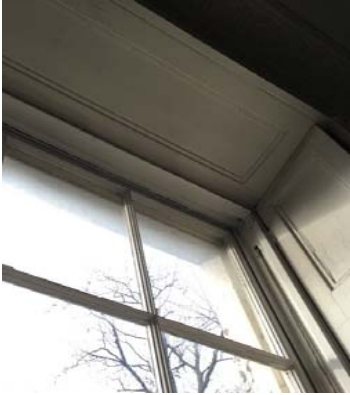
| 1-1-W06 | 1MS/3/002 | Solid timber framed Georgian sash window with top and bottom shutters and top timber reveal panelling | Paint | Paint | Existing | Existing | | <ul style="list-style-type: none"> • Shutter bar to be restricted to prevent further damage to shutters. • Timber bracket to be removed from the top window reveal. (most likely fitted for an internal blind) |

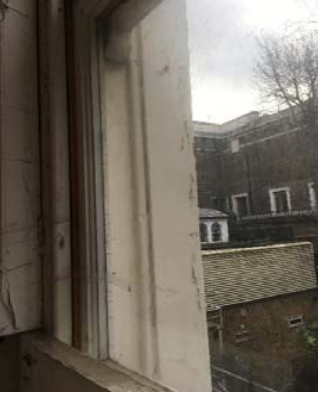
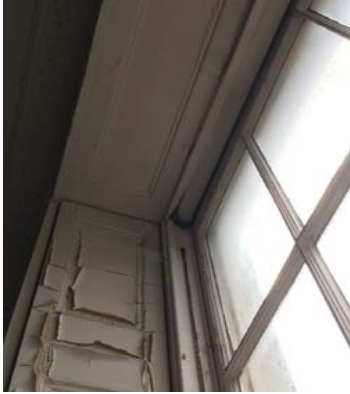
| 1-1-W07 | 1MS/3/002 | Solid timber framed Georgian sash window with top and bottom shutters and top timber reveal panelling | Paint | Paint | Existing | Existing | | <ul style="list-style-type: none"> • Existing gaps in window frame infilled with new pieces of timber. • Some damage to top staff bead. Repair work required. • Bottom shutters doesn't fully fold. Adjusting required. • Shutter bar to be restricted to prevent further damage to shutters. |

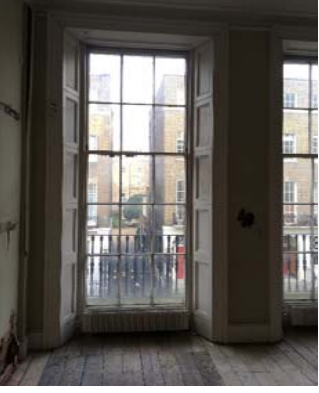
| 1A-1-W01 | 1AMS/3/005 | Solid timber framed Georgian sash window with top and bottom shutters and top timber reveal panelling | Paint | Paint | Existing | Existing | | <ul style="list-style-type: none"> • Shutters currently fixed shut. Adjusting required to restore full operation. • Bottom left pane of glass is cracked. Replacement required. |

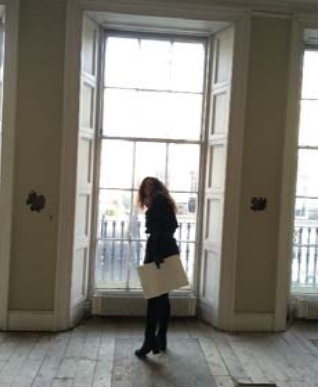
| 1A-1-W02 | 1AMS/3/005 | Solid timber framed Georgian sash window with top and bottom shutters and top timber reveal panelling | Paint | Paint | Existing | Existing | | <ul style="list-style-type: none"> • Shutters currently fixed shut. Adjusting required to restore full operation. |

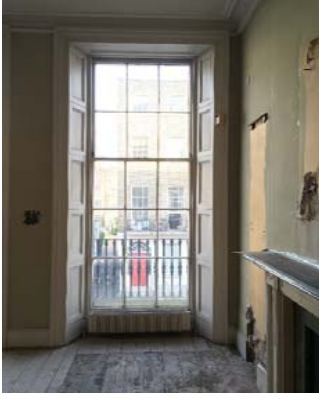
| 1A-1-W03 | 1AMS/3/005 | Solid timber framed Georgian sash window with top and bottom shutters and top timber reveal panelling | Paint | Paint | Existing | Existing | | | <ul style="list-style-type: none"> • Shutters currently fixed shut. Adjusting required to restore full operation. • Sash cord snapped on left side. Replacement required. |

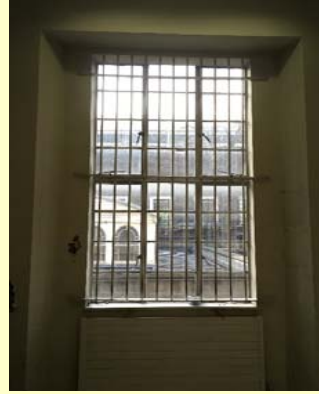
| 1A-1-W04 | 1AMS/3/005 | Solid timber framed Georgian sash window | Paint | Paint | Existing Opening | Existing Opening | | | <ul style="list-style-type: none"> • Existing metal framed window to be removed and replaced. • Making good works to window surround required. • Refer to (31)AD001. |

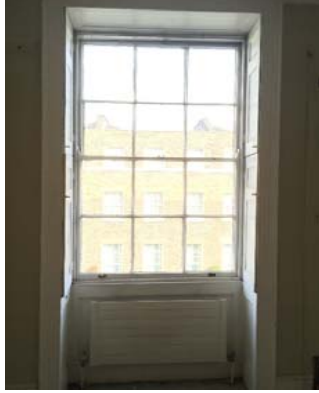
| 1-2-W01 | 1MS/4/004 | Solid timber framed Georgian sash window with top and bottom shutters. Timber floor to cill and reveal panelling. | Paint | Paint | Existing | Existing | | | <ul style="list-style-type: none"> • Timber bracket to be removed from the top window reveal. (most likely fitted for an internal blind) |

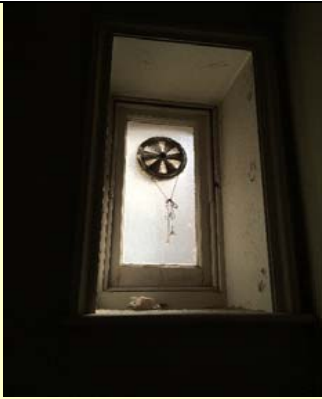
| 1-2-W06 | 1MS/4/003 | Solid timber framed single opening casement window | Paint | Paint | Existing Opening | Existing Opening | | | <ul style="list-style-type: none"> Existing window to be removed and replaced. Making good works to window surround required. |

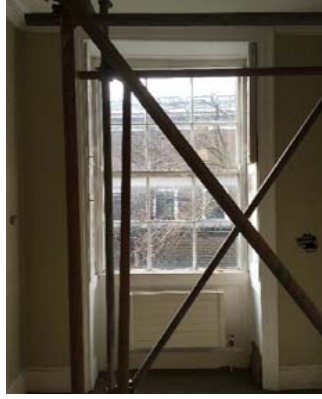
| 1-2-W07 | 1MS/4/007 | Solid timber framed Georgian sash window with top and bottom shutters. Timber floor to cill and reveal panelling. | | | Existing | Existing | | | <ul style="list-style-type: none"> Top right shutter doesn't fully fold. Adjusting required. |

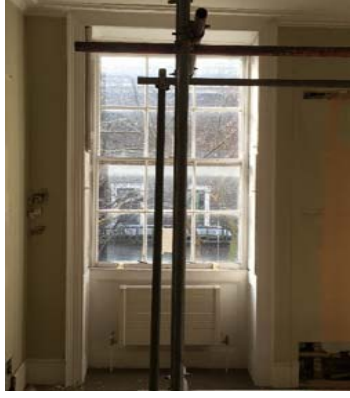
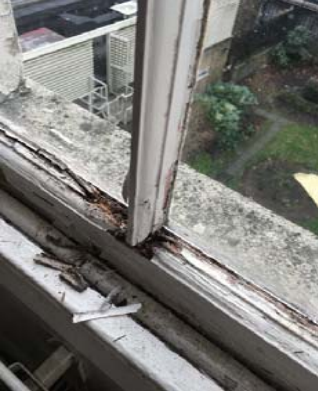
| 1-2-W08 | 1MS/4/008 | Solid timber framed Georgian sash window with top and bottom shutters. Timber floor to cill and reveal panelling. | Paint | Paint | Existing | Existing | | | <ul style="list-style-type: none"> Bottom rail of lower sash to be replaced Top left shutter doesn't fully fold. Adjusting required. |

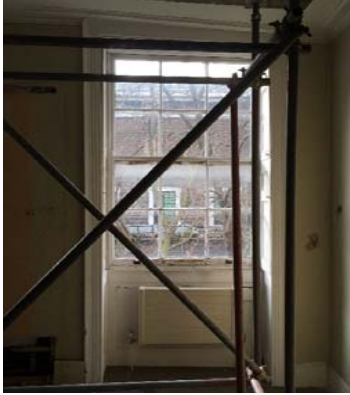
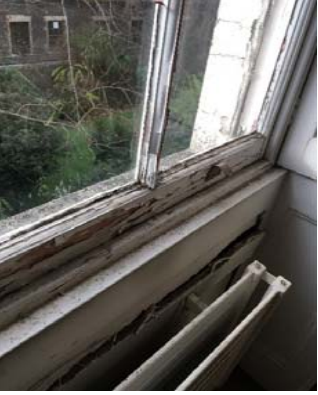
| 1-2-W09 | 1MS/4/008 | Solid timber framed Georgian sash window with top and bottom shutters. Timber floor to cill and reveal panelling. | Paint | Paint | Existing | Existing | | | <ul style="list-style-type: none"> Bottom rail of lower sash to be replaced Damage to existing floor to cill wall panel. Repair works required. |

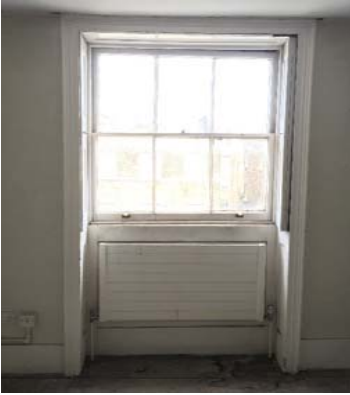
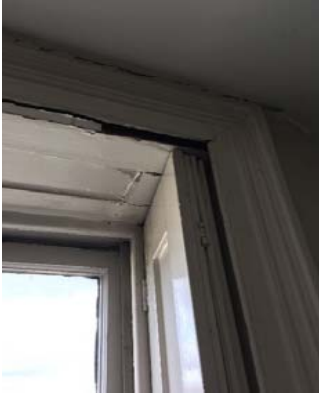
| 1-3-W04 | 1MS/5/009 | Solid timber framed Georgian sash window with top and bottom shutters. Timber floor to cill and reveal panelling. | Paint | Paint | Existing | Existing | | <ul style="list-style-type: none"> Existing drop in top sash. Ease and adjusting required. Existing damage to top window architrave and reveal panelling. Repair works required. Right shutter doesn't fully fold. Adjusting required. |

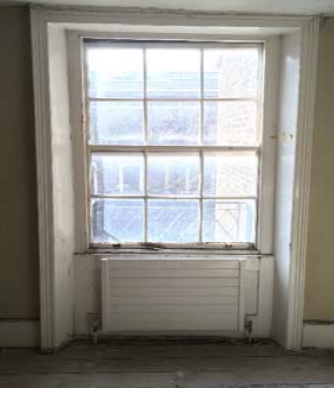
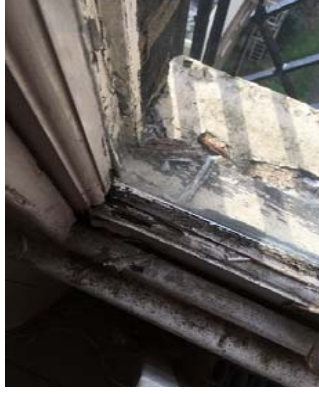
| 1-3-W05 | 1MS/5/009 | Solid timber framed Georgian sash window with top and bottom shutters. Timber floor to cill and reveal panelling. | Paint | Paint | Existing | Existing | | <ul style="list-style-type: none"> Existing drop in top sash. Ease and adjusting required. Existing damage to bottom rail. Sectional replacement required. Bottom left pane of glass is cracked. Replacement required. |

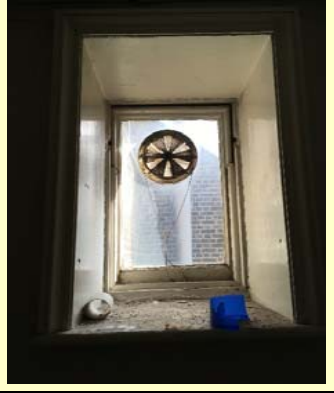
| 1-3-W06 | 1MS/5/013 | Solid timber framed single opening casement window | Paint | Paint | Existing Opening | Existing Opening | | <ul style="list-style-type: none"> Existing window to be removed and replaced. Making good works to window surround required. |

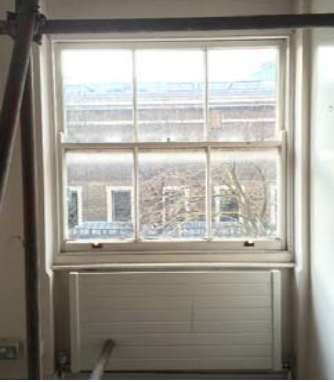
| 1-3-W07 | 1MS/5/013 | Solid timber framed Georgian sash window | Paint | Paint | Existing | Existing | | <ul style="list-style-type: none"> Existing drop in top sash. Ease and adjusting required. Existing damage to bottom rail. Repair work required. |
