<b>Room No. 1MS/2/003 Lobby</b>	
<b>Item</b>	<b>Scope of works</b>
General	<ul style="list-style-type: none"> <li>▪ Existing fittings and services have already been removed;</li> <li>▪ Walls to be redecorated with matt emulsion paint finish -allow for 2 coats. Colour to be agreed with architect and British Museum;</li> <li>▪ Existing ceilings to be redecorated with matt emulsion paint.</li> <li>▪ Existing stairs, skirting, doors and architrave to be retained, repaired where necessary and redecorated;</li> <li>▪ New services provision throughout. Electrical distribution to be recessed.</li> <li>▪ New lighting to be installed</li> <li>▪ External roof light to be retained and cleaned.</li> </ul>
Ceilings	<ul style="list-style-type: none"> <li>▪ Carefully remove all existing services, fixtures and fittings from the existing plaster ceiling together with any friable or loose/live plaster;</li> <li>▪ External roof light to be retained and cleaned, upstand to be redecorated;</li> <li>▪ Areas of existing damaged ceilings and supporting structure to be carefully removed and repaired/ replaced as required;</li> <li>▪ Ceiling to be redecorated with white emulsion paint finish;</li> </ul>

<b>

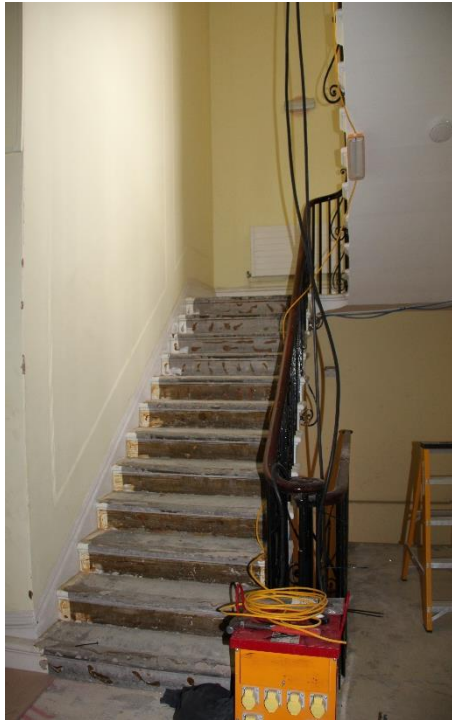
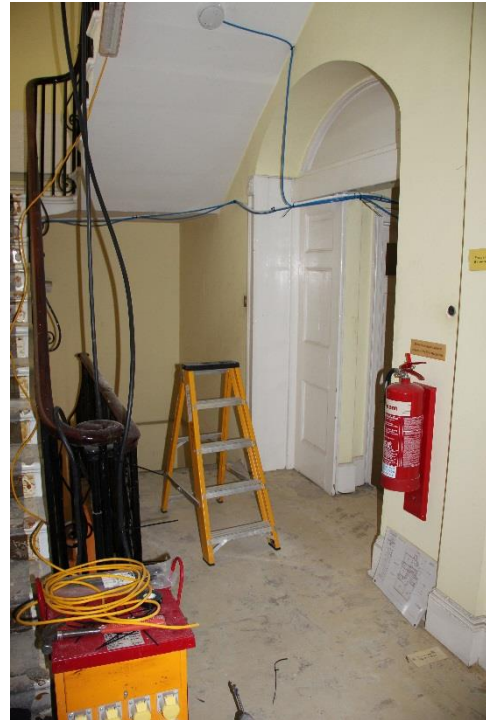
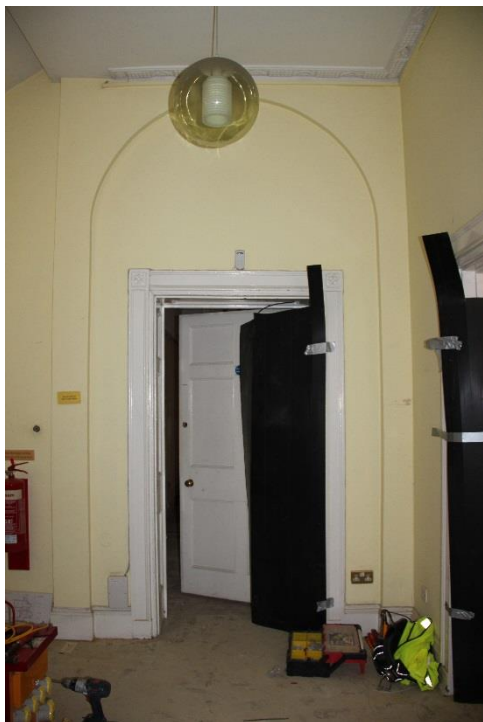
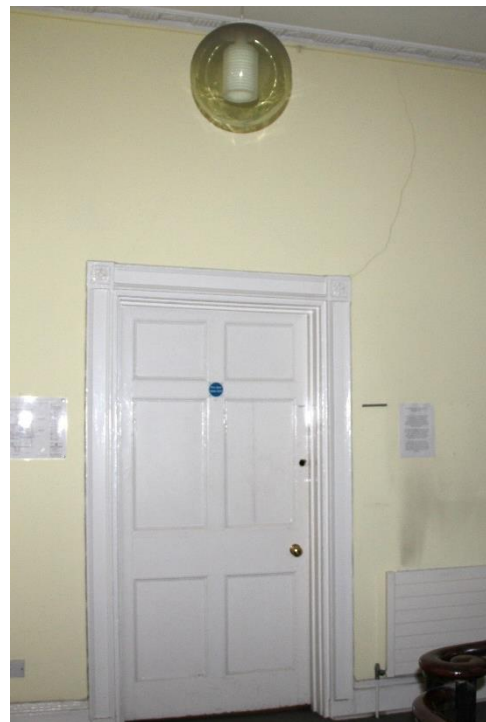
*Existing doors, architrave, fanlight, walls, ceiling, cornices, skirting and stairs to be redecorated*

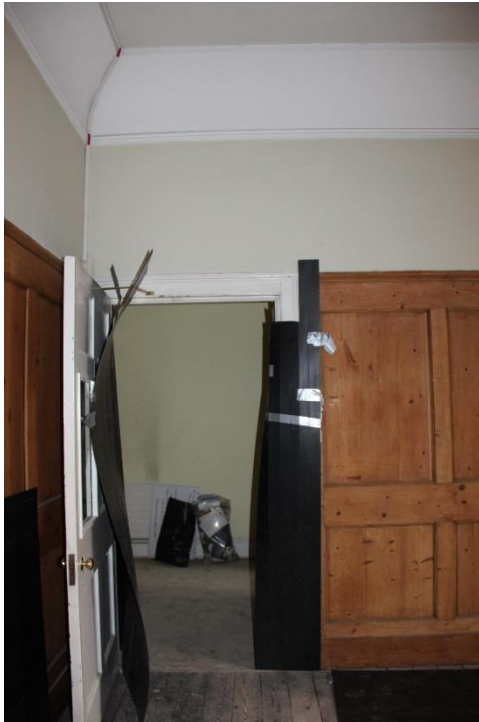
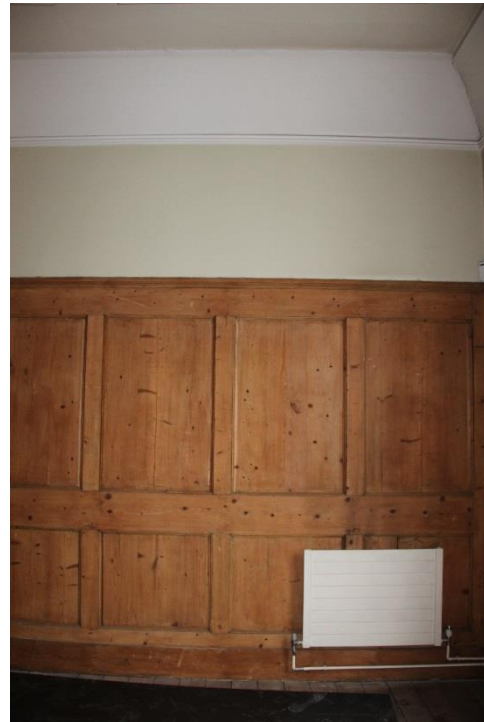
*ELEVATION 1 - Existing door containing asbestos to be carefully removed and replaced with new door and ironmongery to match existing door. Fire upgrade requirements (Existing plaster finish wall to be overboarded with new fire resistant board to provide the required 30 minute fire protection). Original timber wall panelling to be retained, refurbished and redecorated.*

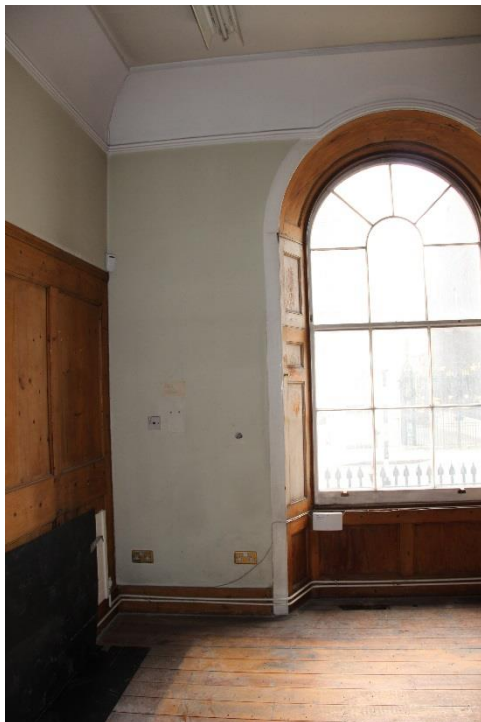
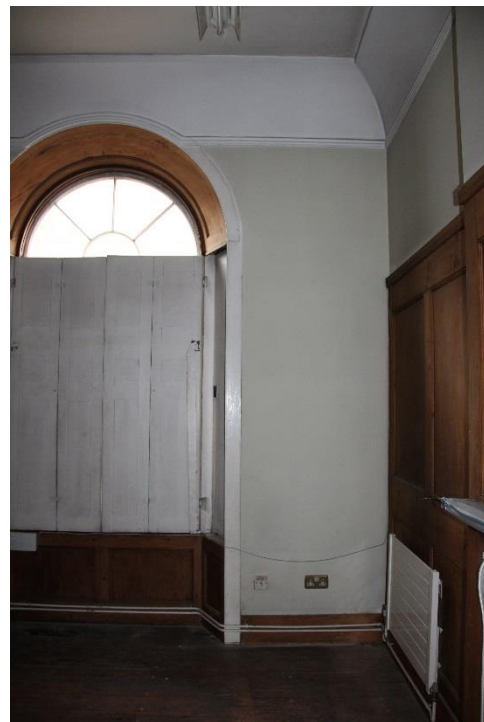
*ELEVATION 2 - Windows to undergo full overhaul to ensure good working condition and receive full redecoration.*

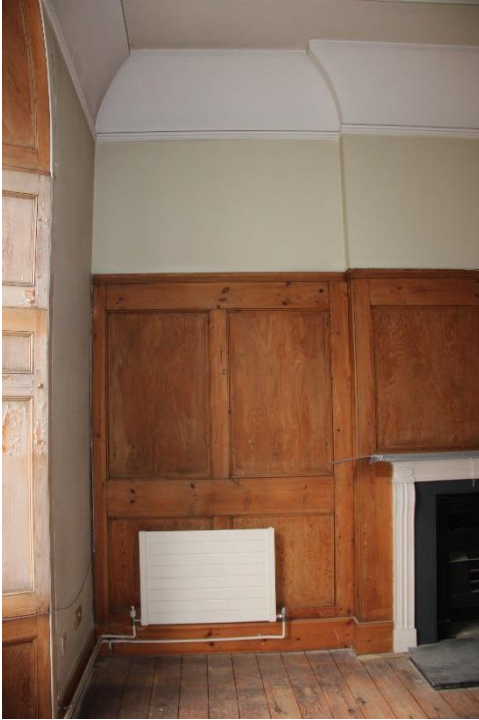
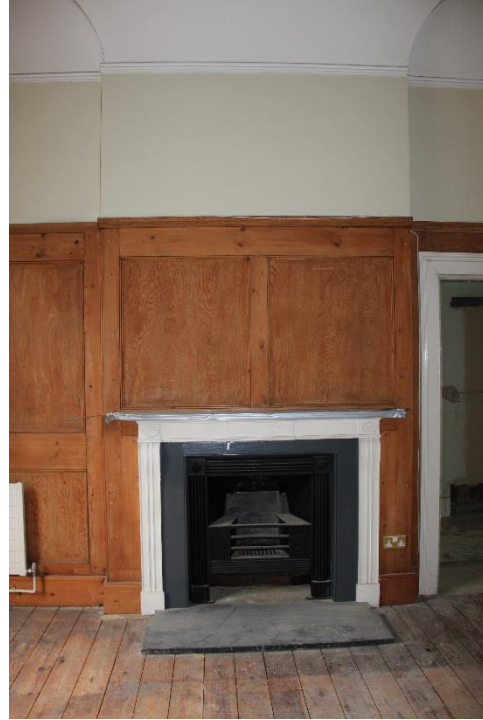
*ELEVATION 3 - Existing radiators to be carefully removed with all other existing services. Original timber panelling to front elevation to be retained, refurbished and redecorated.*

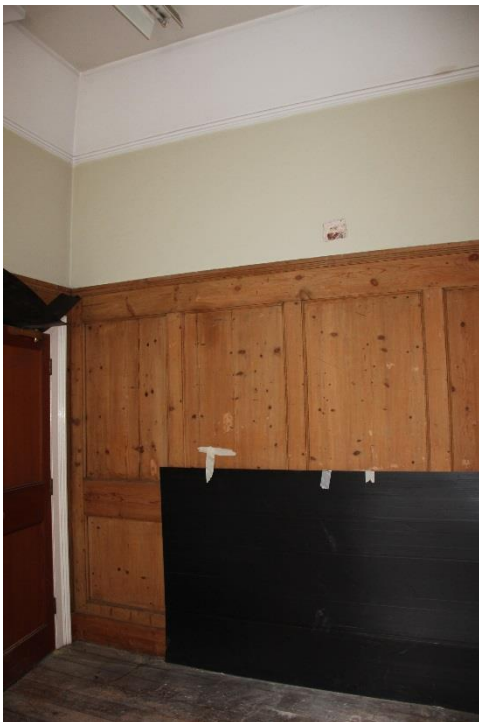
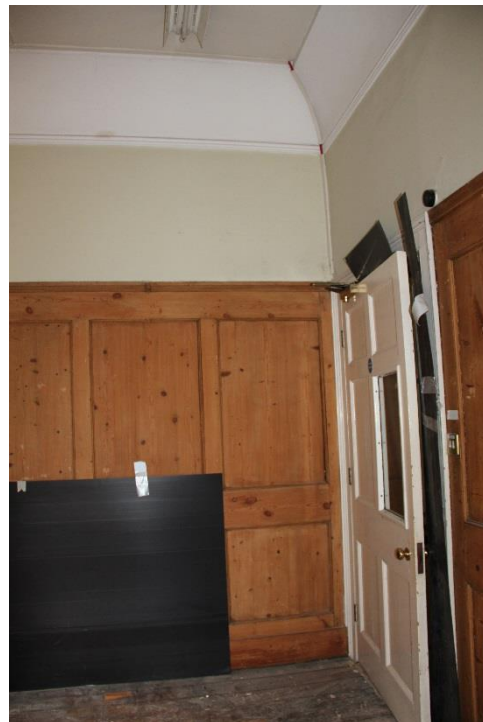
*ELEVATION 4 - Original timber panelling to front elevation to be retained, refurbished and redecorated*

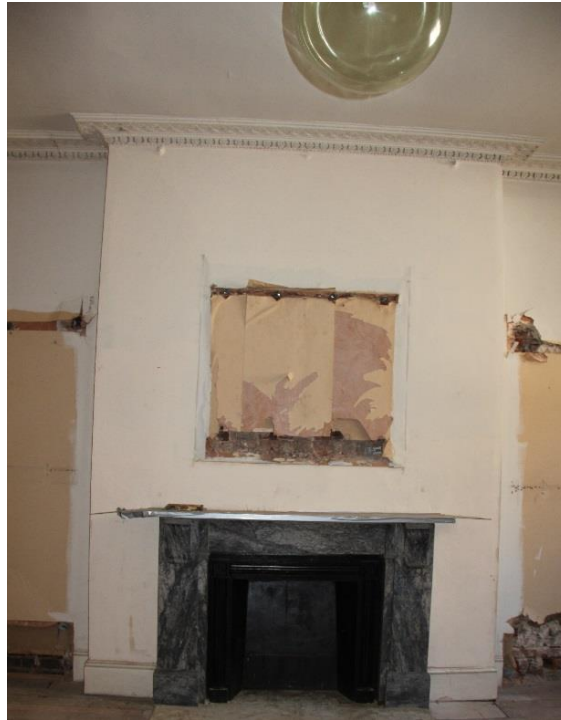
*ELEVATION 1 - Fireplaces to be protected and retained. Non-abrasive cleaning required. Sections of modern replacement wall finishes to be carefully removed and replaced with lath and plaster to match existing adjacent.*

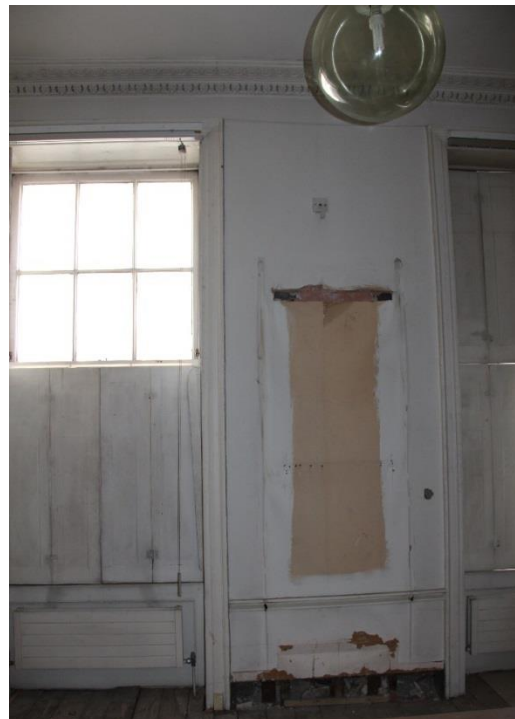
*ELEVATION 2 - Existing radiators to be carefully removed with all other existing services. Original timber panelling to front elevation to be retained, refurbished and redecorated. Windows to undergo full overhaul to ensure good working condition and receive full redecoration.*

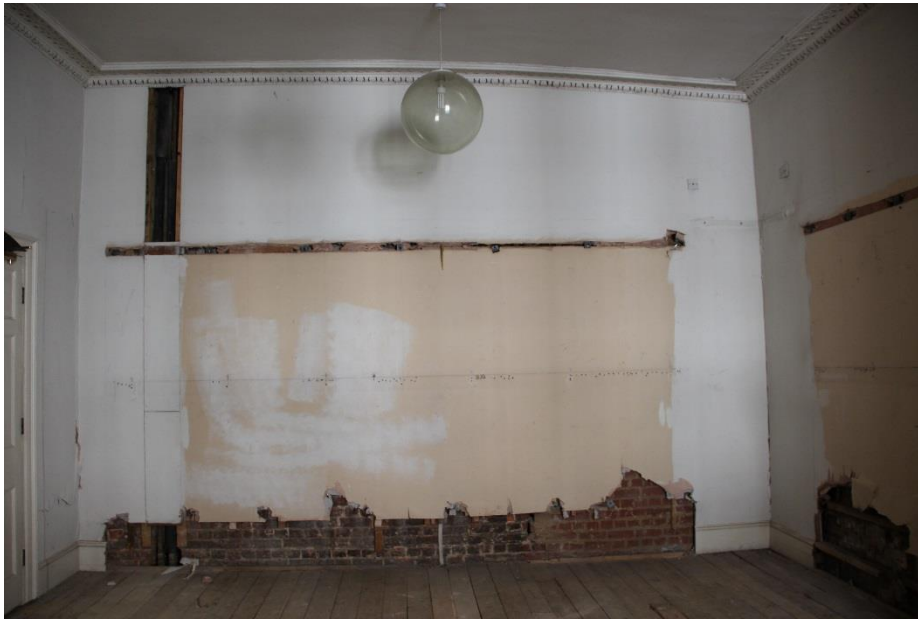
*ELEVATION 3 - Load Bearing masonry partition with existing service riser incorporated. Existing services to be removed. Metal work and damaged modern plaster finishes to be carefully removed and replaced with lath and plaster to match existing adjacent. Redecoration throughout.*

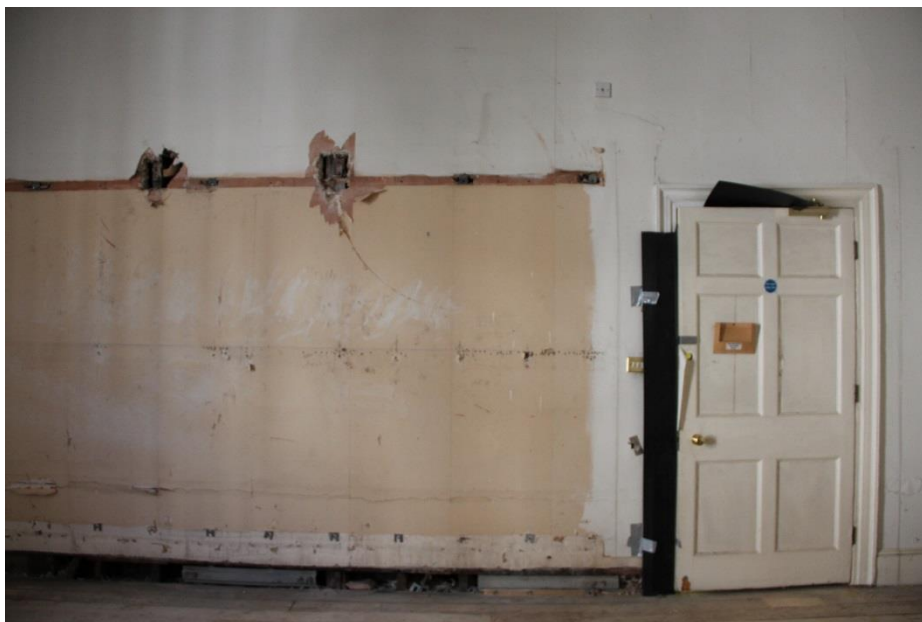
*ELEVATION 4 - Existing door refurbished and redecorated. Fire upgrade requirements. Damaged modern wall finishes to be made good to provide a suitable surface for new fire resistant board. Lath and plaster to be overboarded to achieve 30 minute fire protection. Existing cornice and skirting carefully removed, set aside with care and reinstated when the overboarding is completed. Ironmongery to be retained and refurbished.*

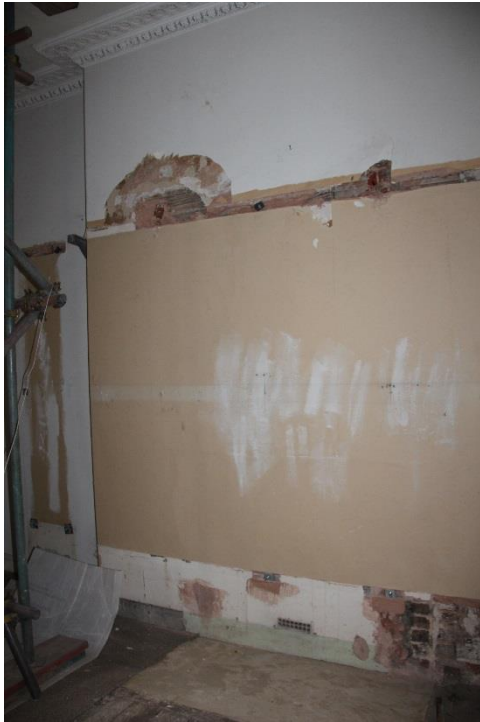
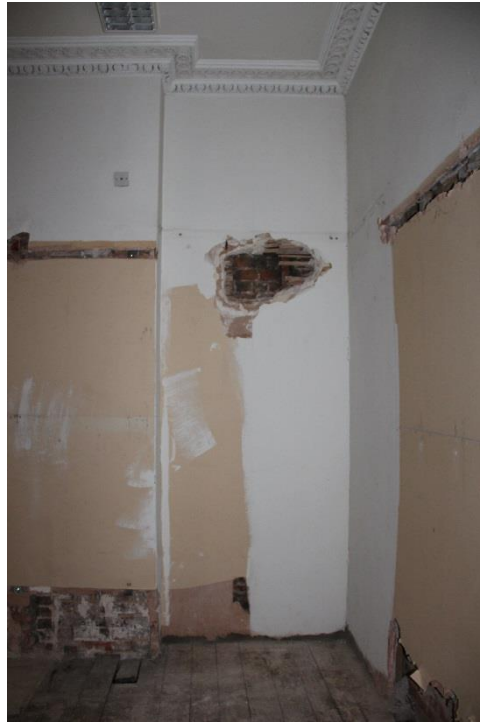
*ELEVATION 1 - Metal work and damaged modern plaster finishes to be carefully removed and replaced with lath and plaster to match existing adjacent. Redecoration throughout.*

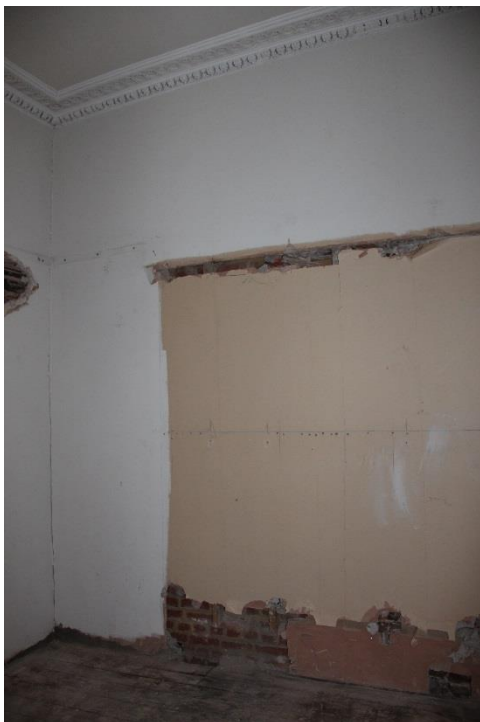
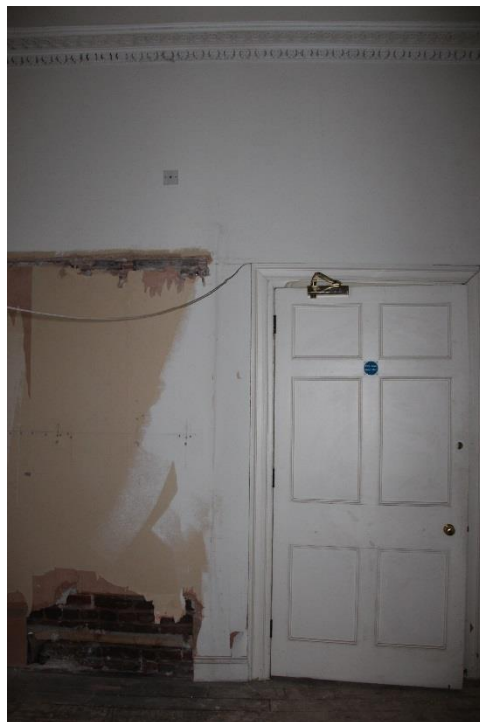
*ELEVATION 2 - Damaged modern wall finishes to be carefully removed with existing adjacent construction to be made good. New lath and plaster finishes required and full redecoration throughout. Existing door refurbished and redecorated. Fire upgrade requirements TBD. Ironmongery to be retained and refurbished.*

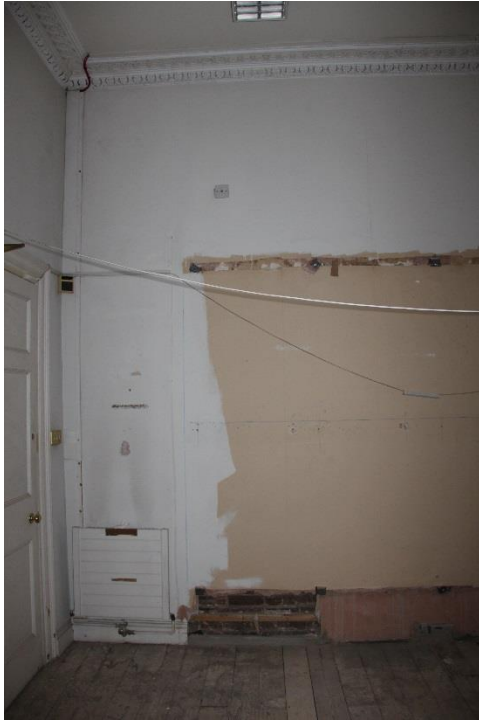
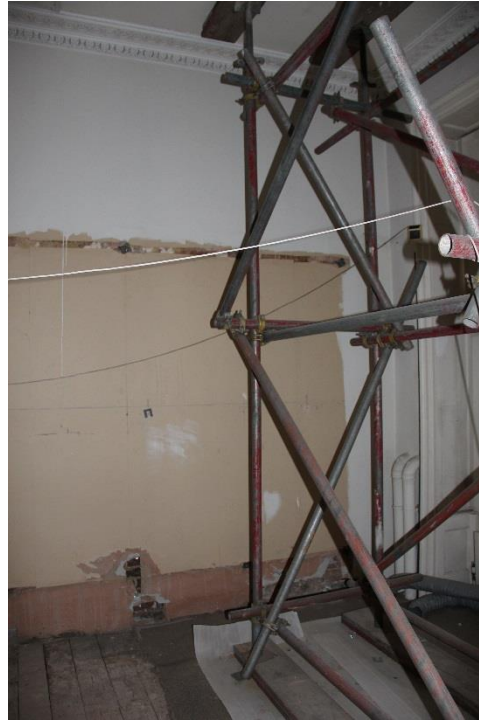
*ELEVATION 3 - Metal work and damaged modern plaster finishes to be carefully removed and replaced with lath and plaster to match existing adjacent. Redecoration throughout.*

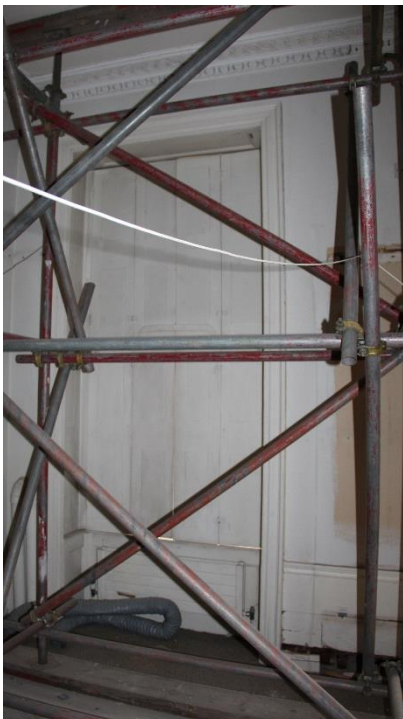
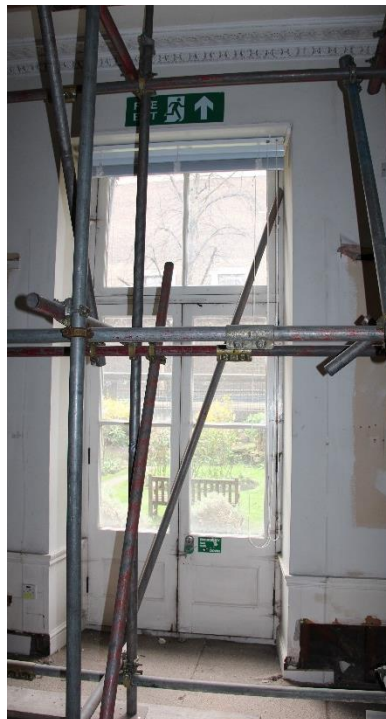
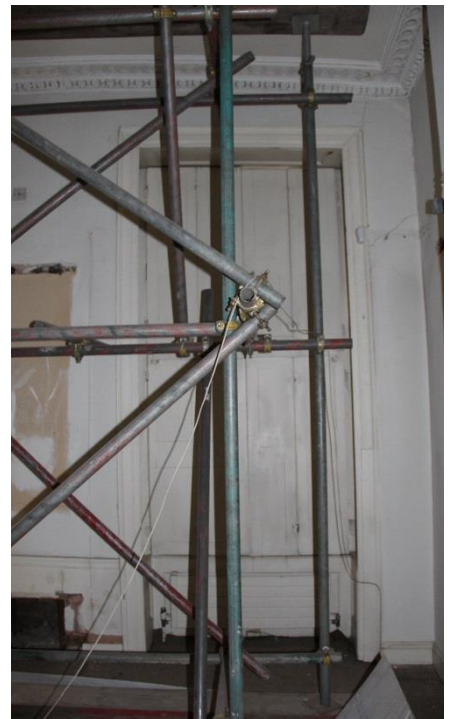
*ELEVATION 4 - Existing radiators to be carefully removed with all other existing services. Original timber panelling to front elevation to be retained, refurbished and redecorated. Windows to undergo full overhaul to ensure good working condition and receive full redecoration*

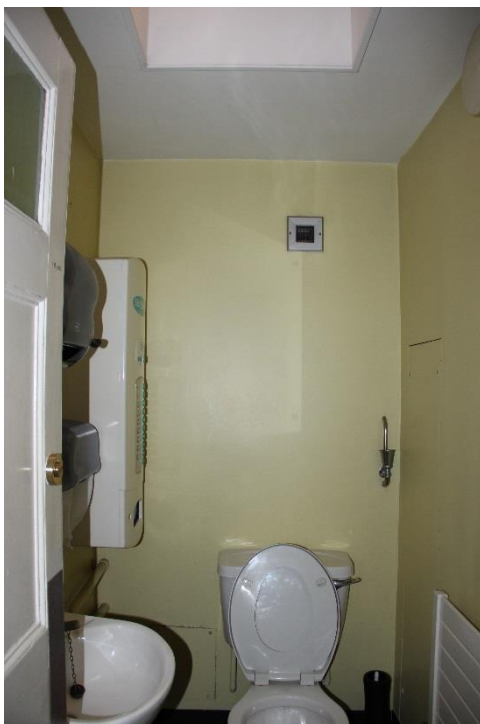
*Existing sanitary ware to be carefully removed. Damaged areas of wall to be repaired and new sanitary ware to be fitted. Redecoration throughout.*

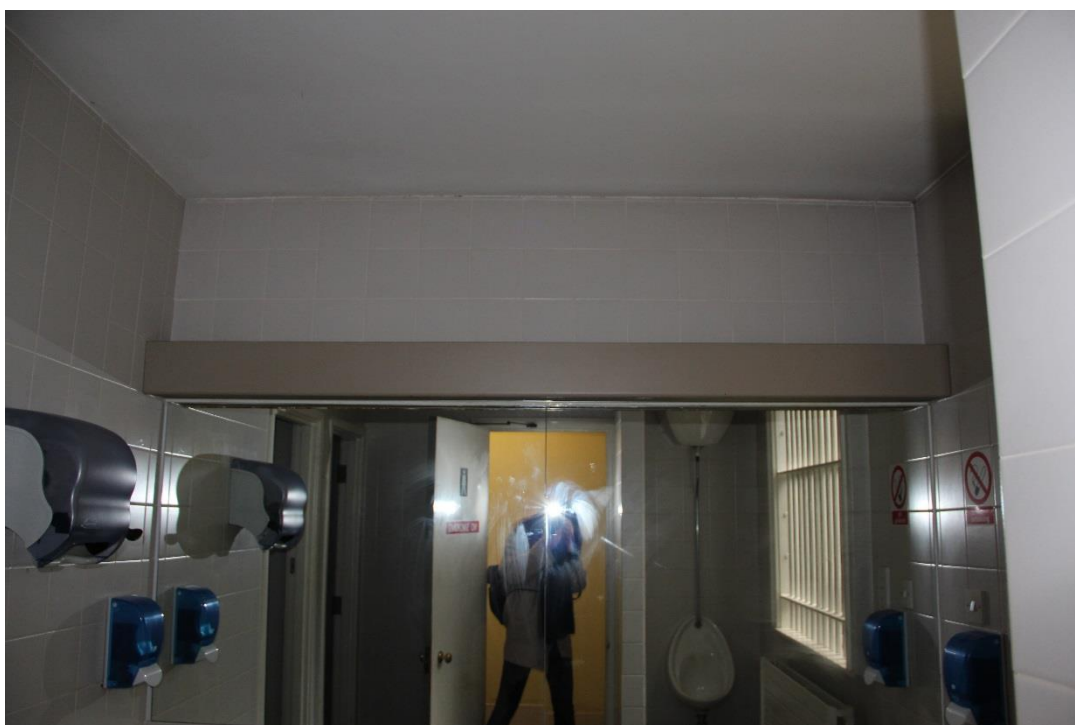
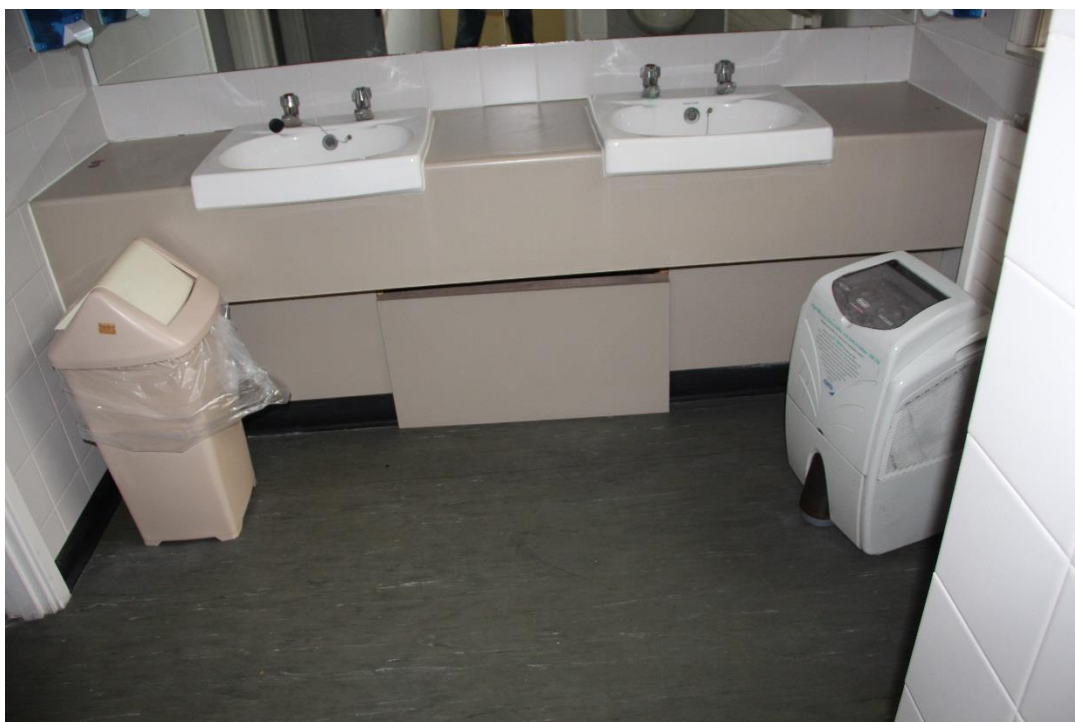
*Existing sanitary ware to be carefully removed. New plasterboard stud partitions to be formed to create kitchenette. Damaged areas of wall to be repaired. Redecoration throughout.*

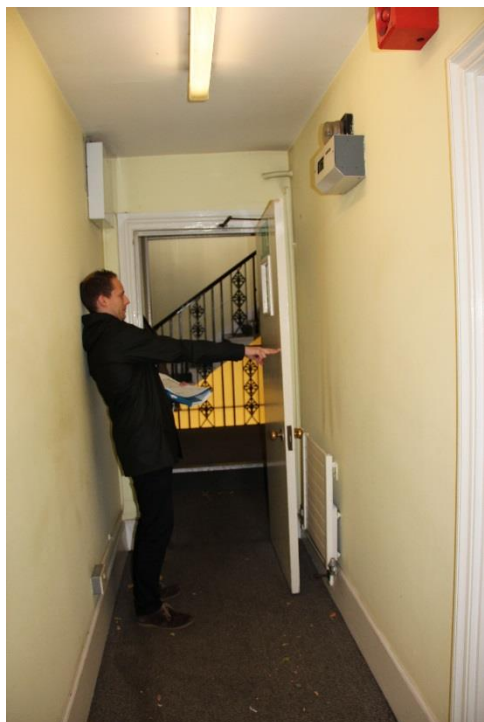
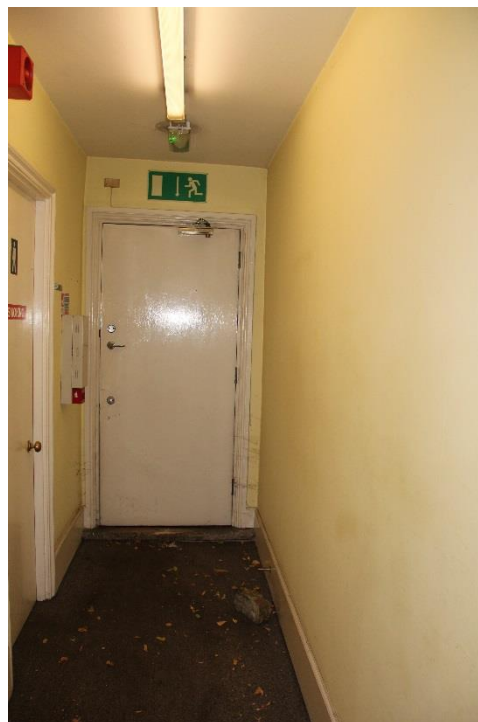
*Existing sanitary ware to be carefully removed. New plasterboard stud partitions to be formed to create passage. Damaged areas of wall to be repaired. Redecoration throughout.*

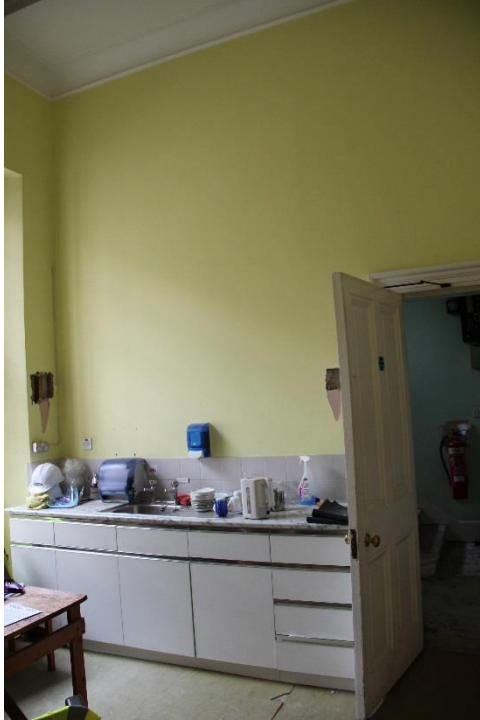
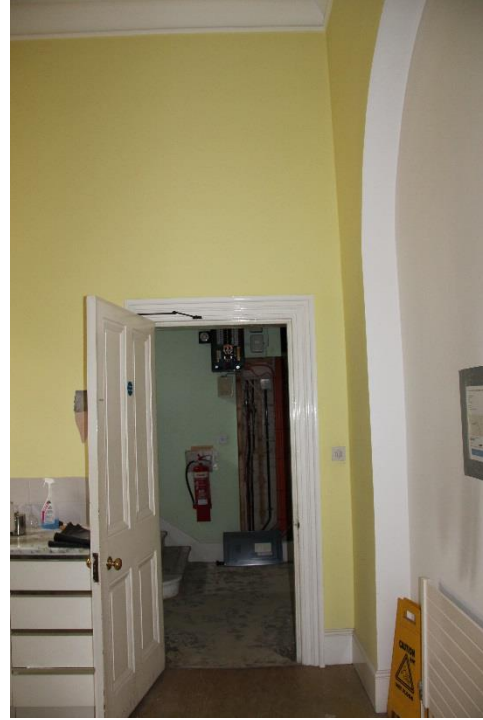
*ELEVATION 1 – Damaged plaster finishes to be carefully removed. To be confirmed on site if wall provides 30 min fire resistance. If it doesn't, wall to be overboarded with new fire resistant board to provide the required 30 minute fire protection. If it does, damaged plasterboard replaced with plasterboard to match existing adjacent. Redecoration throughout. Existing door containing asbestos to be replaced with new door to match design of existing. Refer to BDP drawing (32)AD001*

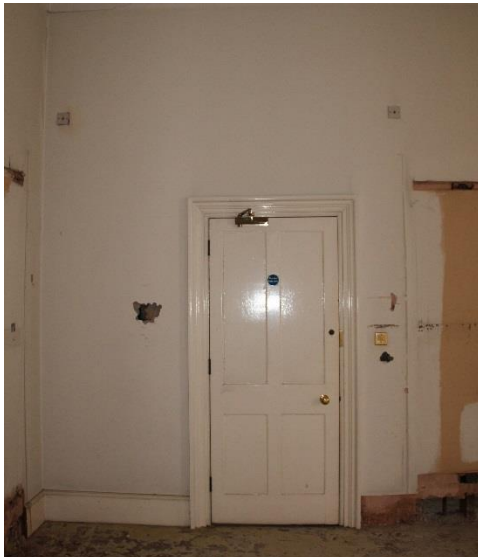
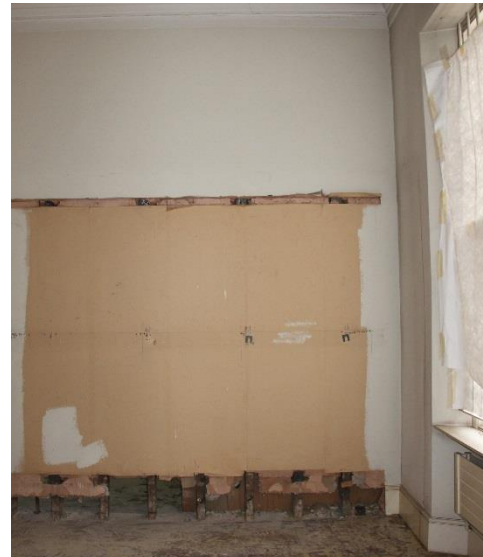
*ELEVATION 1 - Metal work and damaged modern plaster finishes to be carefully removed. To be confirmed on site if wall provides 30 min fire resistance. If it doesn't, wall to be overboarded with new fire resistant board to provide the required 30 minute fire protection. If it does, damaged plasterboard replaced with plasterboard to match existing adjacent. Redecoration throughout. Existing door containing asbestos to be replaced with new door to match design of existing. Refer to BDP drawing (32)AD001*

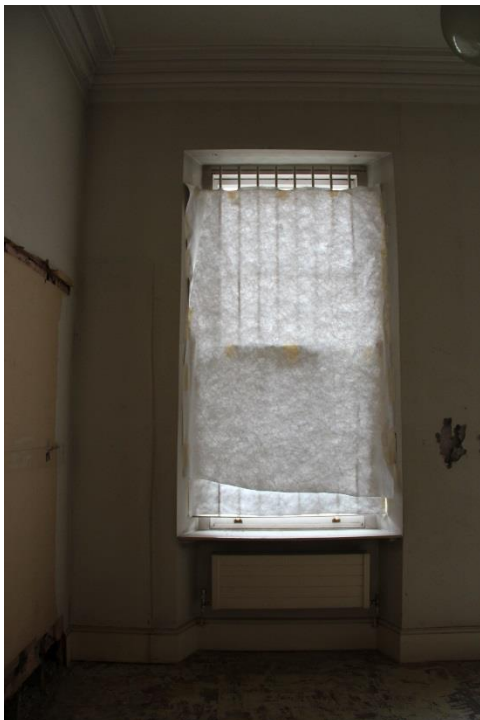
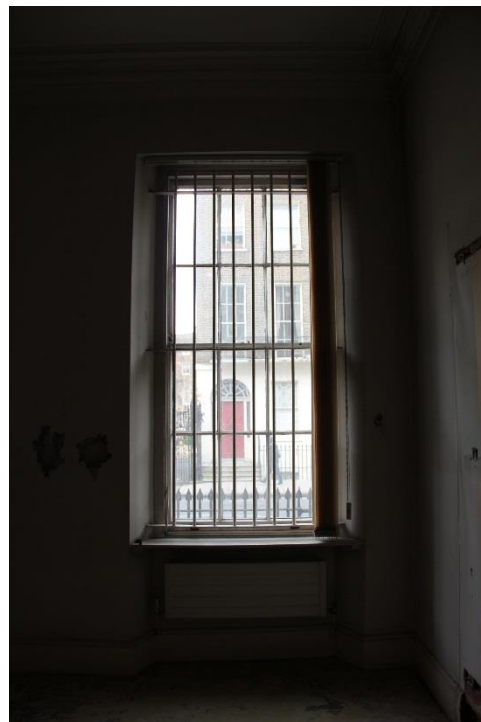
*ELEVATION 2 - Existing radiators to be carefully removed with all other existing services. Windows to undergo full overhaul to ensure good working condition and receive full redecoration*

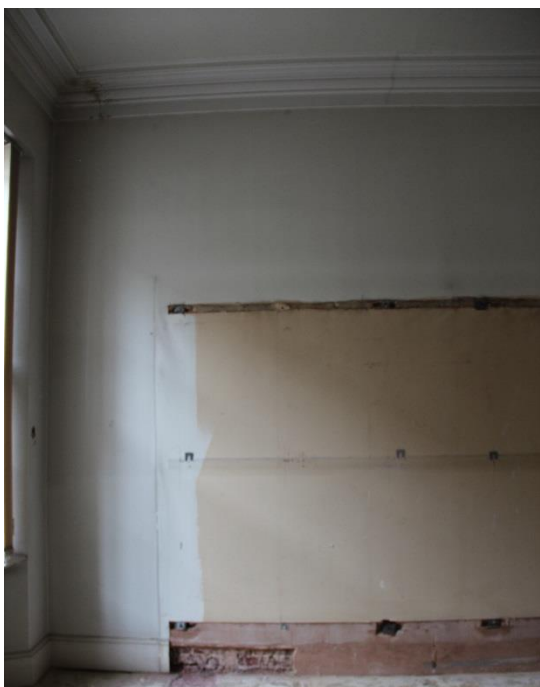
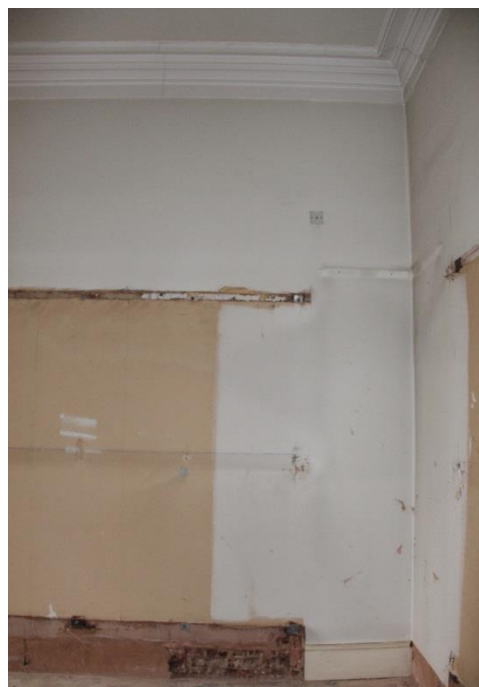
*ELEVATION 3 - Metal work and damaged modern plaster finishes to be carefully removed and replaced with plasterboard to match existing adjacent. Redecoration throughout.*

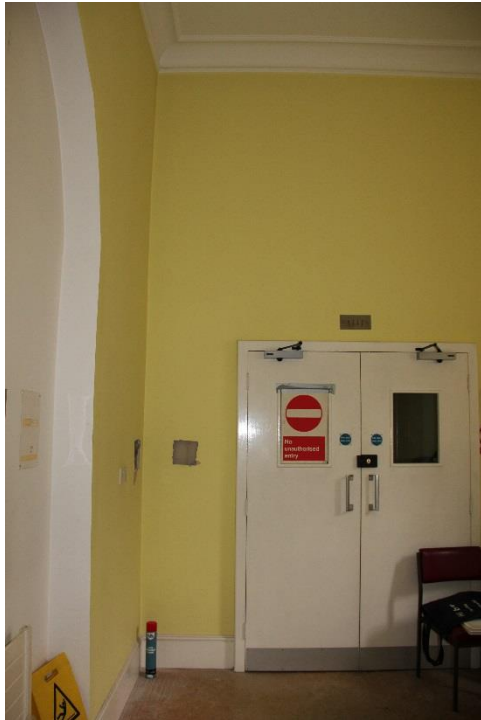
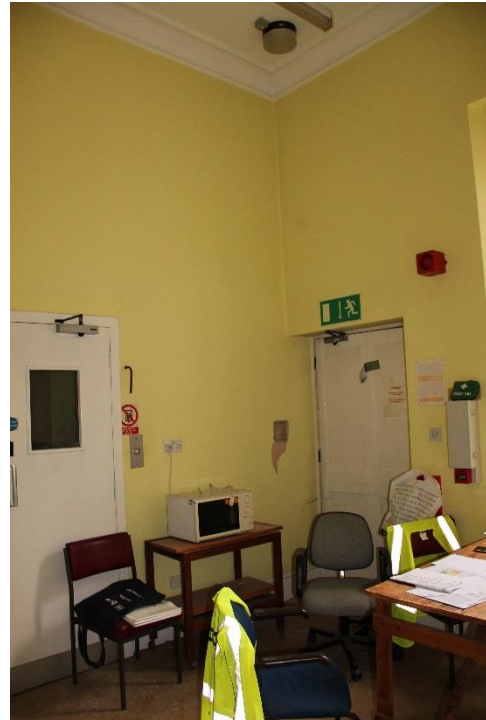
*ELEVATION 3 - Existing lift shaft doors to be carefully removed and replaced with new doors to match design of adjacent doors. See BDP drawing (32)AD002. Existing external door containing asbestos to be replaced with new door to match design of existing. Refer to BDP drawing (32)AD001*

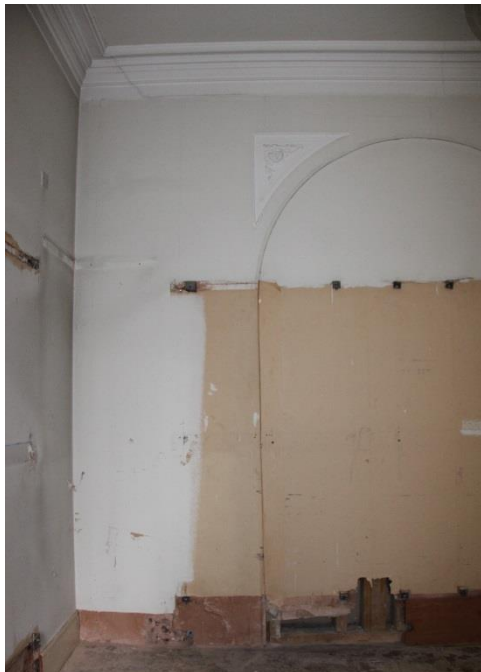
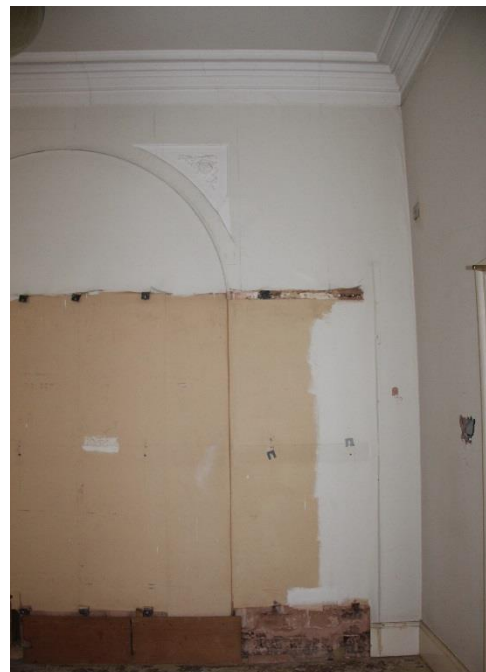
*ELEVATION 4 - Modern timber stud and plasterboard infill to be carefully removed to reinstate original opening. New replacement plasterboard finish to damaged areas of walls and redecoration throughout.*

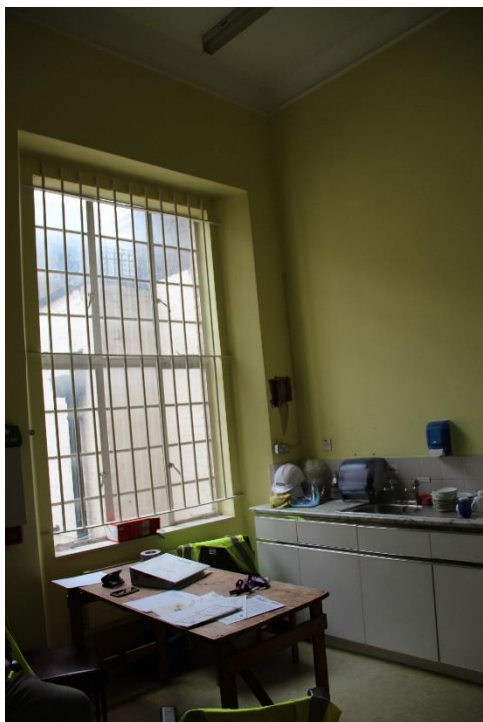
*ELEVATION 5 - New sash window  
1A-G-W03 to replace existing rear window.  
Refer to BDP drawing (31)AD002*

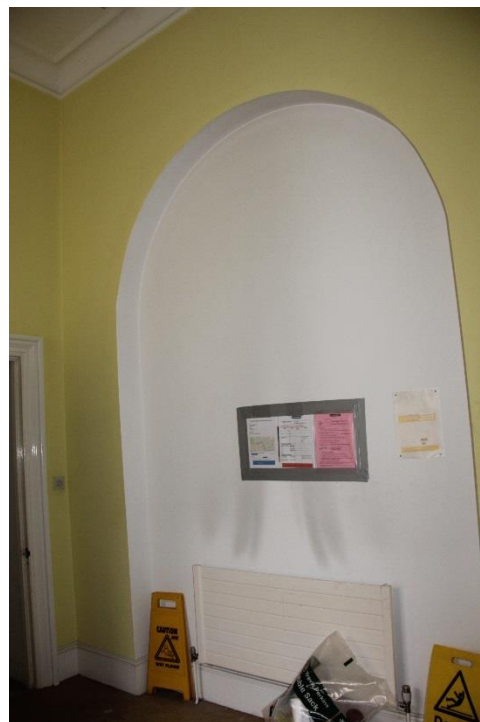
*ELEVATION 6 – Modern timber stud and  
plasterboard infill to be carefully removed to  
reinstate original opening*

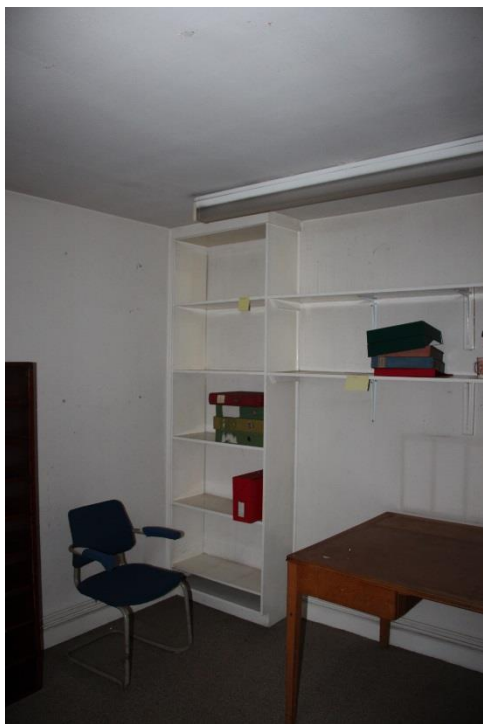
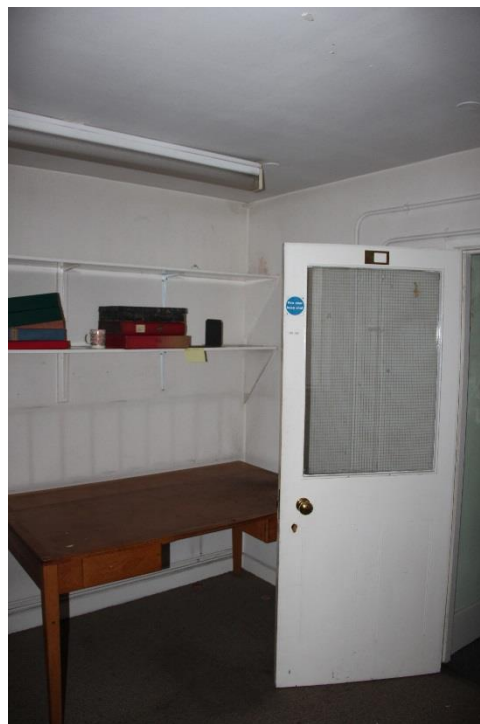
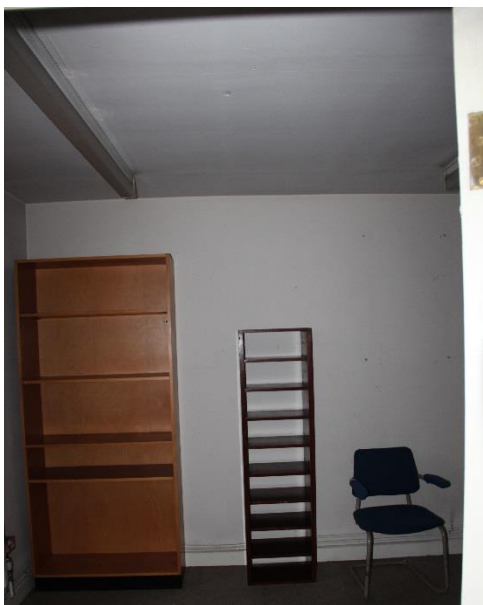
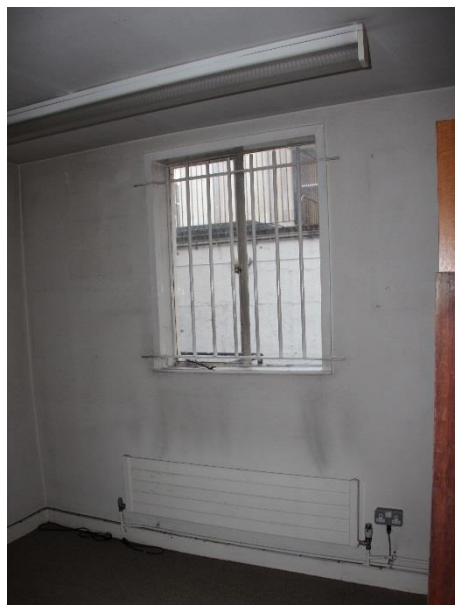
*Door to be replaced to comply with fire escape strategy. Metal framed window refurbished in situ. Redecoration required throughout.*

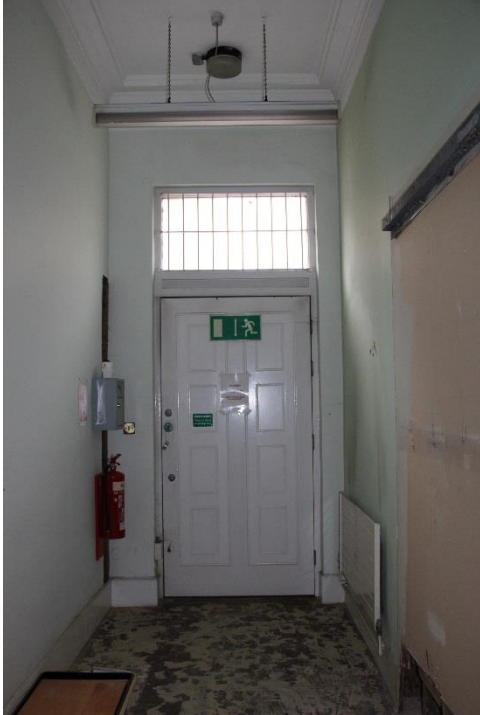
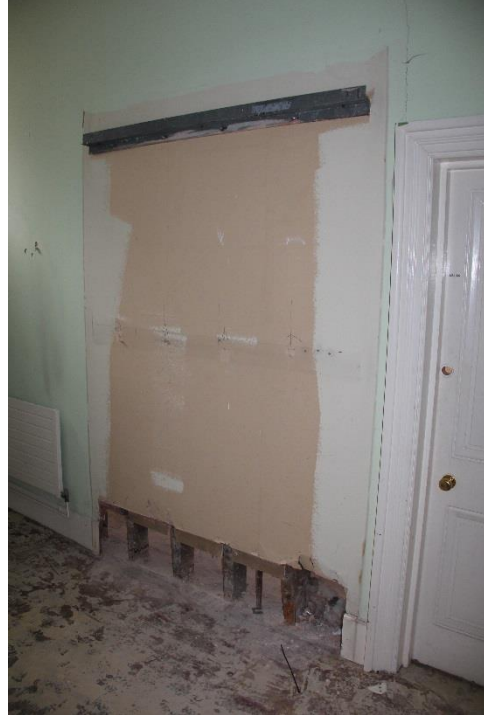
*Damaged modern plaster finishes to be carefully removed and replaced with plasterboard to match existing adjacent. Redecoration throughout.*

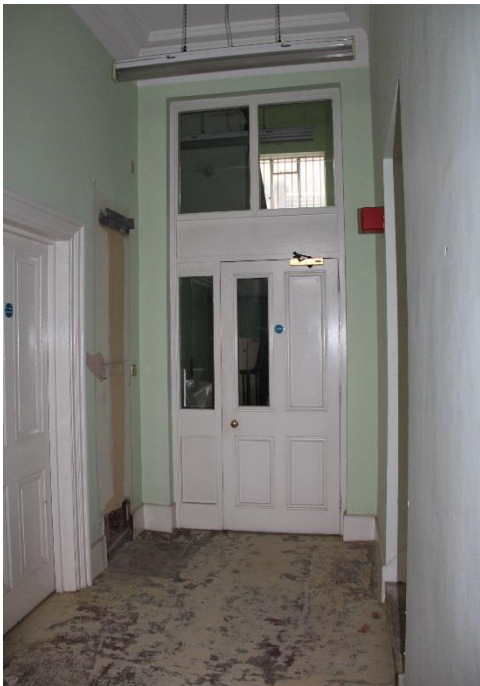
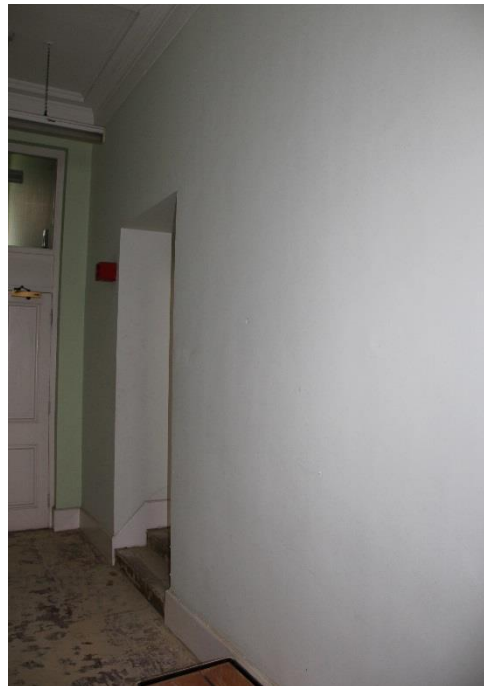
*Existing door between entrance lobby and stairs to be removed.*

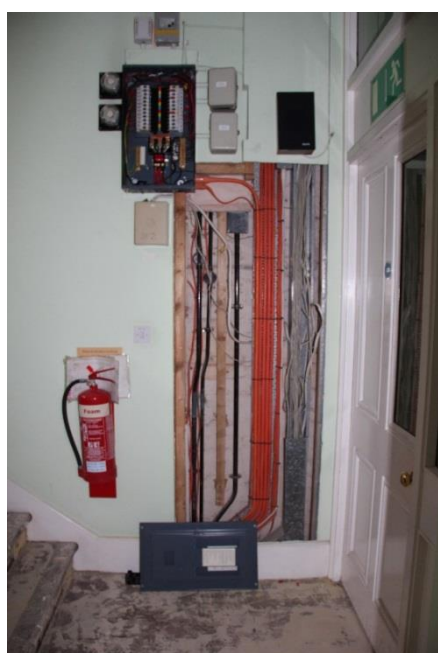
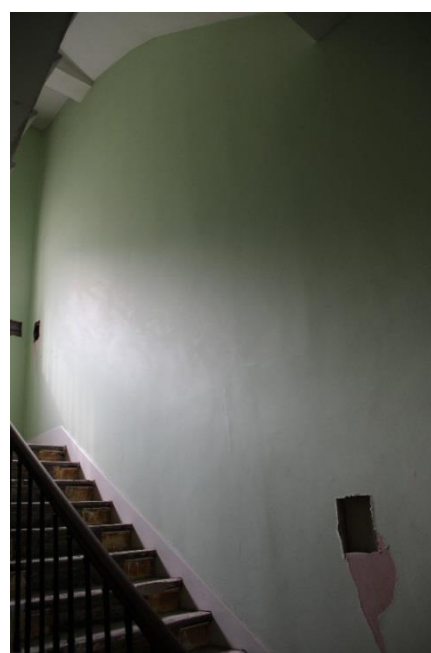
*New plaster finish to damaged areas of walls following removal of existing service and intrusive investigations*

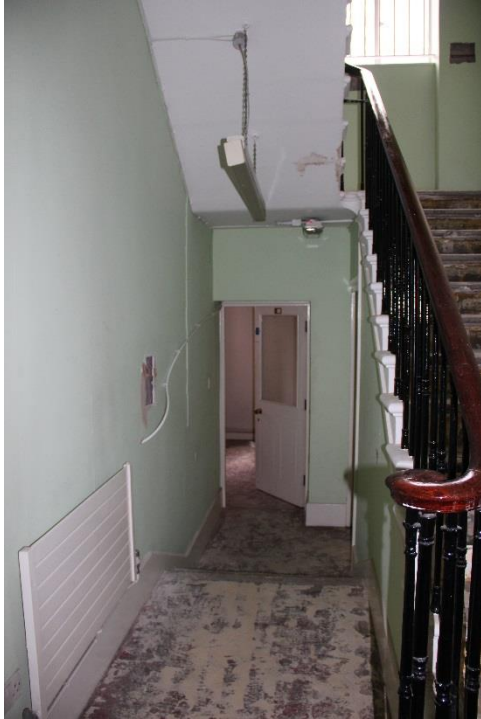
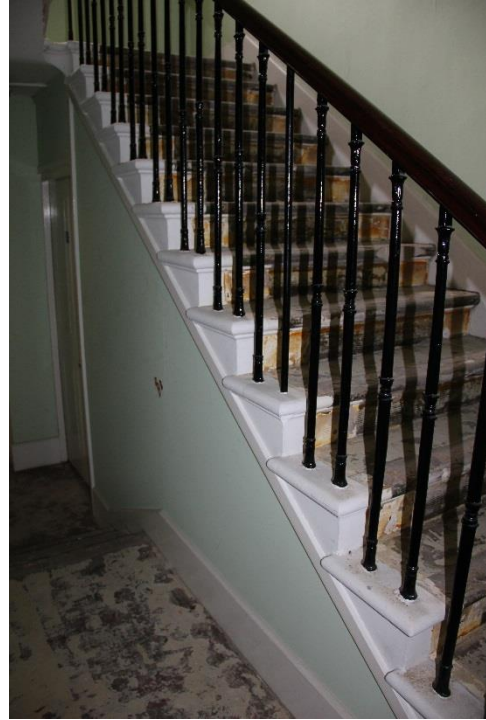
*Existing door containing asbestos underneath stairs to basement, to be replaced with new door to match design of existing. Refer to BDP drawing (32)AD001*
