<b>Room No. 1MS/2/003 Lobby</b>	
<b>Item</b>	<b>Scope of works</b>
General	<ul style="list-style-type: none"> <li>▪ Existing fittings and services have already been removed;</li> <li>▪ Walls to be redecorated with matt emulsion paint finish -allow for 2 coats. Colour to be agreed with architect and British Museum;</li> <li>▪ Existing ceilings to be redecorated with matt emulsion paint.</li> <li>▪ Existing stairs, skirting, doors and architrave to be retained, repaired where necessary and redecorated;</li> <li>▪ New services provision throughout. Electrical distribution to be recessed.</li> <li>▪ New lighting to be installed</li> <li>▪ External roof light to be retained and cleaned.</li> </ul>
Ceilings	<ul style="list-style-type: none"> <li>▪ Carefully remove all existing services, fixtures and fittings from the existing plaster ceiling together with any friable or loose/live plaster;</li> <li>▪ External roof light to be retained and cleaned, upstand to be redecorated;</li> <li>▪ Areas of existing damaged ceilings and supporting structure to be carefully removed and repaired/ replaced as required;</li> <li>▪ Ceiling to be redecorated with white emulsion paint finish;</li> </ul>

<b>

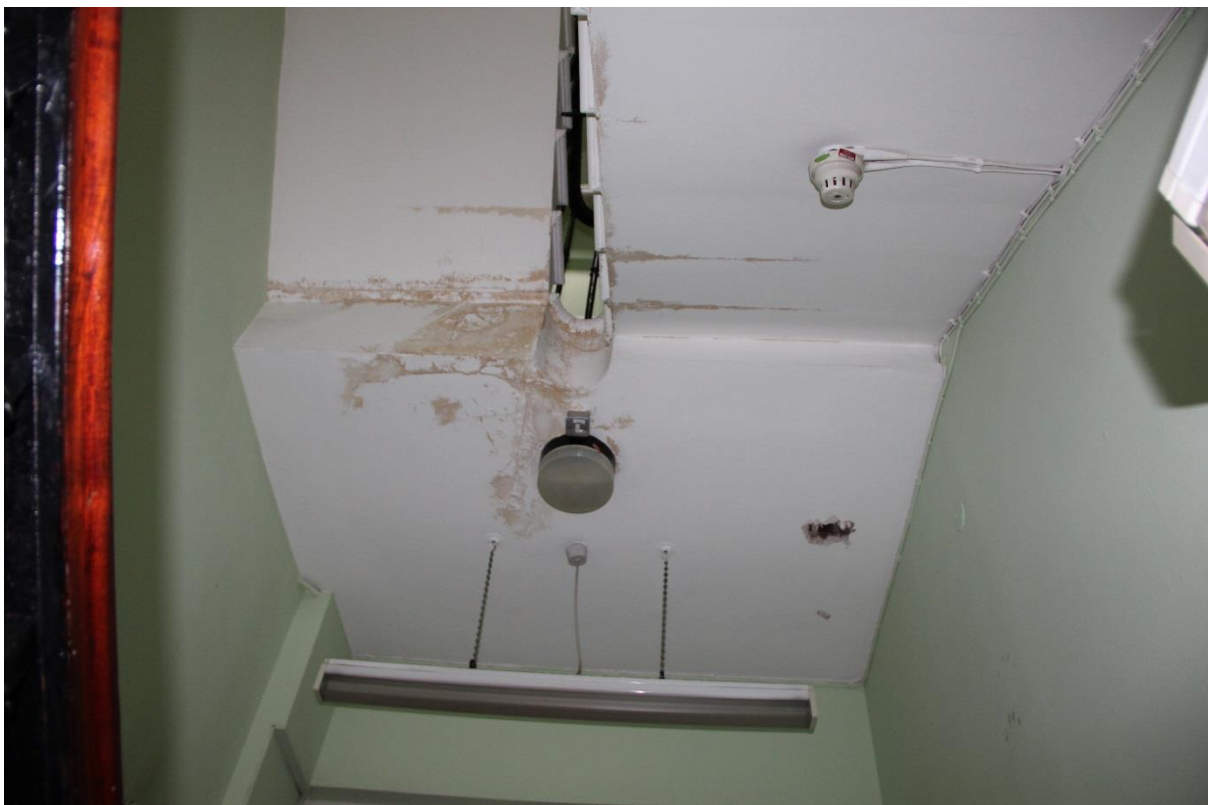
*Where evidence of dampness exists, assess condition and associated structure, rectify source and carry out repairs and relining where necessary;*

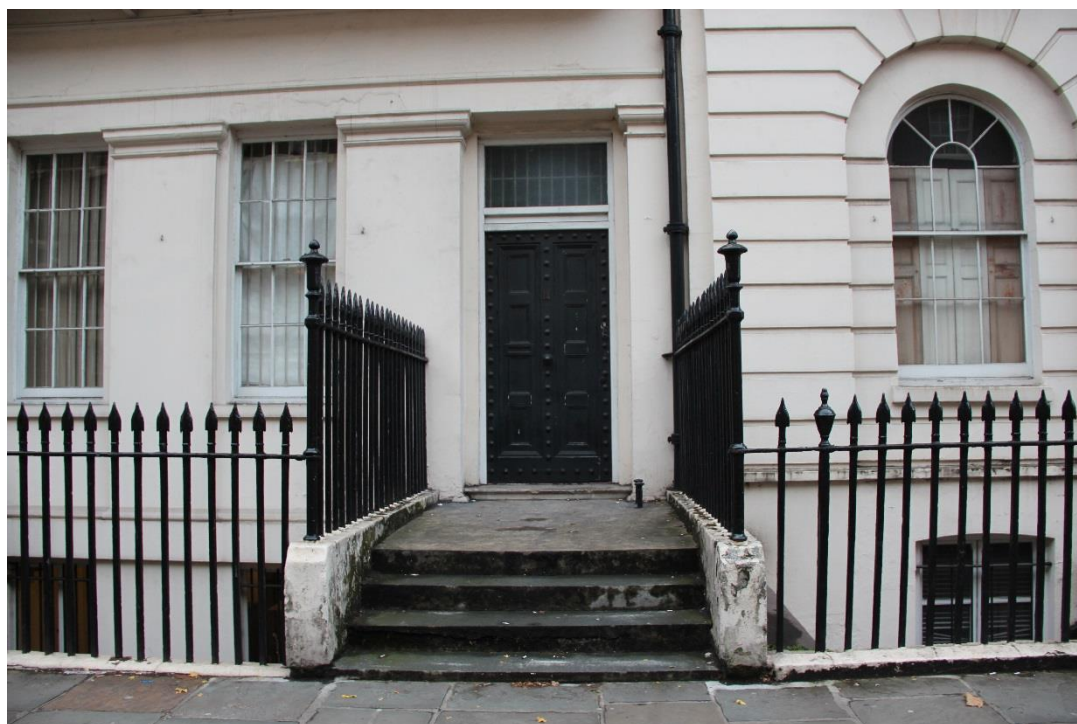
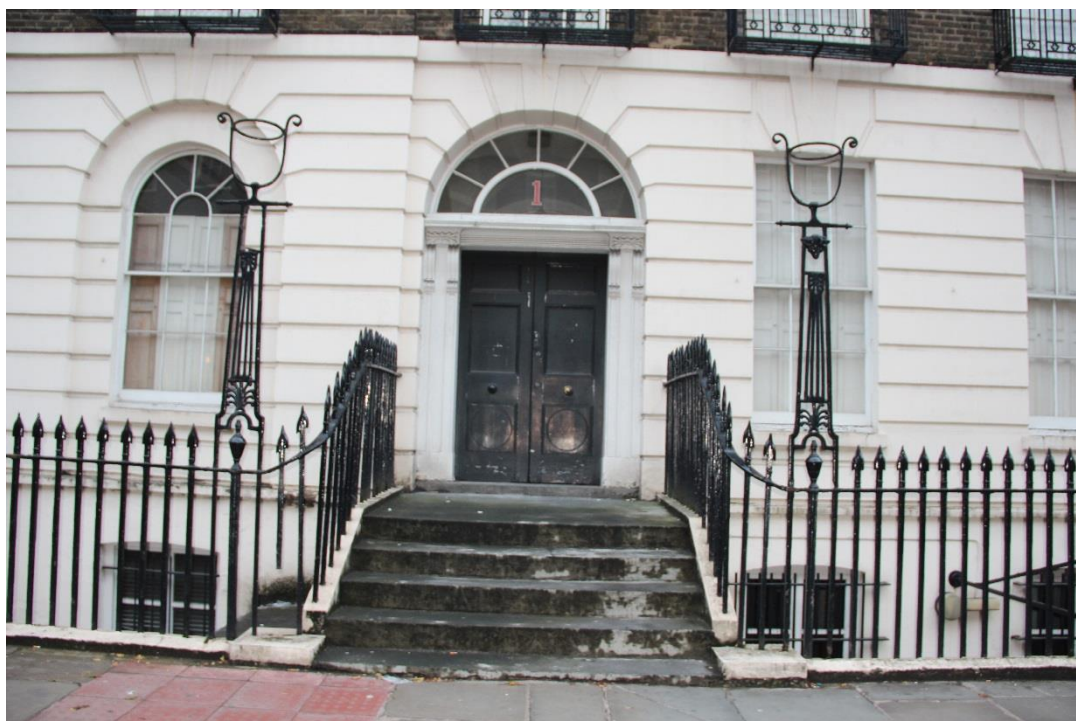
*Existing stucco to be made good where required and redecorated. Existing stone steps to be cleaned and made good where necessary. Existing balustrades to be redecorated.*

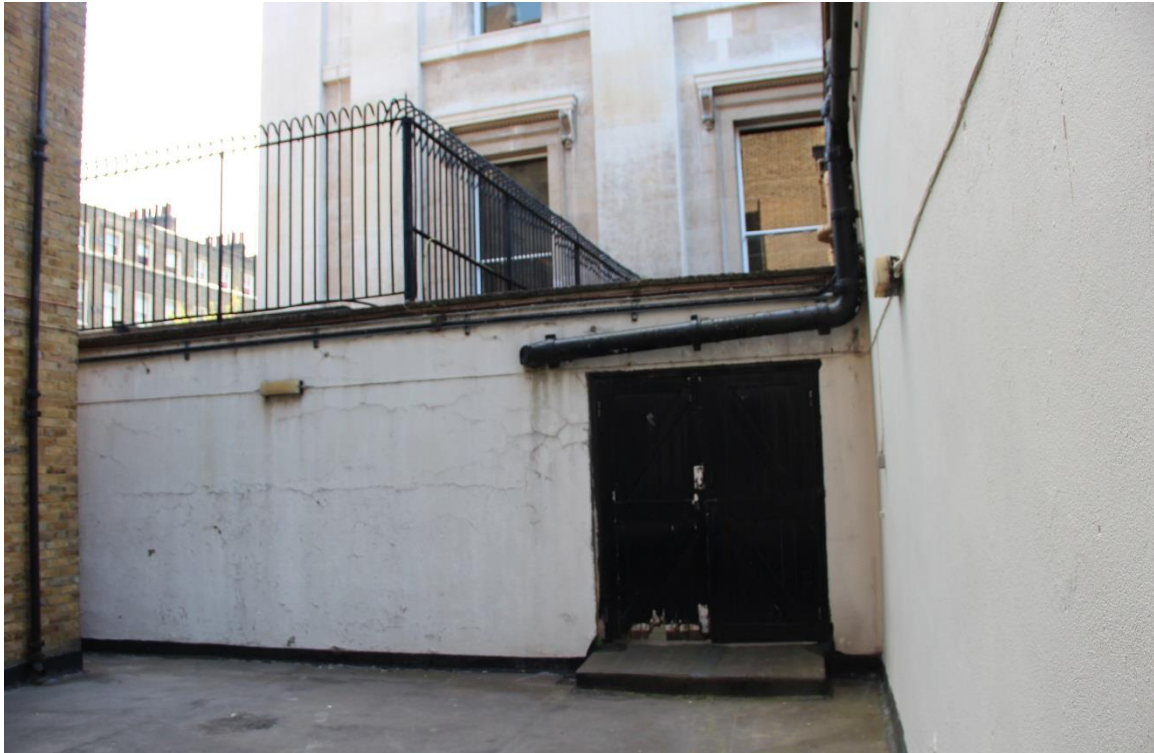
*Existing timber gate secured, refurbished and redecorated in a high gloss, weather resistant paint; For door information refer to door schedule. New proposed section of perimeter railing to match detail, profile and height of existing adjacent railing on wall that forms the boundary between the 1A MS and the British Museum. Refer to drawing (41)AD001. Allow for asphalt repairs around perimeter of existing step to door 1A-G-D08.*

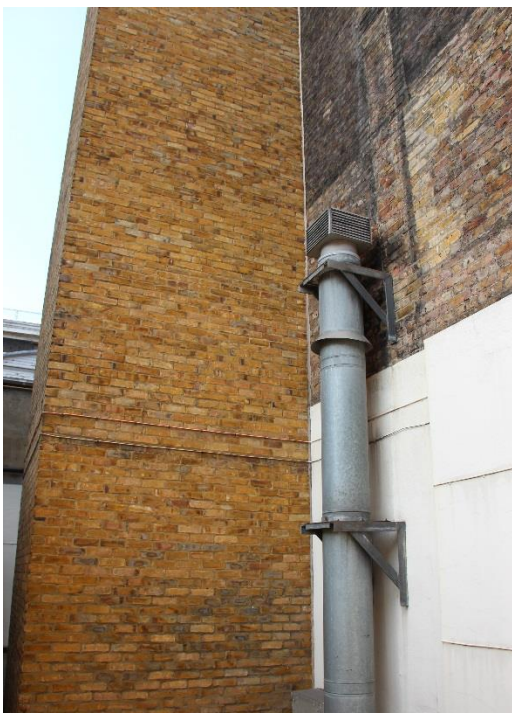
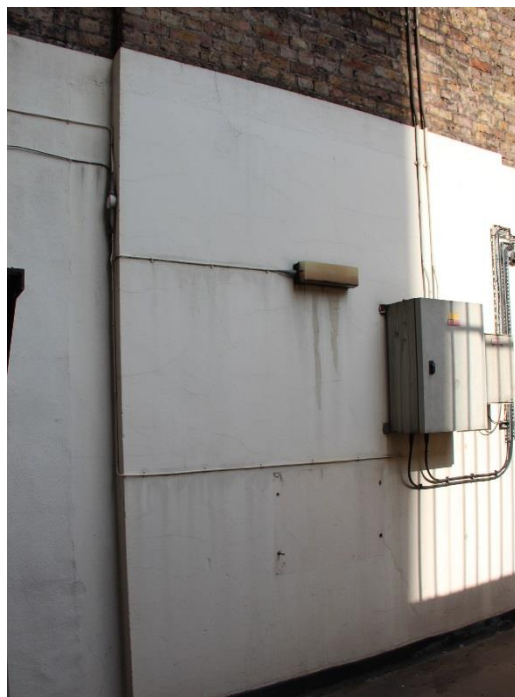
*All existing redundant M&E equipment carefully removed. Wall to be made good and redecorated with exterior paint finish.*

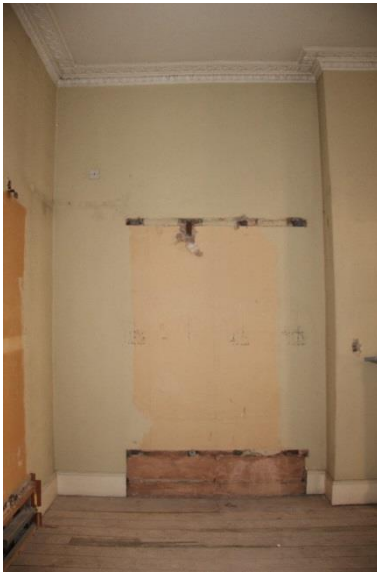
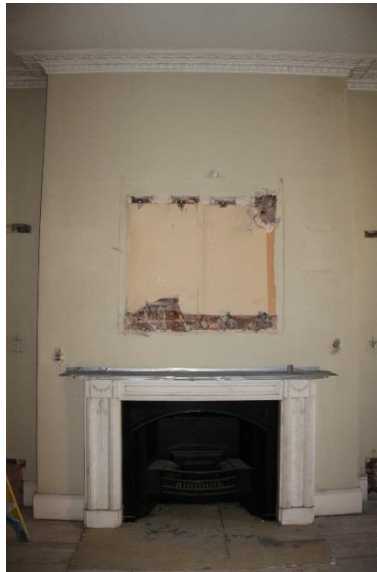
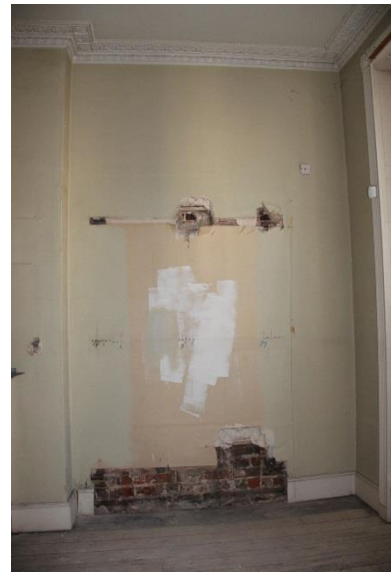
*ELEVATION 1 - Metal work and damaged modern plaster finishes to be carefully removed and replaced with lath and plaster to match existing adjacent. Redecoration throughout.*

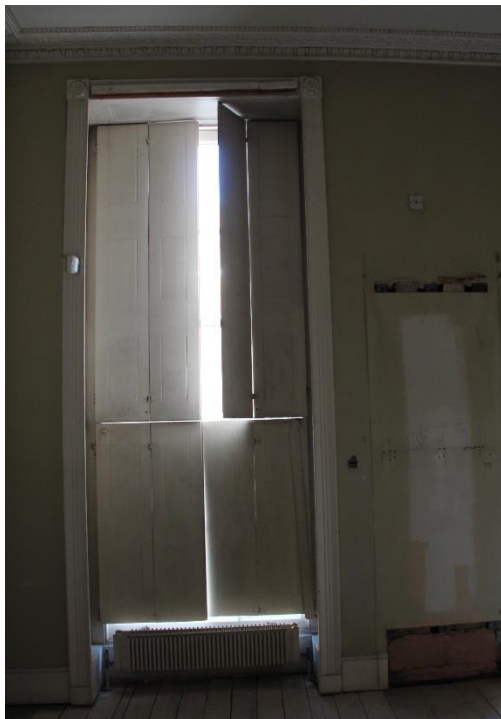
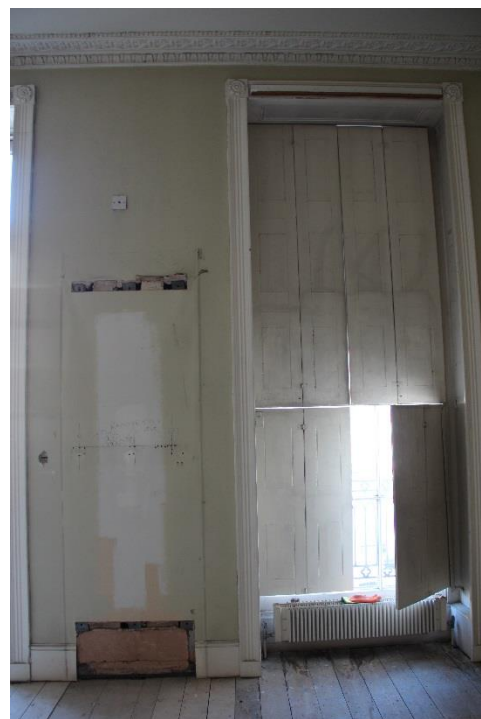
*ELEVATION 2 - Metal work and damaged modern plaster finishes to be carefully removed and replaced with lath and plaster to match existing adjacent. Windows and shutters to undergo full overhaul to ensure good working condition and receive full redecoration. Redecoration throughout.*

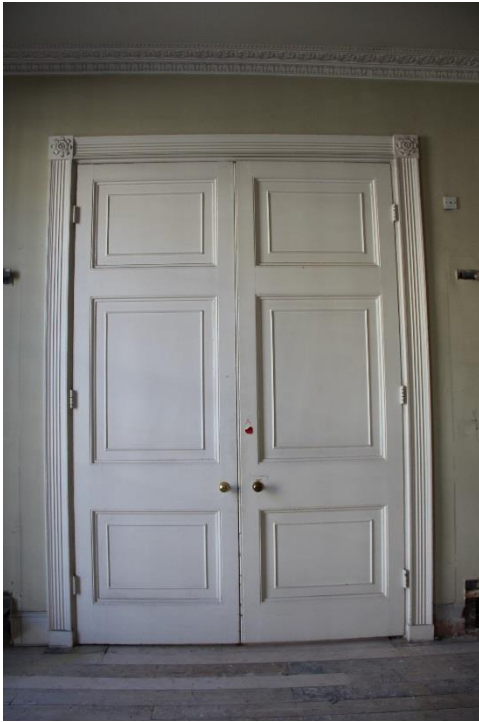
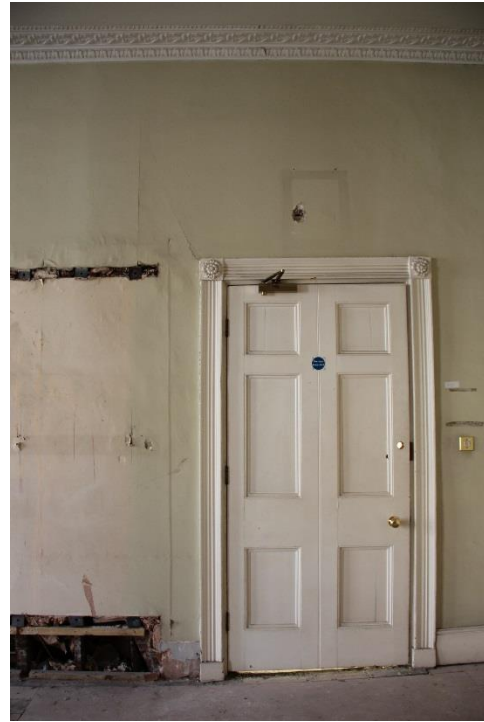
*ELEVATION 3 - Existing door refurbished and redecorated. Fire upgrade requirements. Damaged modern wall finishes to be made good to provide a suitable surface for new fire resistant board. Lath and plaster to be overboarded to achieve 30 minute fire protection. Existing cornice and skirting carefully removed, set aside with care and reinstated when the overboarding is completed. Ironmongery to be retained and refurbished.*

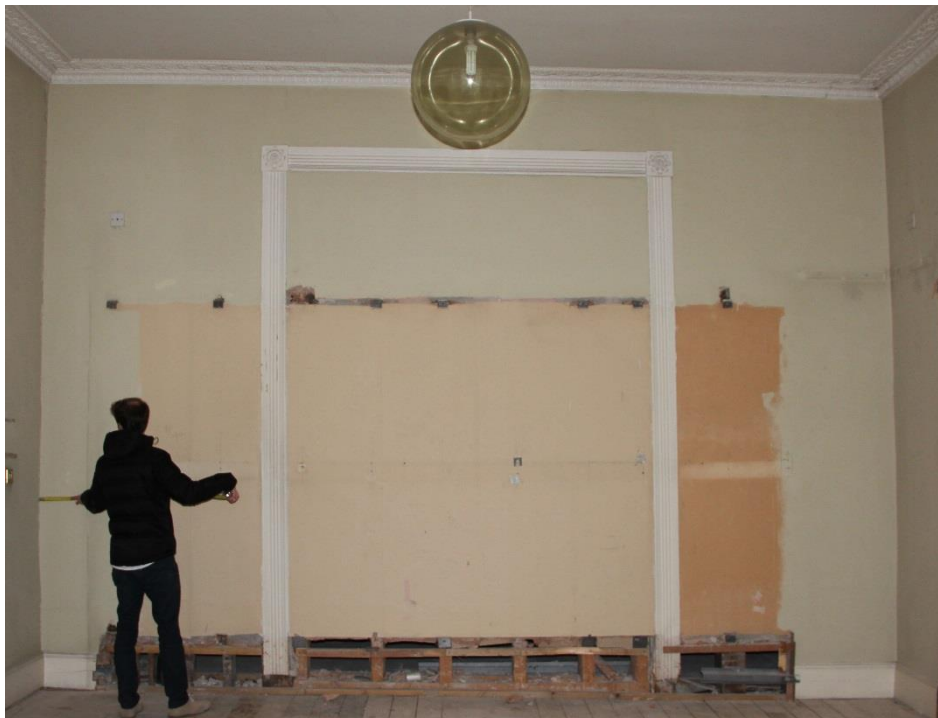
*ELEVATION 4 - Original opening to be reinstated; Modern timber stud and plasterboard infill to be carefully removed; Damaged modern wall finishes to be carefully removed with existing adjacent construction to be made good. New lath and plaster finishes required and full redecoration throughout.*
