Room No. 1MS/3/003 Office	
Item	Scope of works
General	<ul style="list-style-type: none"> ▪ Existing furniture, fittings and services have already been removed; ▪ Carefully remove metal work and modern plaster finishes associated with previous museum shelving arrangement and repair adjacent finishes; ▪ New replacement lath and plaster finish to damaged areas of walls. Refer to BDP drawings (70)AD026/027; ▪ Walls to be redecorated with matt emulsion paint finish -allow for 2 coats. Colour to be agreed with architect and British Museum; ▪ Existing ceilings to be redecorated with matt emulsion paint. ▪ New door 1-1-D06, associated architrave and skirting where missing to be fitted and decorated in eggshell paint; Refer to BDP series drawings (32) ▪ Existing skirting in good condition, doors, architrave, cornices and decorative mouldings to be retained, repaired where necessary and redecorated; ▪ New services provision throughout. Electrical distribution to be recessed. ▪ New lighting to be installed ▪ Windows to be redecorated and receive full overhaul to ensure full operation

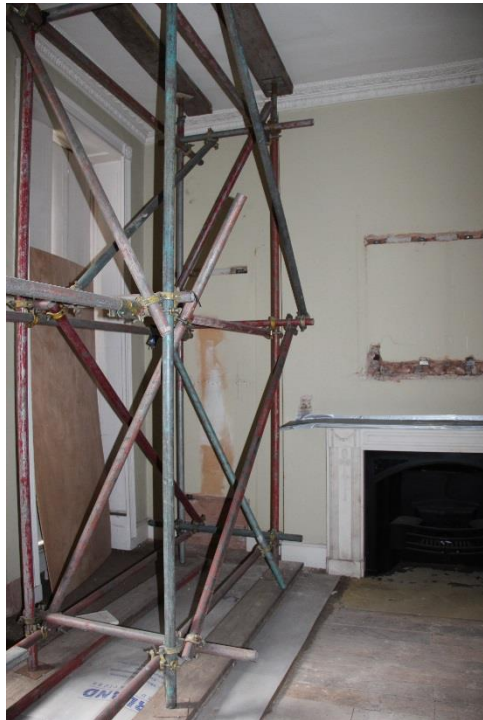
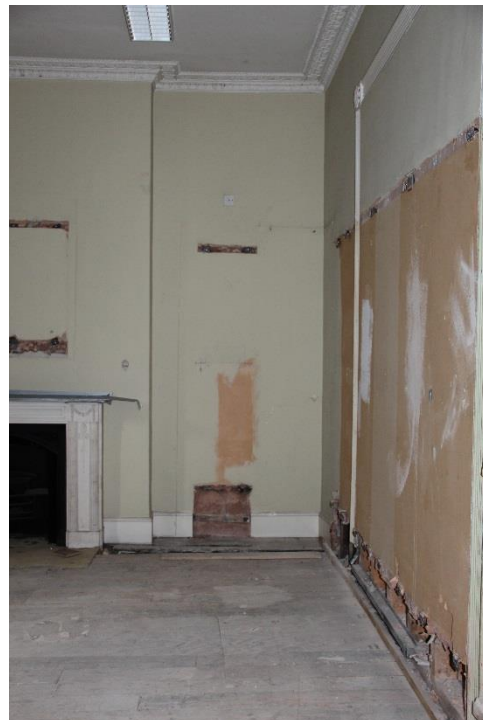
ELEVATION 5 - Metal work and damaged modern plaster finishes to be carefully removed and replaced with lath and plaster to match existing adjacent. Redecoration throughout.

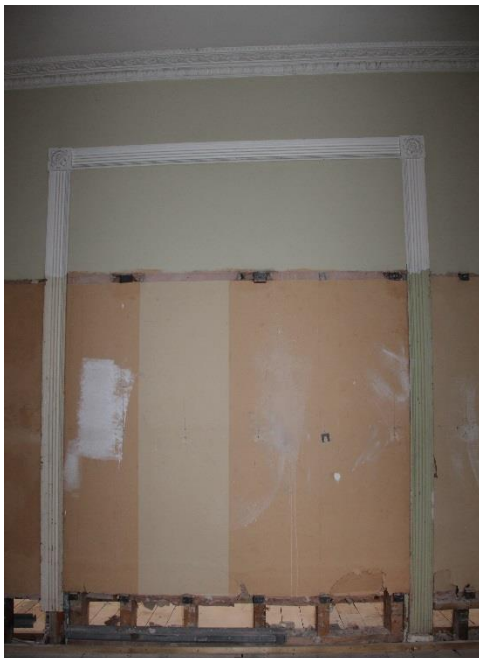
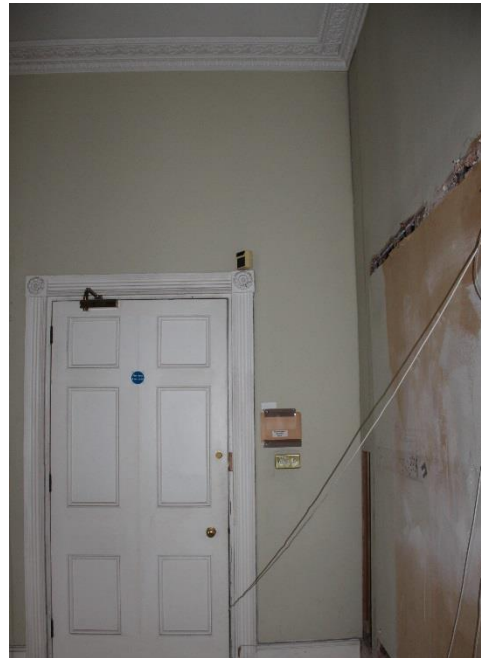
ELEVATION 6 - Original opening to be reinstated; Modern timber stud and plasterboard infill to be carefully removed; Fire upgrade requirements. Fire upgrade requirements. Damaged modern wall finishes to be made good to provide a suitable surface for new fire resistant board. Lath and plaster to be overboarded to achieve 30 minute fire protection. Existing cornice and skirting carefully removed, set aside with care and reinstated when the overboarding is completed. Ironmongery to be retained and refurbished.

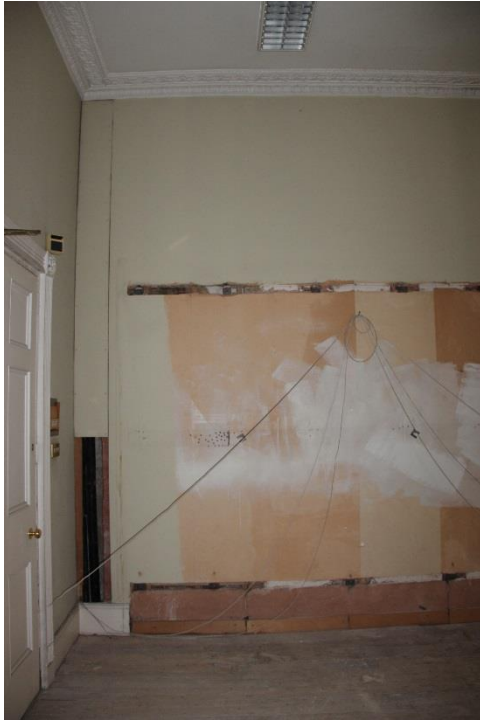
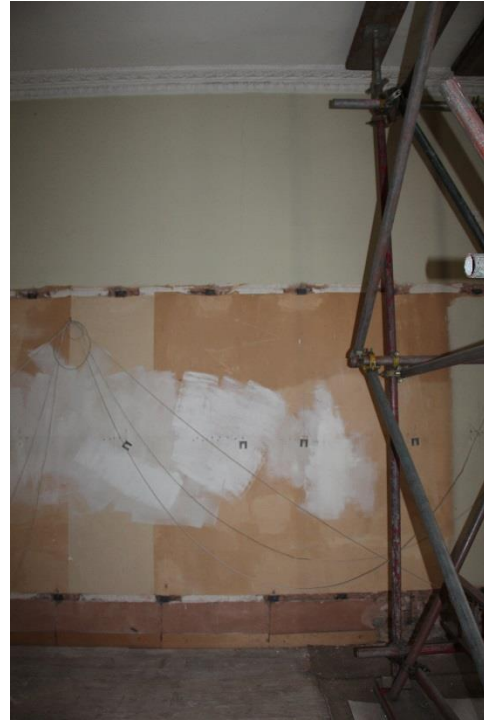
ELEVATION 7 - Metal work and damaged modern plaster finishes to be carefully removed and replaced with lath and plaster to match existing adjacent. Redecoration throughout. New enclosure design for main service run. Refer to BDP detail drawing (50)AD009

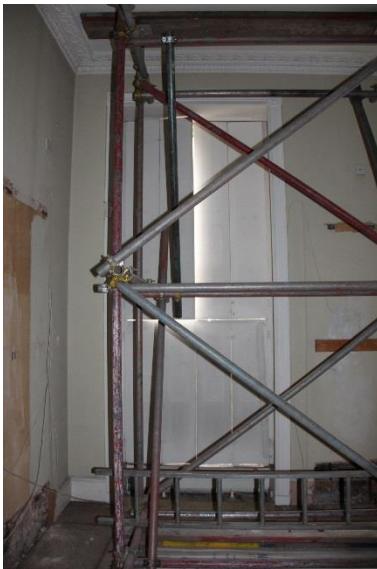
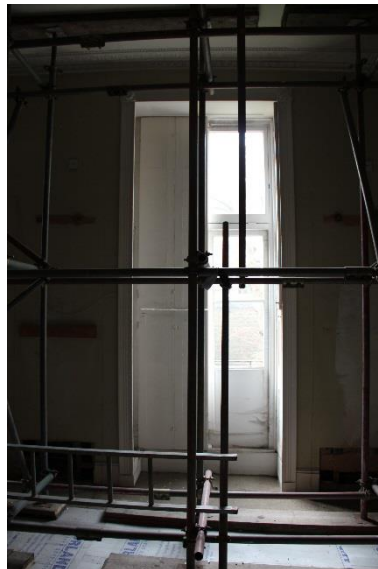
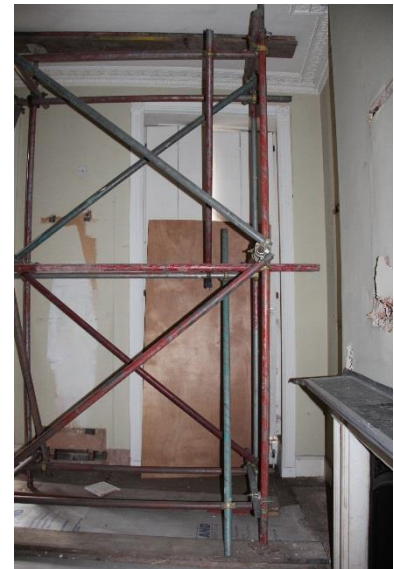
ELEVATION 8 - Windows and shutters to undergo full overhaul to ensure good working condition and receive full redecoration

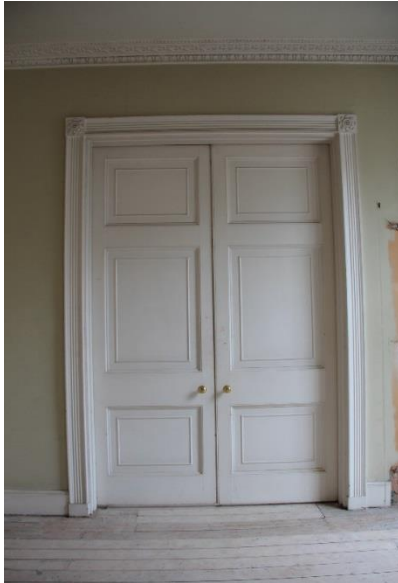
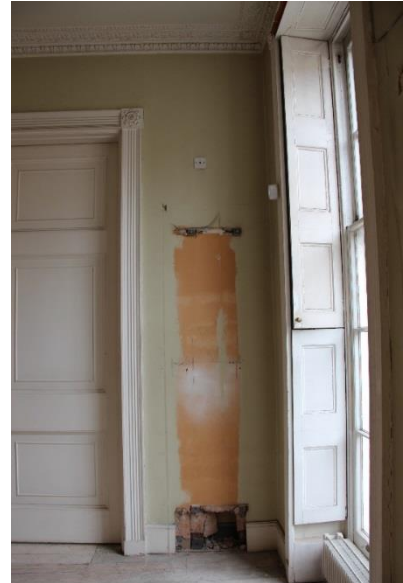
ELEVATION 3 - Damaged modern wall finishes to be carefully removed with existing adjacent construction to be made good. New lath and plaster finishes required and full redecoration throughout. Existing door to be refurbished and redecorated. Ironmongery to be retained and refurbished.

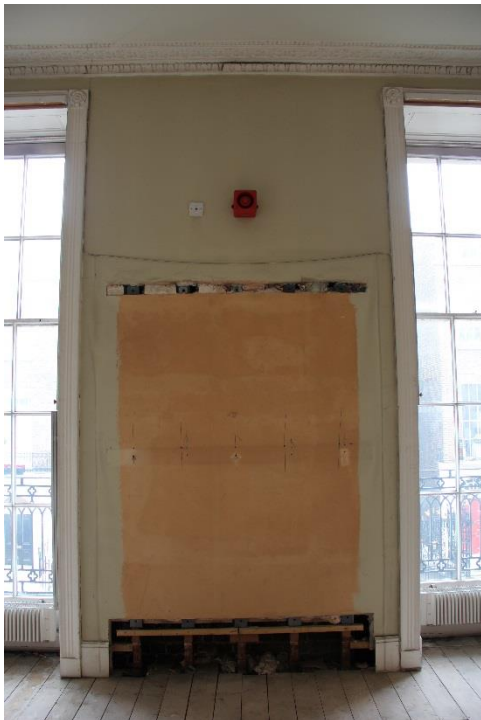
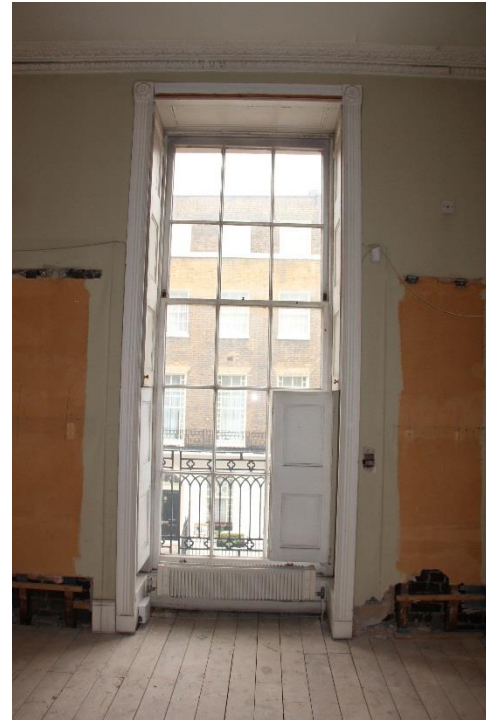
ELEVATION 2 - Windows and shutters to undergo full overhaul to ensure good working condition and receive full redecoration. Metal work and damaged modern plaster finishes to be carefully removed and replaced with lath and plaster to match existing adjacent. Redecoration throughout.

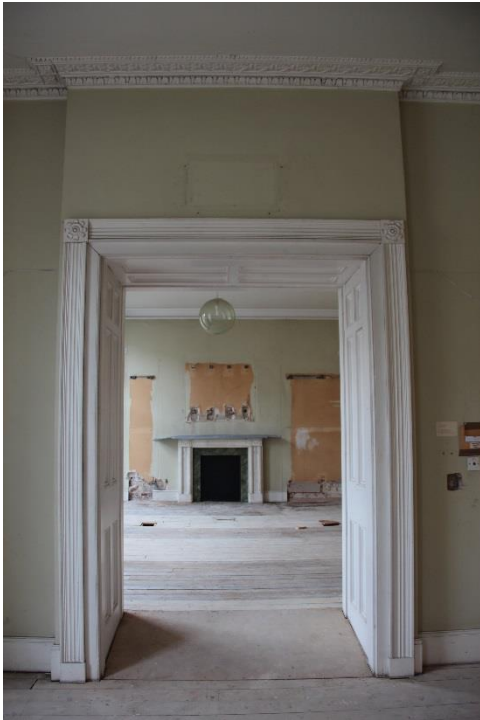
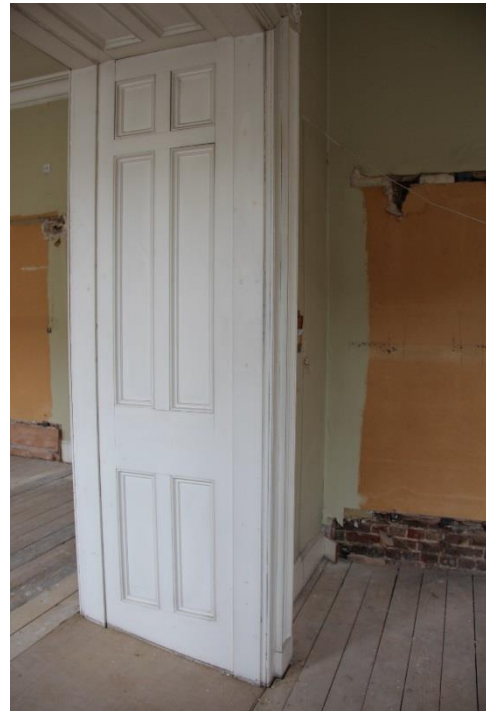
ELEVATION 2 – New FD30 double doors to be fitted in existing opening to match design of door 1-1-D01. Refer to detail drawing (32)AD002

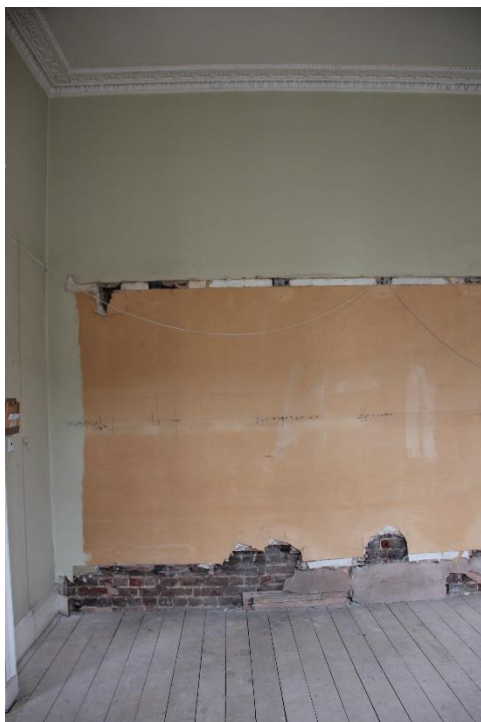
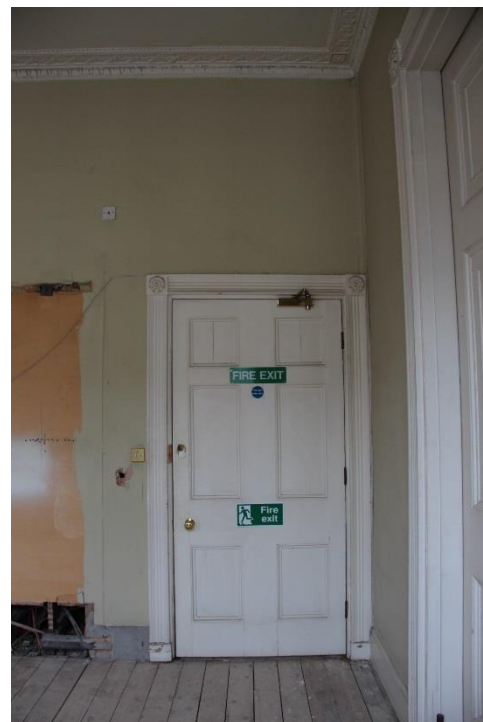
ELEVATION 4 - Metal work and damaged modern plaster finishes to be carefully removed and replaced with lath and plaster to match existing adjacent. Redecoration throughout. Existing door refurbished and redecorated. Fire upgrade requirements TBD. Ironmongery to be retained and refurbished.

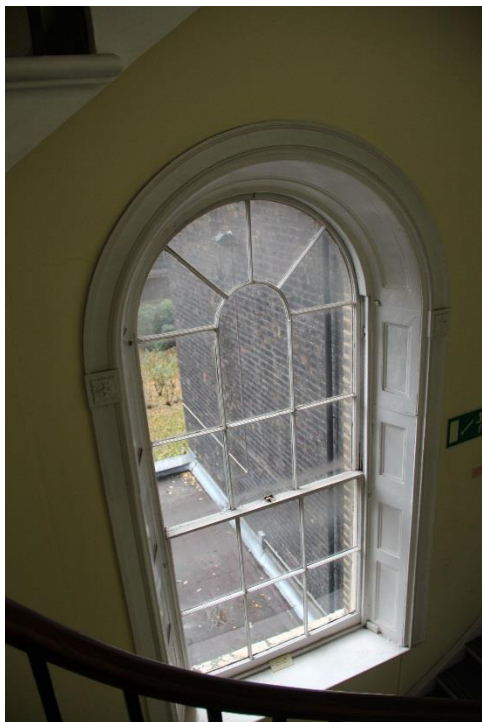
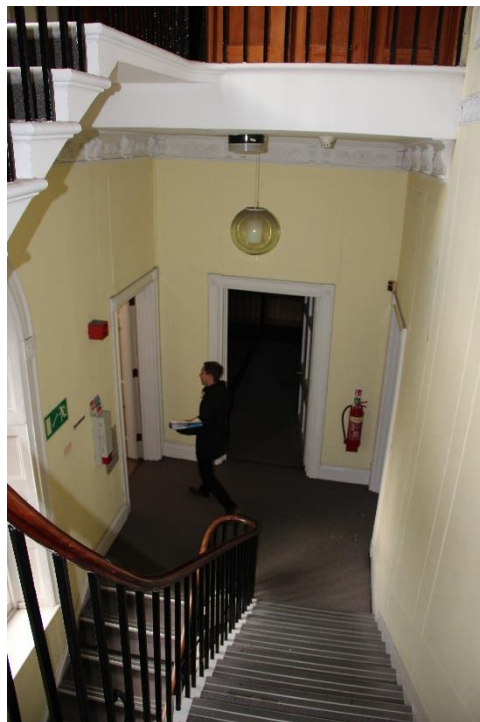
Window to undergo full overhaul to ensure good working condition and receive full redecoration. Existing doors to be refurbished and redecorated. Fire upgrade requirements TBD. Ironmongery to be retained and refurbished. Stairs, balustrade and handrail to be fully refurbished and redecorated

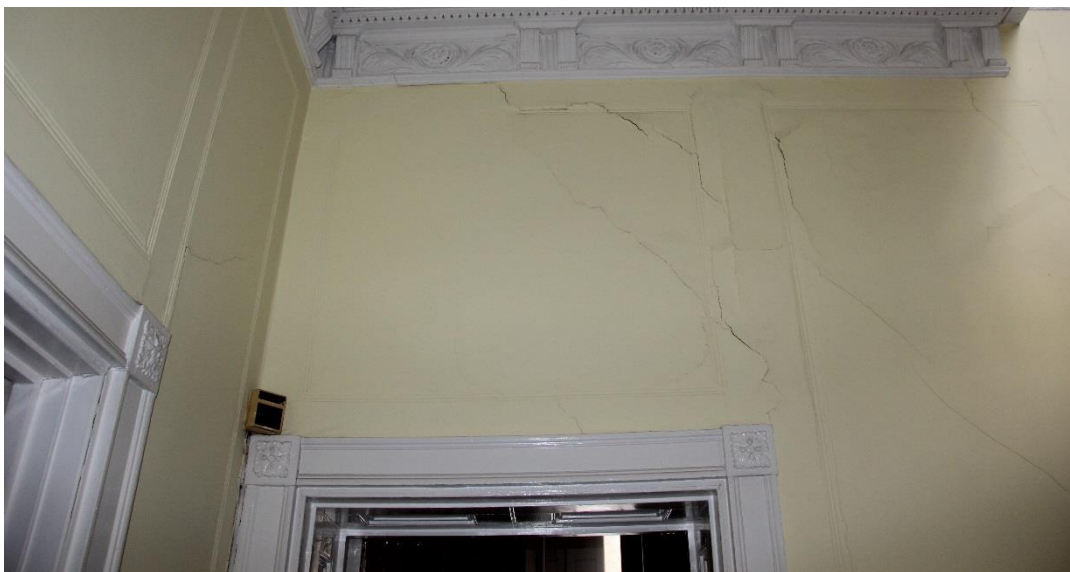
Repairs to be carried out to damaged area of wall. Existing damaged plasterwork to be carefully removed and replaced with new plaster to match adjacent existing. Wall beading to be replaced as required. Full redecoration throughout

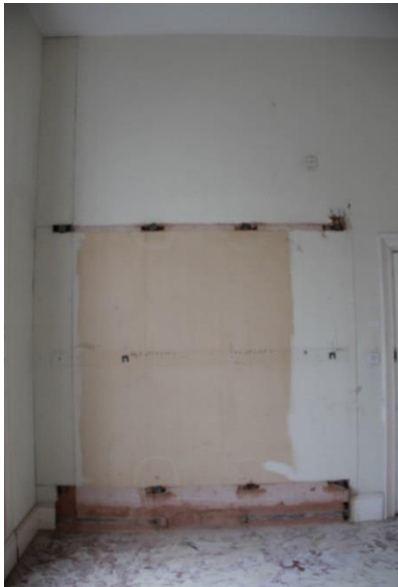
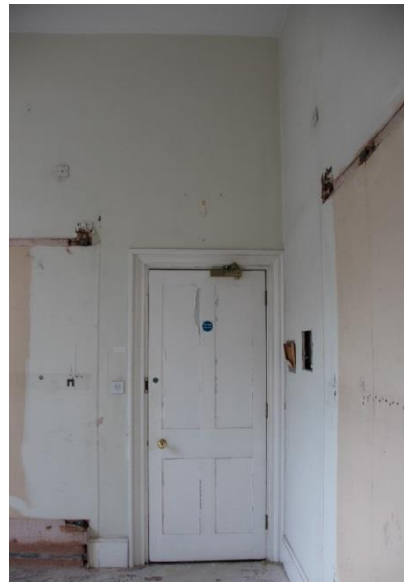
ELEVATION 1 - Metal work and damaged modern plaster finishes to be carefully removed. To be confirmed on site if wall provides 30 min fire resistance. If it doesn't, wall to be overboarded with new fire resistant board to provide the required 30 minute fire protection. If it does, damaged plasterboard replaced with plasterboard to match existing adjacent. Redecoration throughout. Existing door containing asbestos to be replaced with new FD30 door.

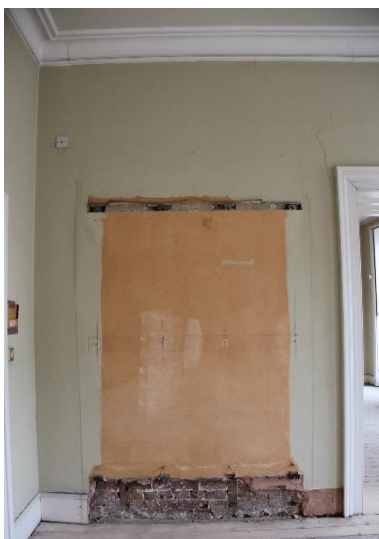
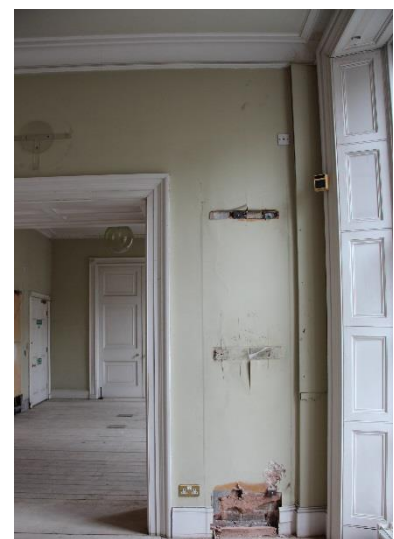
ELEVATION 1 - Metal work and damaged modern plaster finishes to be carefully removed and replaced with original plaster to match existing adjacent. Redecoration throughout. New FD30 double doors to be fitted in existing opening to match design of door 1-1-D01. Refer to detail drawing (32)AD002

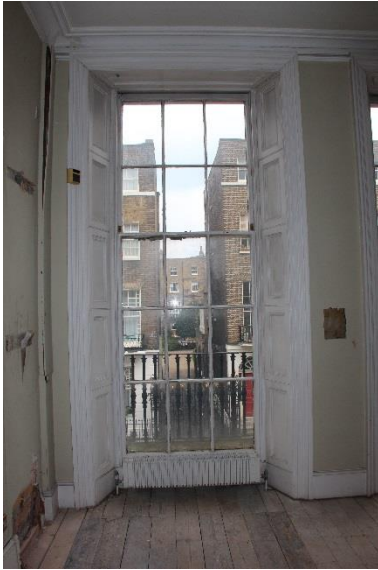
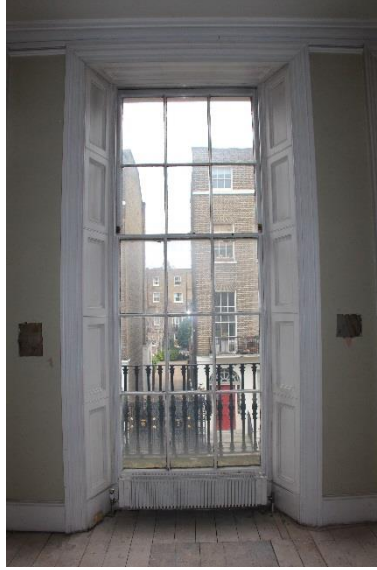
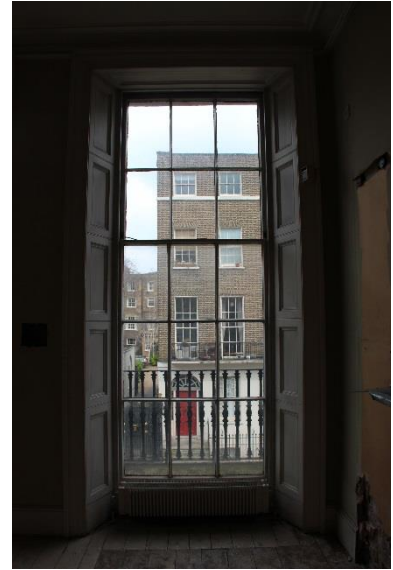
ELEVATION 2 - Windows and shutters to undergo full overhaul to ensure good working condition and receive full redecoration. Metal work and damaged modern plaster finishes to be carefully removed and replaced with original plaster to match existing adjacent. Redecoration throughout.

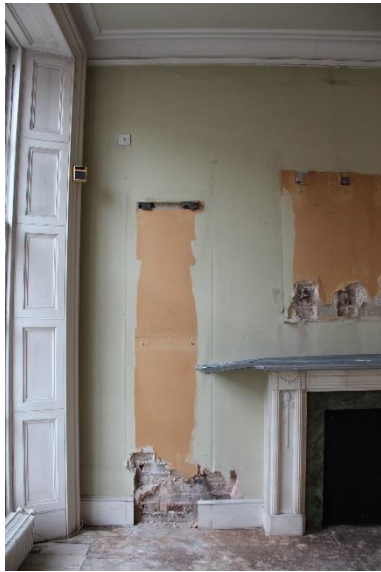
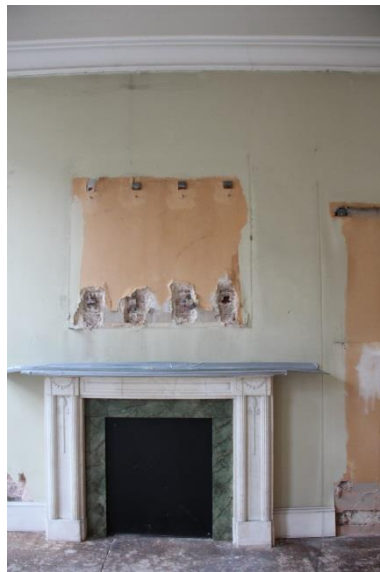
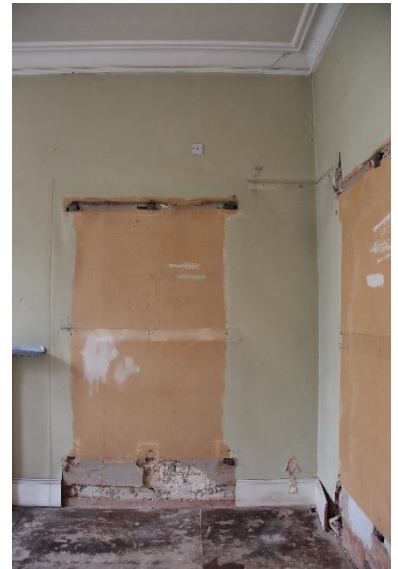
ELEVATION 3 - Metal work and damaged modern plaster finishes to be carefully removed and replaced with original plaster to match existing adjacent. Redecoration throughout. Existing door containing asbestos to be replaced with new FD30 door.

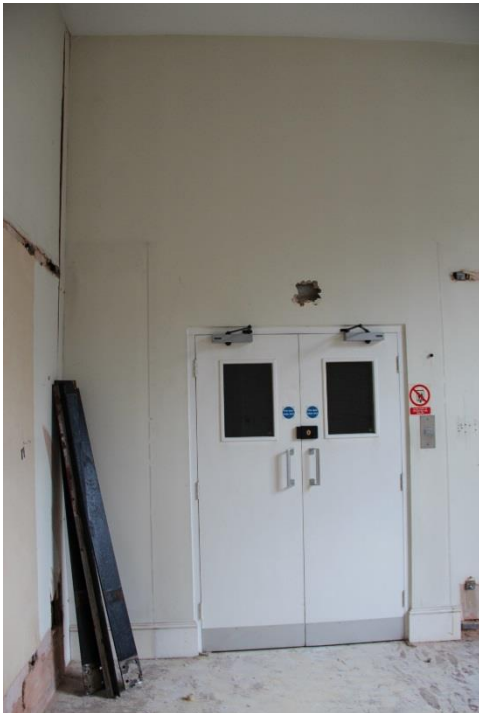
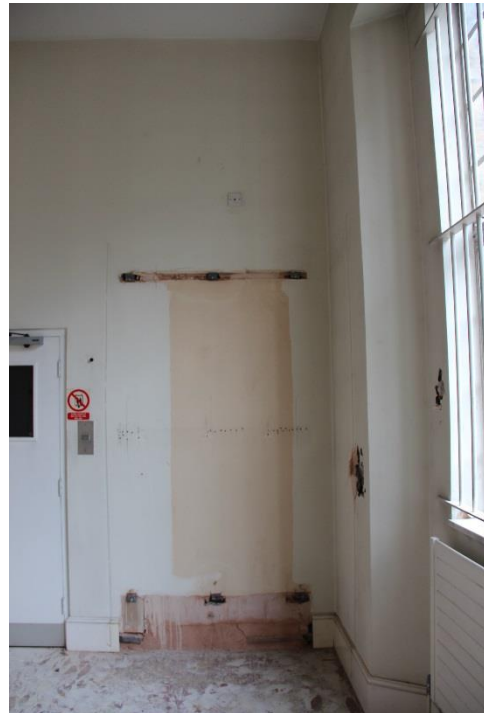
ELEVATION 3 - Metal work and damaged modern plaster finishes to be carefully removed and replaced with original plaster to match existing adjacent. Redecoration throughout. New FD30 double doors to replace existing lift shaft doors to match design of adjacent doors. Refer to detail drawing (32)AD002

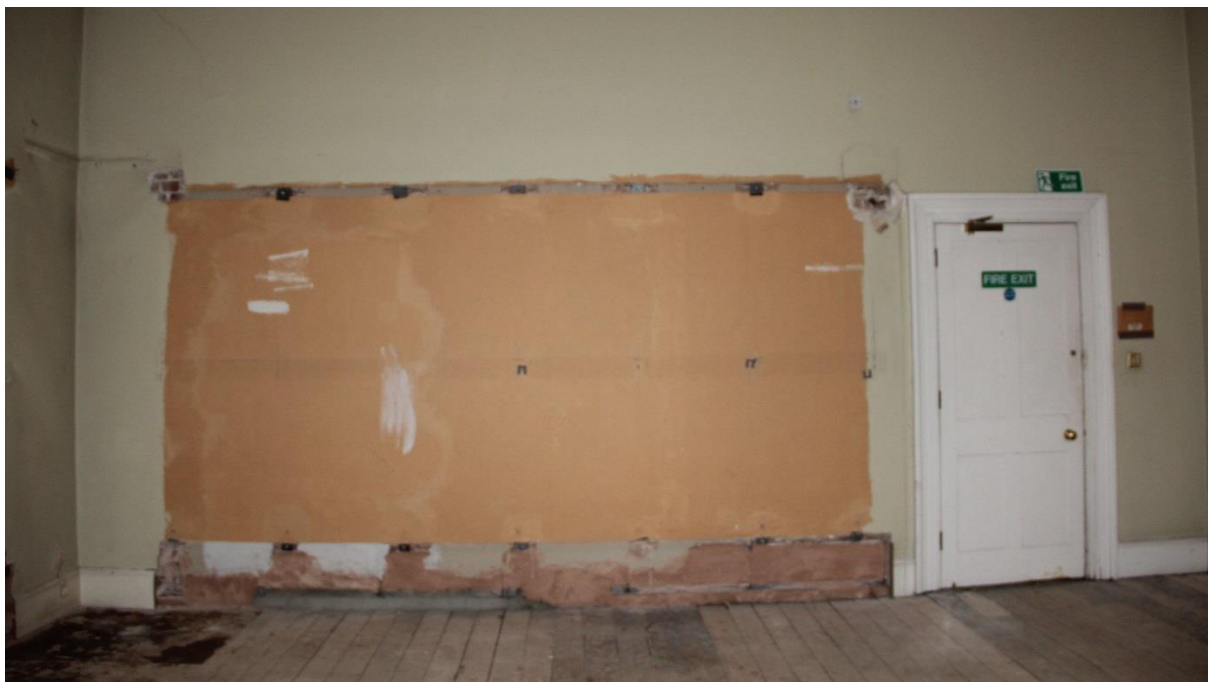
ELEVATION 4 - Metal work and damaged modern plaster finishes to be carefully removed and replaced with original plaster to match existing adjacent. Redecoration throughout. Existing door containing asbestos to be replaced with new FD30 door.

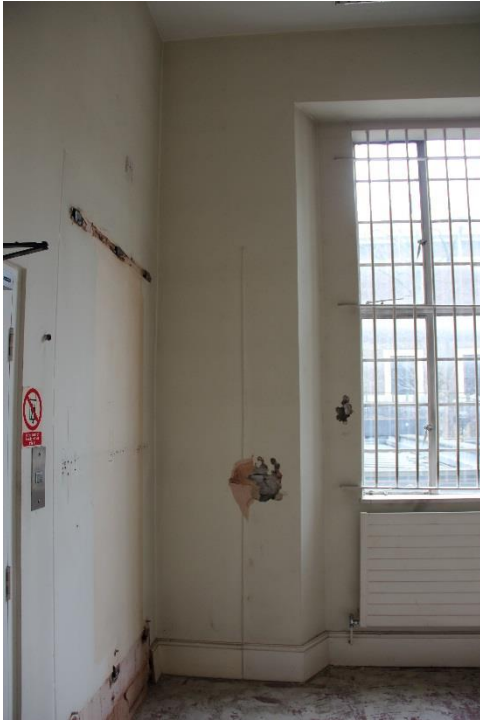
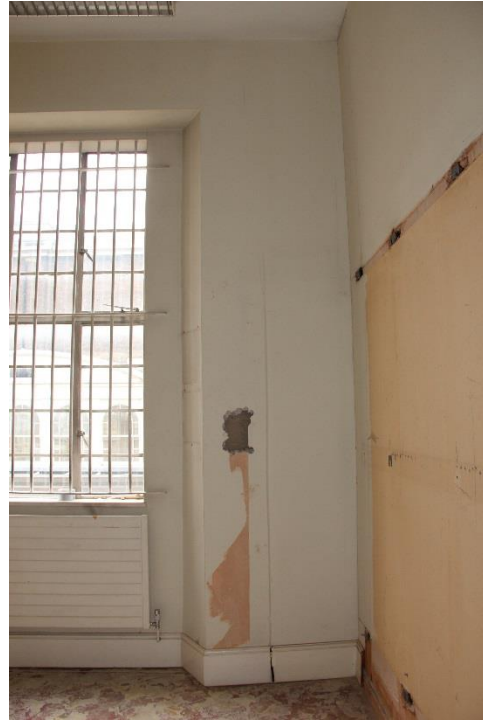
ELEVATION 5 - Damaged modern plaster finishes to be carefully removed and replaced with original plaster to match existing adjacent. Redecoration throughout. New sash window 1A-1-W04 to replace existing rear window. Refer to BDP drawing (31)AD002;

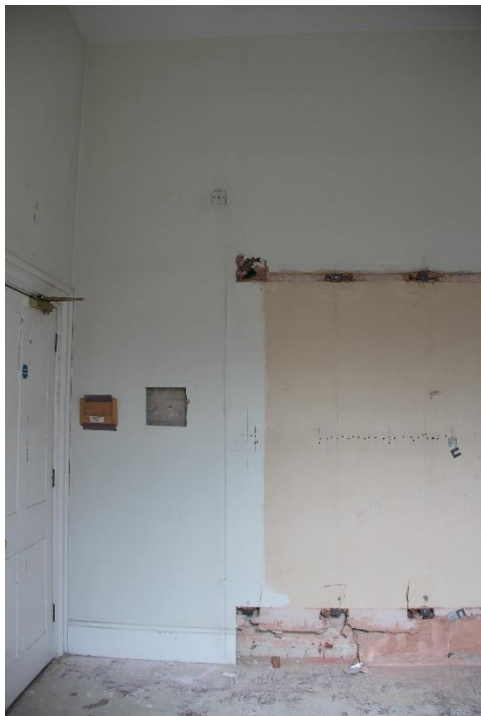
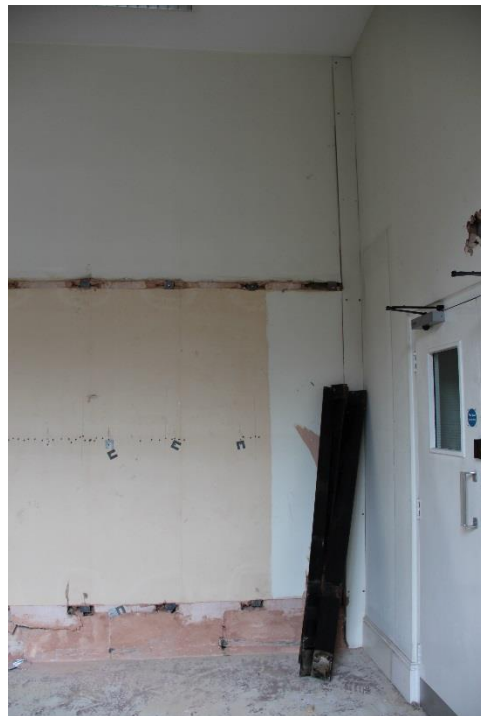
ELEVATION 6 - Metal work and damaged modern plaster finishes to be carefully removed and replaced with original plaster to match existing adjacent. Redecoration throughout.

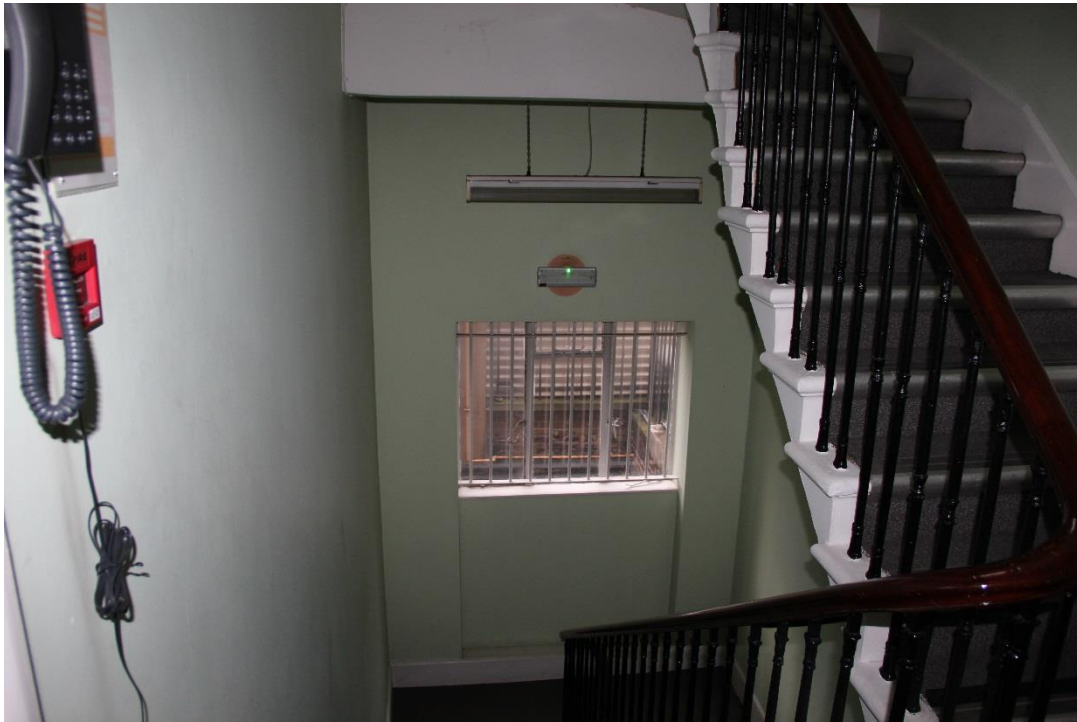
Window to undergo full overhaul to ensure good working condition and receive full redecoration. Stairs, balustrade and handrail to be fully refurbished and redecorated

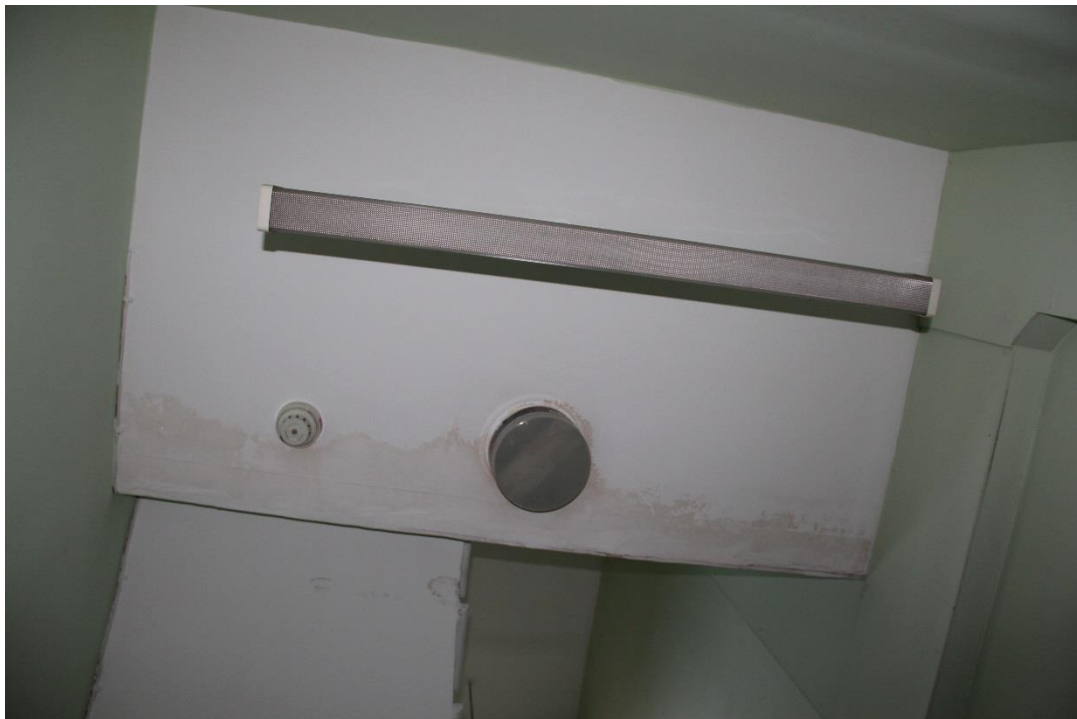
Where evidence of dampness exists, assess condition and associated structure, rectify source and carry out repairs and relining where necessary;

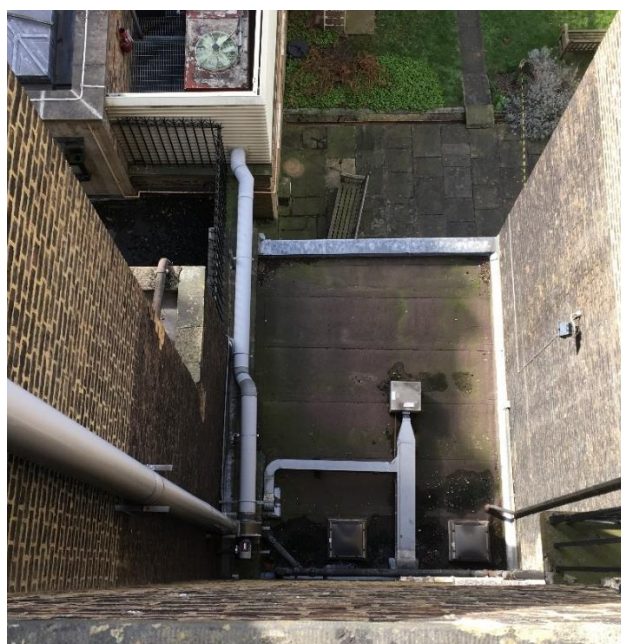
Roof / 3 /X01

Existing roof to be assessed. Parapet walls, roof covering and copings to be repaired if necessary.
 Remove all organic growth.

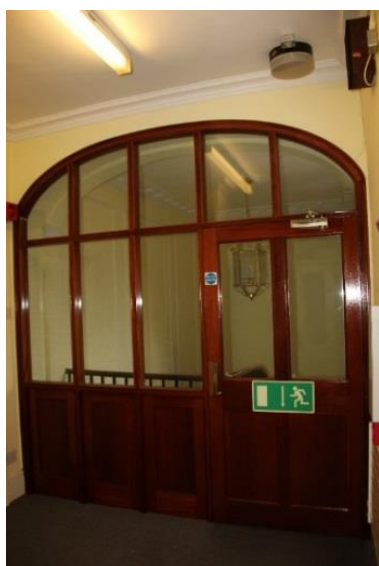
Existing mahogany door and glazed panel to be removed to reinstate original condition

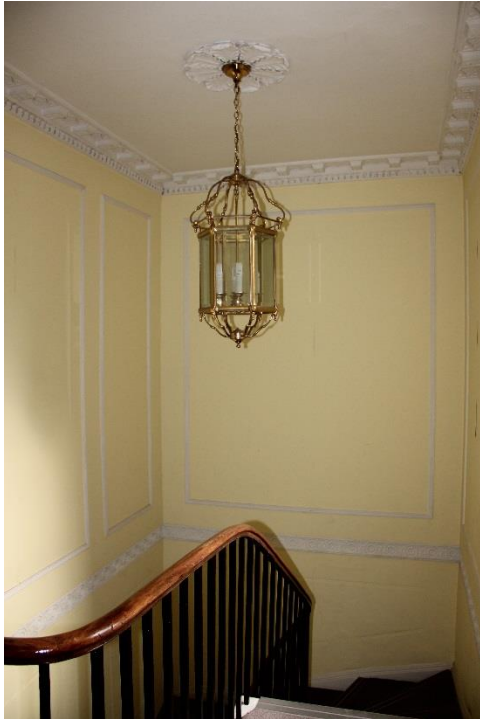
Existing brass light pendant to be retained and refurbished

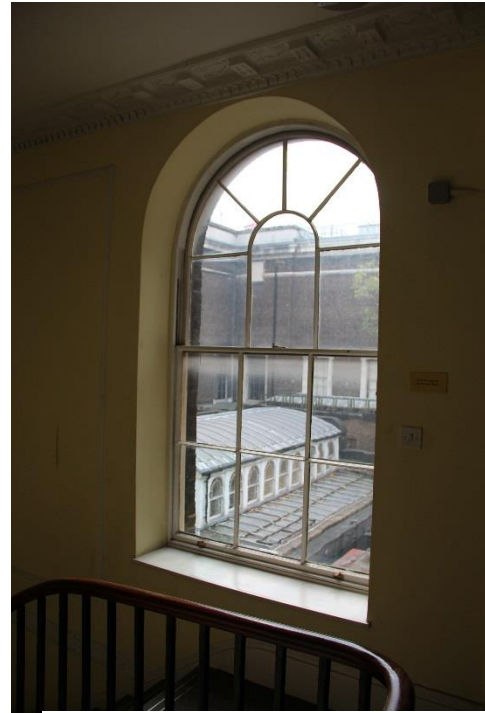
Window to undergo full overhaul to ensure good working condition and receive full redecoration.

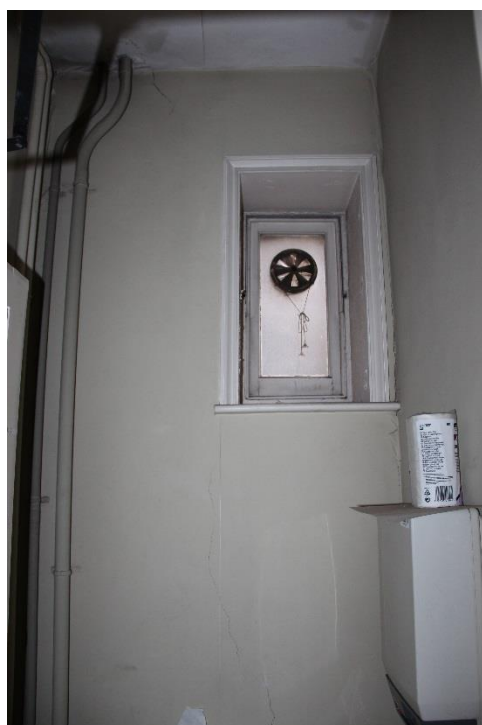
Existing window to be carefully removed and replaced with solid timber framed single opening casement window decorated with at least 3 coats of eggshell paint to match skirting;

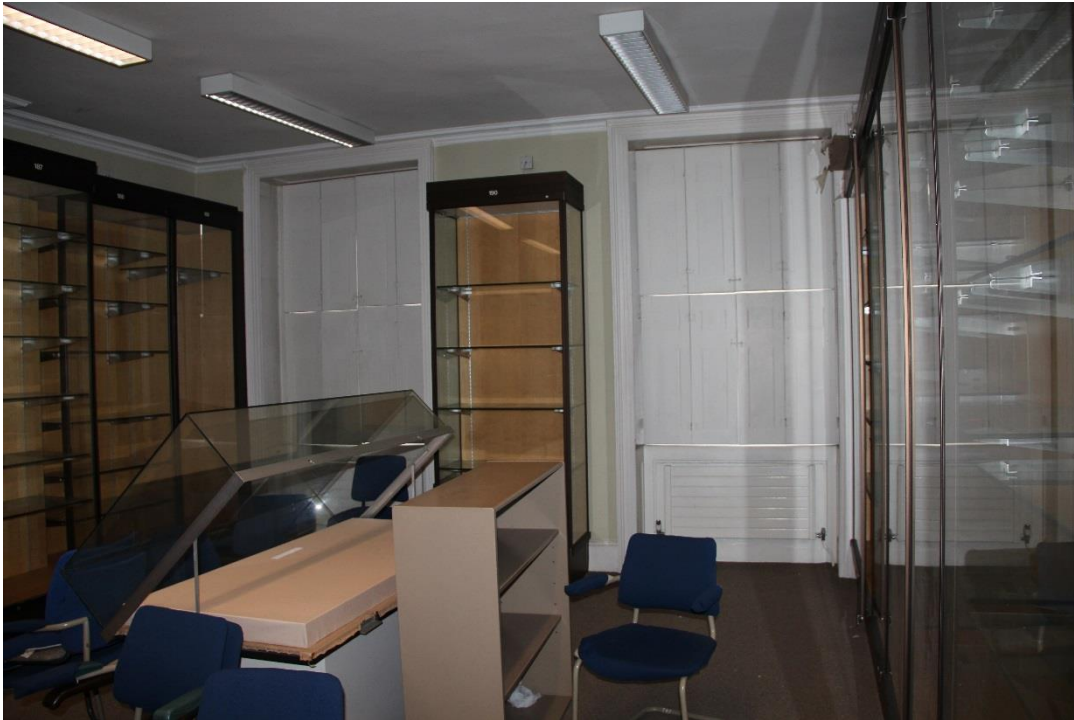
Windows and shutters to undergo full overhaul to ensure good working condition and receive full redecoration.

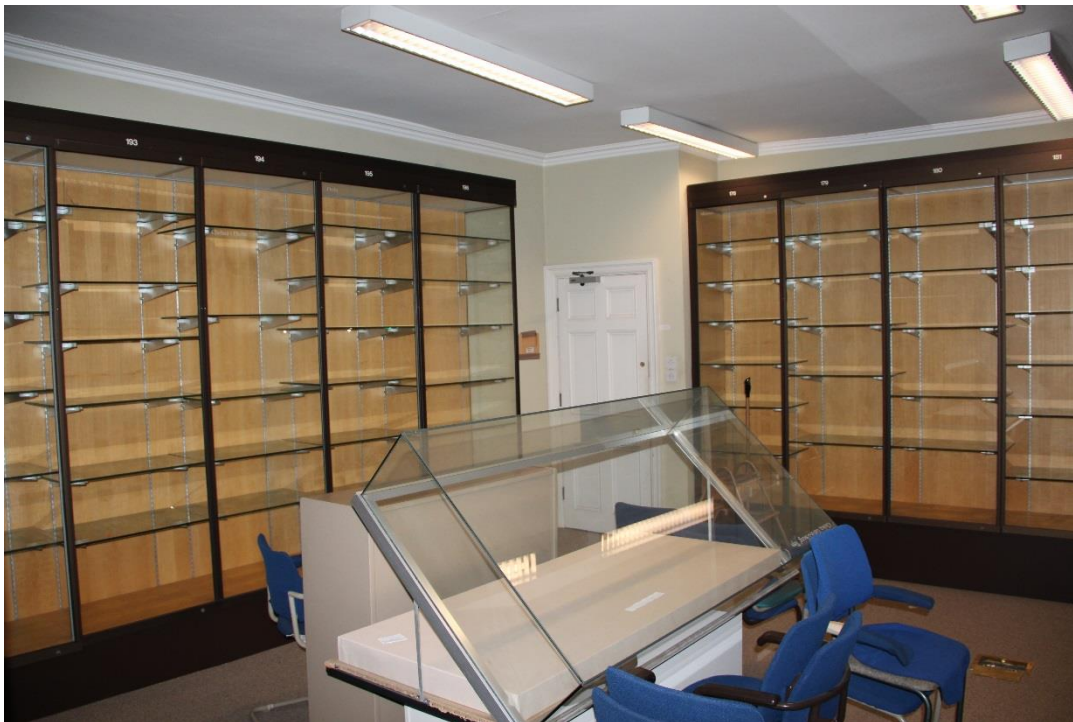
Metal work and damaged modern plaster finishes following removal of museum shelving, to be carefully removed and replaced with lath and plaster/original plaster to match existing adjacent. Redecoration throughout. Existing door refurbished and redecorated. Fire upgrade required. Refer to (67)AP004. Ironmongery to be retained and refurbished.

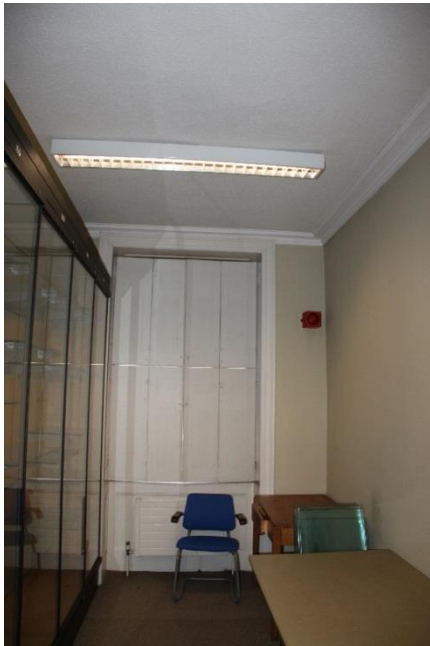
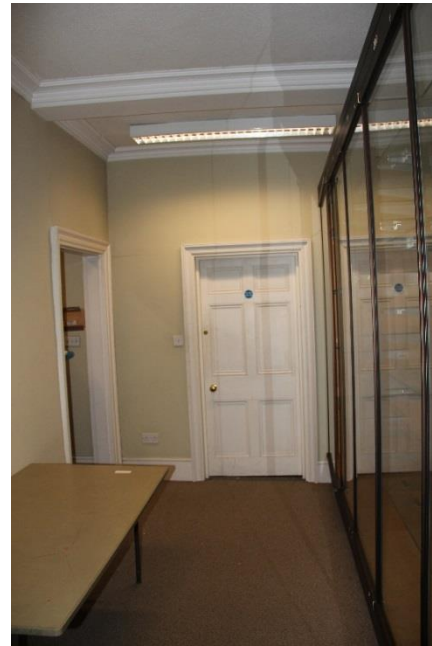
*Opening to be created in existing room 1MS/4/005 to enlarge room to include 1MS/4/006.
Metal work and damaged modern plaster finishes following removal of museum shelving, to be carefully removed and replaced with lath and plaster/original plaster to match existing adjacent.
New replacement lath and plaster finish to damaged areas of walls. Redecoration throughout.*

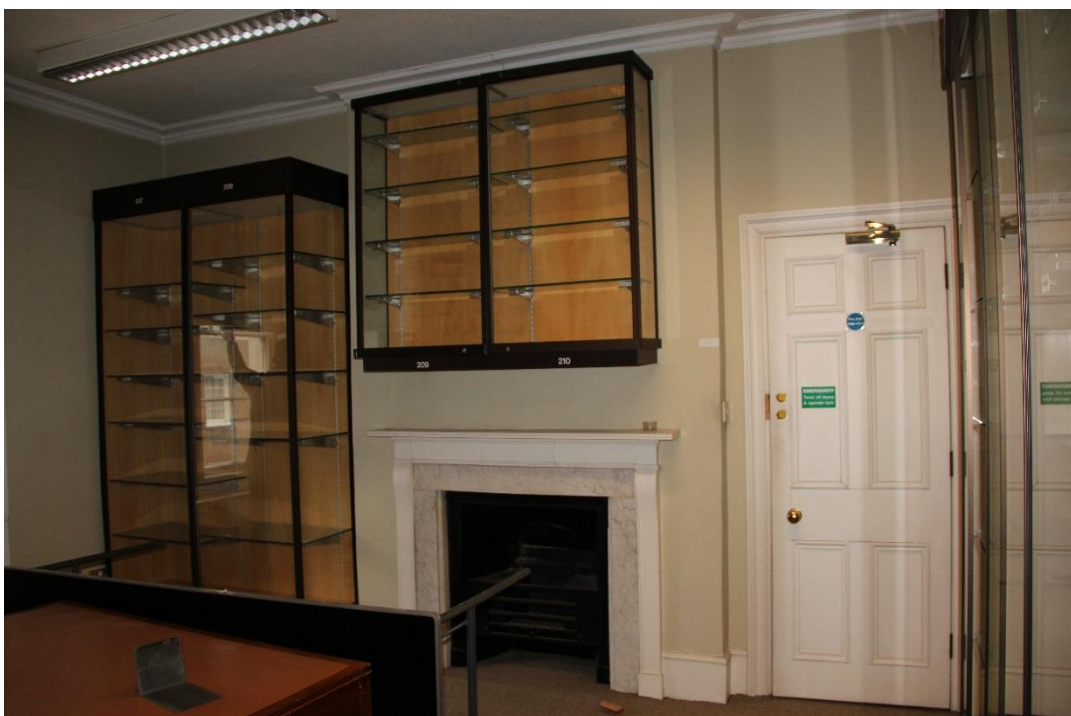
Existing door replaced with FD60 door to match design of existing. Fireplace to be protected throughout construction and cleaned with a non abrasive cleaner

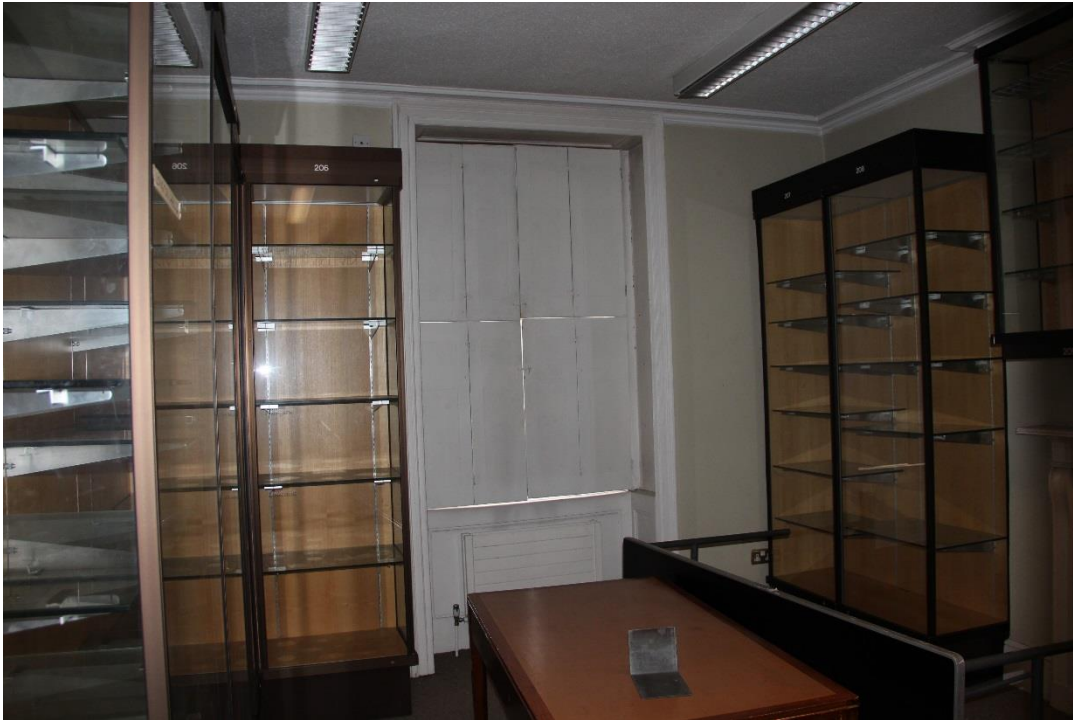
Windows and shutters to undergo full overhaul to ensure good working condition and receive full redecoration.

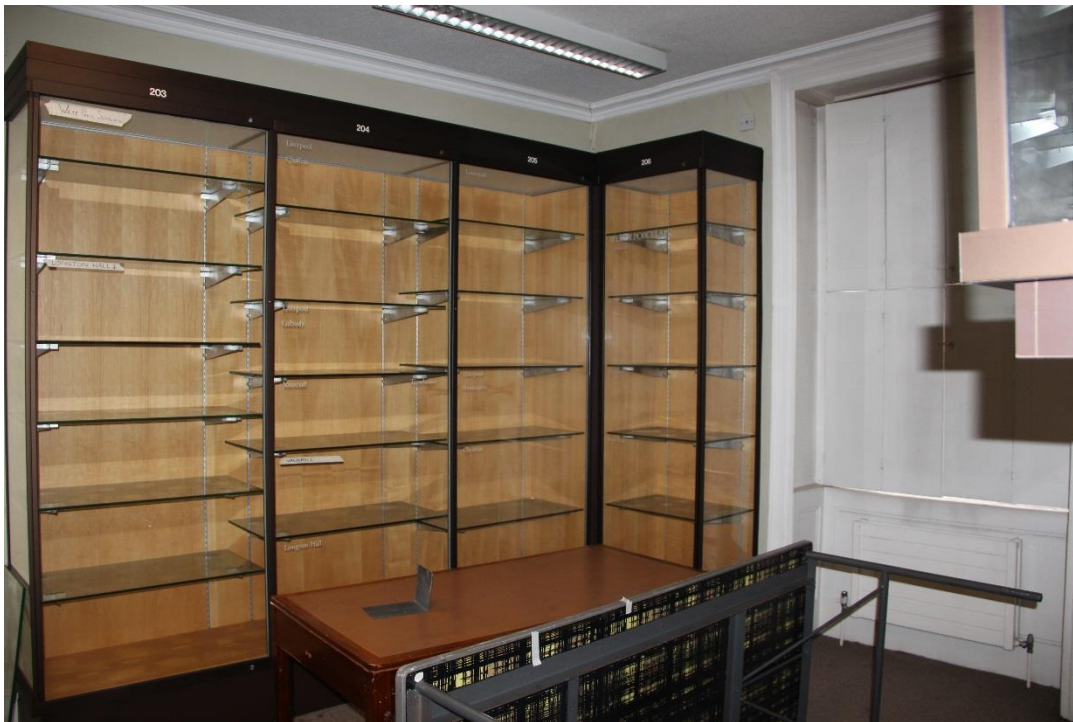
Metal work and damaged modern plaster finishes following removal of museum shelving, to be carefully removed and replaced with lath and plaster/original plaster to match existing adjacent. Redecoration throughout.

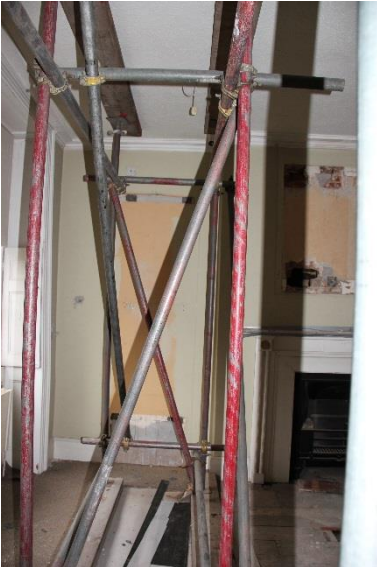
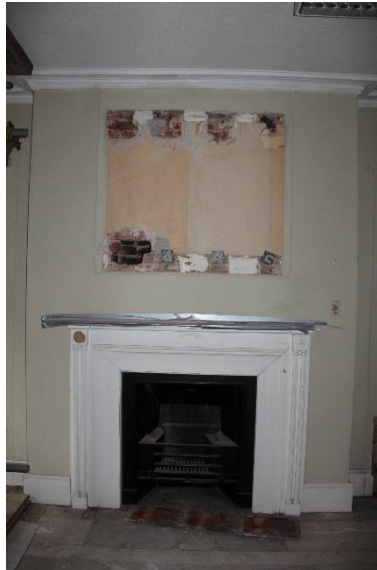
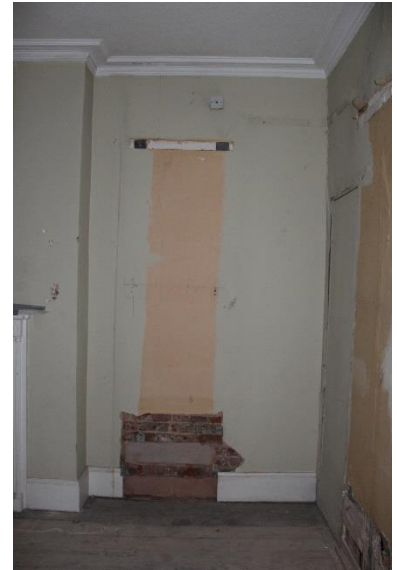
Metal work and damaged modern plaster finishes following removal of museum shelving, to be carefully removed and replaced with lath and plaster/original plaster to match existing adjacent.

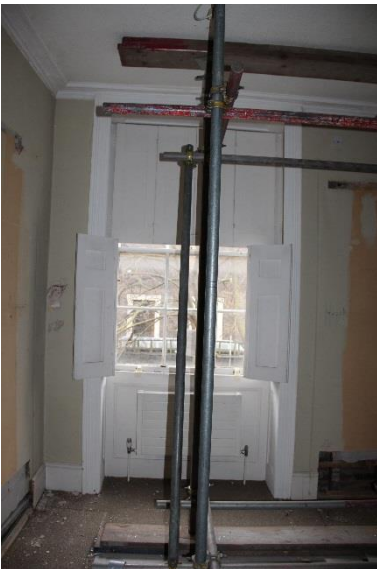
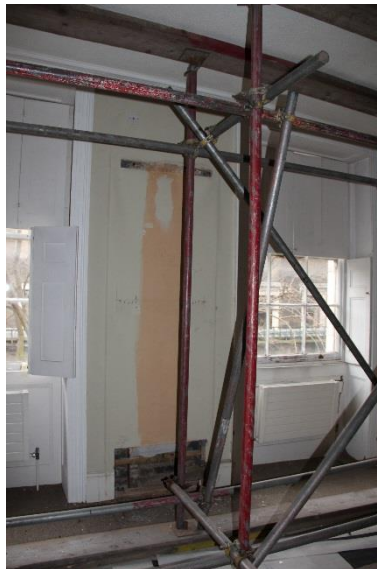
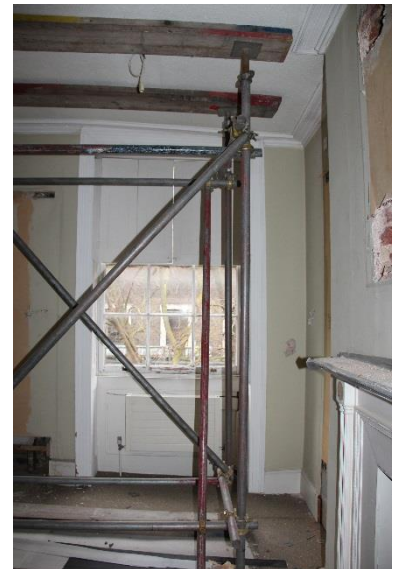
Windows and shutters to undergo full overhaul to ensure good working condition and receive full redecoration.
