Room No. 1MS/3/003 Office	
Item	Scope of works
General	<ul style="list-style-type: none"> ▪ Existing furniture, fittings and services have already been removed; ▪ Carefully remove metal work and modern plaster finishes associated with previous museum shelving arrangement and repair adjacent finishes; ▪ New replacement lath and plaster finish to damaged areas of walls. Refer to BDP drawings (70)AD026/027; ▪ Walls to be redecorated with matt emulsion paint finish -allow for 2 coats. Colour to be agreed with architect and British Museum; ▪ Existing ceilings to be redecorated with matt emulsion paint. ▪ New door 1-1-D06, associated architrave and skirting where missing to be fitted and decorated in eggshell paint; Refer to BDP series drawings (32) ▪ Existing skirting in good condition, doors, architrave, cornices and decorative mouldings to be retained, repaired where necessary and redecorated; ▪ New services provision throughout. Electrical distribution to be recessed. ▪ New lighting to be installed ▪ Windows to be redecorated and receive full overhaul to ensure full operation

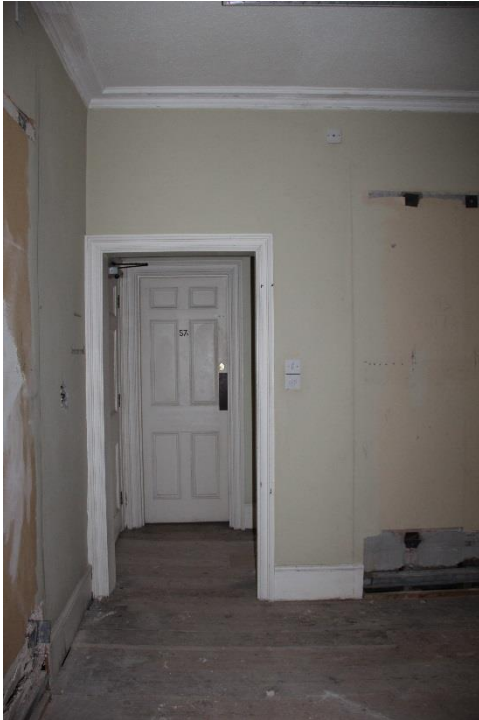
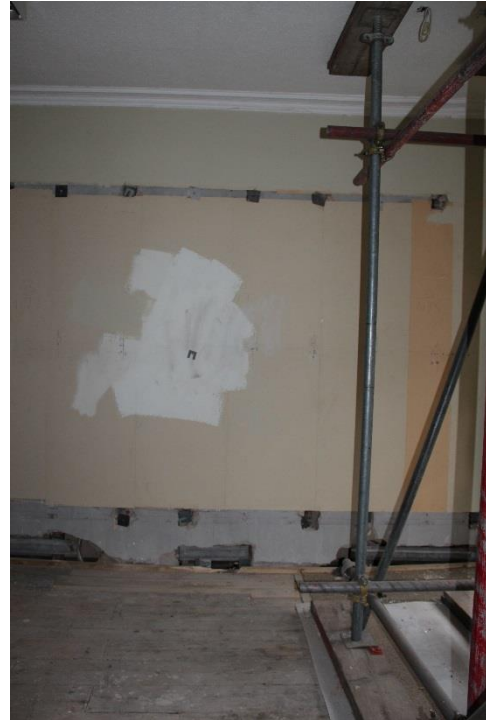
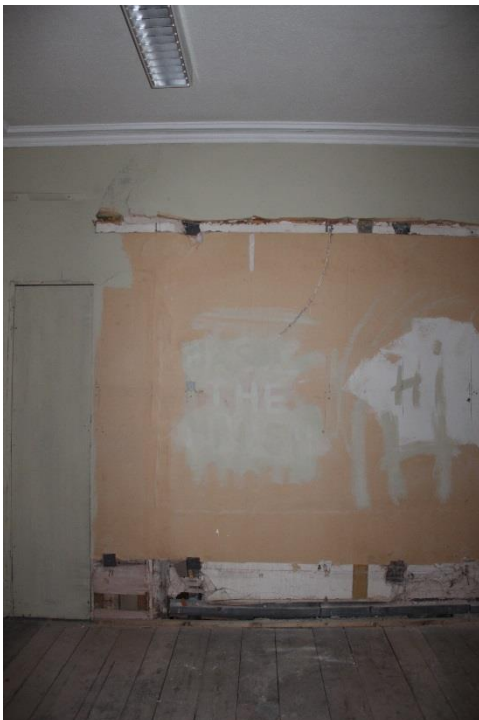
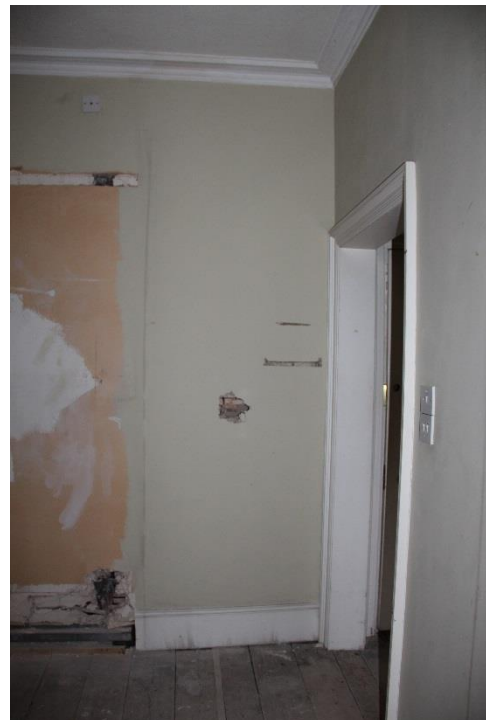
New door to be fitted within existing opening to access 1MS/4/008. Fire upgrade requirements. Damaged modern wall finishes made good to provide a suitable surface for new fire resistant board. Lath and plaster to be overboarded to achieve 30 minute fire protection. Existing cornice and skirting carefully removed, set aside with care and reinstated when the overboarding is completed. Ironmongery to be retained and refurbished.

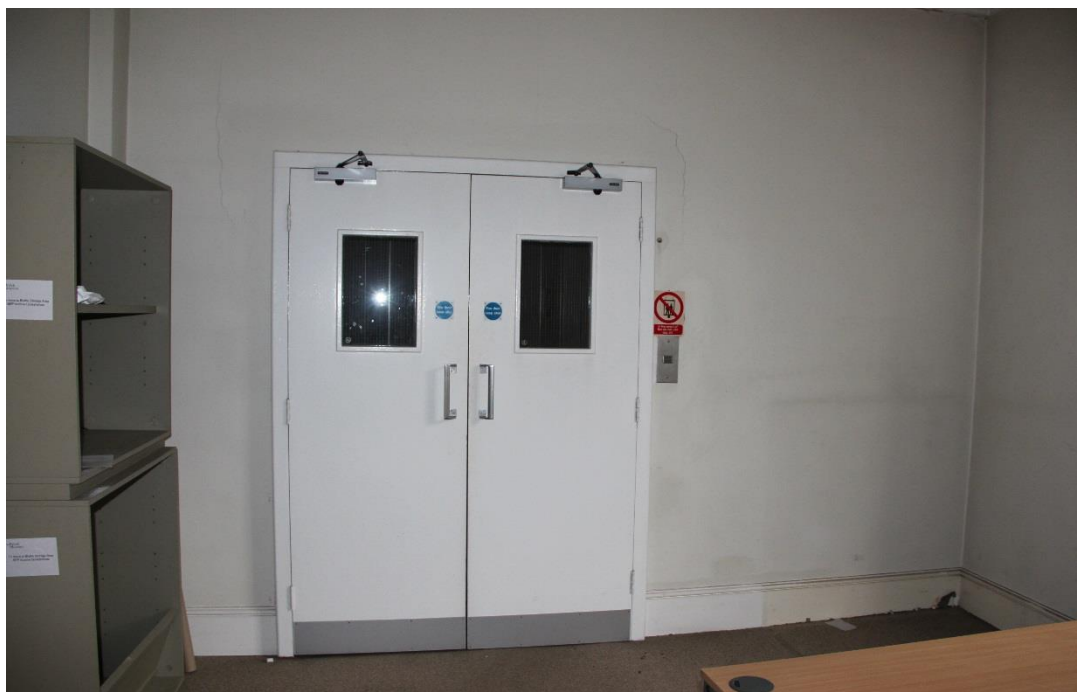
New internal door 1A-2-D02 to be fitted to match existing door 1A-2-D01, to replace existing lift shaft doors

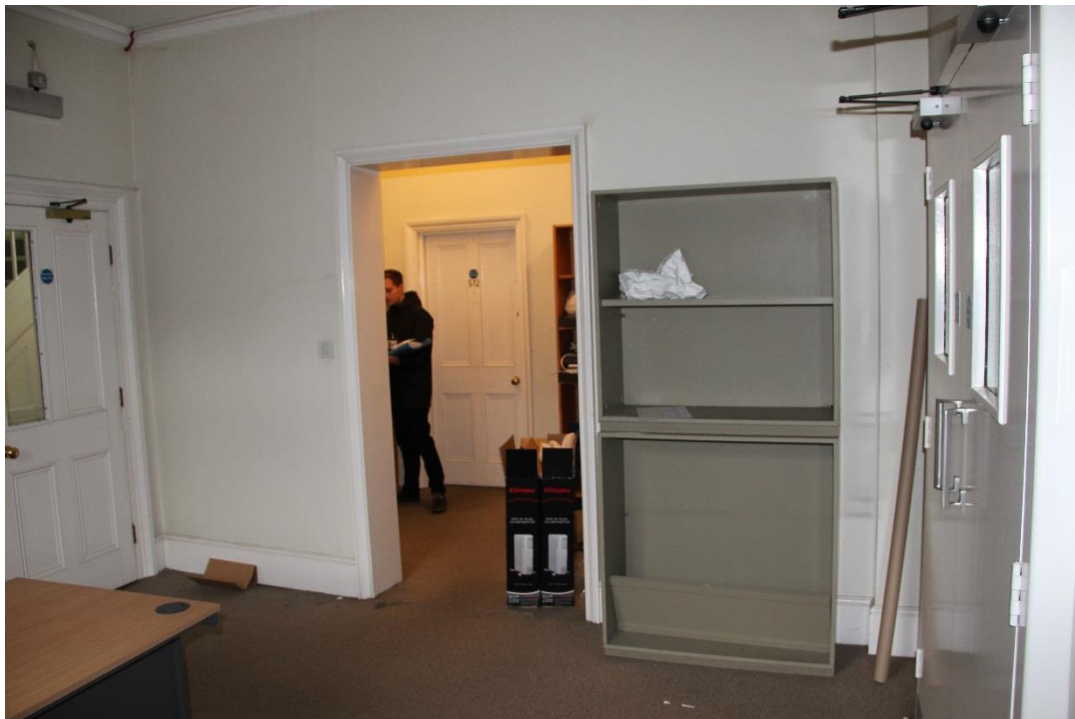
Existing opening to be retained. Redecoration throughout;

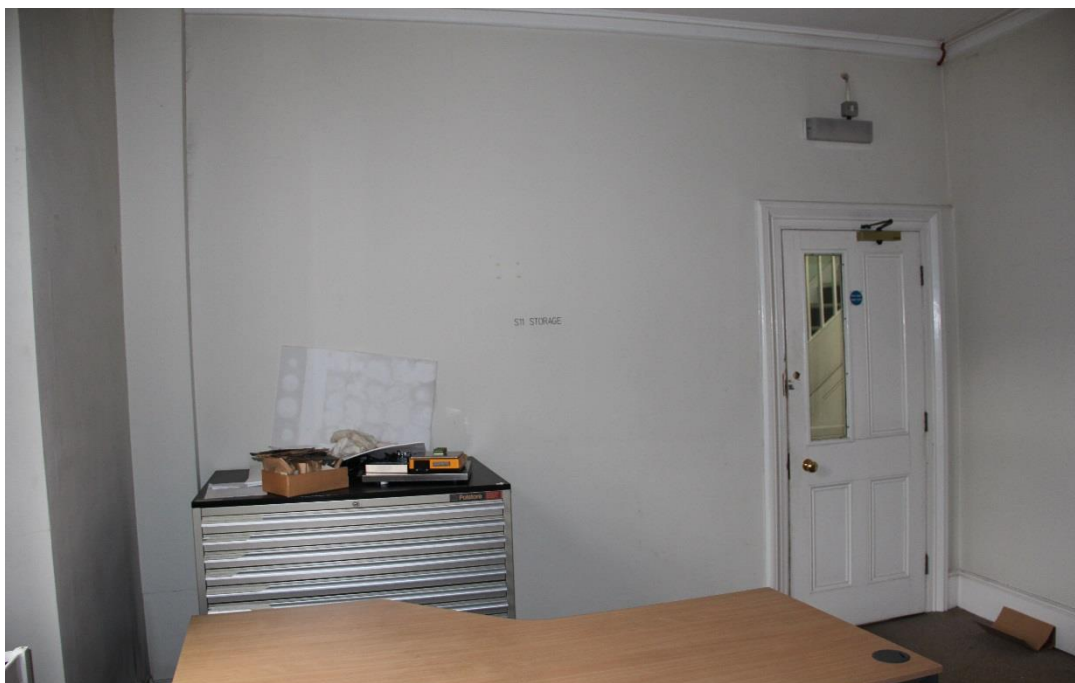
To be confirmed on site if wall provides 30 min fire resistance. If it doesn't, wall to be overboarded with new fire resistant board to provide the required 30 minute fire protection. Cornice carefully removed and set aside with care. Reinstated and redecorated when the overboarding of the wall is completed. If damage occurs refer to method of statement. If it does, damaged plasterboard replaced with plasterboard to match existing adjacent. Redecoration throughout. Existing door opening infilled with 30 minure fire resistance partition.

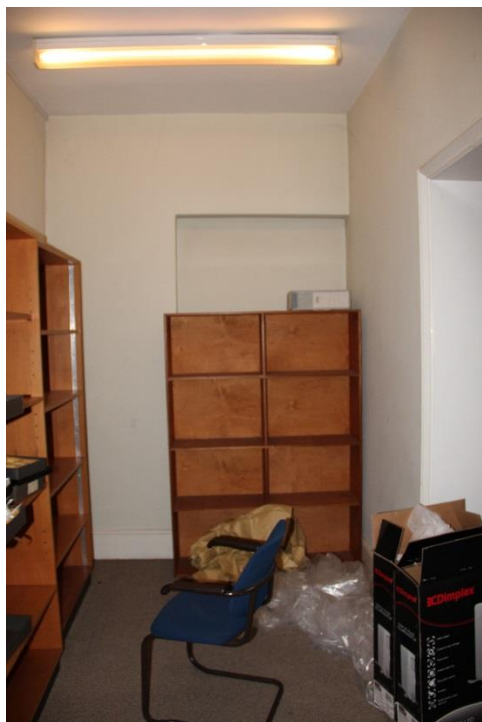
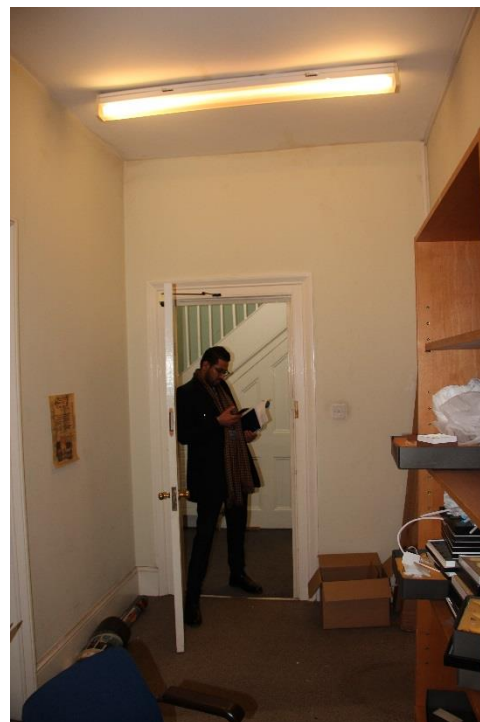
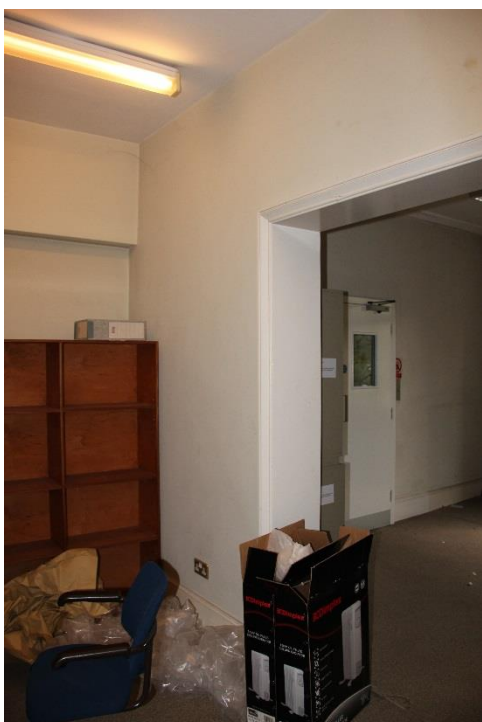
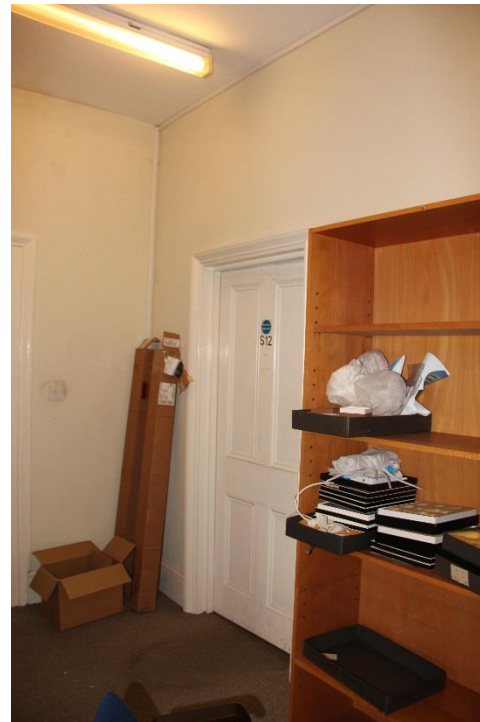
*Existing room 1AMS/4/014:
Existing door to be retained and redecorated; Wall adjoining room 1AMS/4/012 to be completely removed.
Adjoining walls to be made good where necessary. Redecoration throughout.*
