Norland Managed Services Limited
Incident Report

1-1a Montague Street Building Movement 19.09.12

1 & 1a Montague Street, Rear Wall.

Site Address:
1&1A Montague Street, WC1B

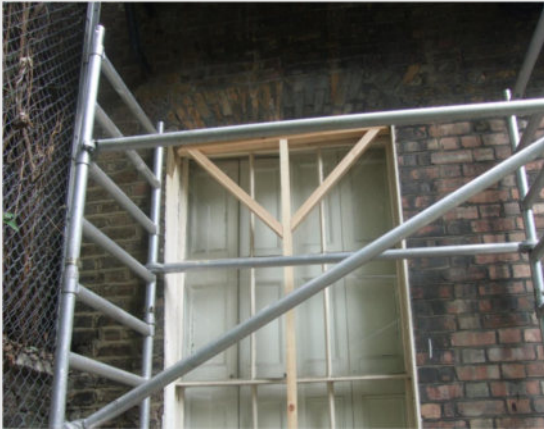
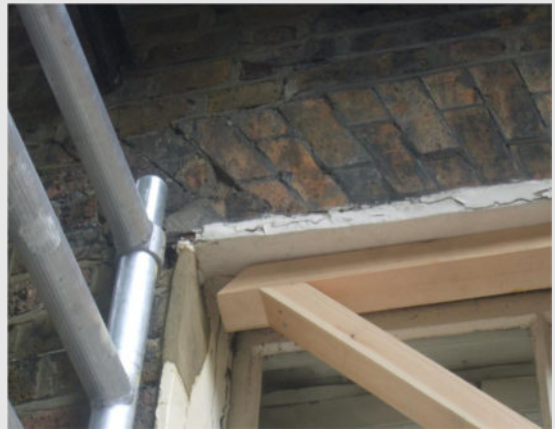
The rear north east corner of 1-1a Montague Street has distorted causing mortar render to come away from the ground floor window.

Sections of the mortar render had fallen from around the north east ground floor window.

Building is 200 plus years old with an external 1st floor balcony. Distortion and cracking in building fabric requires specialist investigation.

Norland team have braced render and made good. I strongly recommend a structural engineer surveys building.

1. Install timber braces in window surround.
2. Make good mortar render
3. Report concerns with building distortion to Building Services Dept.

1. Building structure requires surveying by specialist.

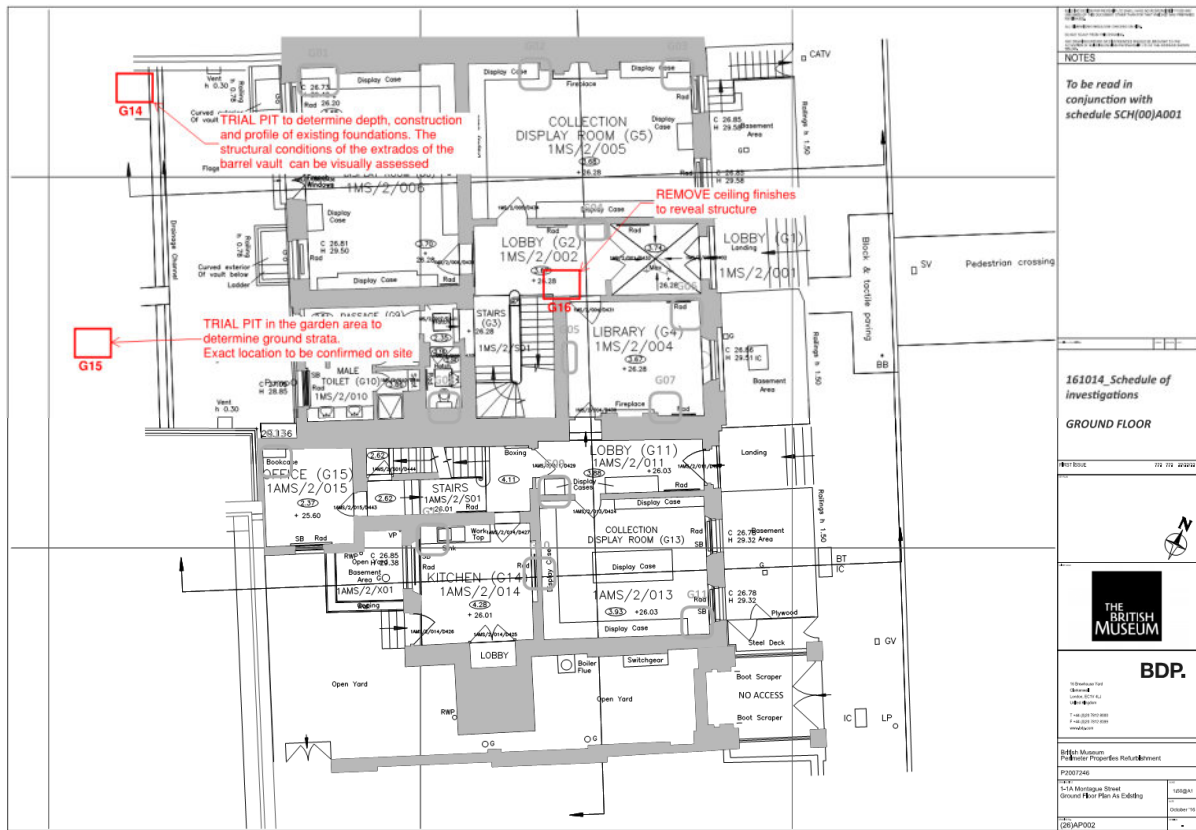
Figure 2: Ground Floor additional Trial Pits locations

At Ground Floor Level we added three trial pits: the G14 will determine depth, construction and profile of existing foundations, and it will be possible to assess the structural conditions of the extrados of the barrel vault; the G15 will determine ground strata in the garden area, the exact location to be confirmed on site. In case the foundation is found to be in bad conditions or it reveals signs of distress, underpinning it will be the solution to avoid any future differential movement. The third item, named G16, will require the removal of the ceiling finishes to reveal structure and further investigate on the cracks visible on the staircase wall in the room 1MS/3/S01. These cracks have clearly occurred after the internal painting has been completed and could be potentially active, hence some sort of strengthening work could be necessary to the underside of the First Floor slab.

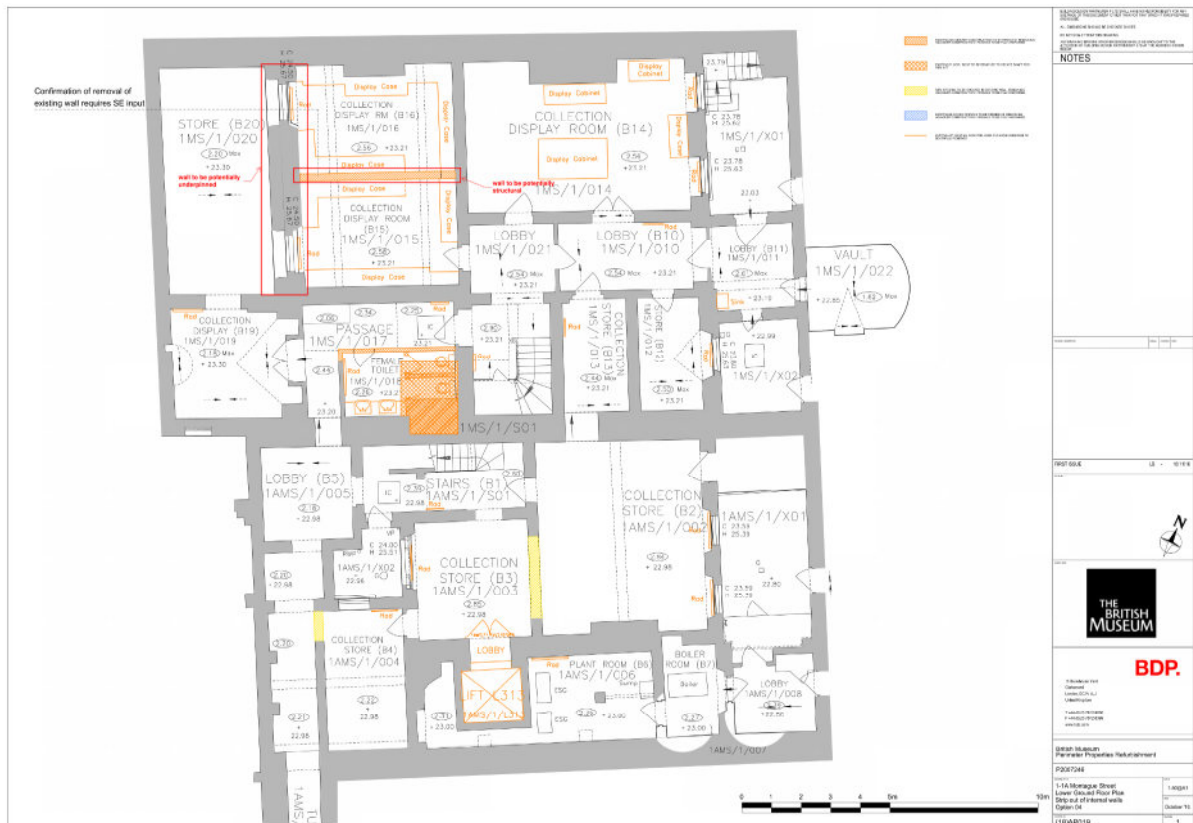
Figure 3: Potential issues to be clarified after the Structural Investigations – Lower Ground Floor

The additional trial pit located in the Collection Display Room (1MS/1/16) and marked with LG23 is necessary to determine depth, construction and profile of the existing foundation and to investigate whether the foundation itself has been subject to any structural intervention in the past. Also at Lower Ground Floor level we added the LG24 to assess the depth, construction and profile of the existing foundation. The information is necessary because the new lift in Option 4 will require a new foundation pad or the underpinning of the existing one if found.
