## 1. Introduction

- 1.1. Following a preliminary visit to the site with Sarah Freeman and Anna Roe of Camden Council, the following further investigation and opening up works were proposed and agreed by e-mail from Sarah Freeman dated 16th March 2017.
- 1.2. The following sections and photographs describe the findings of the investigation works and describe how these findings have influenced the proposals.

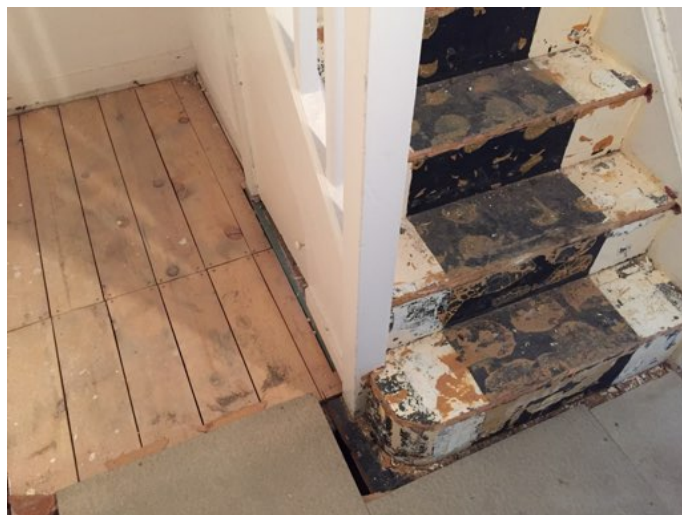
- 2.1.1. Within stair - The floor was patched with pine square edged boards adjacent to the existing stair. This confirmed our expectation that a previous stair flight from the ground floor door has been removed. There were no boards, with chipboard directly over joists at the base of the stair to the second floor.

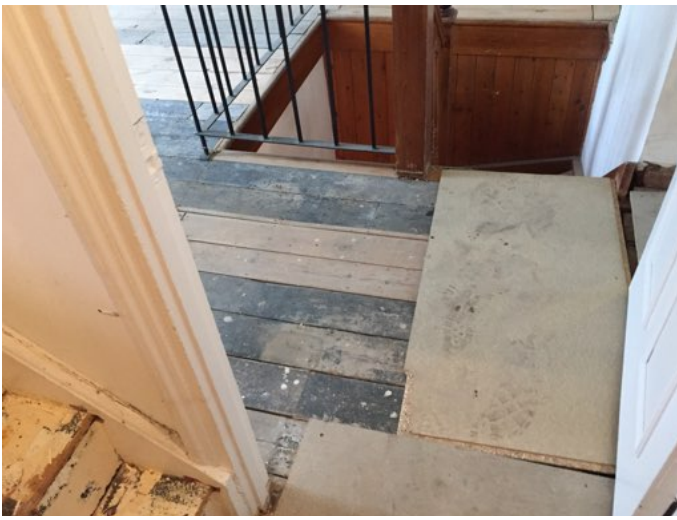
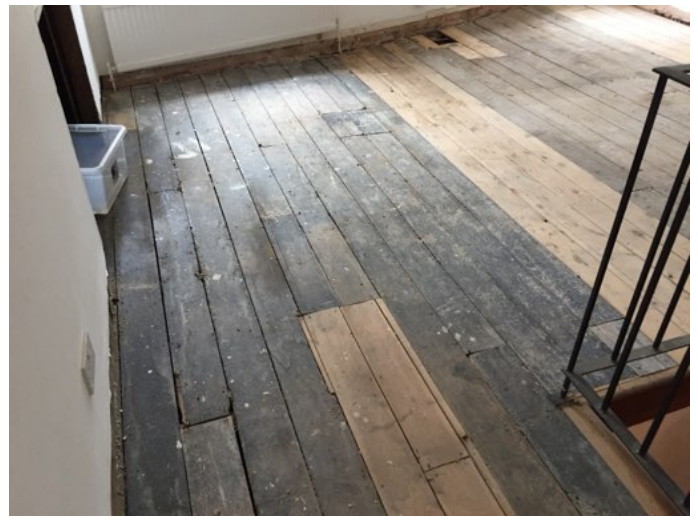
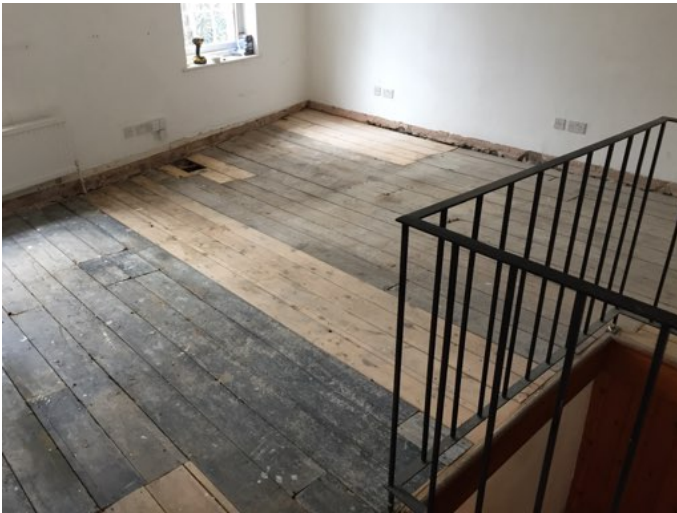
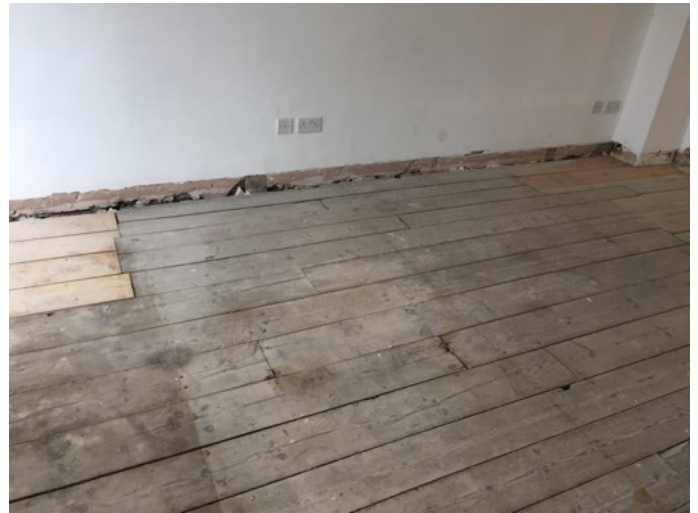
- 2.1.2. The remaining photographs are taken from the stair enclosure sequentially towards the modern stair, to the left towards the front elevation, and then around through the arched opening to the rear room. Running from the stair there is a band of apparently original, dark stained but narrow boards, around 155mm wide, patched locally. There are areas of historic infestation damage leaving the boards soft, fragile and unsound in areas. Running from the

modern stair towards the centre of the front wall is a section of 4x140mm wide modern pine boards that run along the line of the wall below, and of a partition drawn in the 1972 drawing. The floor is significantly sunken where it meets the front wall at this position by around 100mm below the door threshold to the stair. It rises again towards the opposite wall, which is boarded with a relatively consistent section of older, wider boards, unstained, and ranging in width from 180mm to 230mm. There is a further patch of modern boarding into the acute front corner where joists have also been repaired. Below this the joist have been spliced and bolted to more modern joists into the party wall.

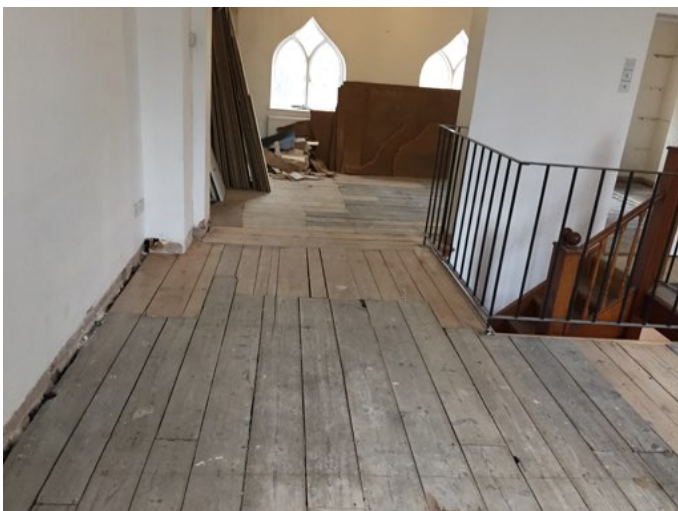
2.1.3. Back towards the rear room through the modern arched opening is a further patched area. with the boards running front to back, indicative of a section of floor previous filled in, possibly when the adjacent stair was installed and new trimmers will have been required.

2.1.4. On the wall line under the arched opening, more new boards run in the direction of the wall.

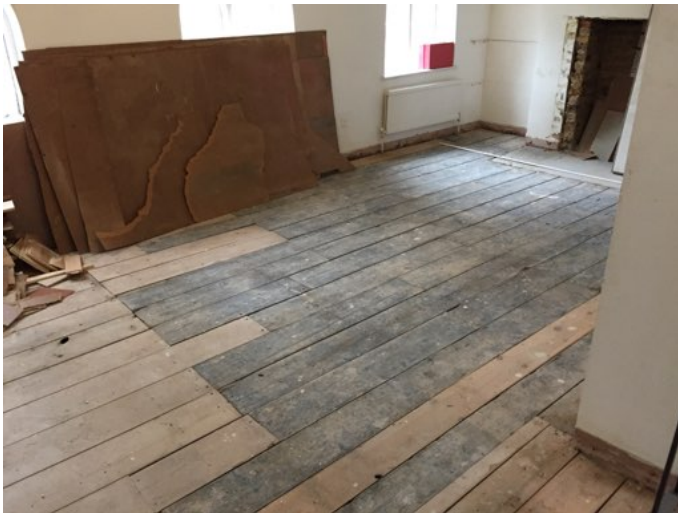
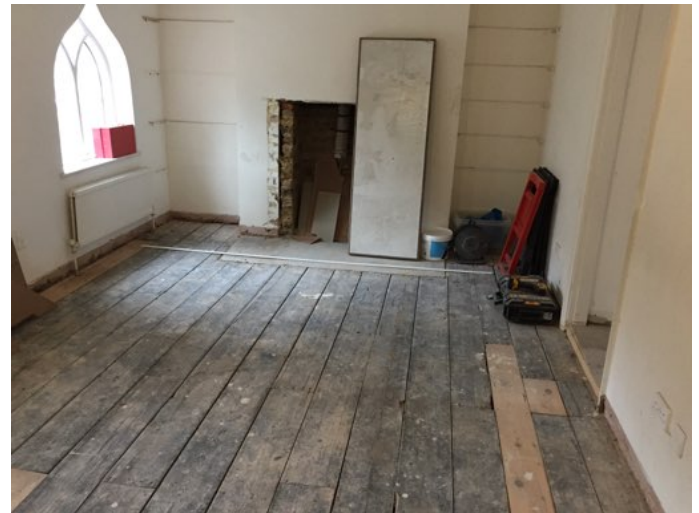
2.1.5. The boards in the rear room run parallel to the rear elevation across the building. The joists below this run across the rear room from back to front. There is a modern boarded area over the utility room consistent with the location of a spiral staircase on the 1973 drawing. This is consistent with the removal of a stair indicated in the drawing. The direction of the boards indicates that the joists within the utility room run in the

long direction. This is consistent with the wall below not being an original supporting wall for joists in the narrow direction. The evidence is consistent with the 1972 drawings which indicate a wall removed at first floor level and the floor being reconstructed at this location.

2.1.6. With the exception of a single board, the remainder of the boards within this room appear original and are again in a dark stain. These also range from 180mm to 230mm in width, but are in a better condition than those adjacent to the stair enclosure in the front room. The highest area of the first floor is in the rear corner by the fireplace. These boards are in reasonable condition.

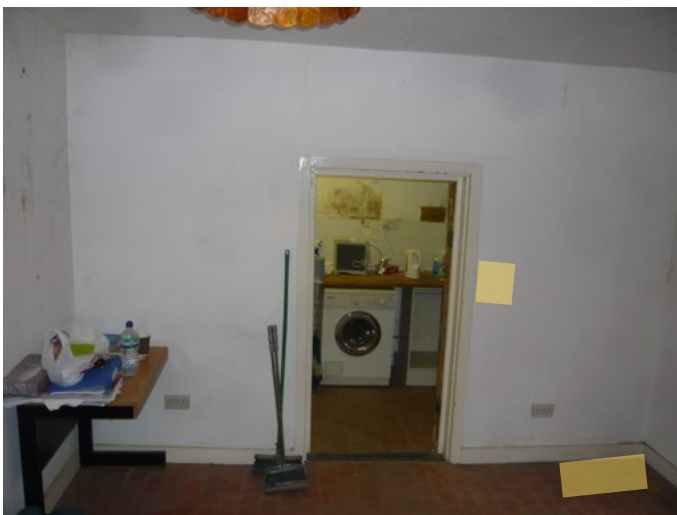
2.2. **Ground Floor construction** - Open up the existing GF construction by local removal of quarry tiles at each level and breaking out substrate to investigate the construction below at the locations marked on the adjacent photographs.

2.2.1. The tiles were removed in the rear corner of the main room to give visibility to both the base of the rear wall and internal wall as well as the floor construction below the quarry tiles. The quarry tiles are laid over 50mm of screed in 2 layers, approximately 15mm over approximately 35mm. Below this is a 100mm concrete slab. There is no damp proof membrane or damp protection. The rear external wall sits on a brick base with a 3 course red

engineering brick footing, the top of which is set approximately 200mm below ffl. The thickness of the screed appears to relate to the difference in floor levels between this room and the lower utility room floor. The utility room floor is also more damaged.

2.2.3. The findings are compatible with the proposal to remove and relay the ground floor slab to incorporate insulation and a damp proof membrane.

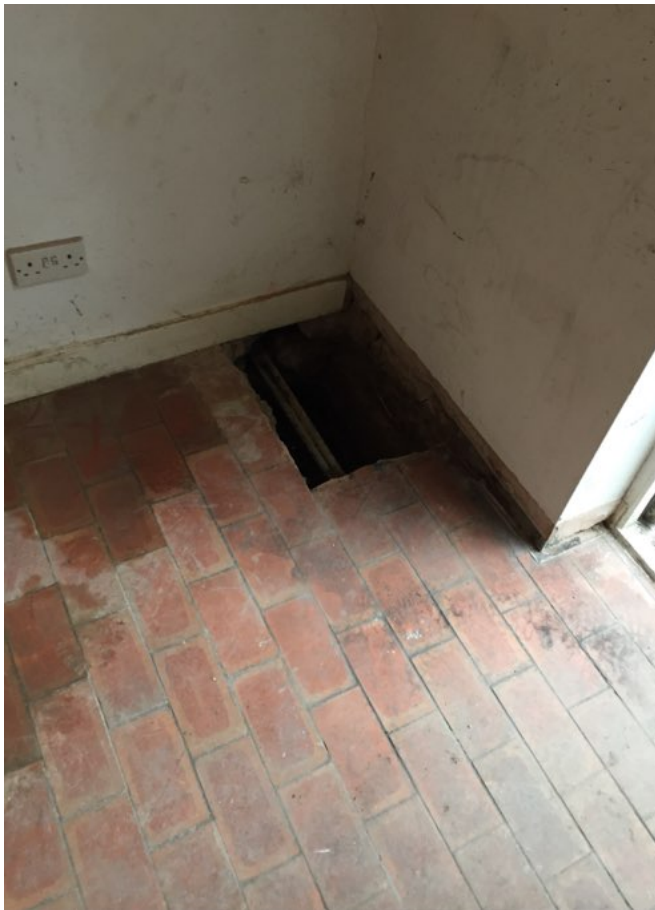
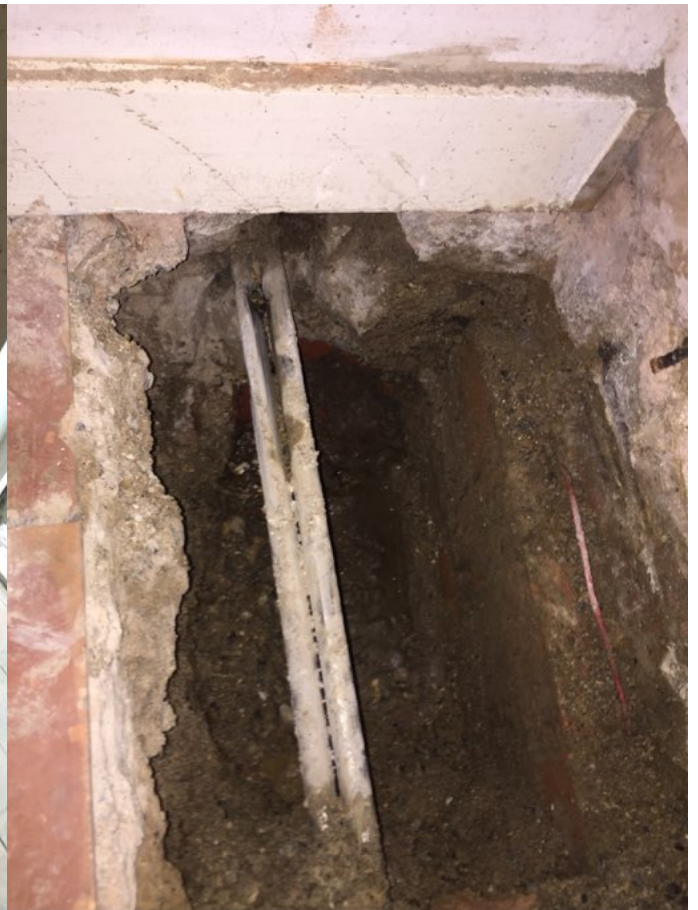
2.2.2. The location of the hole coincided with heating pipes running along the rear elevation. These were set at the base of the concrete slab without sheathing/

protection or insulation. The pipework, and the slab, appears to run below the internal wall, with the slab thicker at the wall position.

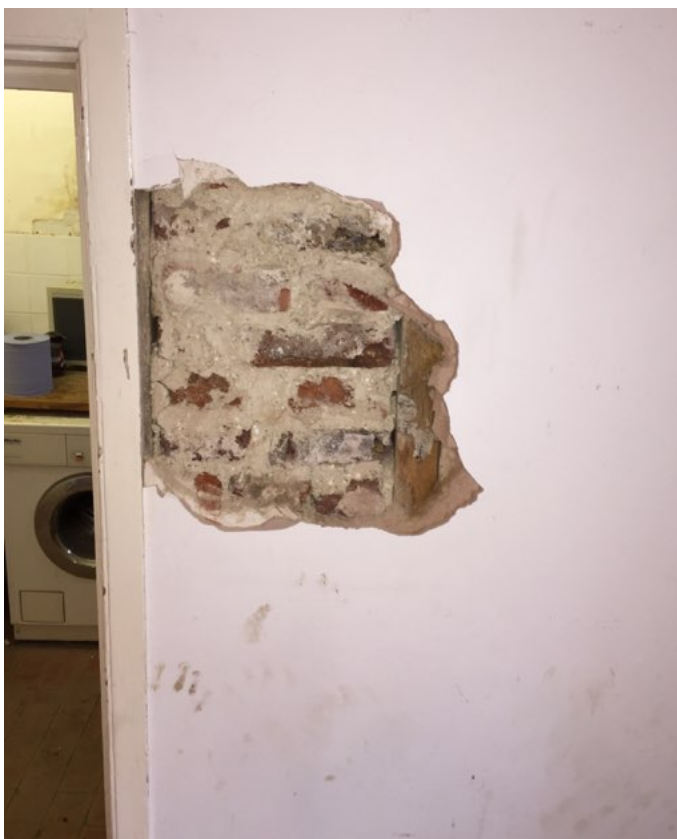
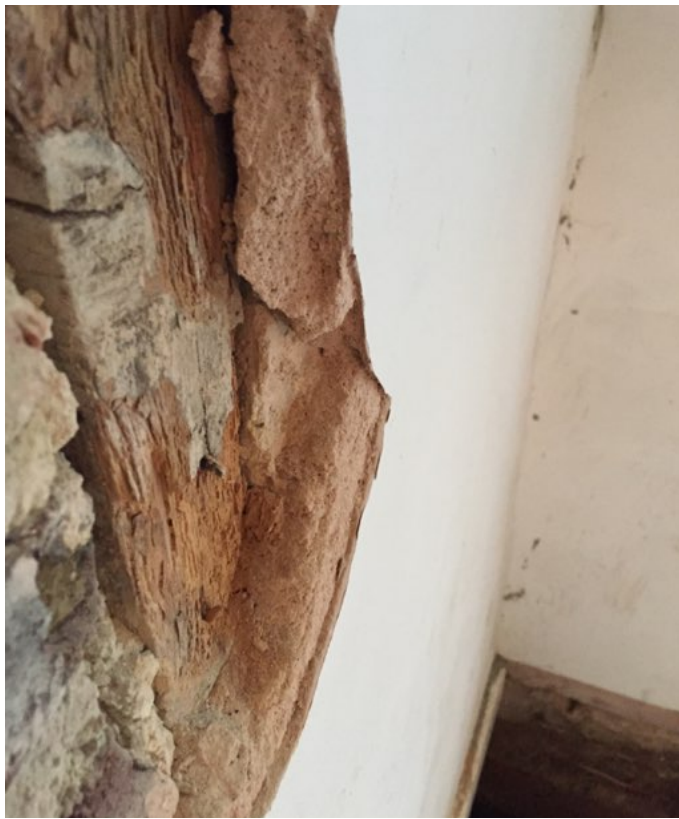
2.3.1. The main room side consisted of a gypsum plaster skim finish over a gypsum plaster and lime plaster base over a brick wall. The lime plaster is closer to the doorway. Tapping the wall indicates that there is a large extent of debonding of the plaster finish. There was a timber stud embedded in the wall, suggestive of the possibility that the brickwork could be infill within a timber stud wall, and the poor quality of the brickwork supports this possibility. There was decay within the timber stud parts of which become powder on touch, there is no evidence of any lath

either on the timber stud, nor in the pattern of remaining lime plaster.

2.3.2. On the **utility room** side, the finish was gypsum plaster over a lath and plaster base on brickwork. Again, the hollow sound upon tapping suggests that this plaster appears to be debonded.

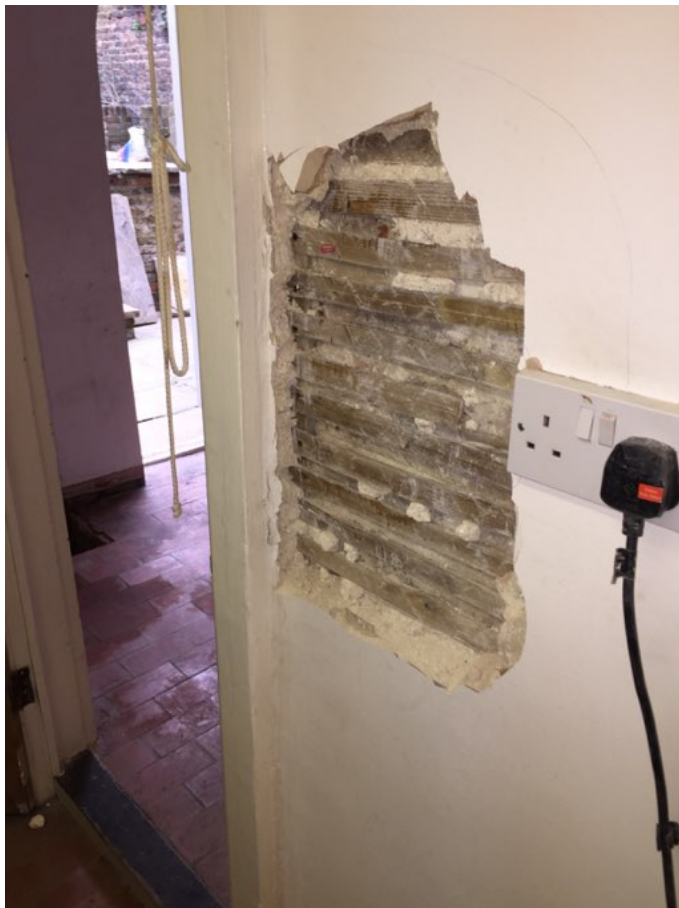
2.3.3. This wall is somewhat incongruous. Having speculated initially that this wall may pre-date the rear elevation, that appears not to be the case, as the rear elevation and its foundation is prominent, and the slab upon which it sits is set within the rear wall.

2.3.4. This wall is not a primary aspect of the architectural and historic interest in the property although it contains some features of interest. It is constructed on a concrete slab without dpm that we would like to replace, the lime plaster is cracked and debonded from the wall and the timber studs are in poor condition.

2.3.5. The original proposal was to remove this wall. In discussion with the Conservation Officer, a strong preference was expressed for its retention on a precautionary basis. The proposal has therefore been revised to retain this wall and the utility room within the ground floor.

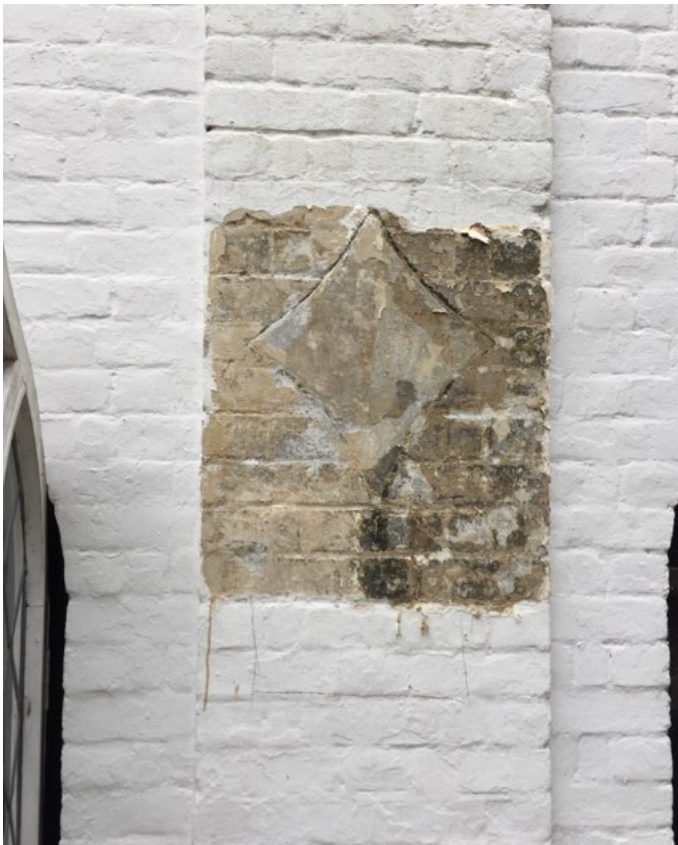
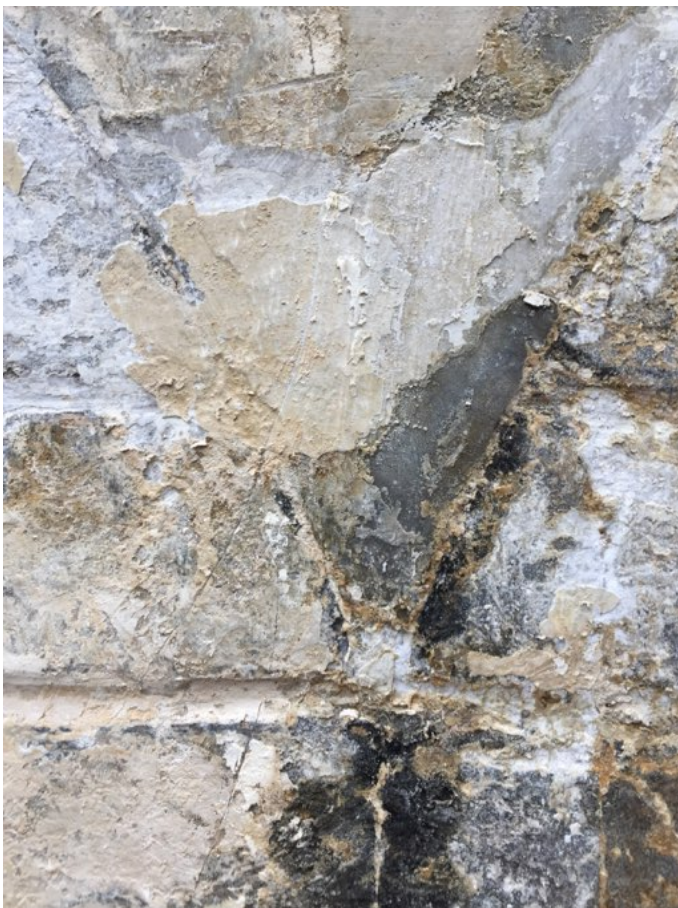
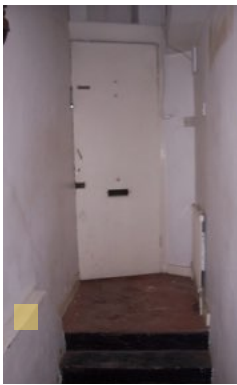
approximately 24 hours which removed the top layer of paint, revealing a yellower layer below that may be weather/pollution stained rather than that colour intentionally. A layer below is whiter, and may be a lime wash layer. A second application of poultice to the right hand half of the area revealed dark grey/black brickwork. The diamond shaped inset panel appears to be dark pennant stone, and there appears to be black mortar within the joints. A third layer of poultice removed slightly more of the paint but still did not remove it completely.

2.3.8. This suggests that the original intention may have been for this to be a black/imposing Gothick elevation rather than the white that appears to be the consistent colour since the first application of paint. That the foundation to this wall is a red engineering brick further reinforces the opinion that the original intention was for a dark finish. It is not known when the paint was first applied, and the colour changed to white, and it has also not been able to determine this through historical research.

not considered that returning this north facing elevation to a dark finish is desirable to either the property and the use of the garden, or its appearance from the adjacent properties to the rear. The applicant therefore proposes to maintain a white painted finish and to redecorate the elevation over the existing finishes, rather than to remove the existing finishes.

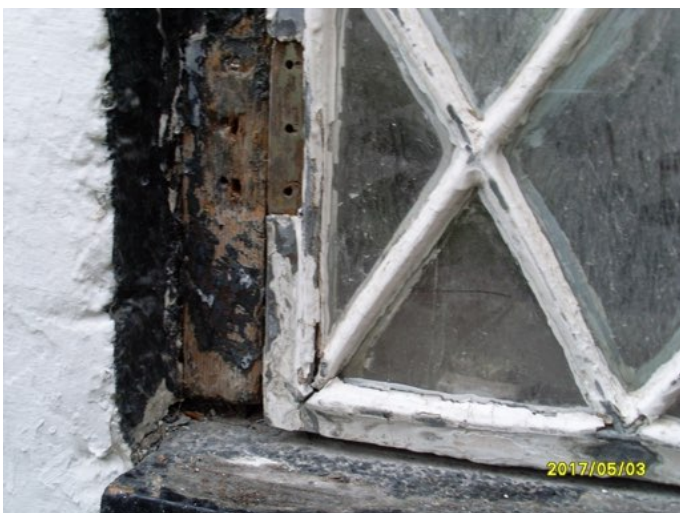
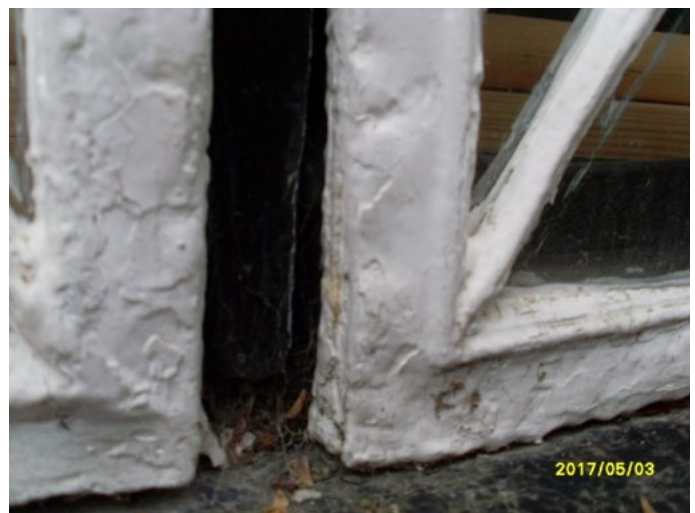
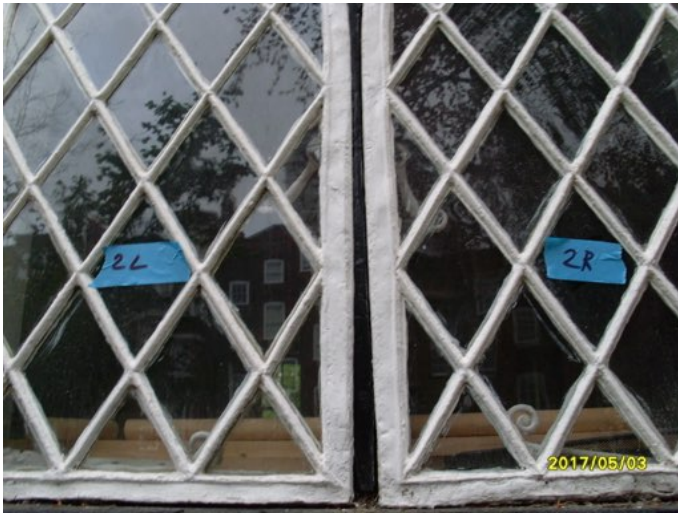
2.6. **Rear Windows** - It was also agreed by the Conservation Officer that one of the rear metal casement windows could be removed for assessment and for trial repair to inform the works to the remaining windows. The windows are distorted, with gaps between sashes and frames, and rot to the surrounding frames.

2.7. A Method Statement was prepared for this purpose, included within the application as *24 Perrins window repair method statement*. This work, undertaken by George Hammond, revealed that the existing windows are significantly corroded. There is a central steel frame with thin 15mm x 3mm glazing bars to create the diamond glazing pattern. The steel frame is wrapped in lead as shown in the accompanying photograph.

but this is a fundamentally flawed approach. The lead would accelerate the corrosion of the iron, and thereby the deterioration of the windows. The hinges and pins, and screws are also corroded and falling out.

2.9. It is proposed that the lead should be removed from the existing windows, and the windows repaired using sections to match the original profiles, including the iron glazing bars. The extent of the

damage and the proposed works are set out on the accompanying schedule *Rear Window Works*. The exact extent of the replacement of each steel sash and frame can't be determined until the lead has been removed from each. The glass will then be reset within the steel frame with putty. The windows will be fitted within their frames with new draftproofing to ensure a weather resistant seal. The work to the first sample window has not yet been completed at the time of writing.
