REF: 2084-17

**43 MUSEUM STREET
LONDON**

**NON-DESTRUCTIVE DIAGNOSTIC REMEDIAL
TREATMENT SURVEY REPORT ON THE PRESENCE OF
DAMPNESS TO READILY ACCESSIBLE WALLS WITHIN
THE REAR RIGHT CORNER OF THE UTILITY AREA IN
THE BASEMENT.**

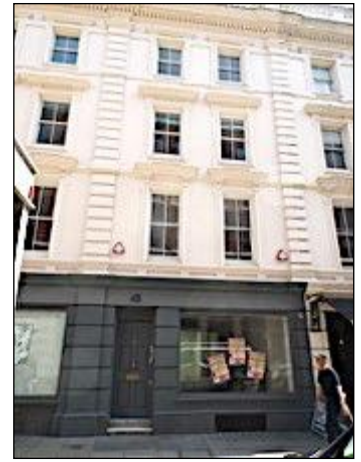
Front elevation

1. The age of the building pre-dates the installation of any physical damp proof course within the brickwork; this only became common practice following the Public Health Act of 1875.
2. The only external elevation accessible at the time of the survey was the front elevation. Although not the area in question, no obvious cause of water ingress was noted.

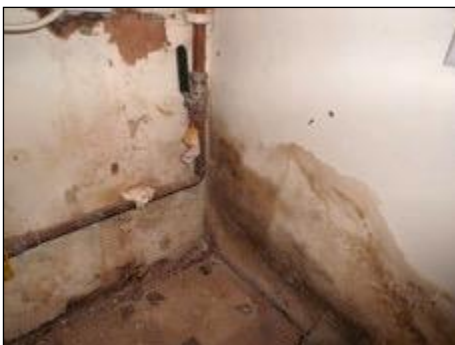
Damp plaster and boarding rear right corner of cellar area

8. Examination of these areas using an electrical moisture meter, where not impeded by boarding, fixtures and fitting revealed high readings indicative of dampness.

9. The possible causes of these readings indicative of dampness and possible future damp issues are as follows:
 - A. Soil retaining walls allowing lateral penetration of moisture to the full thickness of the wall structure.

- B. The use of a gypsum based plaster. Gypsum plaster will extract moisture and salts from the substrate and retain it, therefore should not be used in damp conditions.

- C. Possible plumbing fault, client's plumber to investigate further.
10. If the plaster was removed in this area and a cement based tanking system i.e. Sika or similar applied to the walls, this would prevent the evaporation of moisture and possibly force the dampness to other areas.

- A. The removal of the plaster complete and apply a lime plaster (this may have to be repeated as, when and if dampness reappears).
 - B. The supply and fitting of a high density Polyethylene cavity drain membrane system as per manufactures specification to the exposed masonry. **Please note** this is not a sealed system and would not prevent water ingress from flood, burst drainage, high water tables etc. but would prevent the migration of salts and moisture from the wall to the surface of the new wall finish. Re-plaster/plaster board the high density Polyethylene cavity drain membrane as per the membrane manufactures specification.

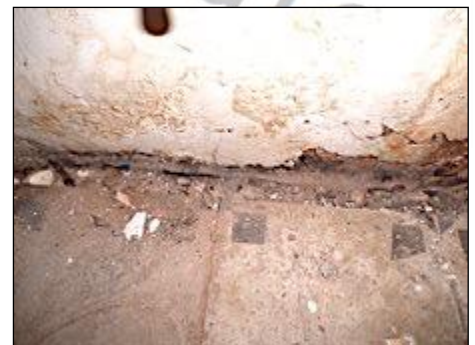
Damp plaster at low level
