Webb Yates Sketch showing manhole in basement of 32 Torrington Square to be surveyed  
Sketch No: J2889-C-SK-0002  
Date: 20/12/16

| Project Name | 32 Torrington Sq WC1E |
| Project Description | WinCan Import in Miraculix WRc4 Standard |

## Section Inspection - 16/05/2017 - X

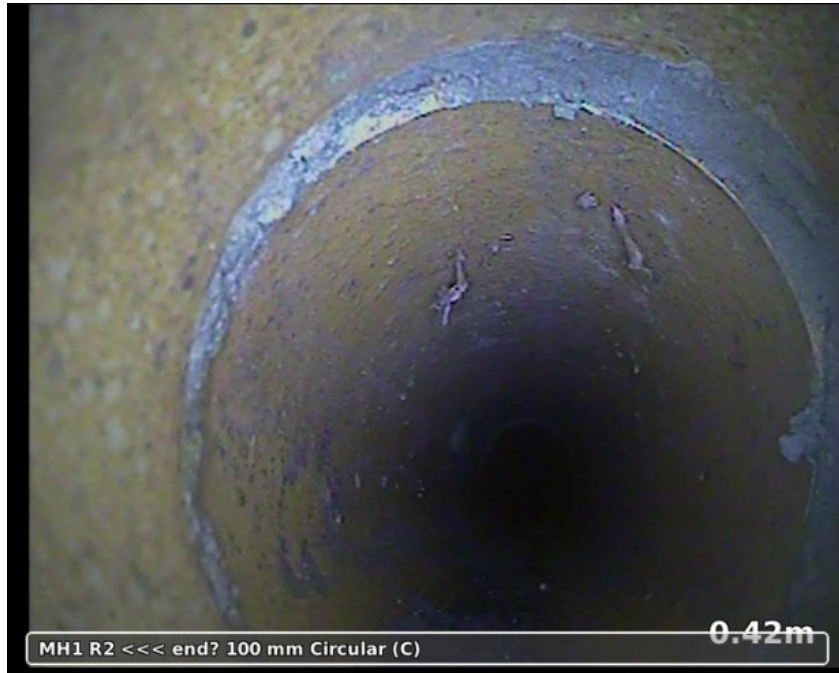
| 1:50 | Position m | Code | Observation | MPEG | Photo | Grade |
|---|---|---|---|---|---|---|
| | 0.42 | JDM | Joint displaced, medium | 00:00:29 | | 1 |

20170516-092920-snap0000.jpg, 00:00:29, 0.42m  
Joint displaced, medium

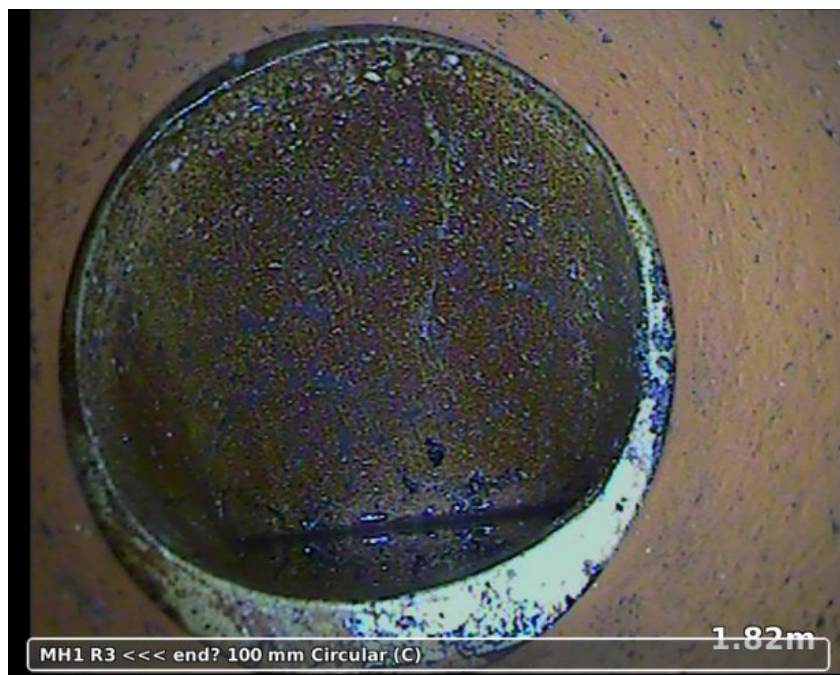
<table><tr> <td style="width: 15%; text-align: center;">0.91</td> <td style="width: 10%; text-align: center;">GP</td> <td style="width: 45%;">General photograph taken at this point</td> <td style="width: 10%; text-align: center;">00:00:32</td> <td></td> <td></td> </tr><tr> <td style="text-align: center;">1.82</td> <td style="text-align: center;">JDM</td> <td style="color: red;">Joint displaced, medium</td> <td style="text-align: center;">00:00:56</td> <td></td> <td style="text-align: center;">1</td> </tr></table>

20170516-095202-snap0001.jpg, 00:00:56, 1.82m  
Joint displaced, medium

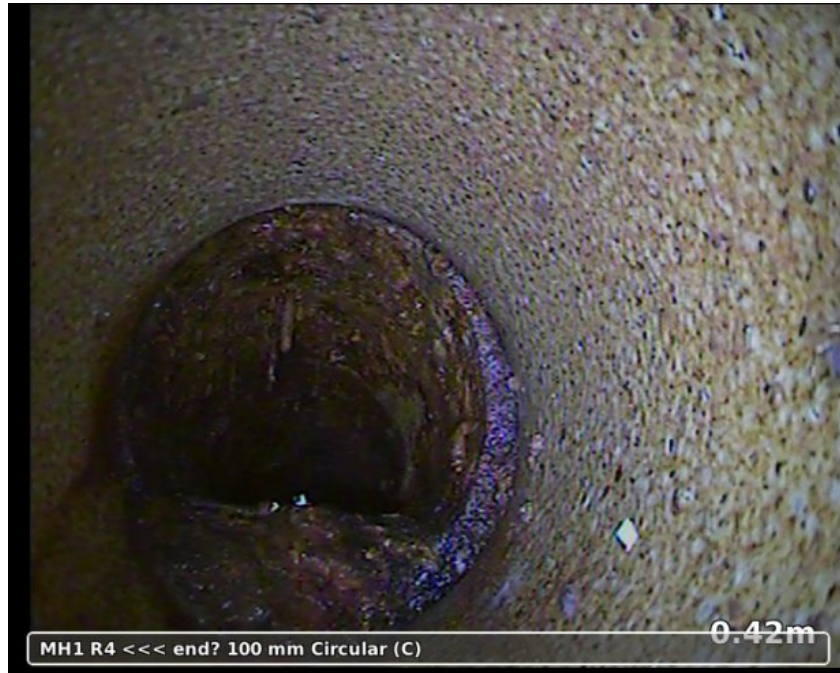
| Section | Pipe Ref | Grade | Description |
|---|---|---|---|
| 4 | X | 4 | Settled deposits, hard or compacted, 30 % cross-sectional area loss |

Grade 4: Best practice suggests consideration should be given to maintenance activity to avoid potential blockages.

<table><tr> <td style="width: 10%;"></td> <td style="width: 15%;"></td> <td style="width: 10%;"></td> <td style="width: 45%;"></td> <td style="width: 10%;"></td> <td style="width: 10%;"></td> <td style="width: 10%;"></td> </tr><tr> <td></td> <td>0.42</td> <td>DEC</td> <td>Settled deposits, hard or compacted, 30 % cross-sectional area loss</td> <td>00:00:47</td> <td></td> <td>4</td> </tr></table>

20170516-095512-snap0000.jpg, 00:00:47, 0.42m  
Settled deposits, hard or compacted, 30 % cross-sectional area loss

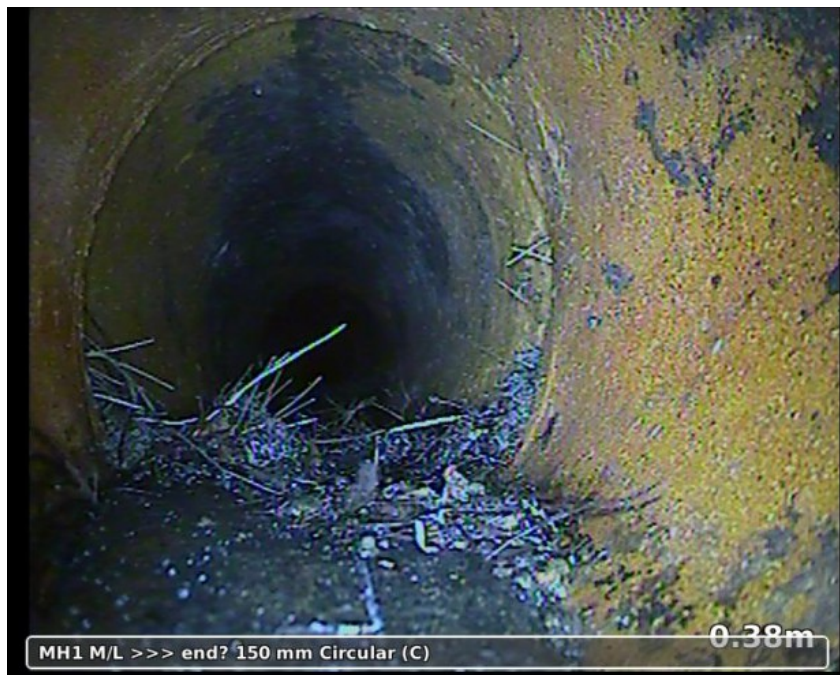
| 1:128 | Position m | Code | Observation | MPEG | Photo | Grade |
|---|---|---|---|---|---|---|
| | 0.38 | REM | General remark: Roots | 00:01:26 | | |

20170516-100118-snap0002.jpg, 00:01:26, 0.38m  
General remark

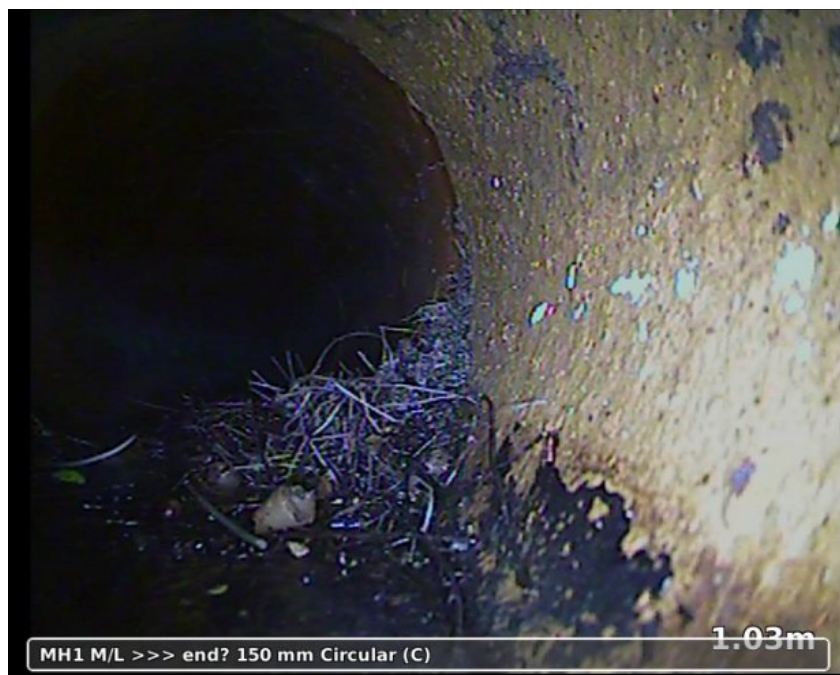
| 1:128 | Position m | Code | Observation | MPEG | Photo | Grade |
|---|---|---|---|---|---|---|
| | 1.03 | REM | General remark: Roots | 00:01:59 | | |

20170516-100118-snap0003.jpg, 00:01:59, 1.03m  
General remark

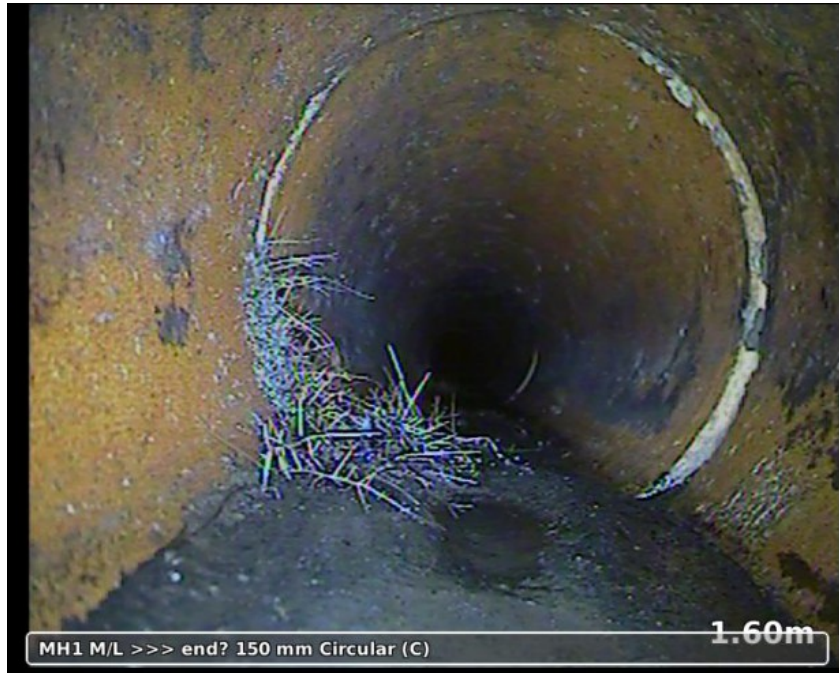
| Section | Pipe Ref | Grade | Description |
|---|---|---|---|
| 5 | MH1 M/LX | 3 | Settled deposits, hard or compacted, 10 % cross-sectional area loss |

Grade 3: Best practice suggests consideration should be given to maintenance activities in the medium term.

| 1:128 | Position m | Code | Observation | MPEG | Photo | Grade |
|---|---|---|---|---|---|---|
| | 1.60 | DEC | Settled deposits, hard or compacted, 10 % cross-sectional area loss | 00:02:36 | | 3 |

20170516-100118-snap0004.jpg, 00:02:36, 1.60m  
Settled deposits, hard or compacted, 10 % cross-sectional area loss

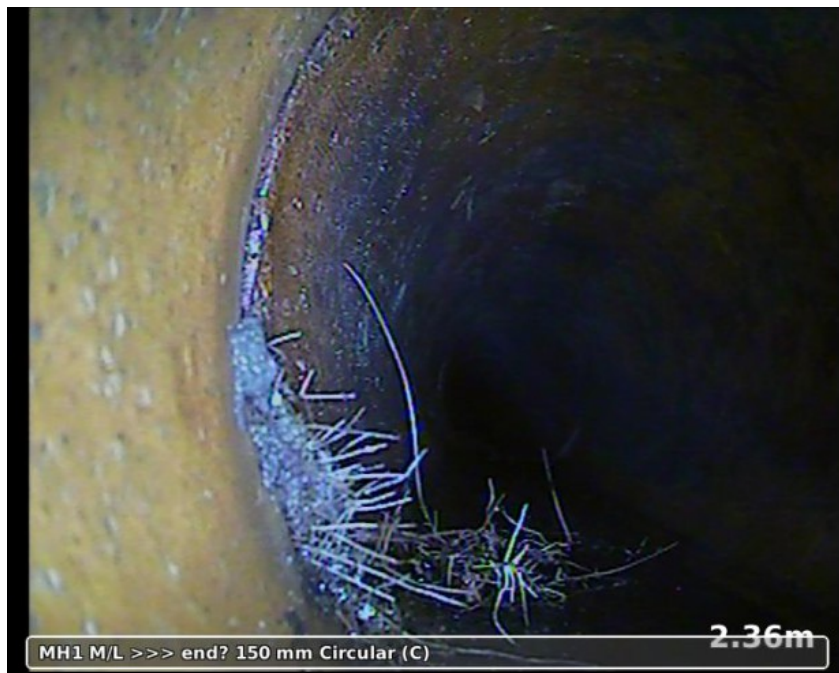
| 1:128 | Position m | Code | Observation | MPEG | Photo | Grade |
|---|---|---|---|---|---|---|
| | 2.32 | REM | General remark: Roots | 00:03:07 | | |

20170516-100118-snap0005.jpg, 00:03:07, 2.32m  
General remark

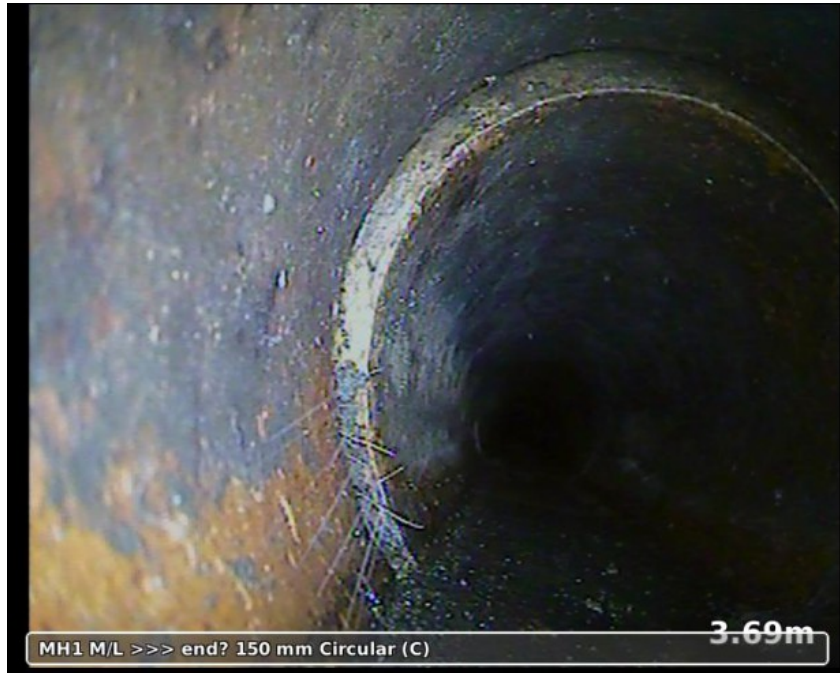
| 1:128 | Position m | Code | Observation | MPEG | Photo | Grade |
|---|---|---|---|---|---|---|
| | 3.69 | JDM | Joint displaced, medium | 00:03:39 | | 1 |

20170516-100118-snap0006.jpg, 00:03:39, 3.69m  
Joint displaced, medium

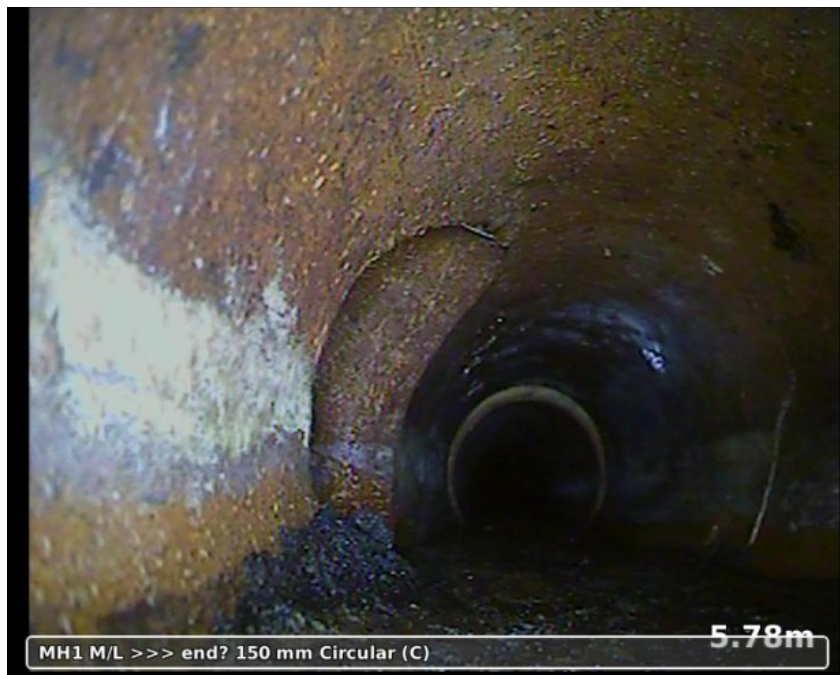
| 1:128 | Position m | Code | Observation | MPEG | Photo | Grade |
|---|---|---|---|---|---|---|
| | 5.74 | CC | Crack, circumferential, from 12 to 05 o'clock | 00:04:58 | | 2 |

20170516-100118-snap0008.jpg, 00:04:58, 5.74m  
Crack, circumferential, from 12 to 05 o'clock

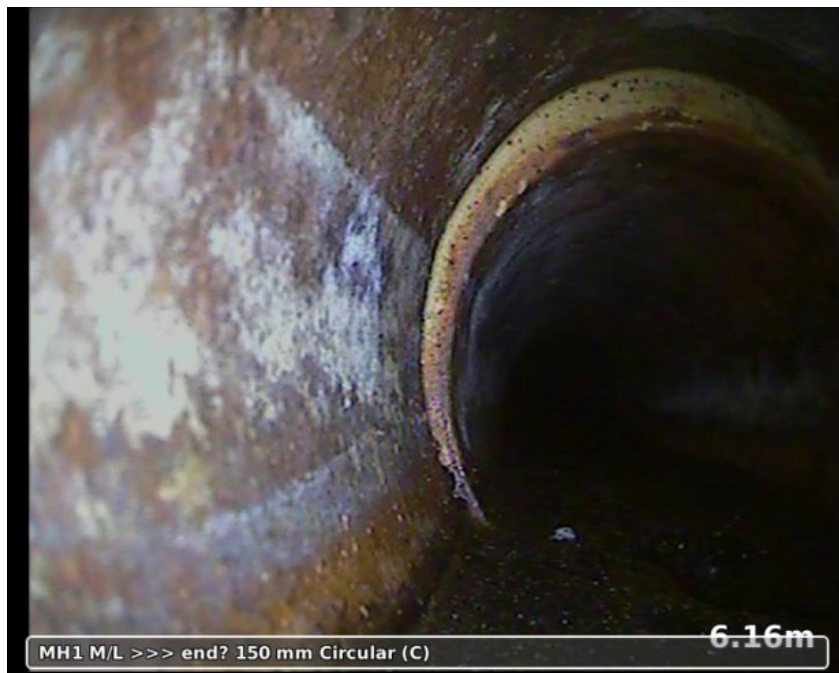
| 1:128 | Position m | Code | Observation | MPEG | Photo | Grade |
|---|---|---|---|---|---|---|
| | 6.16 | JDM | Joint displaced, medium | 00:05:36 | | 1 |

20170516-100118-snap0009.jpg, 00:05:36, 6.16m  
Joint displaced, medium

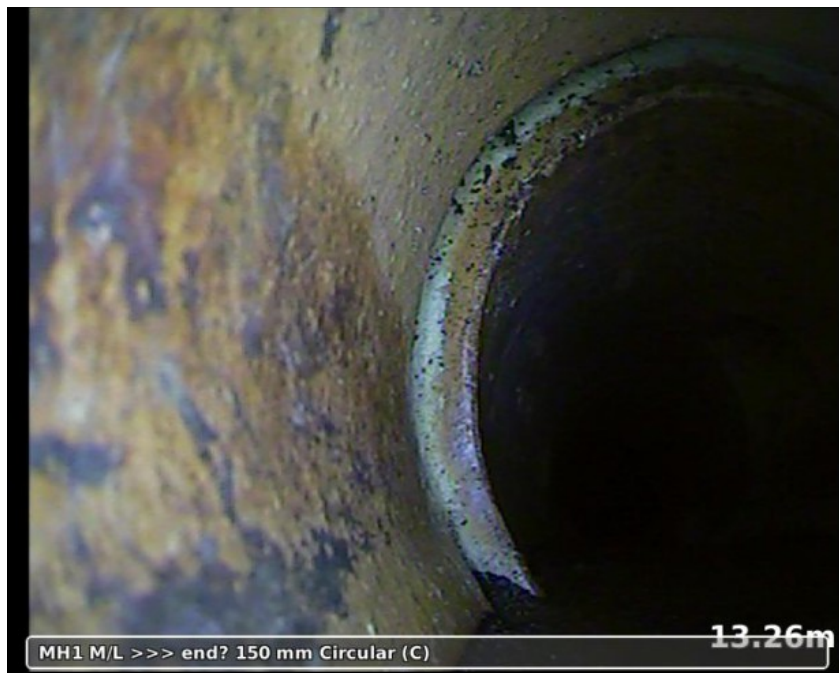
| 1:128 | Position m | Code | Observation | MPEG | Photo | Grade |
|---|---|---|---|---|---|---|
| | 13.26 | JDM | Joint displaced, medium | 00:07:39 | | 1 |

20170516-100118-snap0011.jpg, 00:07:39, 13.26m  
Joint displaced, medium
