Supporting Statement

Rosslyn House 2A Pilgrims Lane NW3 1SL

28 July 2017

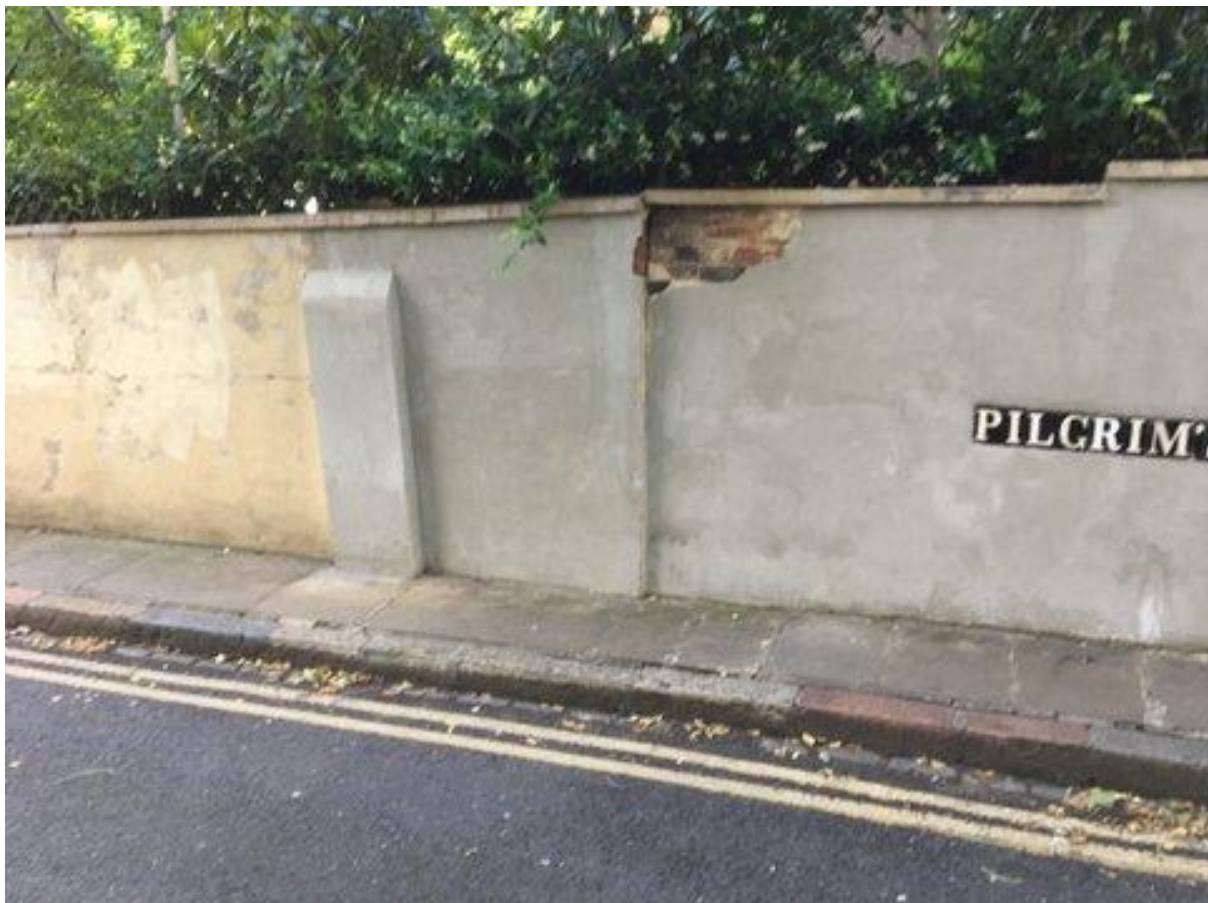
Pic 1

Refer to image below, it appears that the tree roots are undermining the foundations for the wall and this has resulted in a section of the wall which has bowed and moved away from the vertical.

The proposal is to remove a section of the wall approx. 4.5m long, the existing foundation (if any) will be inspected and if required a new foundation will be poured. The wall will then be rebuilt using as many of the bricks from the original wall as possible. A brick buttress will also be incorporated on the garden side similar to existing. The public face of the wall will then be rendered and painted to match existing.

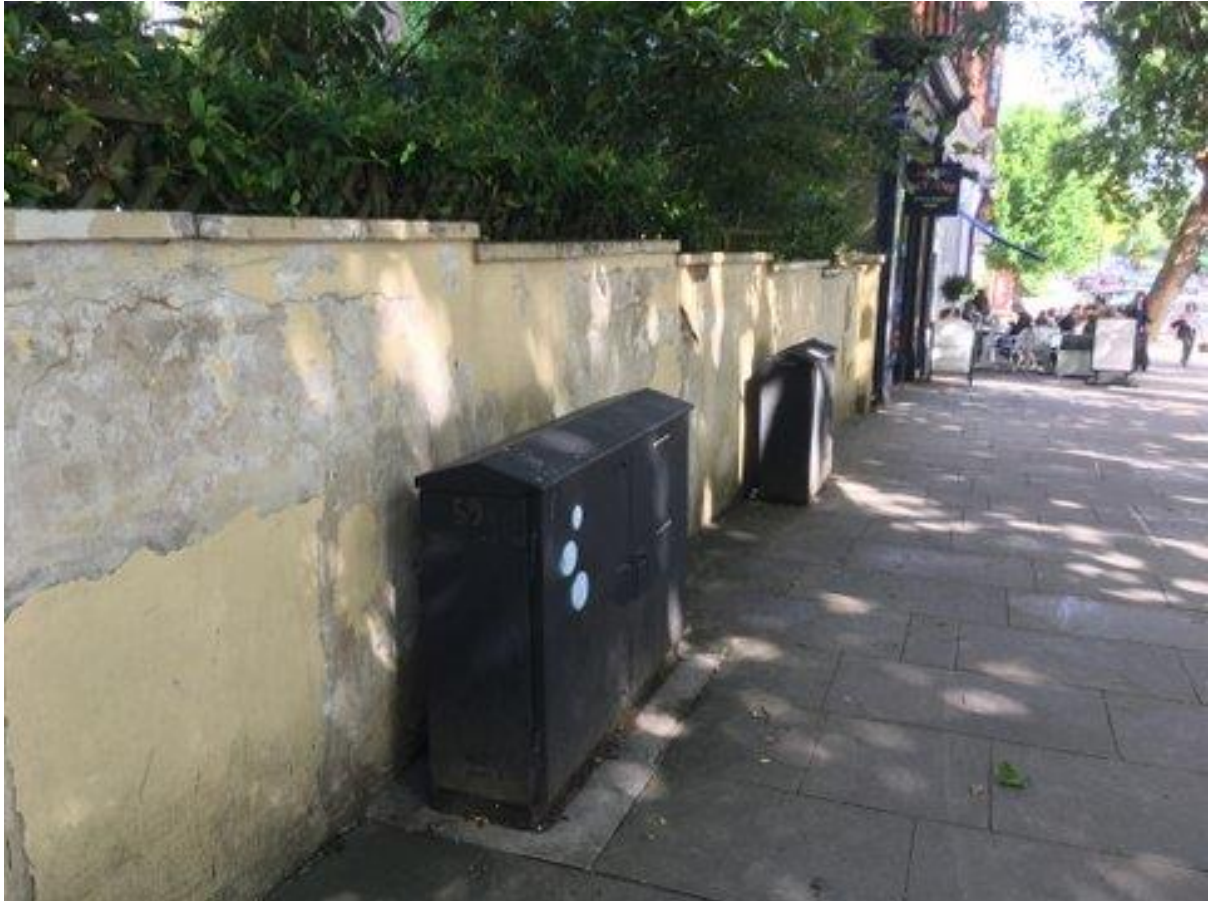
Pic 2

Refer to image below, the render to this wall has cracked in several places, however it appears to be structurally stable. The proposal is to remove the render where the cracks are evident and incorporate reinforcing bars in the mortar joints and re-render / paint to match existing.

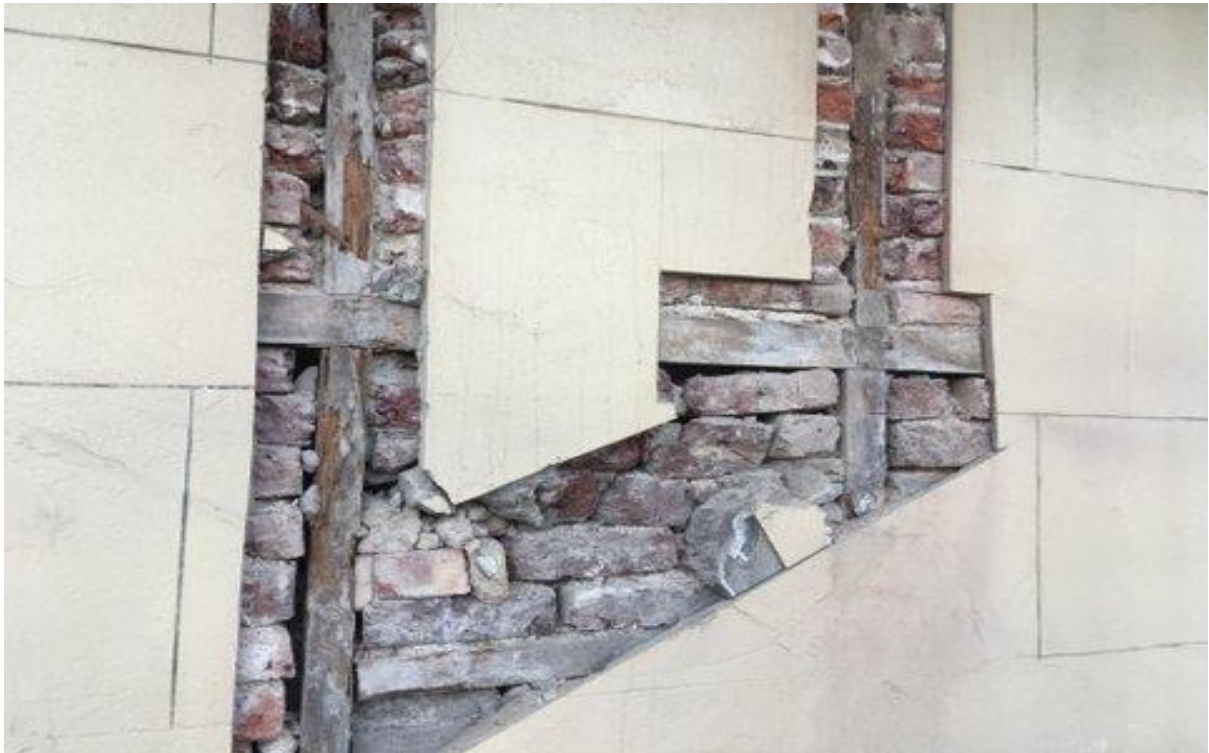
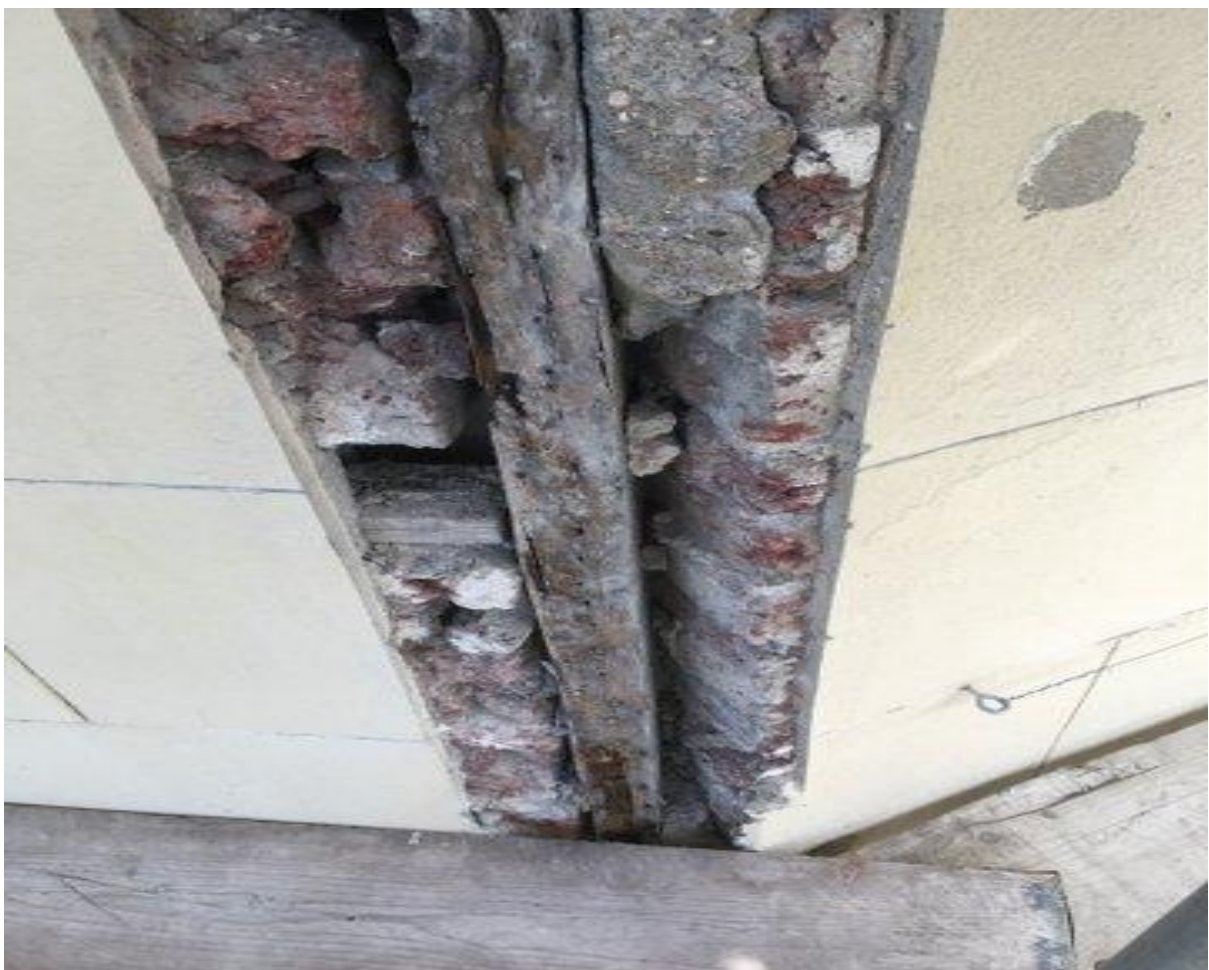
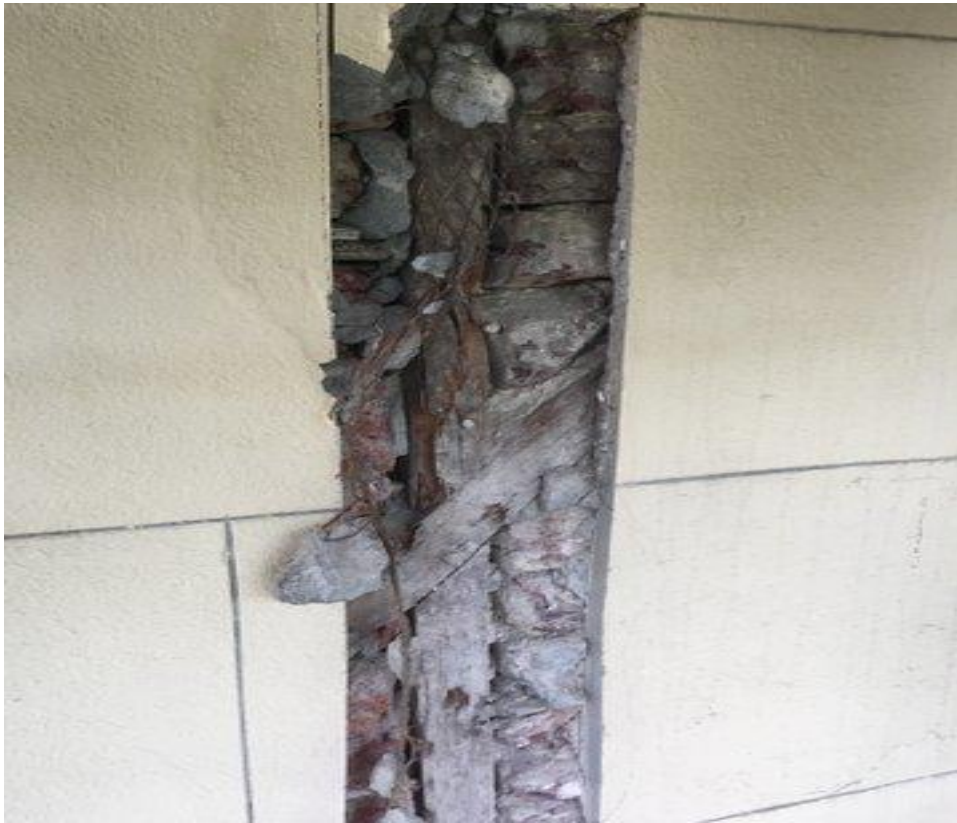
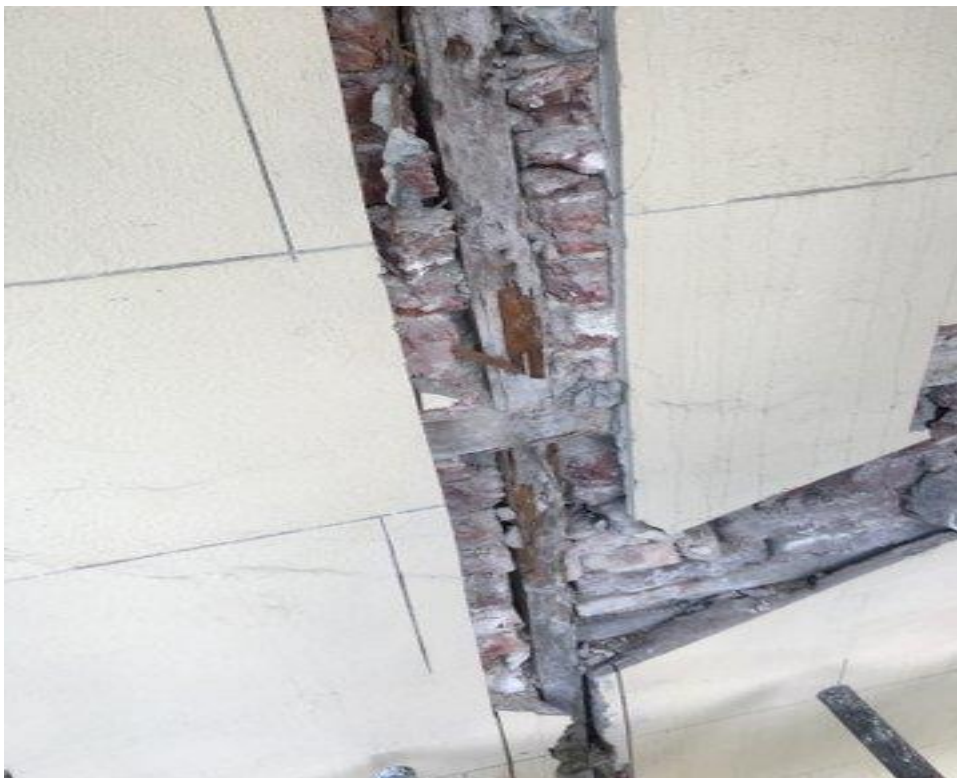
The original intention was to repair locally and repaint the main building same colour as existing, however once contractors commenced and investigated the cracking to the splayed (north west) elevation, they discovered that the entire building appears to be timber frame with brick infill, from initial examination the cracking appears to have occurred in the line of the timber posts which have been subject to water ingress and this has resulted in the disintegration of the timber. A report by a timber specialist confirmed that the damage to the timber has been caused by wet rot.

Further exposure and examination revealed poor quality infill brick between timber framing. In relation to the areas exposed, it is evident that most of the exposed timbers will have to be replaced, in addition all unstable infill brickwork to be removed and re-built. It was also clear from the additional exposed areas that the structure is a single skin element.

As this is a loadbearing wall, the works should be carried out in phases approximately 1sq. m panels exposed at a time, the infill brickwork to be removed and re-built initially, where elements of timber have to be removed and replaced, the remaining timber to be temporarily supported locally by a metal frame supported off the brickwork. The replacement timbers to be connected to the retained timber by a metal joining plate.

This will have to be repeated for the splayed section of the elevation above the ground floor flat roof to underside of fascia. It appears that the internal dri-lining is supported off secondary timber battens.

Once the repairs / reinstatement works have been completed, eml can be applied and then rendered and decorated to match existing.

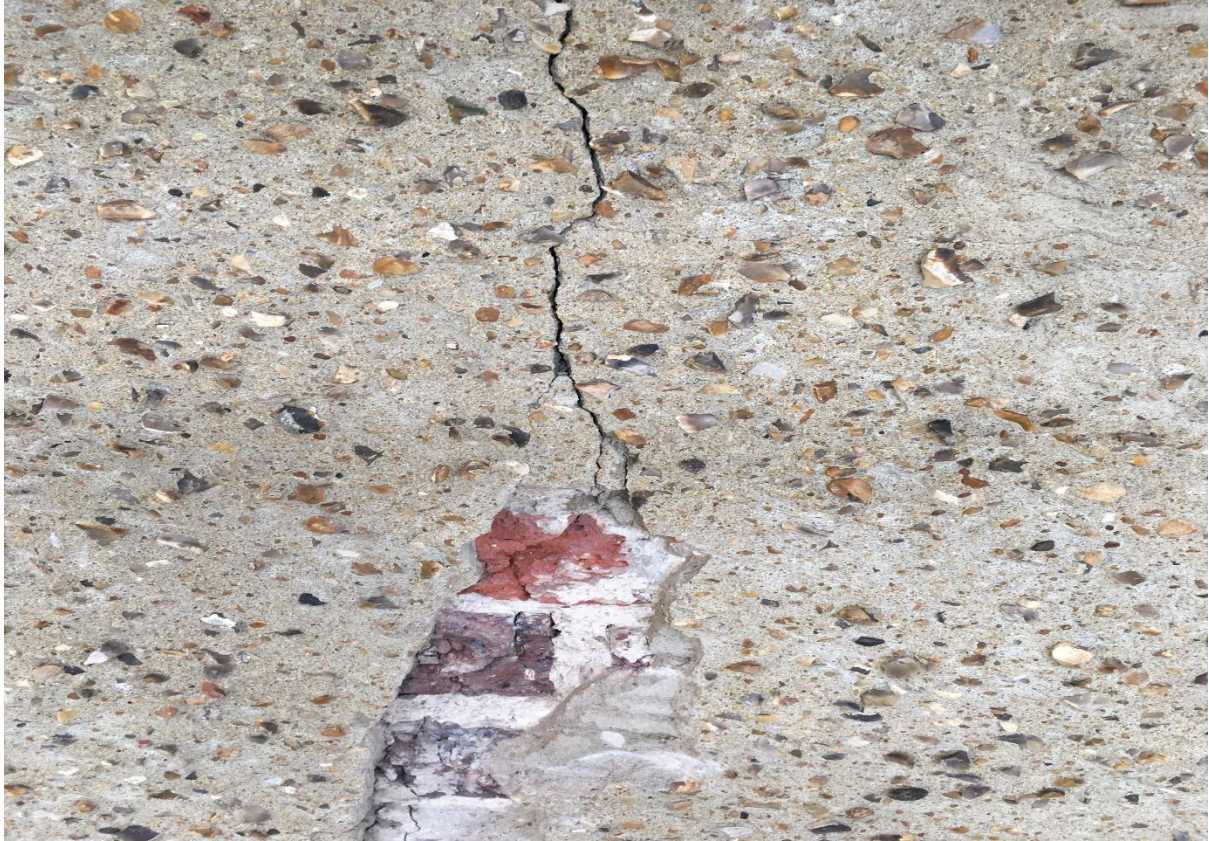
Pic 7

With reference to the historic OS Map dated 1873, a row of properties abutted this elevation. Subsequently the elevation had a pebble ash render applied, however the strength of the render was such that when any movement took place it resulted in cracking of the brickwork as the render was of a greater strength than the brick bonding. Refer to Pic 7.

The proposal is to remove the cracked render locally, re-render to achieve a smooth finish, apply emul and smooth render which will be finished to match the other elevations.

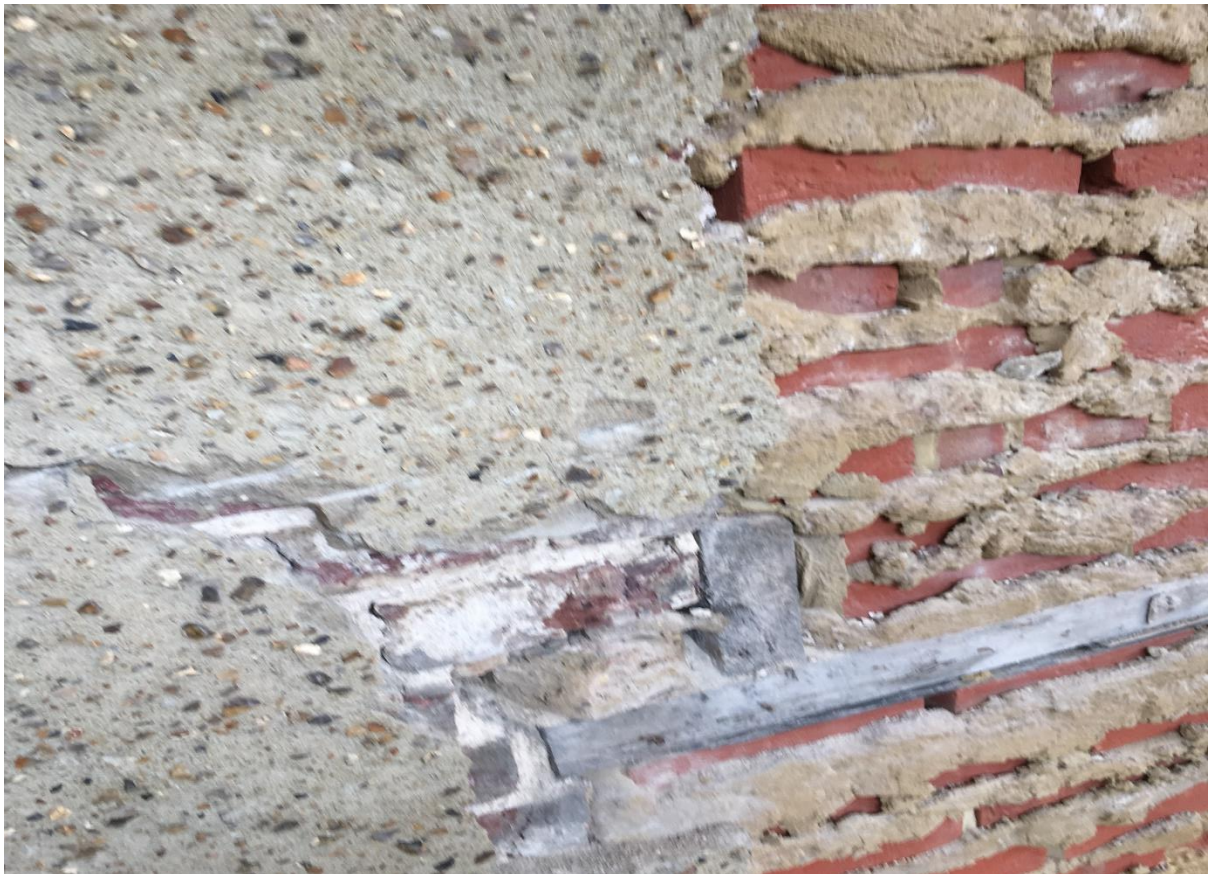
Pic 8

In addition it appears that an opening in the gable wall has been infilled from the interior without disturbing the external render finish. Refer to Pic 8.
