ARBORICULTURAL ASSESSMENT REPORT

| | Risk Address: | Flat 7 - Flat 10, Cliff Road Studios, 5 Cliff Road, London, NW1 9AN |
| Refs: | OCA Ref: | 69928 |

| Arborist Name: | Matthew Gardner | Date: | 31/05/2017 |

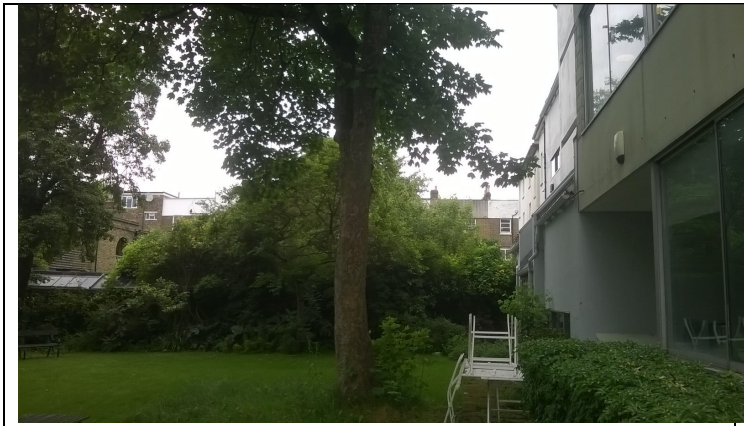
| TP/BH1:USF | 10mm | Acer spp. (Maple/Sycamore) |
| BH1:2300mm | 4mm | Acer spp. (Maple/Sycamore) |

| Tree No | Common Name | Age Class | Condition | Height (m) | Crown Spread (m) | Stem diam. (mm) | Dist to bldg. (m) | Pruning history | Recommendation | Tree work constraints | Notes | Owner address | Owner |
|---|---|---|---|---|---|---|---|---|---|---|---|---|---|
| T5 | Sycamore | Mature | Fair | 17 | 13.0 | 560 | 3.4 | Recently Reduced | Fell and treat stump. | Access through building | | Flat 7 - Flat 10, Cliff Road Studios, 5 Cliff Road, London, NW1 9AN | PH |

| Tree No: | Species | Works Required |
|---|---|---|
| T5 | Sycamore | Fell and treat stump. |

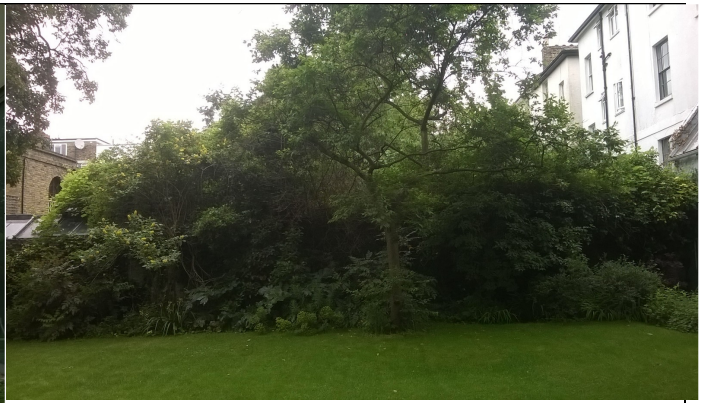
T9 and G1

| T9 | Cherry | Mature | Fair | 5.8 | 6 | 200 | 6.5 | No significant past management. | No work required. | Access through building | . | Flat 7 - Flat 10, Cliff Road Studios, 5 Cliff Road, London, NW1 9AN | PH |
| G1 | Mixed group | Early Mature | Fair | 3 | 10 | 20 | 1 | No significant past management. | No work required. | Access through building | Elder, Ivy, Ceanothious and Hazel. | Flat 7 - Flat 10, Cliff Road Studios, 5 Cliff Road, London, NW1 9AN | PH |

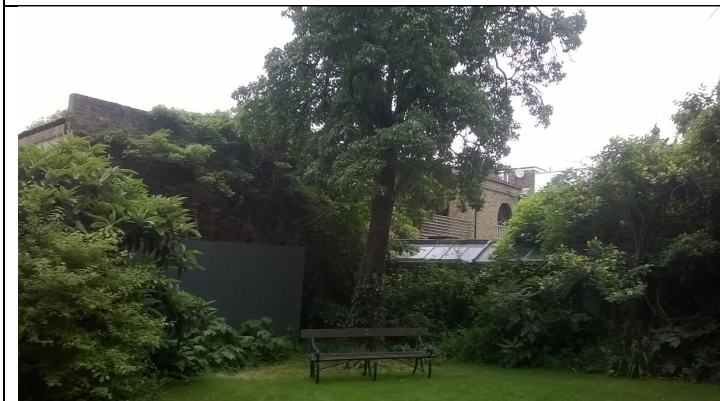
| T8 | Pear | Mature | Poor | 14 | 7.0 | 570 | 16.5 | Recently Reduced. significant decay at base | Fell close to ground level (approx 50mm). | Access through building | | Flat 7 - Flat 10, Cliff Road Studios, 5 Cliff Road, London, NW1 9AN | PH |

| Tree No: | Species | Works Required |
|---|---|---|
| T8 | Pear | Fell close to ground level (approx 50mm). |

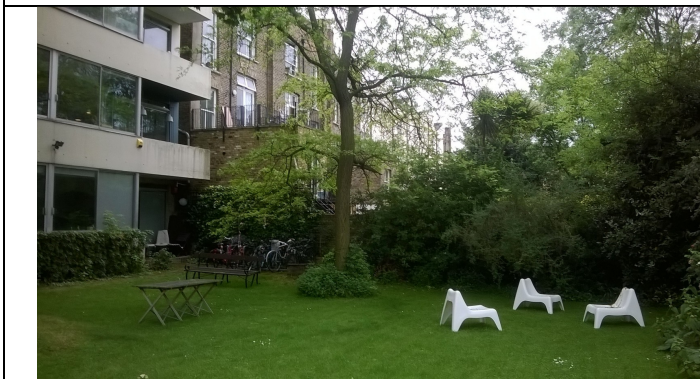
T6 and G2

| | 1.5mm | Leguminosae spp. (Laburnum/Wisteria/False Acacia) |

| Tree No | Common Name | Age Class | Condition | Height (m) | Crown Spread (m) | Stem diam. (mm) | Dist to bldg. (m) | Pruning history | Recommendation | Tree work constraints | Notes | Owner address | Owner |
|---|---|---|---|---|---|---|---|---|---|---|---|---|---|
| T6 | False Acacia | Mature | Fair | 16.8 | 10 | 420 | 7.8 | Recently | Fell and treat | Access through | | Flat 7 - Flat 10, | PH |

| G2 | Mixed group | Early Mature | Fair | 3 | 10 | 20 | 1 | No significant past management. | No work required. | Access through building | Elder, Ivy, Ceanothious and Hazel. | Flat 7 - Flat 10, Cliff Road Studios, 5 Cliff Road, London, NW1 9AN | PH |

| Tree No: | Species | Works Required |
|---|---|---|
| T6 | False Acacia | Fell and treat stump. |

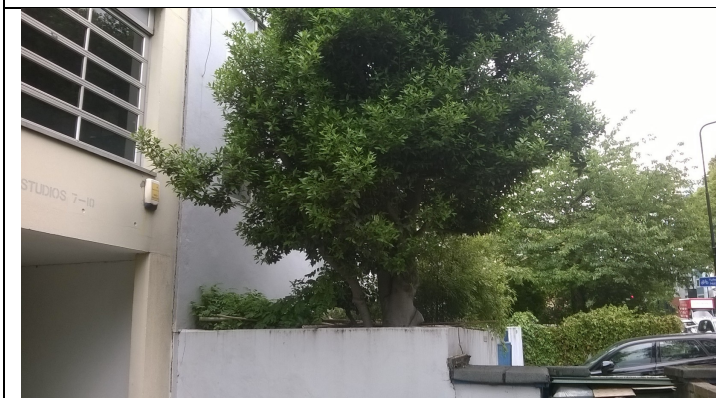
| Tree No | Common Name | Age Class | Condition | Height (m) | Crown Spread (m) | Stem diam. (mm) | Dist to bldg. (m) | Pruning history | Recommendation | Tree work constraints | Notes | Owner address | Owner |
|---|---|---|---|---|---|---|---|---|---|---|---|---|---|
| T1 | Bay | Early Mature | Fair | 8 | 2.8 | 400 | 2.5 | Recently Reduced | No work required. | | | Flat 7 - Flat 10, Cliff Road Studios, 5 Cliff Road, London, NW1 9AN | PH |

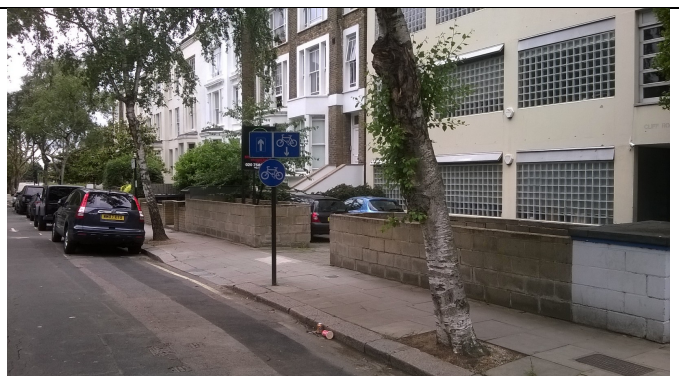
T2 and T3

| Tree No | Common Name | Age Class | Condition | Height (m) | Crown Spread (m) | Stem diam. (mm) | Dist to bldg. (m) | Pruning history | Recommendation | Tree work constraints | Notes | Owner address | Owner |
|---|---|---|---|---|---|---|---|---|---|---|---|---|---|
| T2 | Birch | Early Mature | Fair | 12 | 8 | 310 | 9 | No significant past management. | No work required. | | | London Borough of Camden | LA |
| T3 | Birch | Early Mature | Fair | 12 | 8 | 270 | 9 | No significant past management. | No work required. | | | London Borough of Camden | LA |
