Project  
**GOODENOUGH CLUB STAIRS**

Drawing Title  
**HOUSE 24 - PROPOSED WORKS**

Drawn JG Checked CP  
Drawing number 16010-A-0004 Revision P01

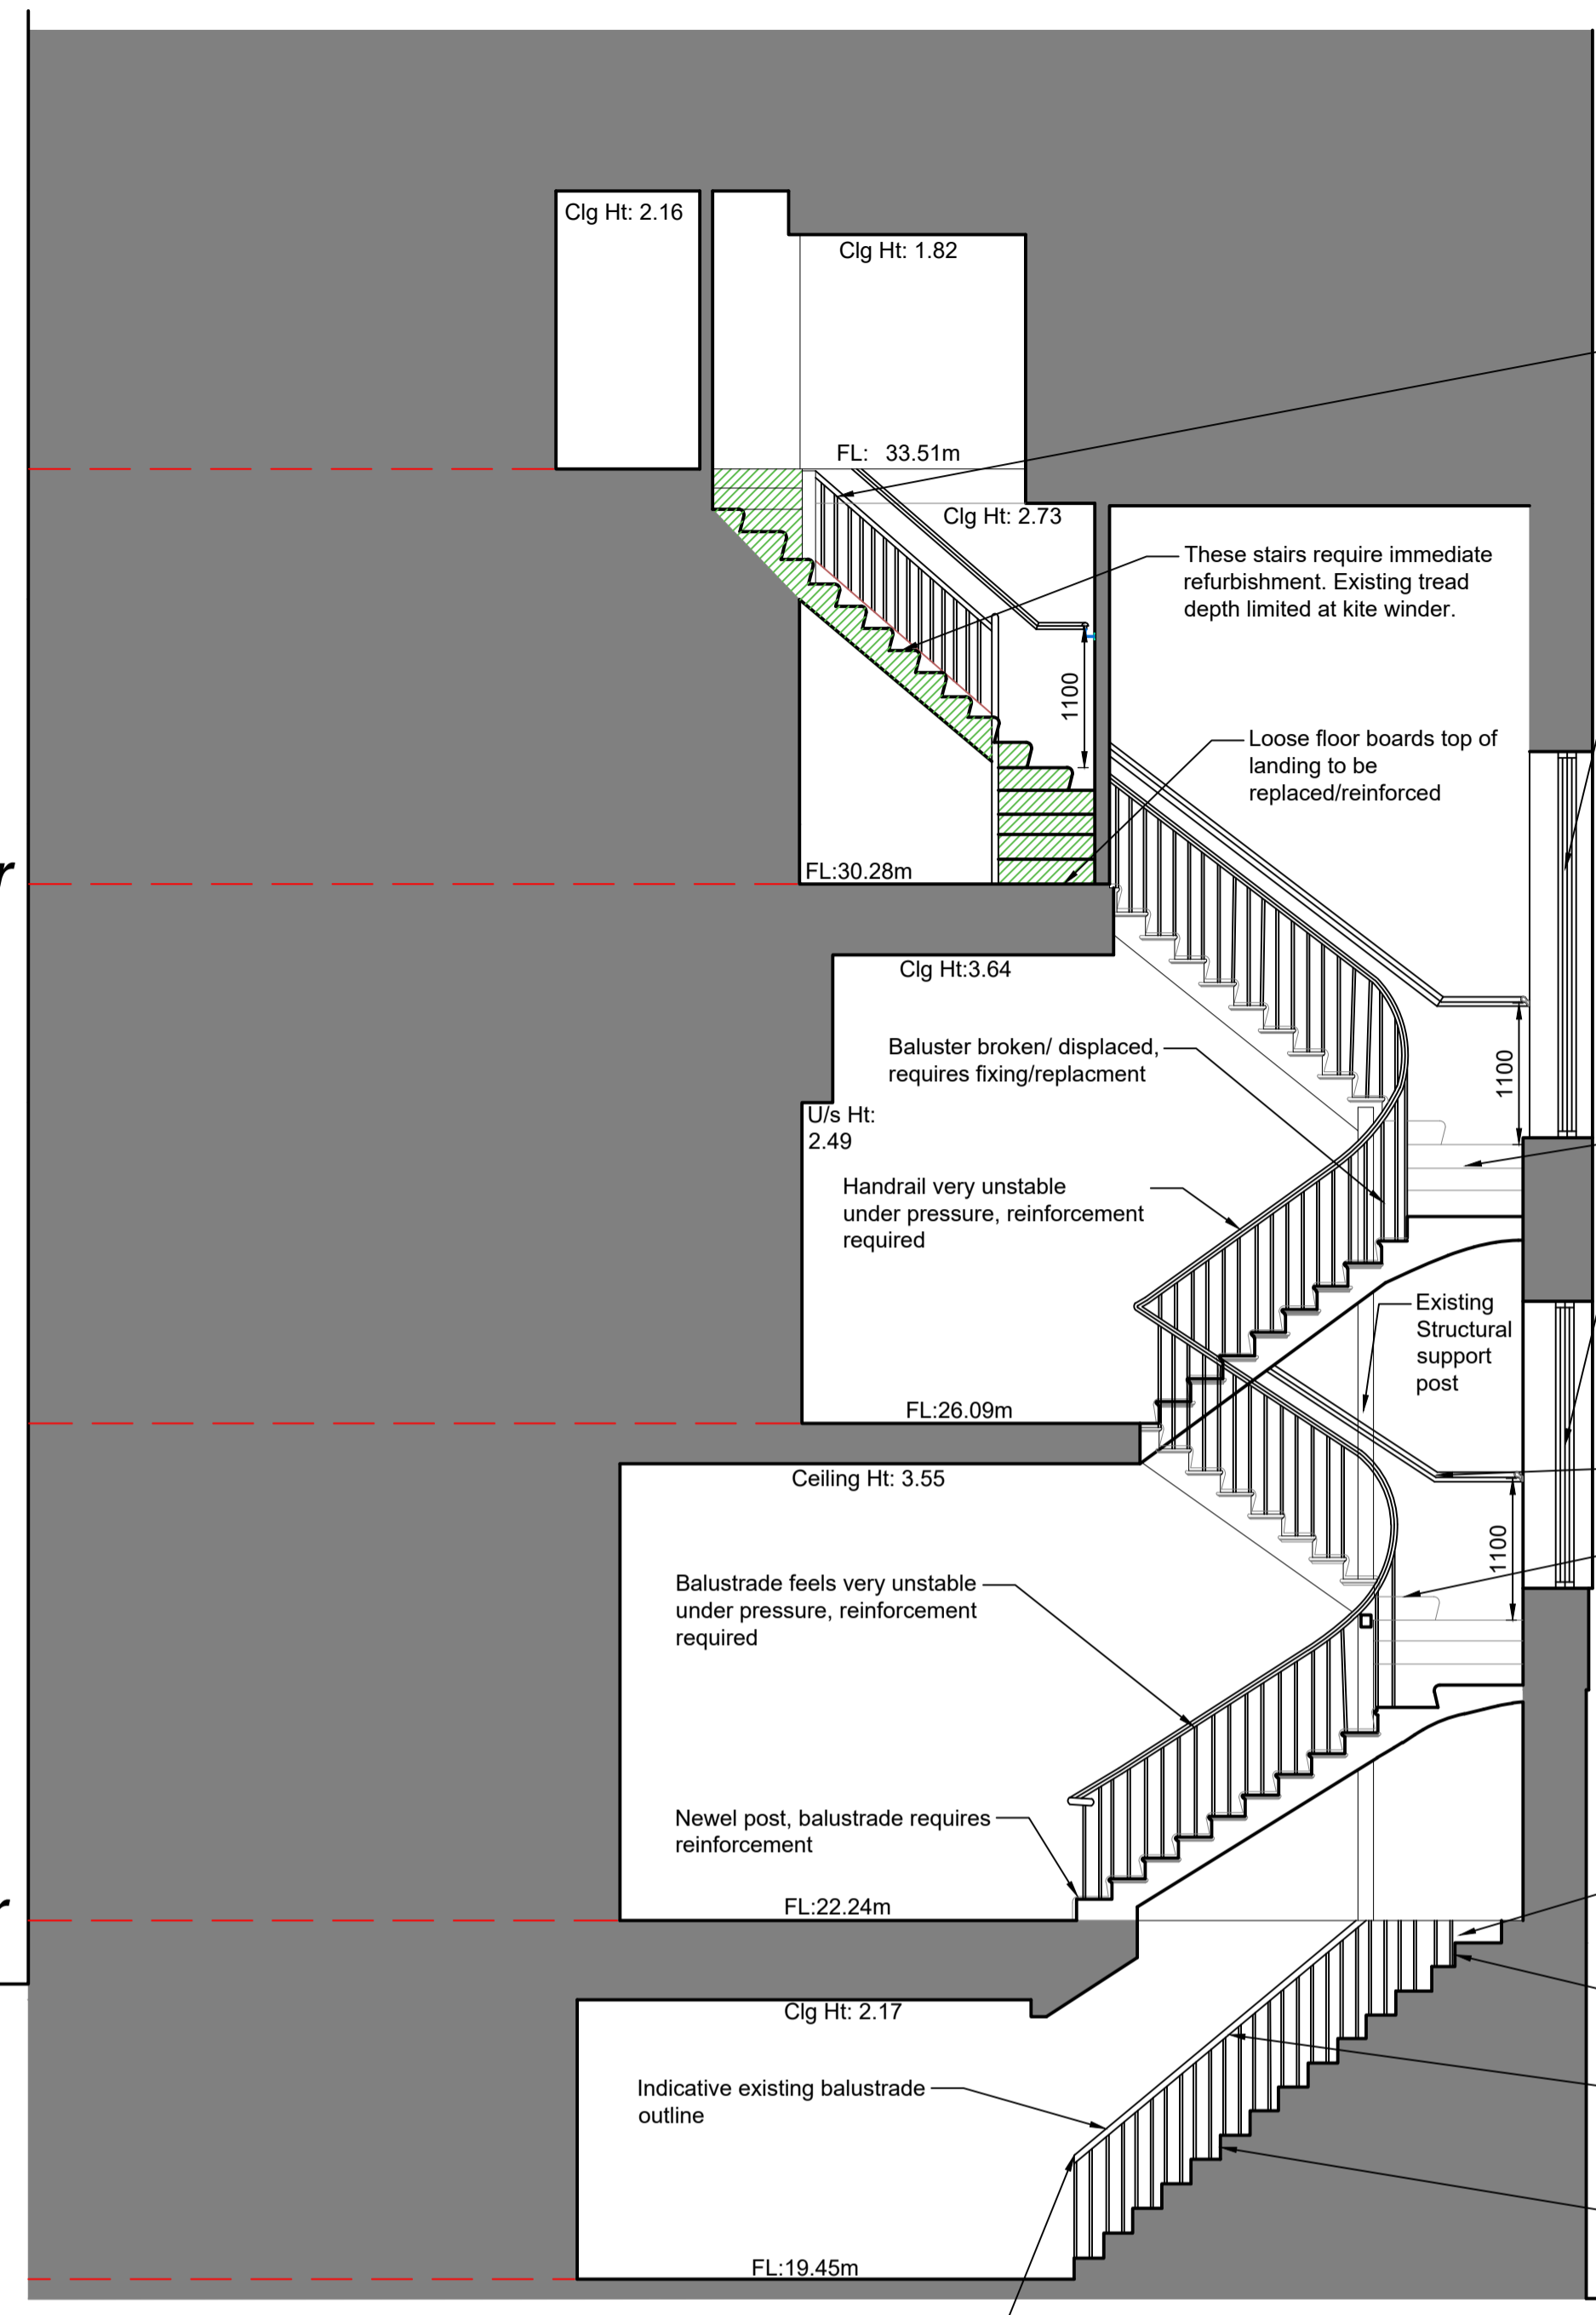
**Section**  
Scale 1:50 @ A1

Handrail at the top of the stair is loose, requires repair/reinforcement  
New timber baluster to be installed to reduce spacing where unstable / extreme

Window at landing not safety/toughened glass. S70 Safety Film provided by 3M to be applied to the interior surface of existing glass to provide additional protection and to meet building regulations. Refer to data sheet

Kite winder treads appear to have dropped at mid-landing transition, feel unstable require reinforcement

Window at mid landing not safety/toughened glass. S70 Safety Film provided by 3M to be applied to the interior surface of existing glass to provide additional protection and to meet building regulations. Refer to data sheet

Top of stairs, treads appear loose require strengthening to this upper section

Kite winder treads feel unsafe/loose. Replacement/reinforcement required

Handrail twisted at top of stairs indicating previous movement, requires reinforcement

Treads generally varied heights and require regularizing

New feature handrail to be installed. Colour to be confirmed. Handrail stopped at window jambs.
