## ASBESTOS REFURBISHMENT/DEMOLITION SURVEY

Parliament Hill  
Highgate Road  
London  
NW5 1RL

Lantern Services  
Barnet by Pass  
South Mimms  
Potters Bar  
Hertfordshire  
EN6 3NQ

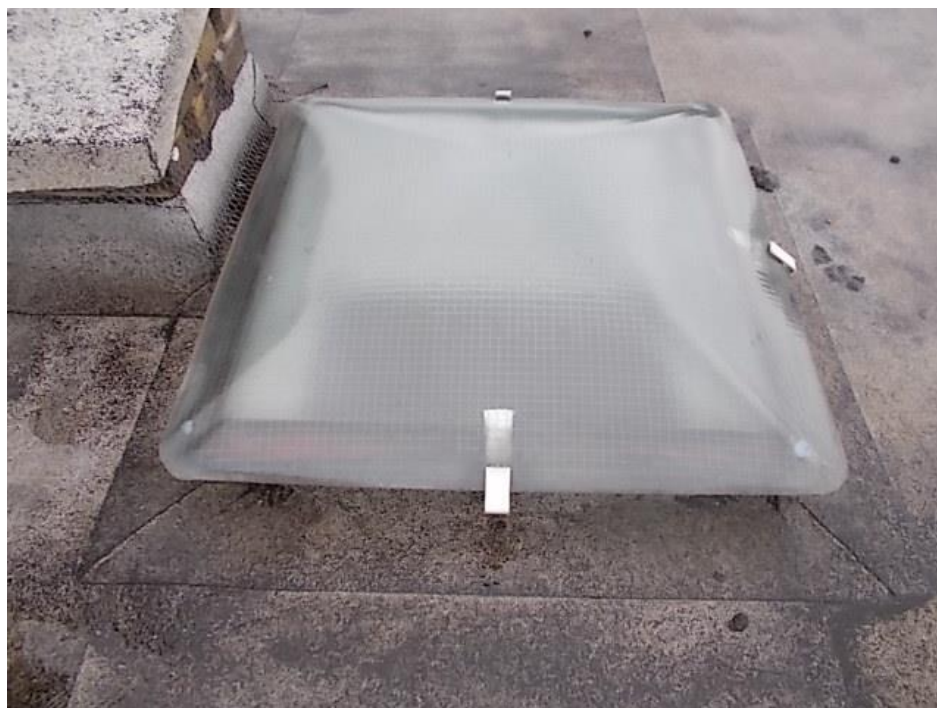
Sample Ref	Description	Location & Extent	Asbestos Type
KA001	Health Building - Flat Roof Textile to skylight	External Approx. 16m <sup>2</sup>	Chrysotile
Material Assessment Score	Priority Assessment Score	Recommendation	
10	2	Remove under controlled conditions prior to demolition works

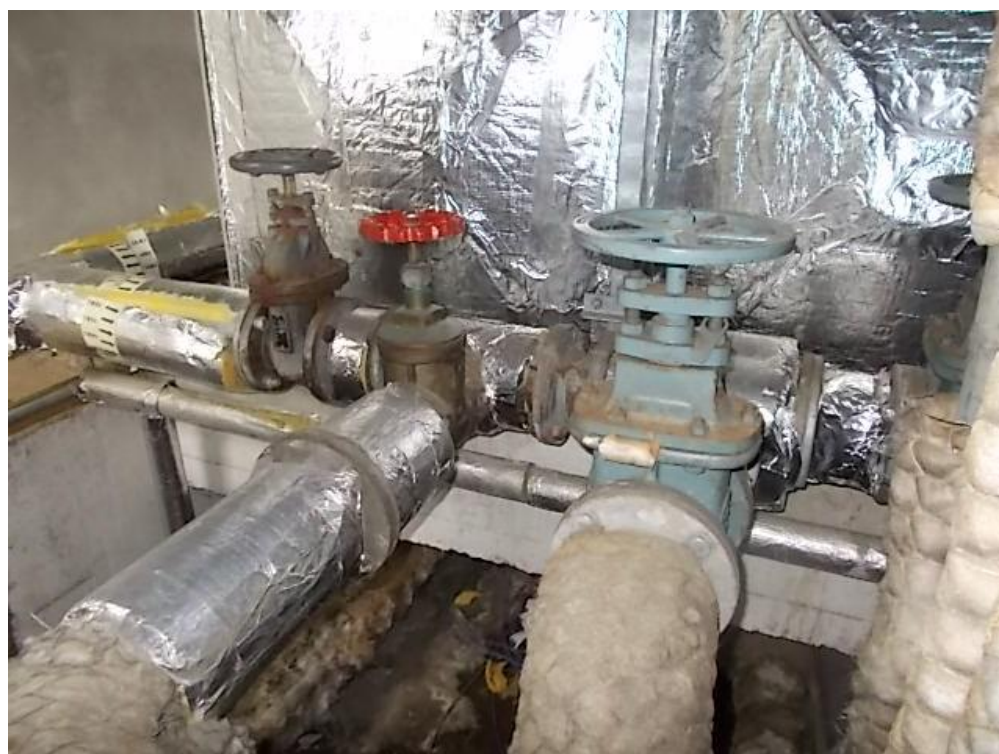
Sample Ref	Description	Location & Extent	Asbestos Type
KA004	Health Building - Tank Room Gaskets to pipe flange	Tank Room - Roof Small amounts/items	Chrysotile
Material Assessment Score	Priority Assessment Score	Recommendation	
10	2	Remove under controlled conditions prior to demolition works

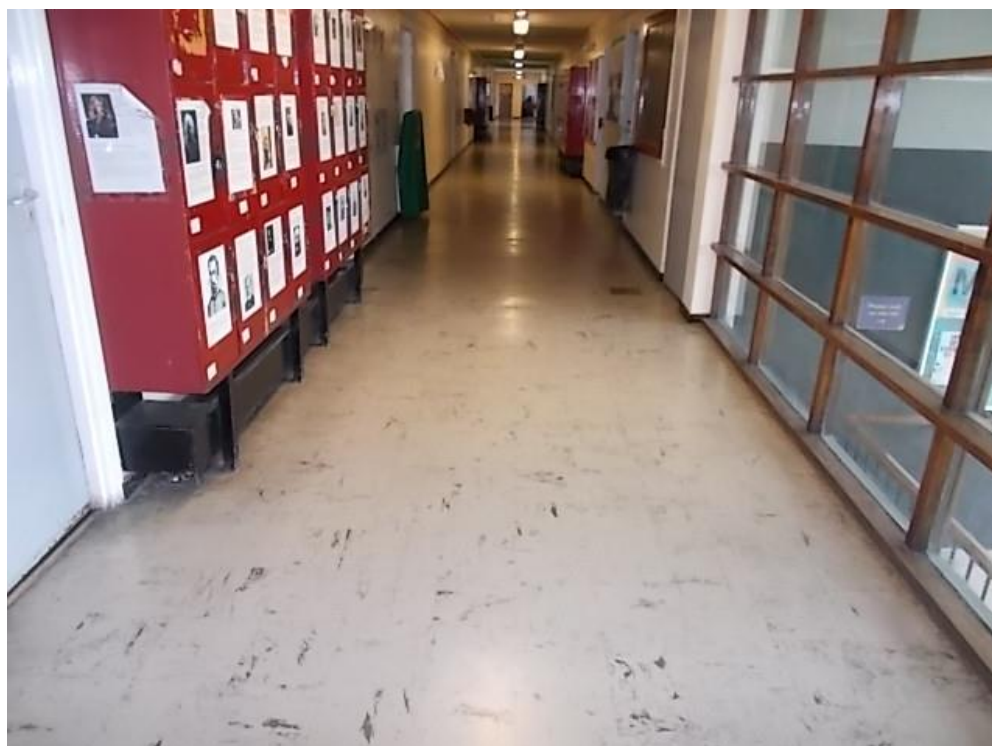
Sample Ref	Description	Location & Extent	Asbestos Type
KA006	Health Building - 3rd Floor Corridor, Floor Tiles	Internal Approx. 100 m <sup>2</sup>	Chrysotile
Sample Ref	Description		Asbestos Type
KA007	Health Building - 3rd Floor Corridor, Adhesive		Chrysotile
Material Assessment Score	Priority Assessment Score	Recommendation	
10	2	Remove under controlled conditions prior to demolition works

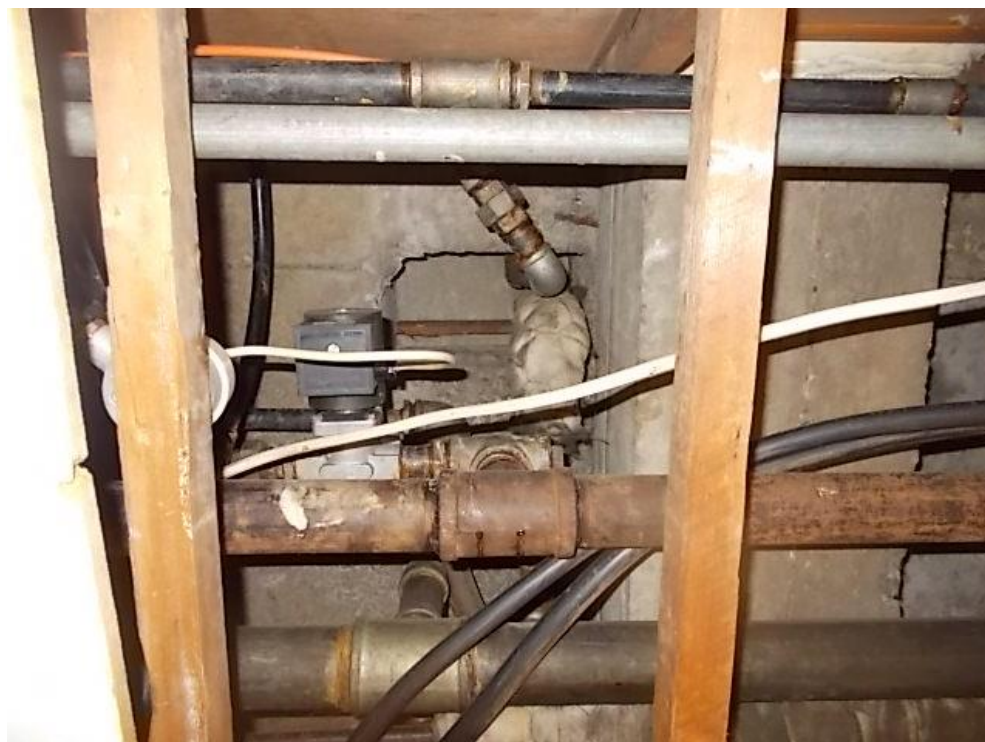
Sample Ref	Description	Location & Extent	Asbestos Type
KA010	Health Building - Room 43, Cement Shuttering	Internal floor duct unknown	Chrysotile Crocidolite
Material Assessment Score	Priority Assessment Score	Recommendation	
10	2	<b>Remove under controlled conditions during demolition works</b> <b>** Further investigation will be required during the demolition work to establish the exact extent of the cement materials below the floor screed.</b>

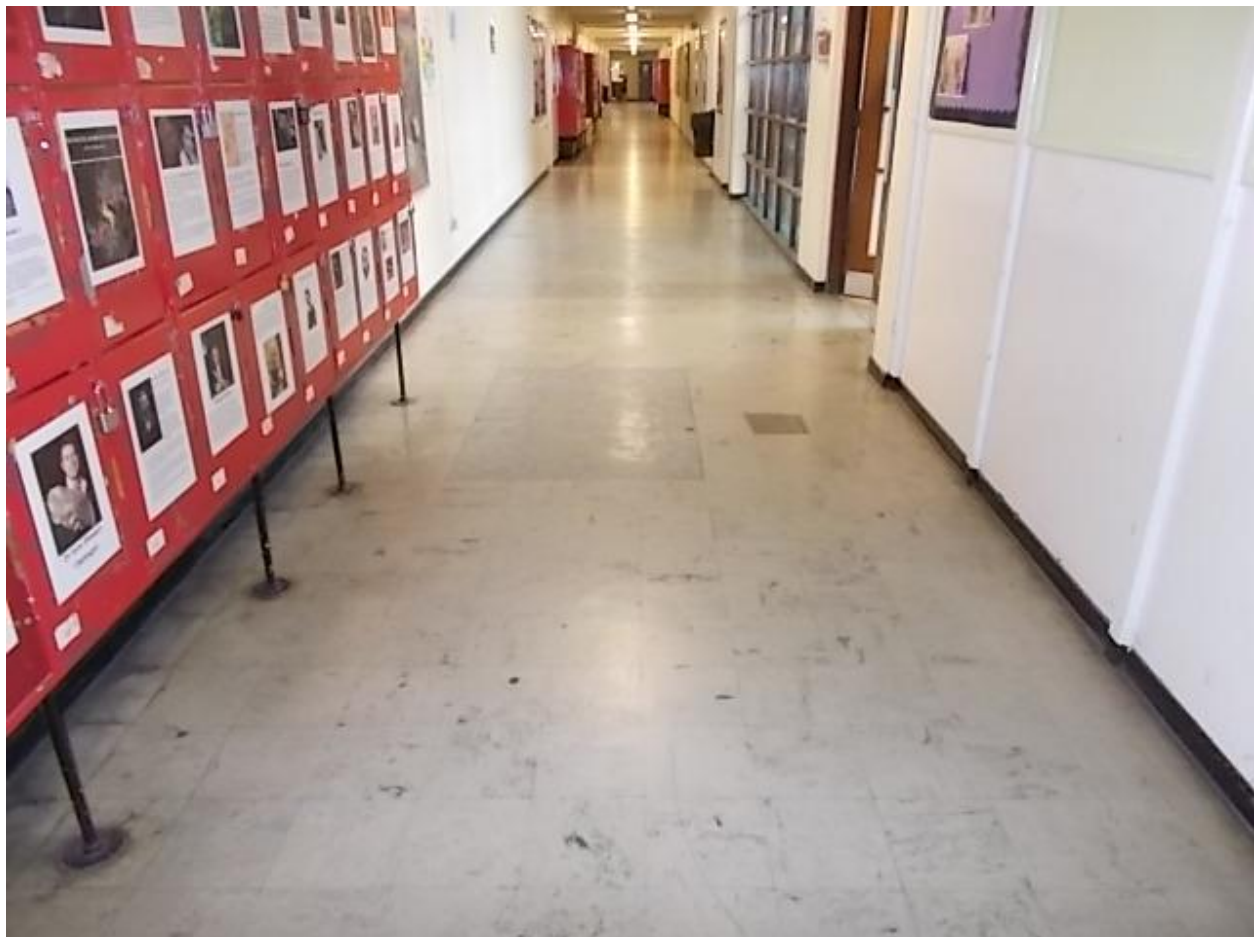
Sample Ref	Description	Location & Extent	Asbestos Type
KA012	Health Building - 1st Floor Corridor, Floor Tiles	Internal Approx. 100m <sup>2</sup>	Chrysotile
Sample Ref	Description		Asbestos Type
KA013	Health Building - 1st Floor, Adhesive		Chrysotile
Material Assessment Score	Priority Assessment Score	Recommendation	
10	2	Remove under controlled conditions prior to demolition works

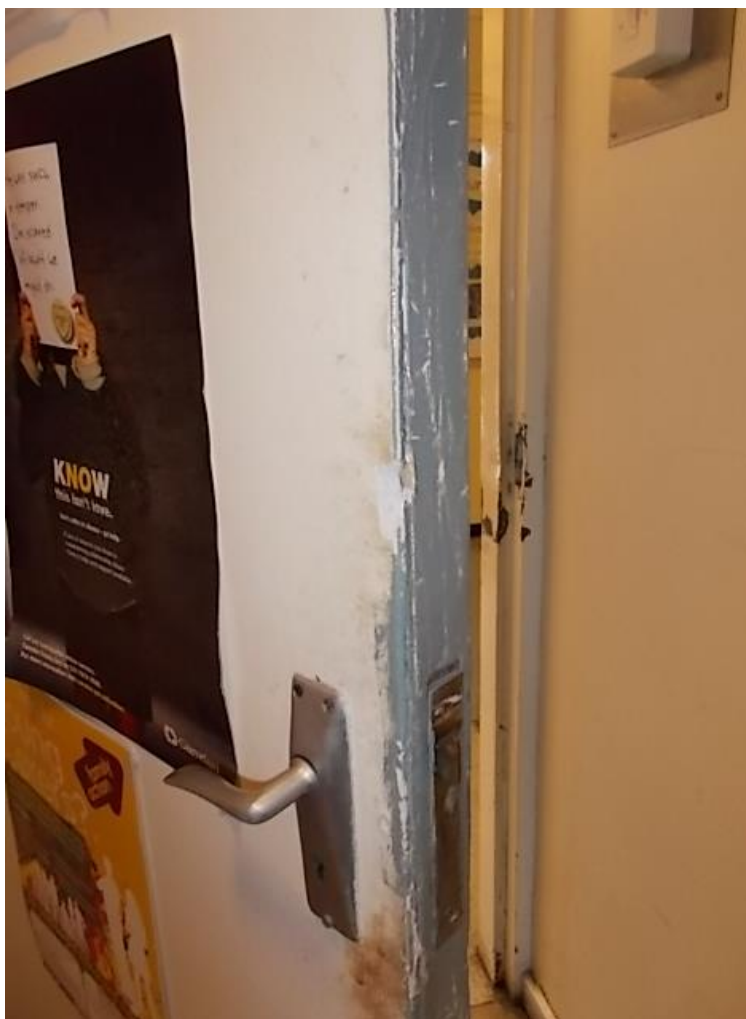
Sample Ref	Description	Location & Extent	Asbestos Type
KA014	Health Building - Assistant Head, Insulating Board	Internal Approx. 3m <sup>2</sup>	Chrysotile Amosite
Material Assessment Score	Priority Assessment Score	Recommendation	
10	2	Remove under fully controlled conditions by a licenced contractor prior to demolition works

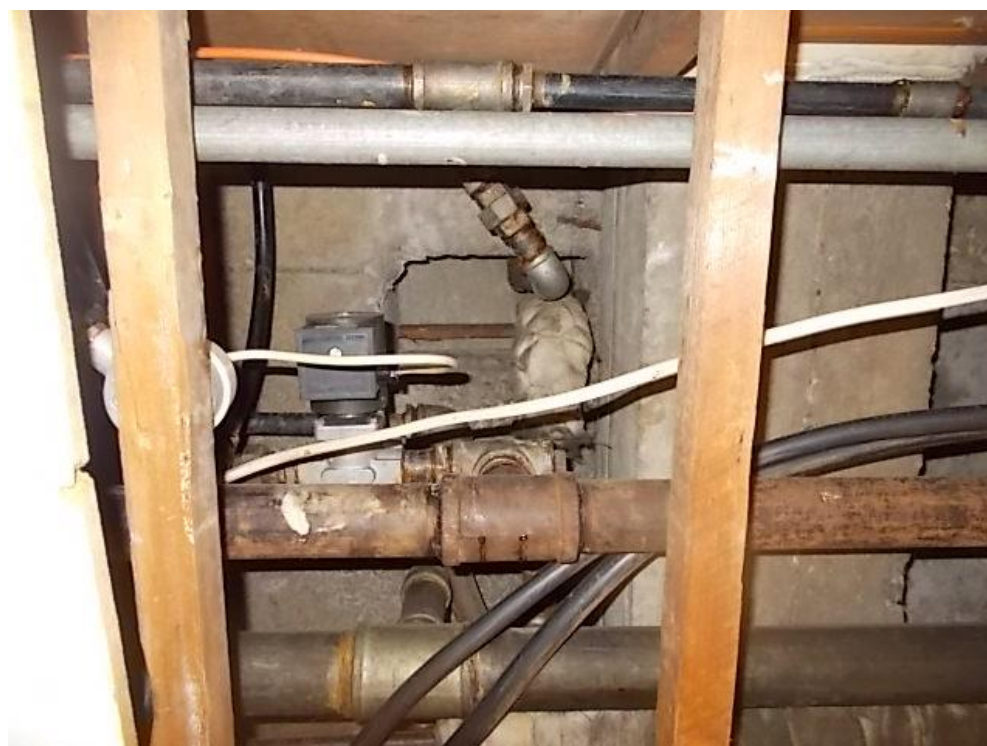
Sample Ref	Description	Location & Extent	Asbestos Type
KA017	Health Building - Room 17, Riser, Cement Shuttering	Unquantified	Chrysotile Crocidolite
Material Assessment Score	Priority Assessment Score	Recommendation	
10	2	<p><b>Remove under controlled conditions during demolition works</b></p> <p><b>** Further investigation will be required during the demolition work to establish the exact extent of the cement materials below the floor screed.</b></p>

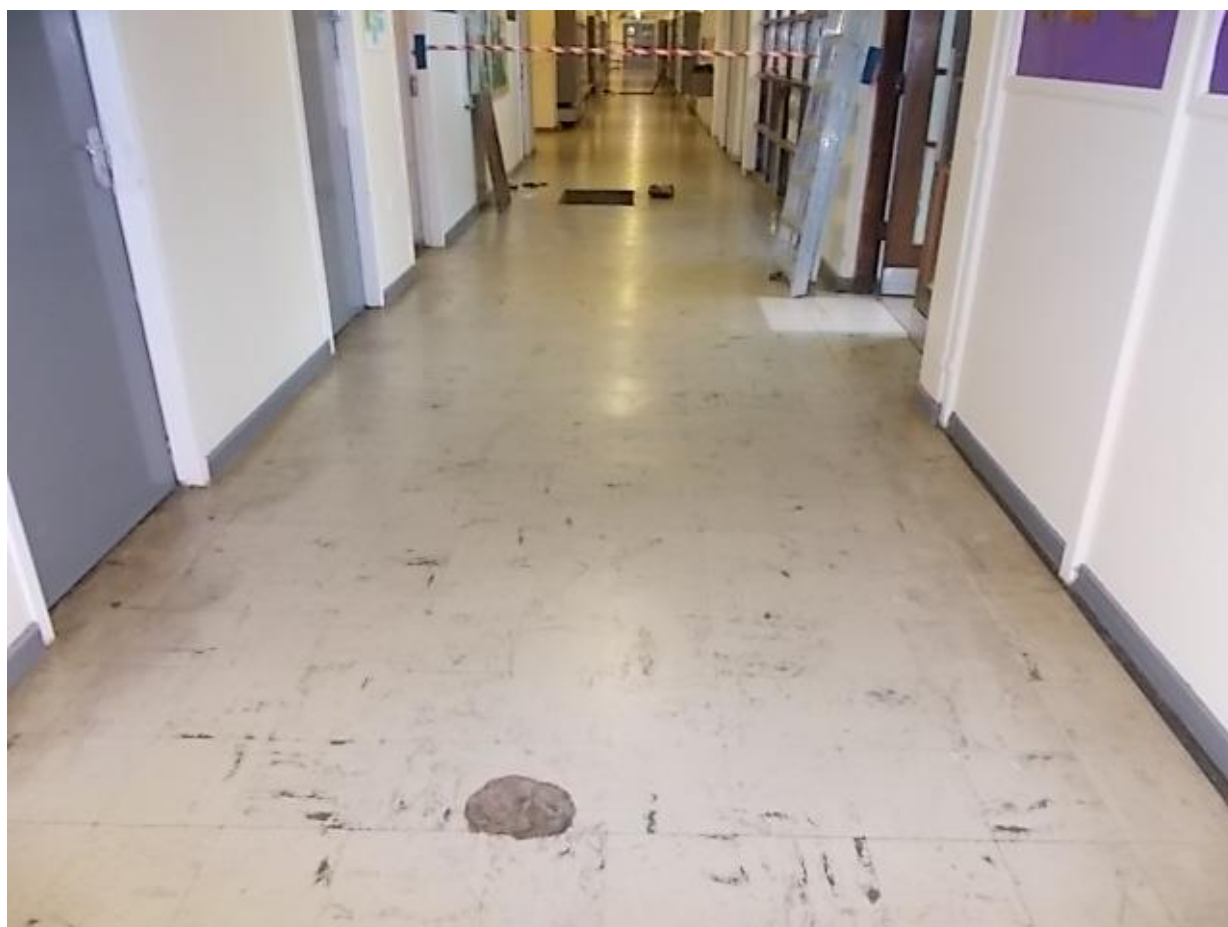
Sample Ref	Description	Location & Extent	Asbestos Type
KA019	Health Building - Ground Floor, Corridor, Floor Tiles	Internal Approx. 100m <sup>2</sup>	Chrysotile
Sample Ref	Description		Asbestos Type
KA020	Health Building - Ground Floor Corridor, Adhesive		Chrysotile
Material Assessment Score	Priority Assessment Score	Recommendation	
10	2	Remove under controlled conditions prior to demolition works

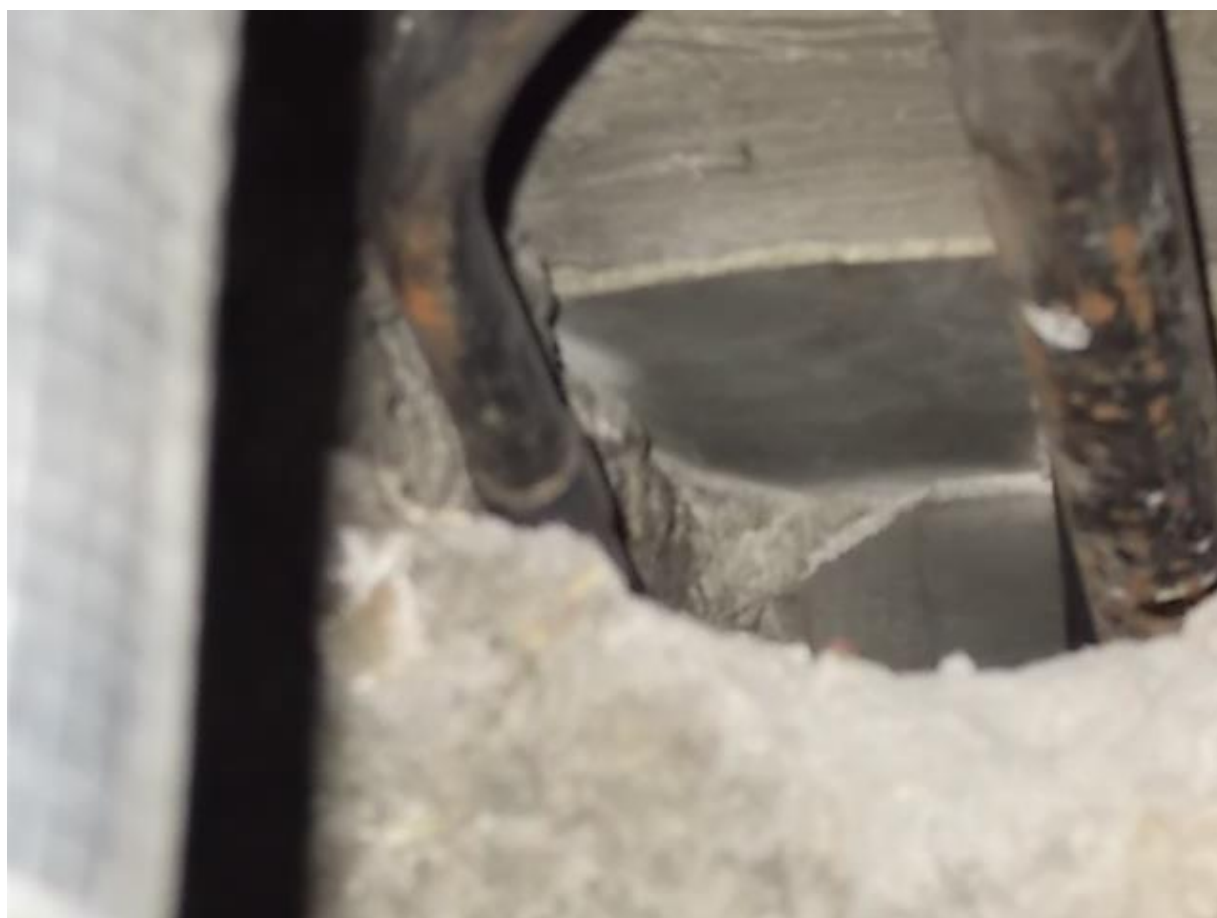
Material Assessment Score	Priority Assessment Score	Recommendation
10	2	<p><b>Remove under controlled conditions during demolition works</b></p> <p><b>** Further investigation will be required during the demolition work to establish the exact extent of the cement materials below the floor screed.</b></p>

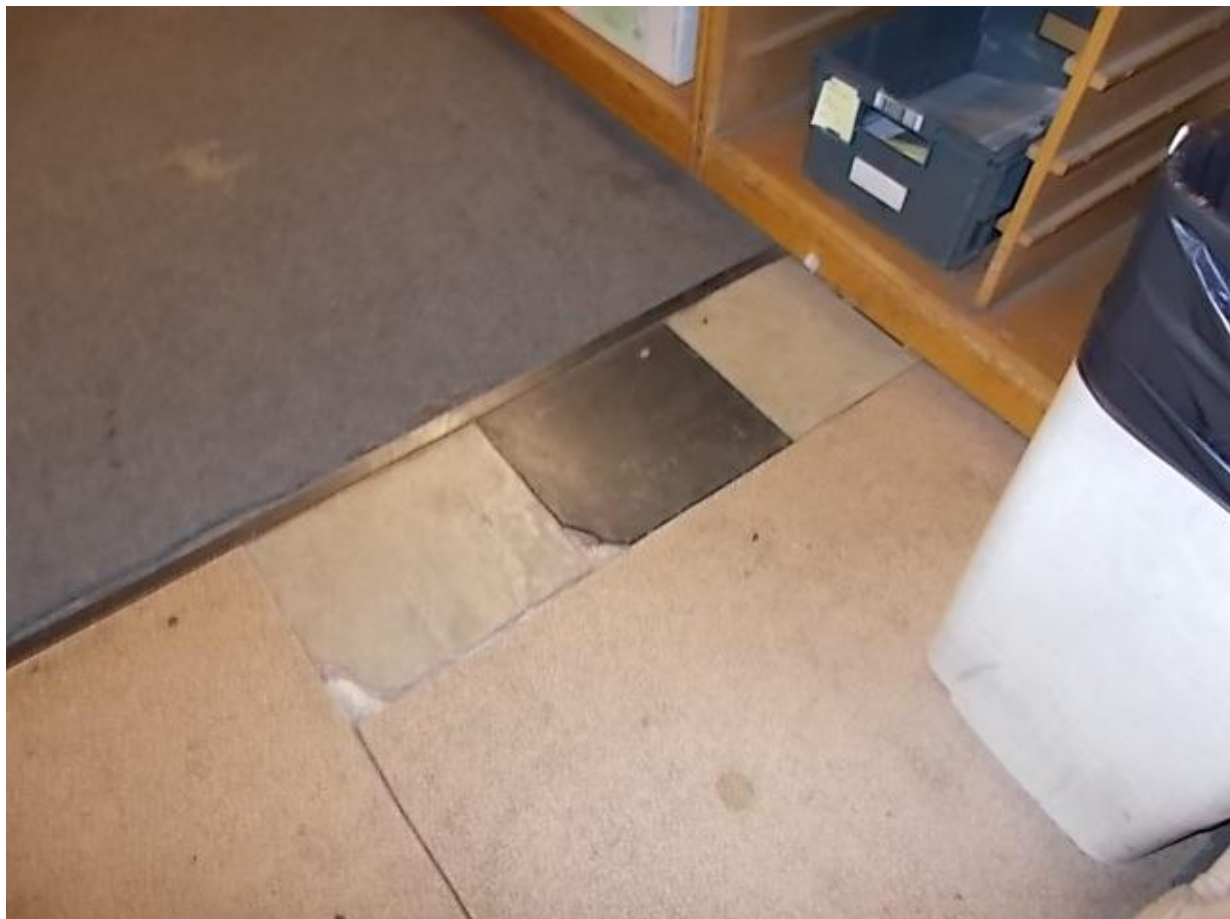
Sample Ref	Description	Location & Extent	Asbestos Type
KA023	Health Building - Room 8, Floor Tiles	Internal Approx. 12m <sup>2</sup>	Chrysotile
Sample Ref	Description		Asbestos Type
KA024	Health Building - Room 8, Adhesive		Chrysotile
Material Assessment Score	Priority Assessment Score	Recommendation	
10	2	Remove under controlled conditions prior to demolition works

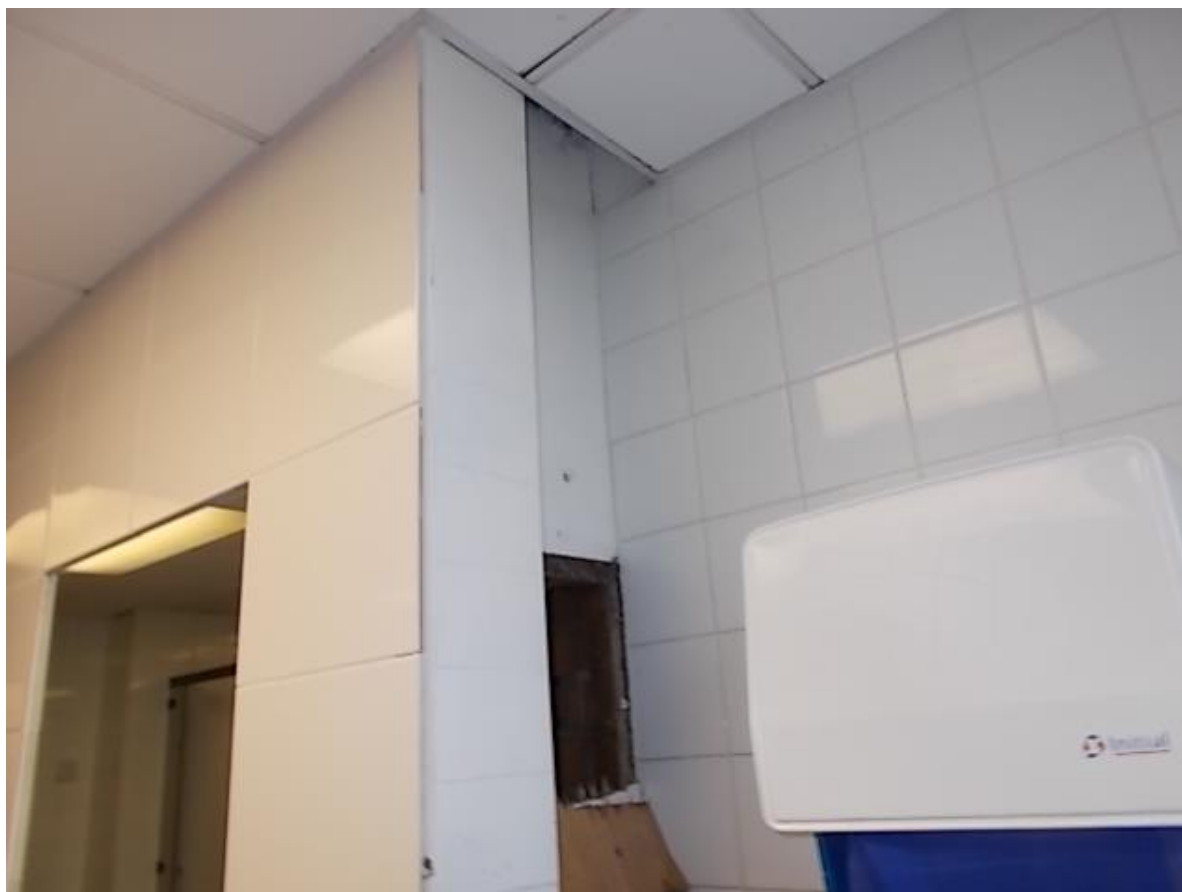
Sample Ref	Description	Location & Extent	Asbestos Type
KA027	Health Building - Lower Ground, Ladies W/C, Cement Panel	Internal Approx. 1m <sup>2</sup>	Chrysotile Crocidolite
Material Assessment Score	Priority Assessment Score	Recommendation	
10	2	Remove under controlled conditions prior to demolition works

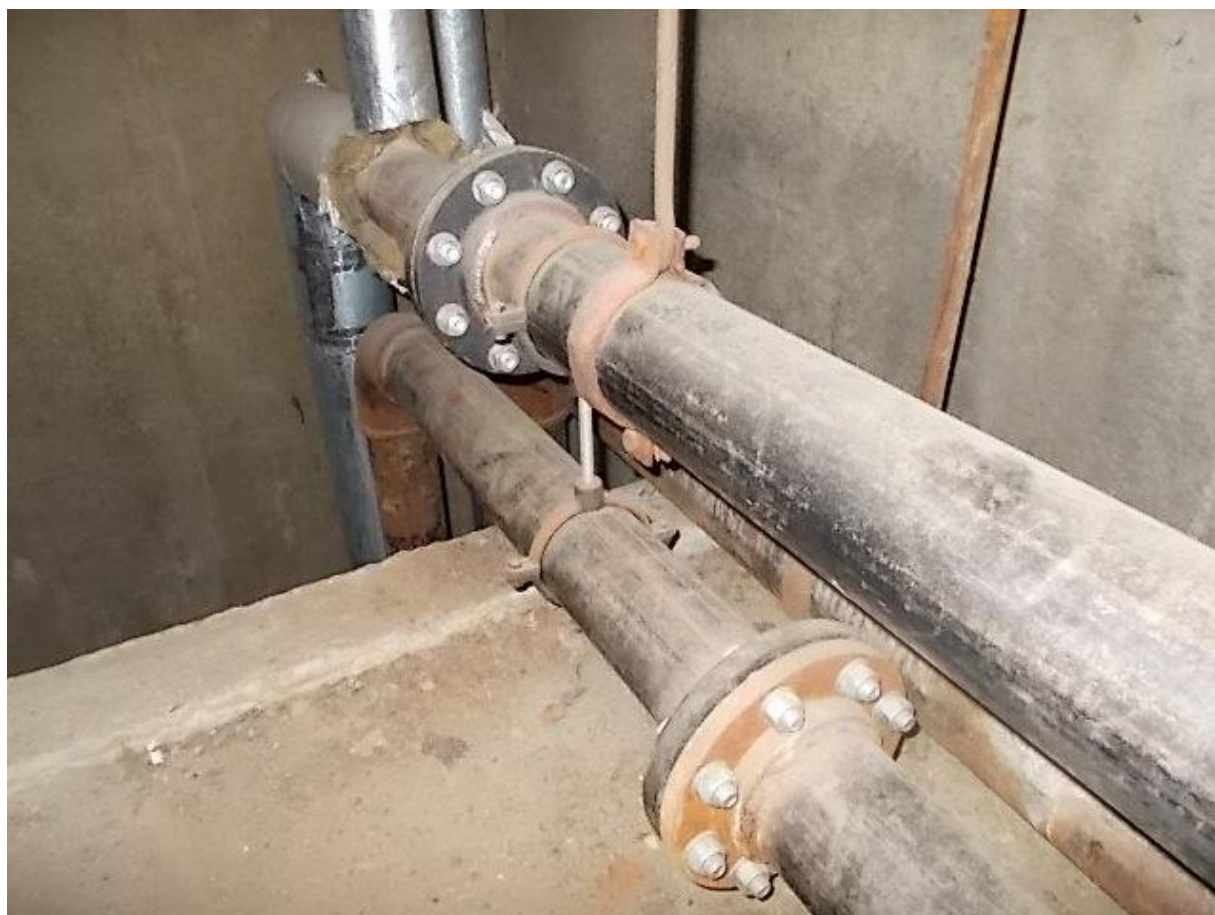
Sample Ref	Description	Location & Extent	Asbestos Type
KA028	Health Building - Lower Ground, Corridor, Gaskets	Internal Unquantified	Chrysotile
Material Assessment Score	Priority Assessment Score	Recommendation	
10	2	Remove under controlled conditions prior to demolition works

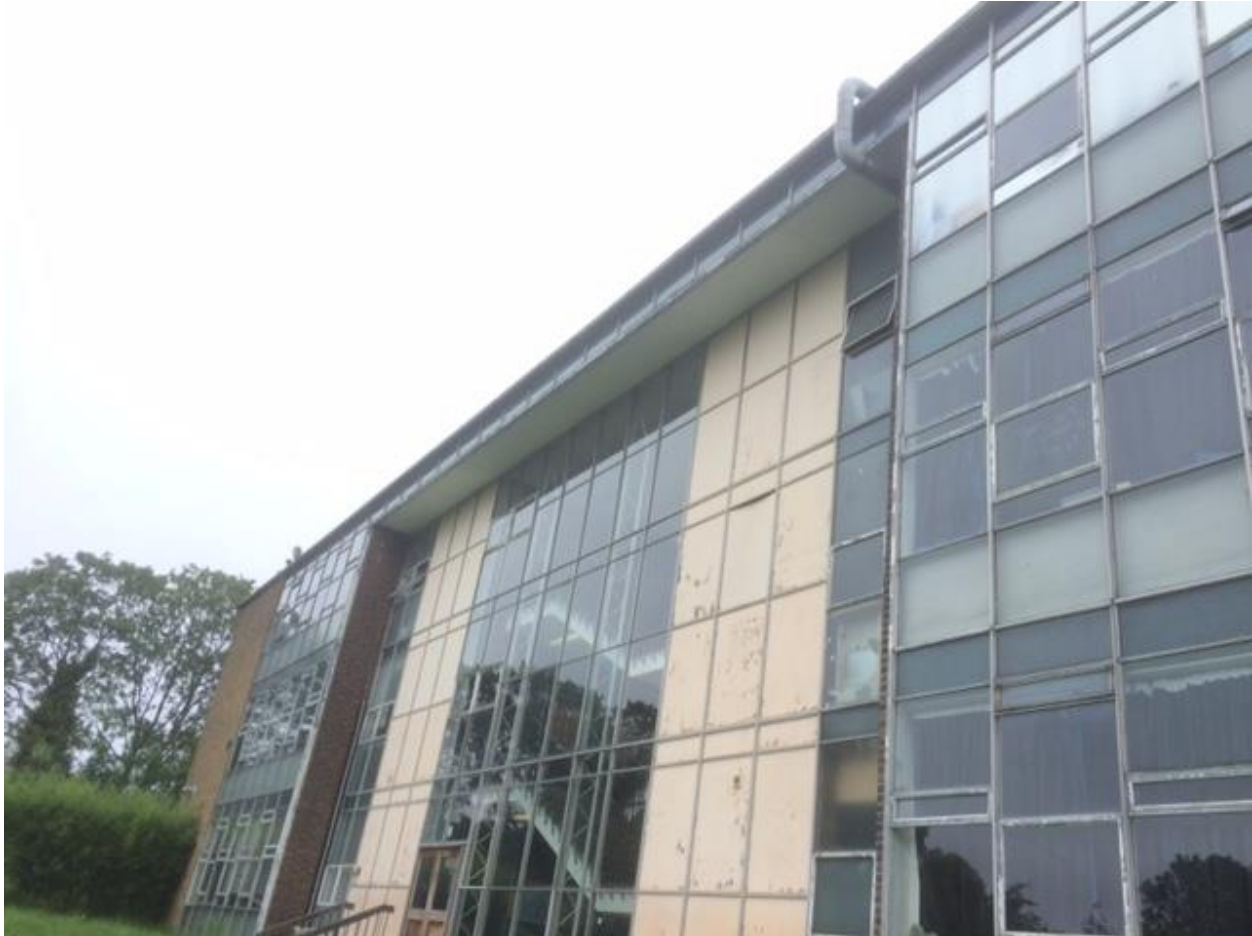
Sample Ref	Description	Location & Extent	Asbestos Type
KA030	Health Building - External, Window Putty	External Approx. 2800 Im	Chrysotile
Material Assessment Score	Priority Assessment Score	Recommendation	
10	2	Remove under controlled conditions prior to demolition works

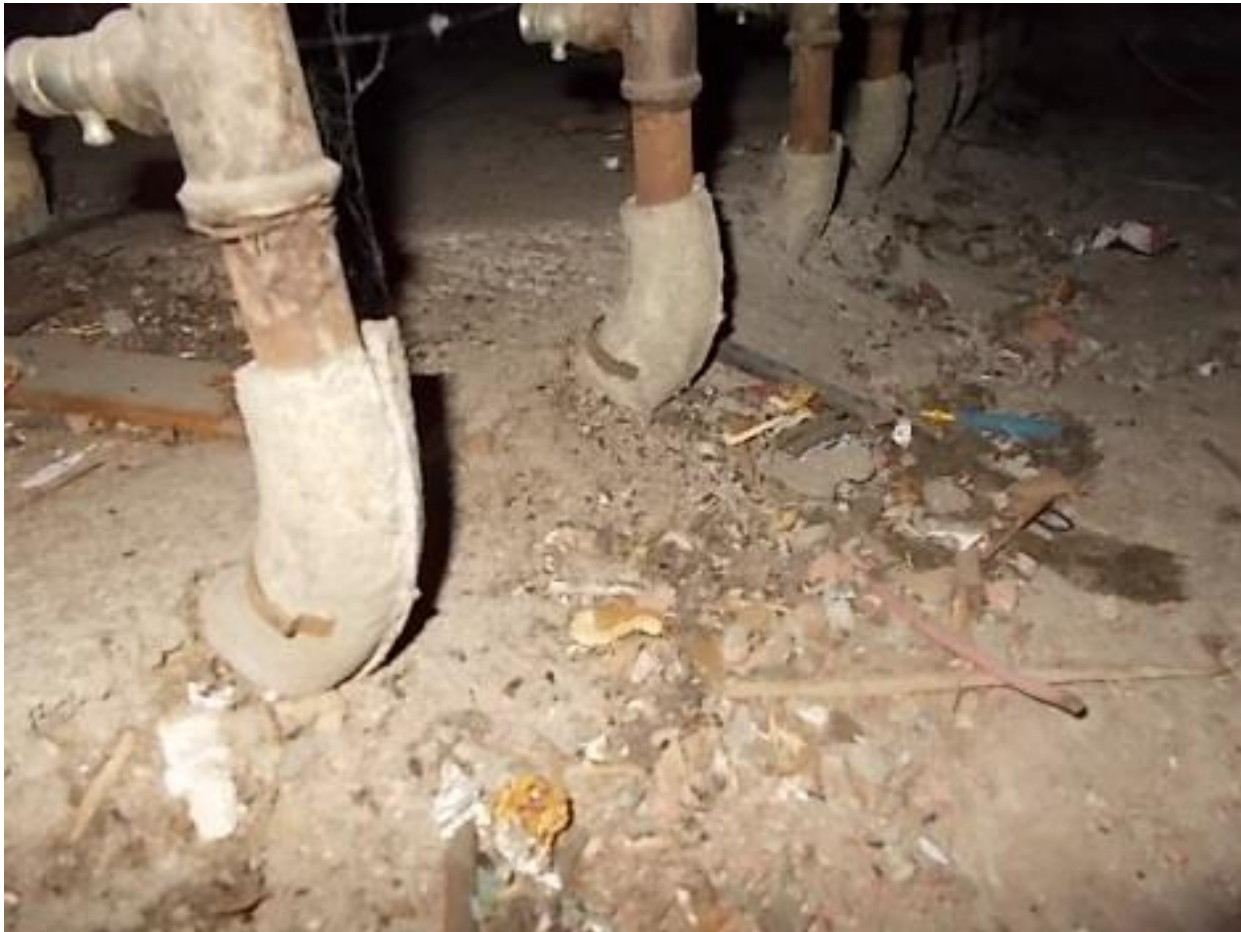
Sample Ref	Description	Location & Extent	Asbestos Type
KA031	Main Hall Stage - Cement Sleeve	Internal Approx. 16 Im	Chrysotile
Material Assessment Score	Priority Assessment Score	Recommendation	
10	2	Remove under fully controlled conditions prior to demolition works

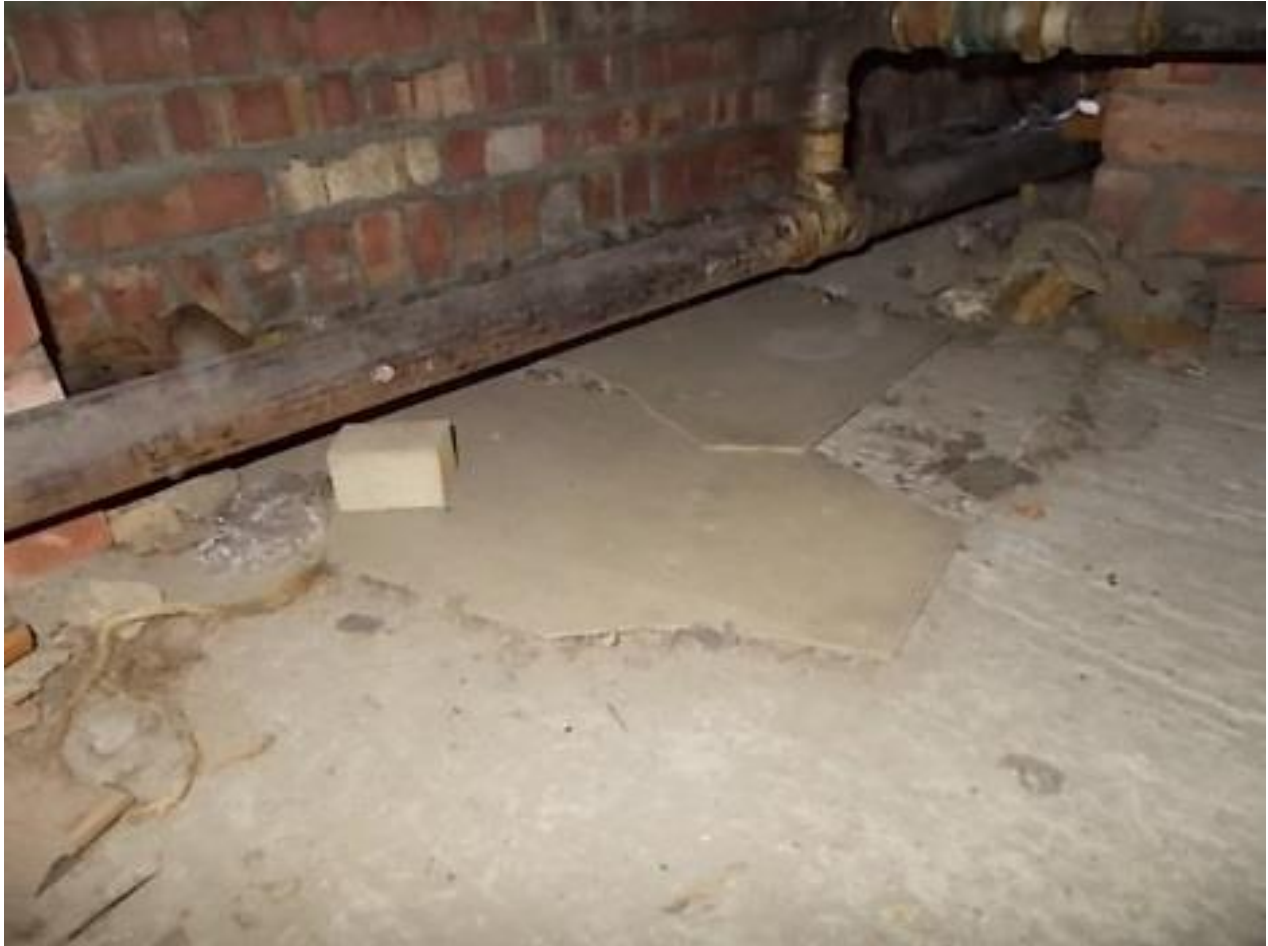
Sample Ref	Description	Location & Extent	Asbestos Type
KA032	Main Hall Stage - Board Debris	Internal Approx. 20 m <sup>2</sup>	Chrysotile
Material Assessment Score	Priority Assessment Score	Recommendation	
10	2	Remove under controlled conditions prior to demolition works

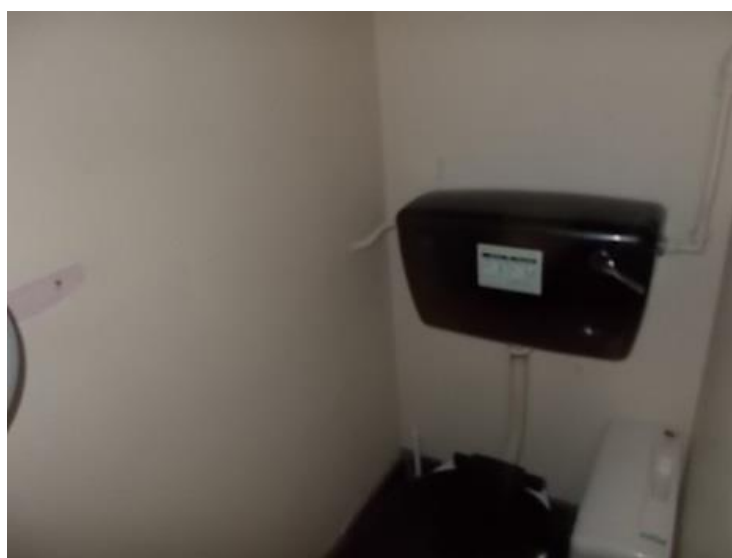
Material Assessment Score	Priority Assessment Score	Recommendation
10	2	Remove under controlled conditions prior to demolition works

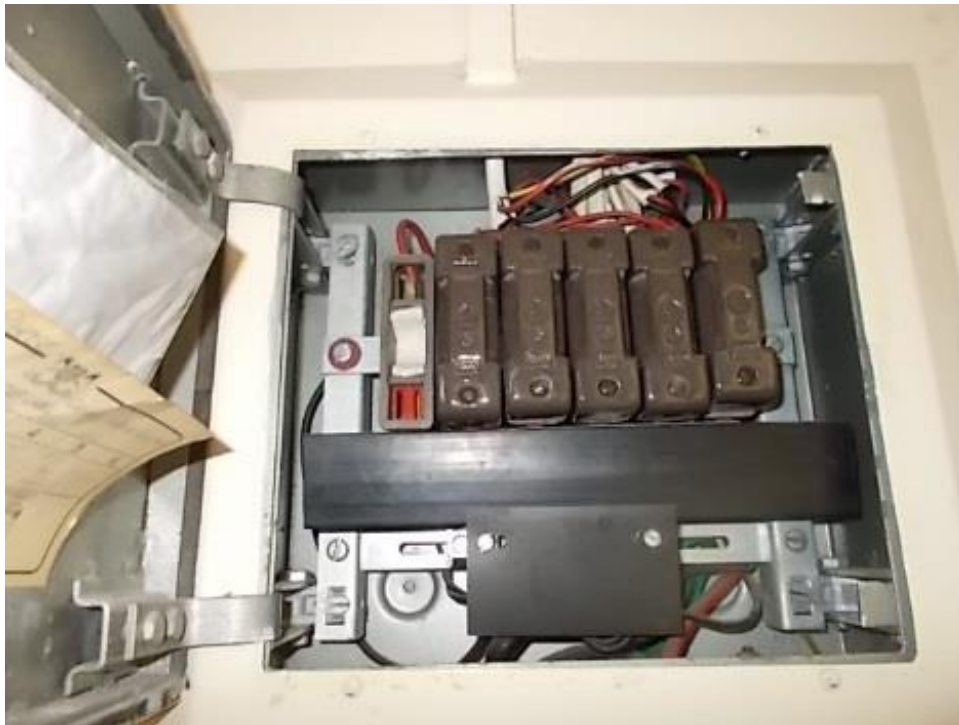
Sample Ref	Description	Location & Extent	Asbestos Type
KA039	Octagon Lobby - Flash Guards In Fuse Box	Internal Small amounts/items	Chrysotile
Material Assessment Score	Priority Assessment Score	Recommendation	
10	2	Remove under controlled conditions prior to demolition works

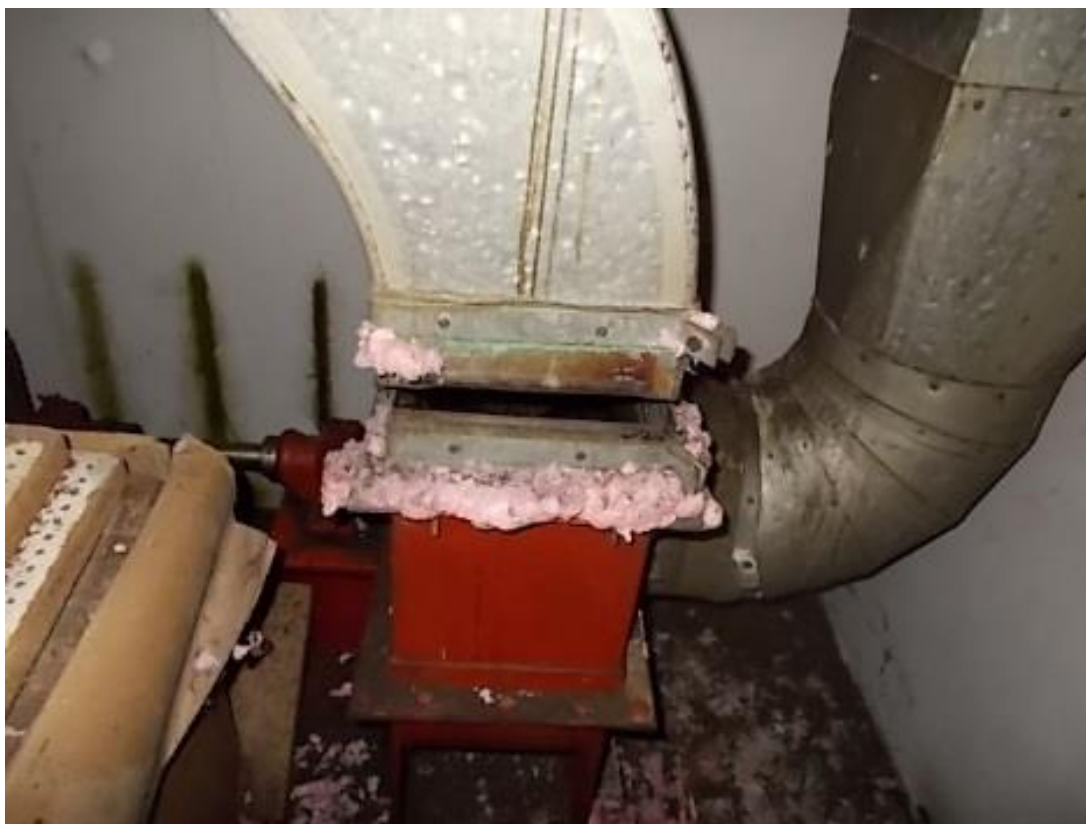
Sample Ref	Description	Location & Extent	Asbestos Type
KA041	Main Hall Stores - Putty	Internal Small amounts/items	Chrysotile
Material Assessment Score	Priority Assessment Score	Recommendation	
10	2	Remove under controlled conditions prior to demolition works

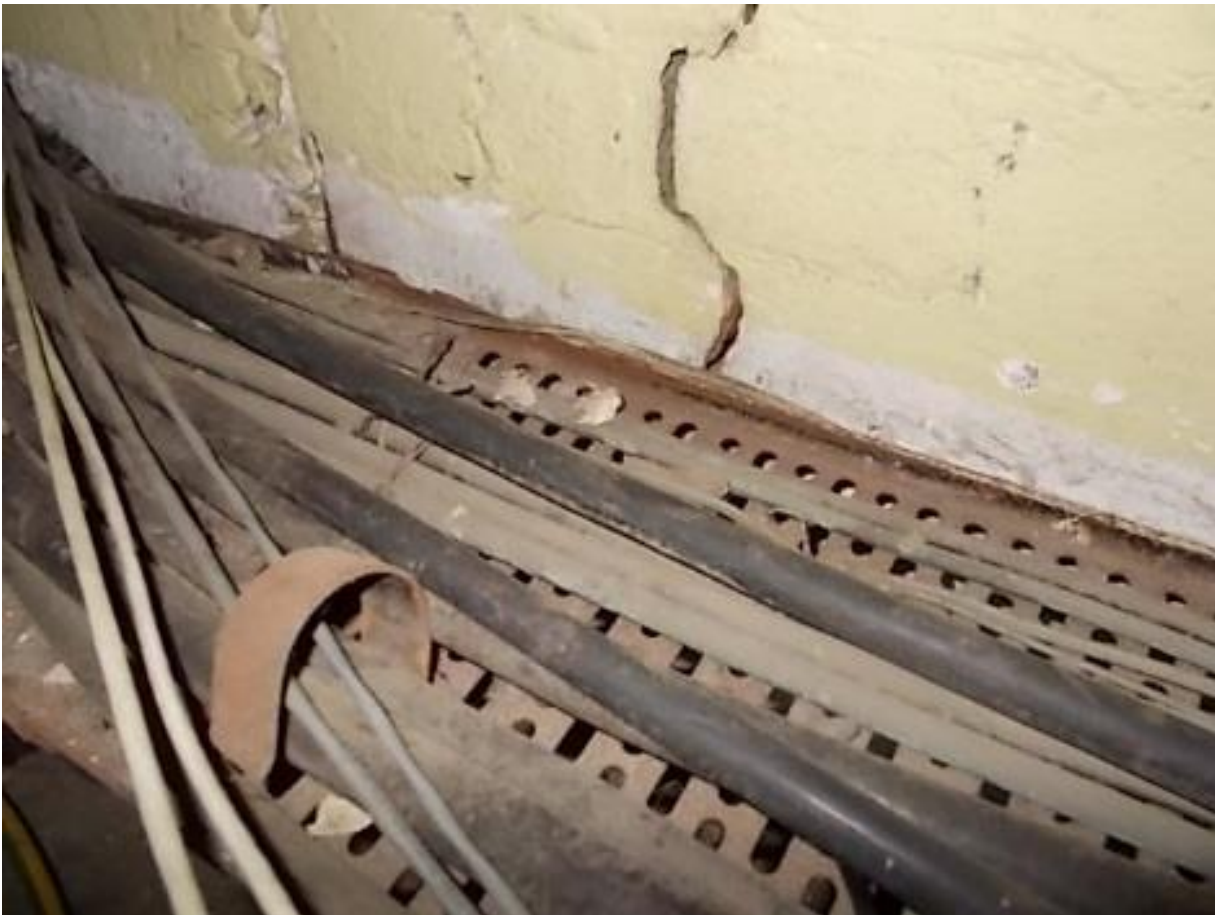
Sample Ref	Description	Location & Extent	Asbestos Type
KA043	Boiler Room - Dust & Debris in Pipe Duct	Internal Throughout boiler room	Chrysotile Amosite
Material Assessment Score	Priority Assessment Score	Recommendation	
10	2	Remove under fully controlled conditions by a licenced contractor prior to demolition works

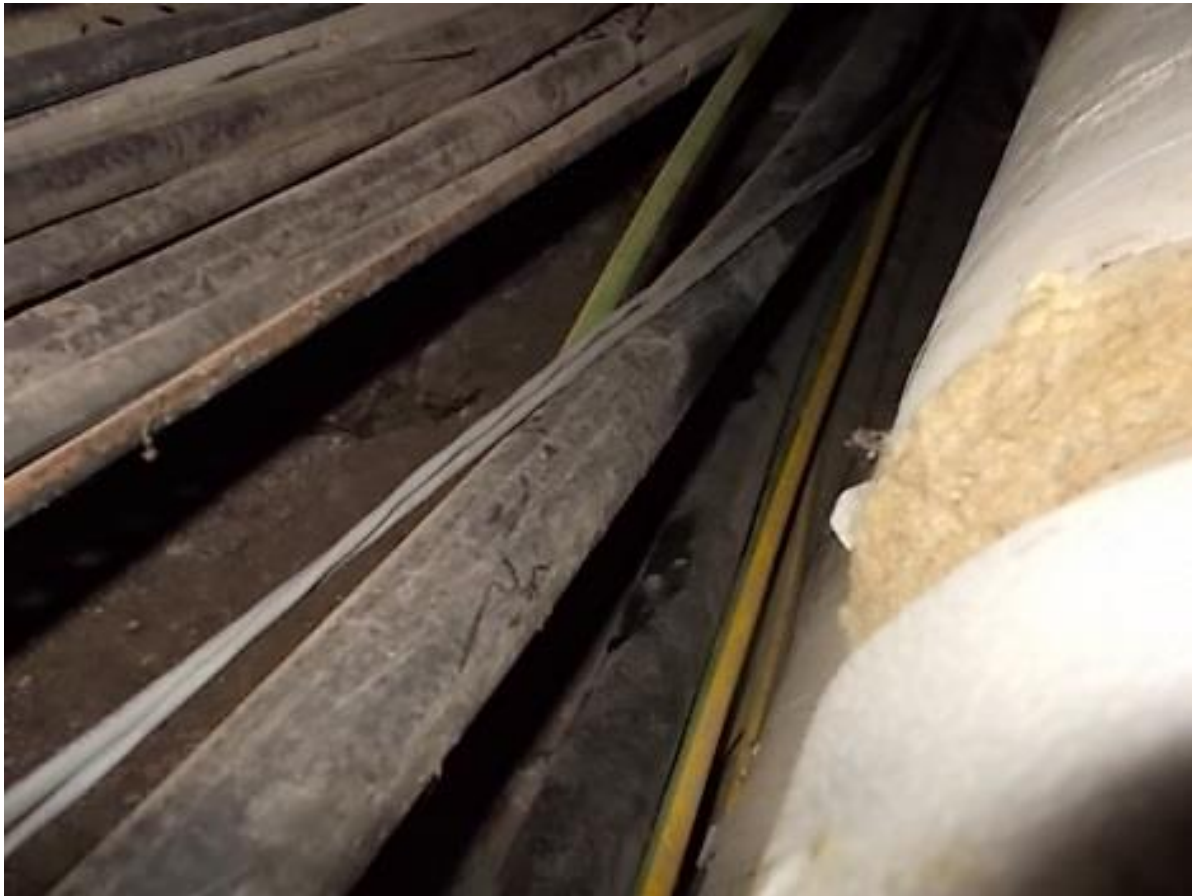
Sample Ref	Description	Location & Extent	Asbestos Type
KA044	Boiler Room - Dust & Debris In Pipe Duct	Internal Throughout boiler room	Chrysotile
Material Assessment Score	Priority Assessment Score	Recommendation	
10	2	Remove under fully controlled conditions by a licenced contractor prior to demolition works

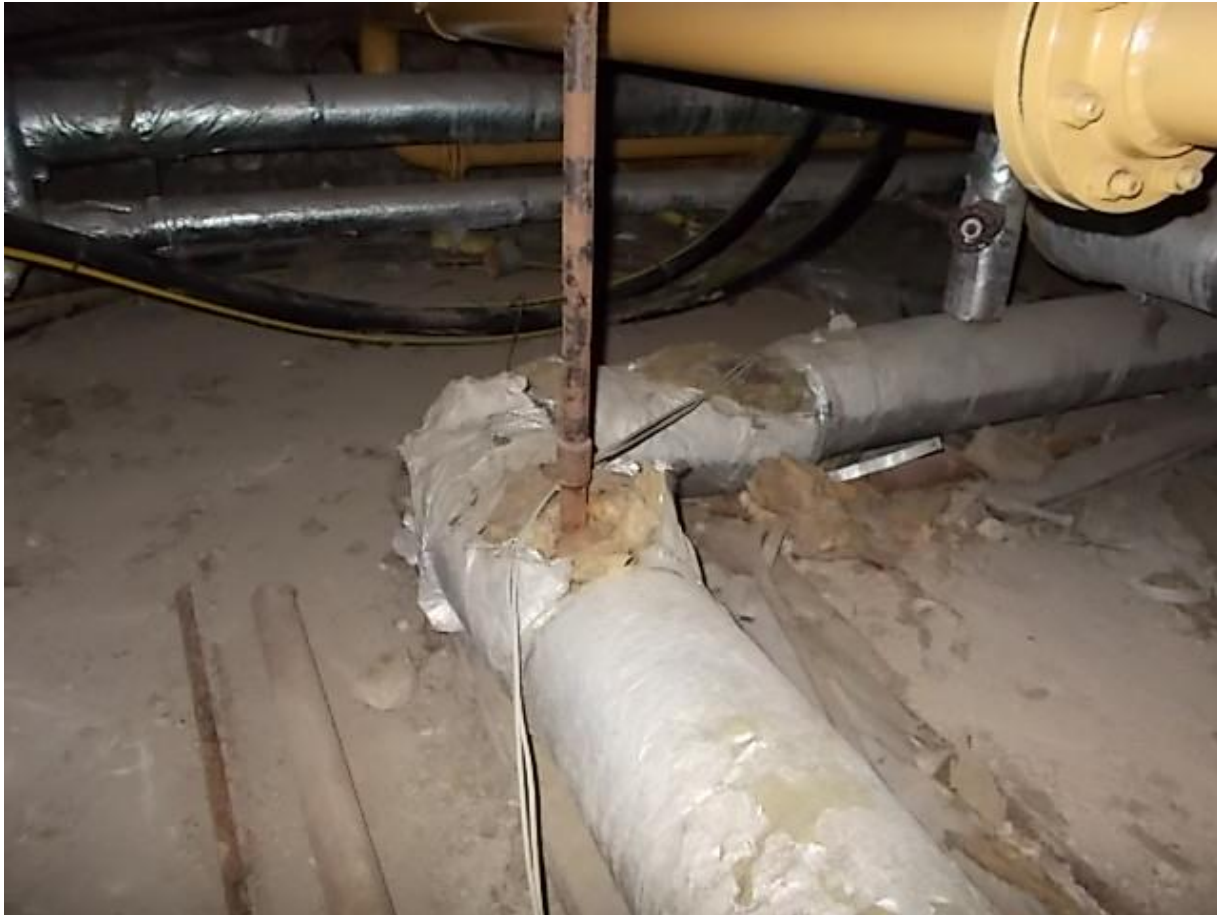
Sample Ref	Description	Location & Extent	Asbestos Type
KA045	Boiler Room - Residues To Pipes	Internal Throughout boiler room	Chrysotile Amosite
Material Assessment Score	Priority Assessment Score	Recommendation	
10	2	Remove under fully controlled conditions by a licenced contractor prior to demolition works

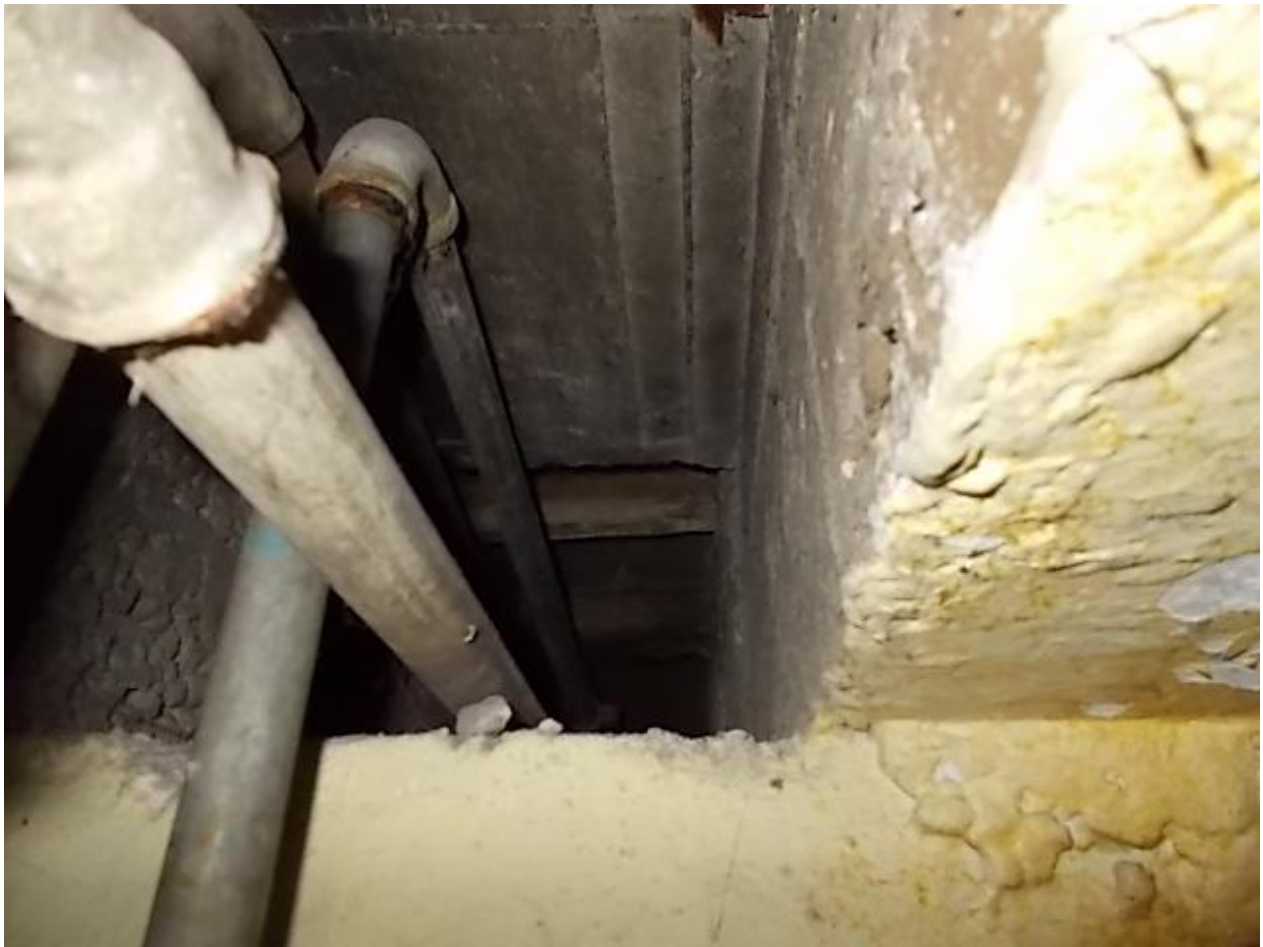
Sample Ref	Description	Location & Extent	Asbestos Type
KA048	Boiler Room - Dust & Debris	Internal Throughout boiler room	Chrysotile Amosite
Material Assessment Score	Priority Assessment Score	Recommendation	
10	2	Remove under fully controlled conditions by a licenced contractor prior to demolition works
