## ASBESTOS REFURBISHMENT/DEMOLITION SURVEY

Parliament Hill  
Highgate Road  
London  
NW5 1RL

Lantern Services  
Barnet by Pass  
South Mimms  
Potters Bar  
Hertfordshire  
EN6 3NQ

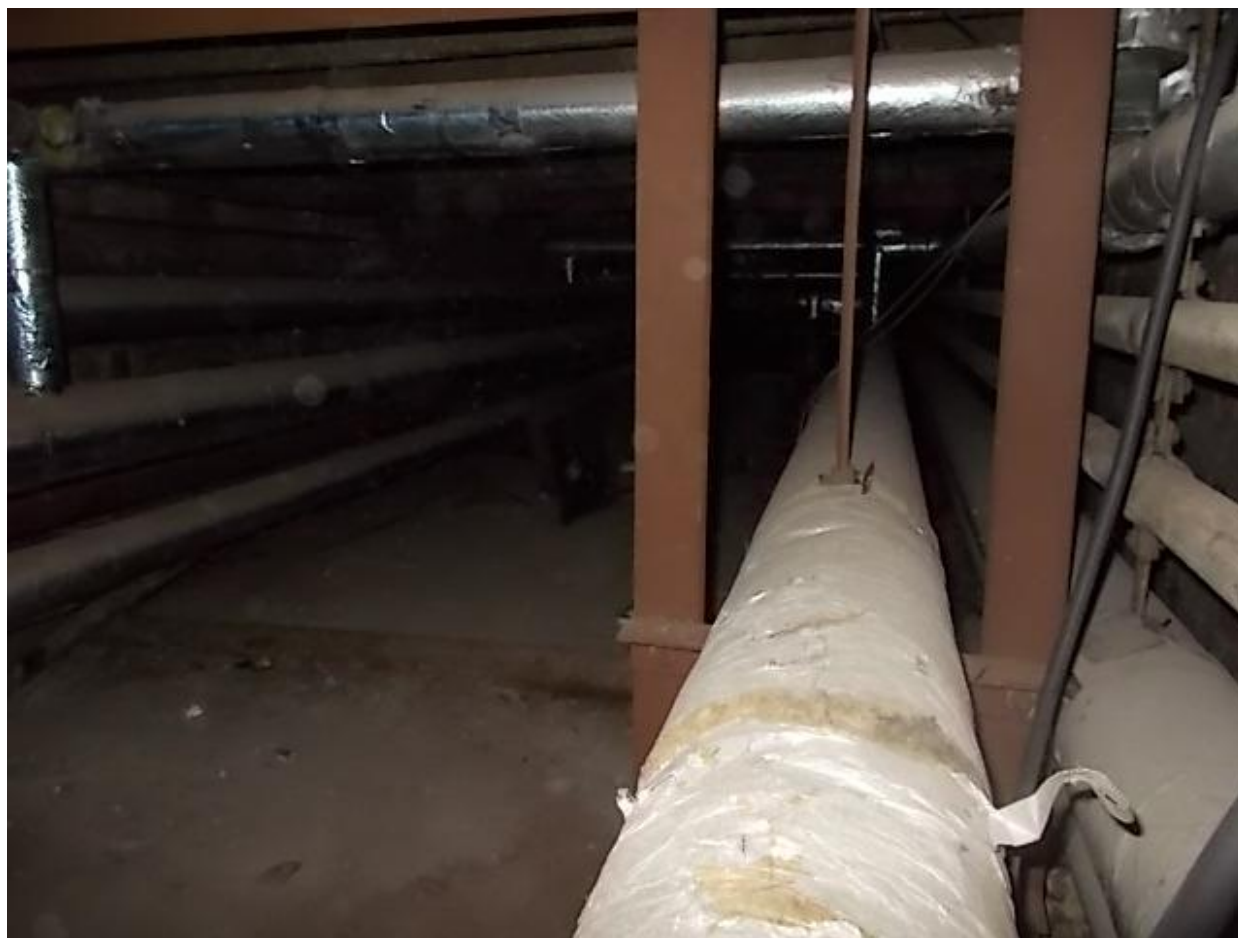
Sample Ref	Description	Location & Extent	Asbestos Type
KA049	Boiler Room - Dust & Debris	Internal Throughout boiler room	Chrysotile Amosite
Material Assessment Score	Priority Assessment Score	Recommendation	
10	2	Remove under fully controlled conditions by a licenced contractor prior to demolition works

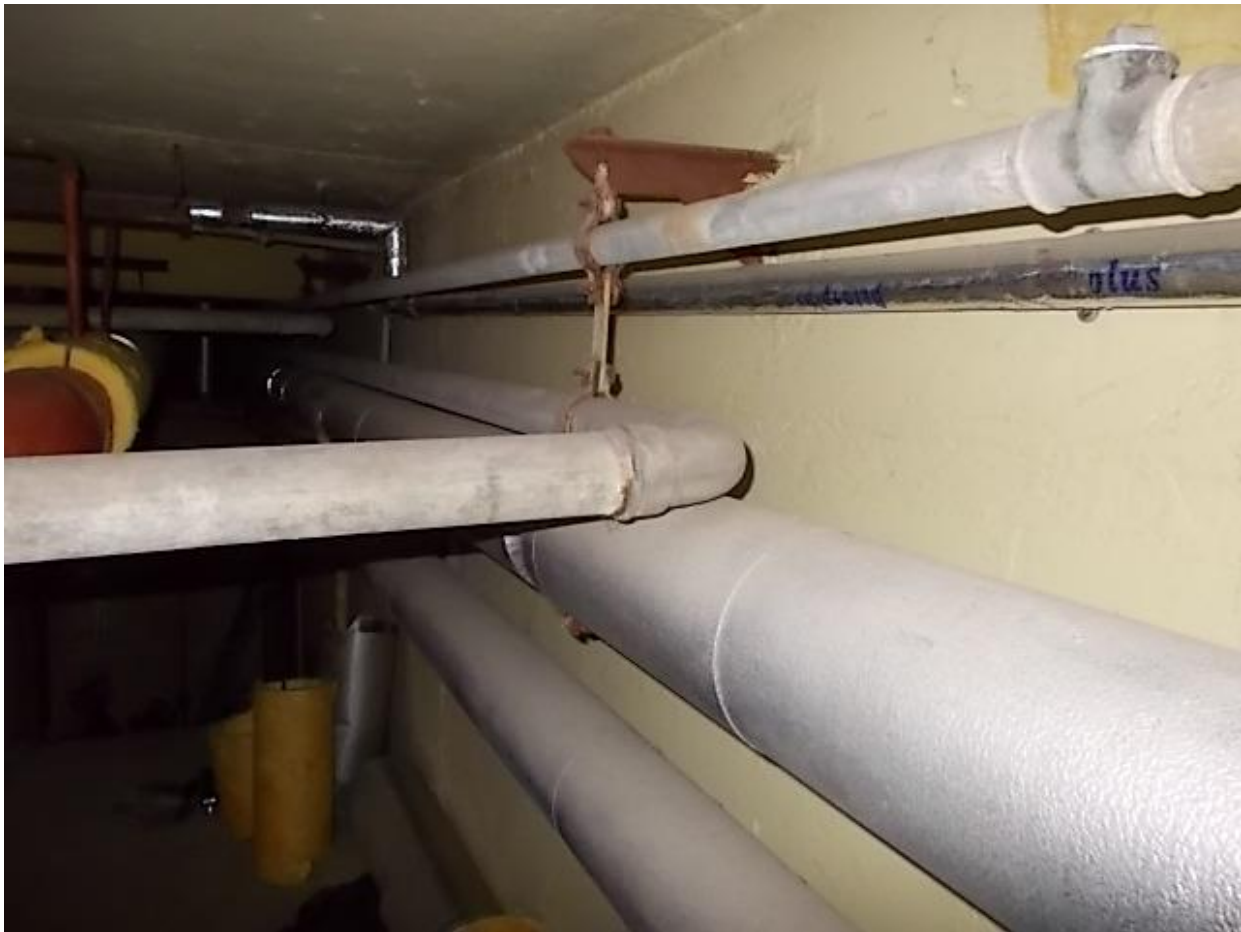
Sample Ref	Description	Location & Extent	Asbestos Type
KA057	Boiler Room - High Level Pipe Residues	Boiler room Full length of pipework	Amosite
Material Assessment Score	Priority Assessment Score	Recommendation	
10	2	Remove under fully controlled conditions by a licenced contractor prior to demolition works

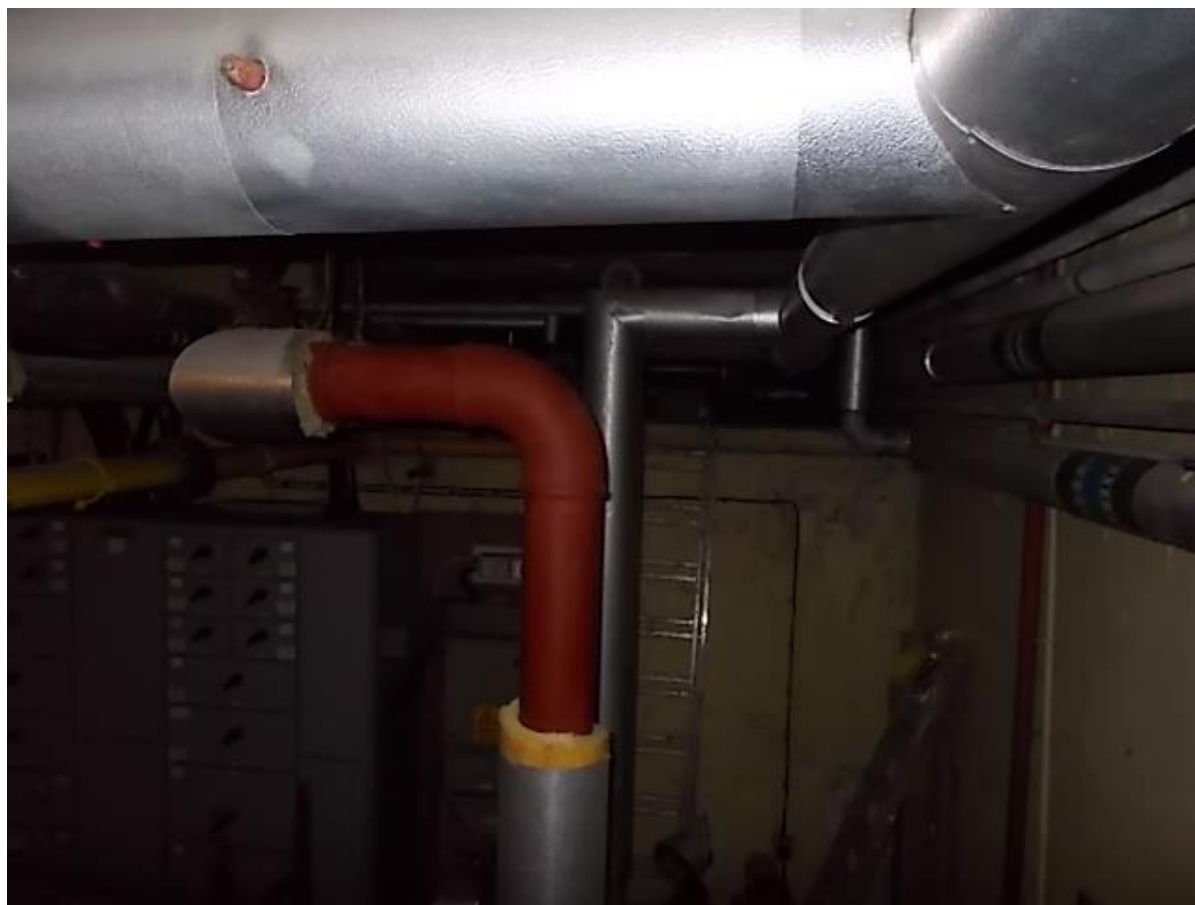
Sample Ref	Description	Location & Extent	Asbestos Type
KA058	Boiler Room - High Level Pipe Residues	Boiler room Full length of pipework	Chrysotile
Material Assessment Score	Priority Assessment Score	Recommendation	
10	2	Remove under fully controlled conditions by a licenced contractor prior to demolition works

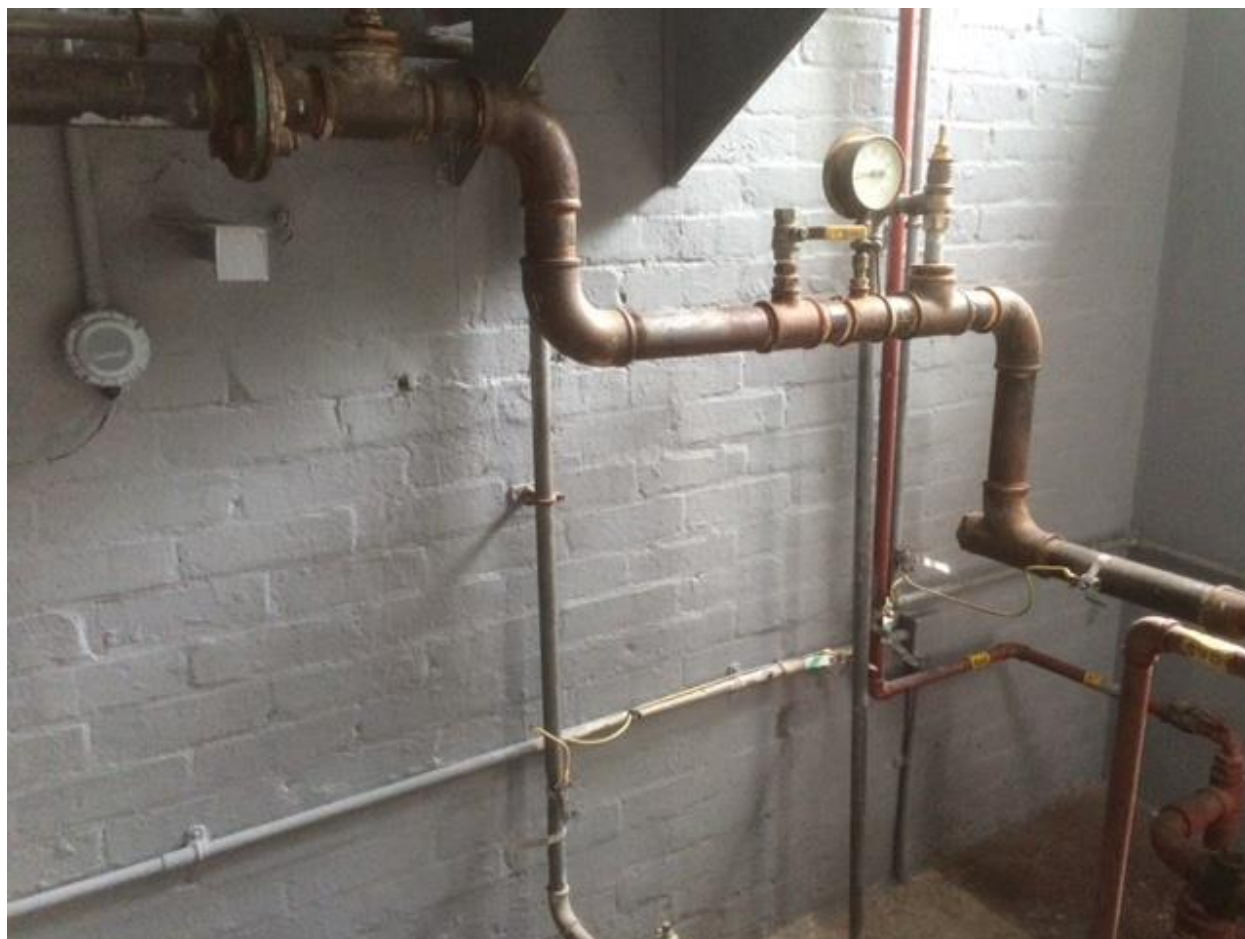
Sample Ref	Description	Location & Extent	Asbestos Type
KA404	Gym Boiler Room - Pipe Residues	Internal Small amounts	Chrysotile Amosite
Material Assessment Score	Priority Assessment Score	Recommendation	
10	2	Remove under fully controlled conditions by a licenced asbestos removal contractor prior to demolition works

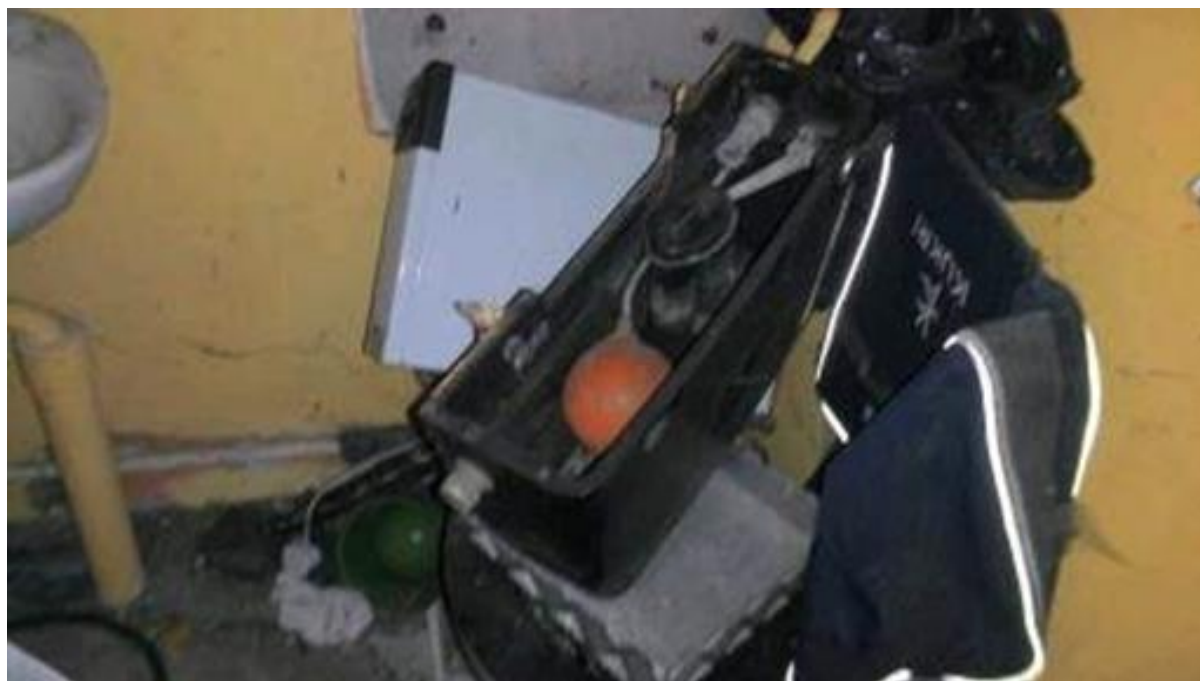
Sample Ref	Description	Location & Extent	Asbestos Type
KA502	Caretakers House - Toilet Seat & Cistern (redundant)	Internal Items – cistern, seat & lid	Amosite
Material Assessment Score	Priority Assessment Score	Recommendation	
10	2	Remove under controlled conditions prior to demolition works
