CONDITION REPORT

8 ST GEORGE'S MEWS, LONDON, NW1 8XE

COLLETT-ZARZYCKI LTD

June 2017

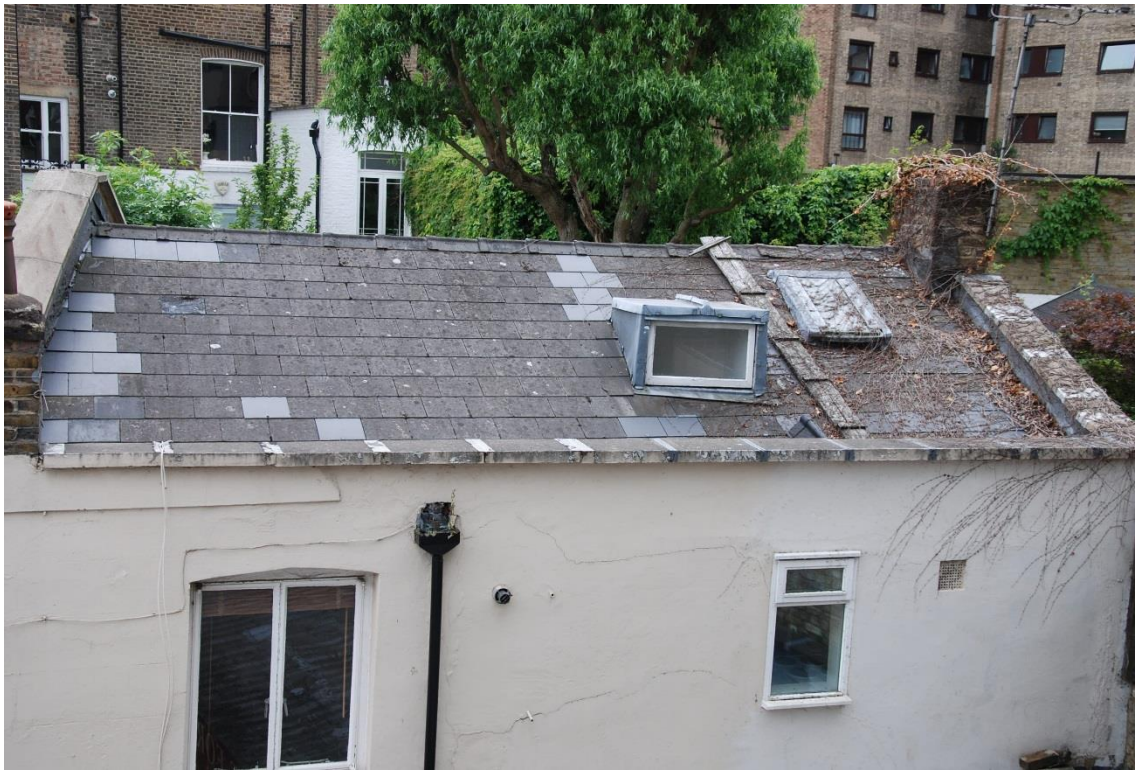
A close-up inspection of the main roof to the building was not possible due to height/access restrictions but a visual inspection would indicate that the roof is nearing the end of its lifespan.

Whilst piecemeal repairs appear to have been taken over time, the original roofing material is strongly suspected to contain asbestos, which would indicate that the roof in its current guise has been in-situ for a minimum of forty years or more.

No specific faults in the roof can currently be identified however it is a fair assumption that the original roofing tiles are nearing the end of their useful life and will need replacing within the next 10 years at the very latest.

Photograph 1: Main roof from front

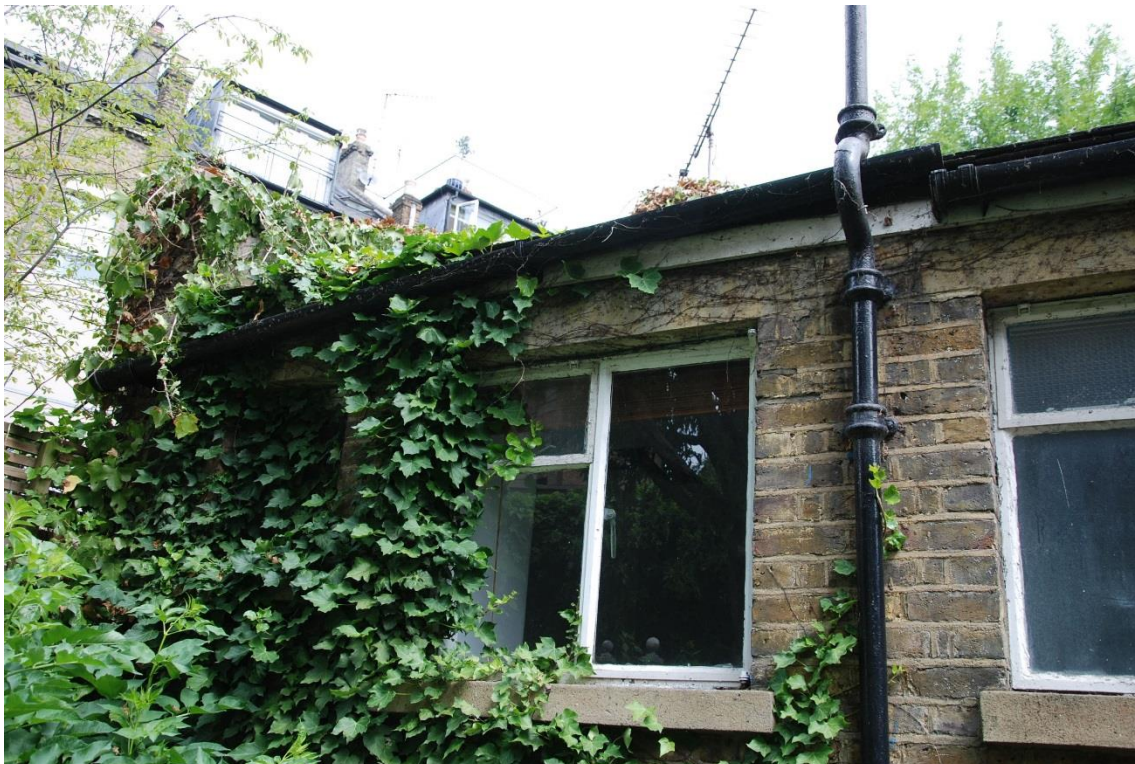
Whilst the lead flashings to the parapet valley gutter cannot be inspected, the rainwater goods to front elevation appear to be in a reasonable state of repair. However, the guttering and downpipes to the rear elevation are in a very poor condition, broken in places and, where inadequate, are causing damp to the rear façade.

Photograph 2: Roof and rainwater goods to rear

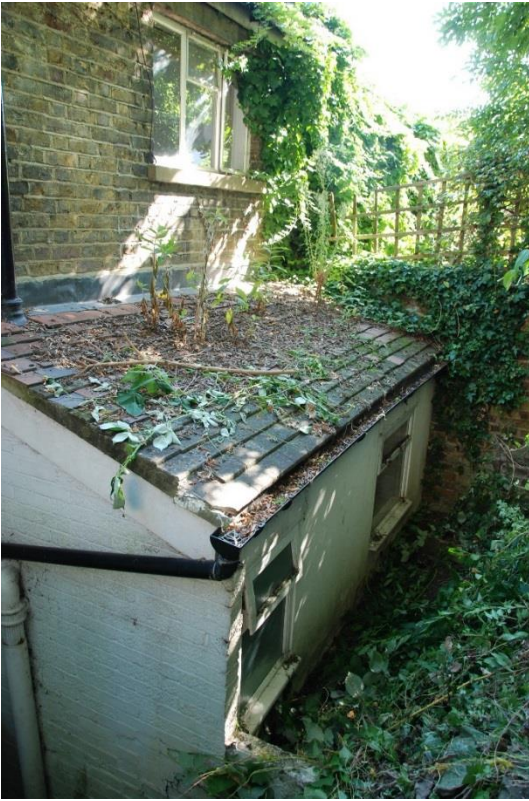
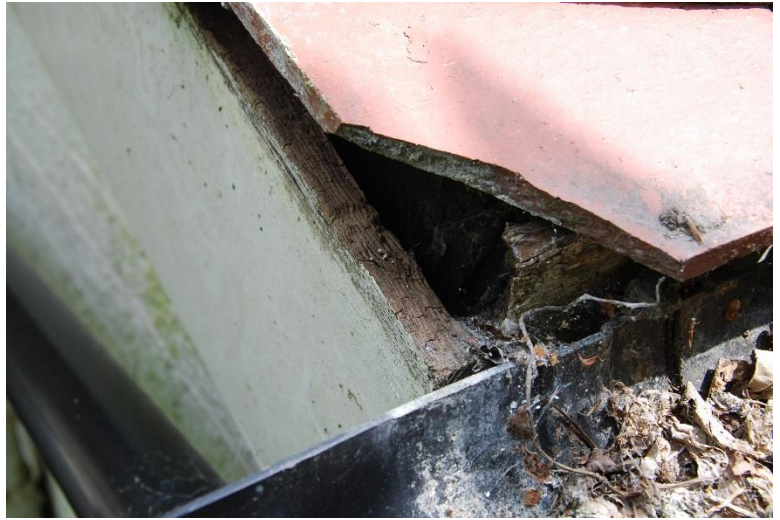
The roof to this addition has not been maintained, with evidence of slipped/missing tiles, guttering failure, rotting fascias, as well as shrubbery taking root between roofing tiles.

Photographs 3&4: Roof to rear addition and detail showing cracked tiles and rotten fascia board

Works to the roof, eaves, fascias and external openings are essential to ensure water tightness from rainwater.

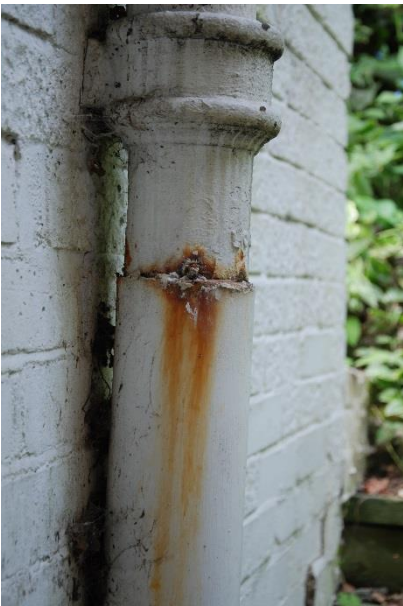
Photograph 5: Rainwater Pipe

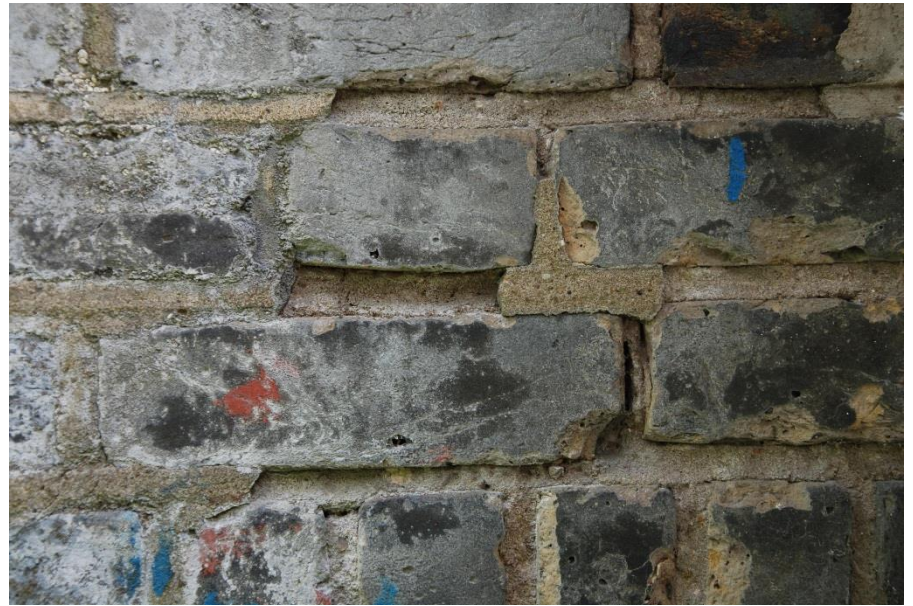
Brickwork would appear to be in good condition however there are signs in numerous places where the pointing requires attention as part of regular maintenance.

Photograph 6: Detail of brickwork to rear elevation

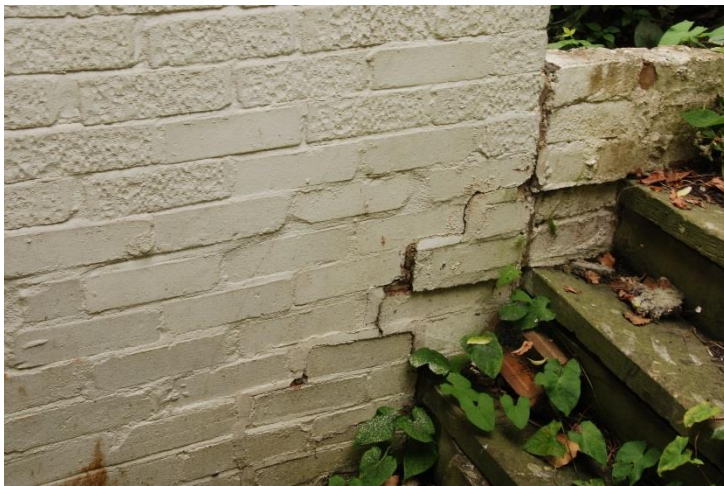
The single storey rear addition to the rear of the ground floor, which currently houses the WC and kitchenette would appear to have been cheaply built and is in a particularly poor state of repair.

Photograph 7: Cracked brickwork to rear addition

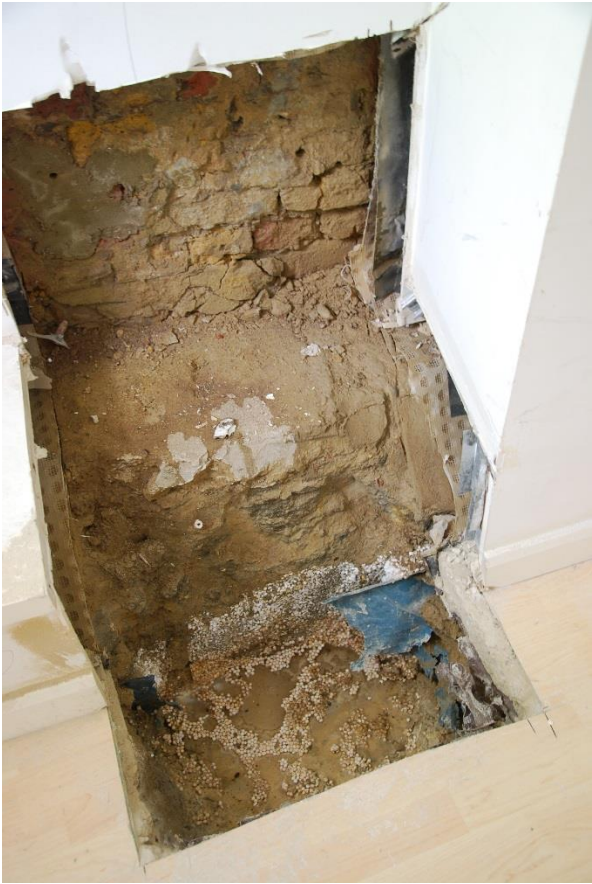
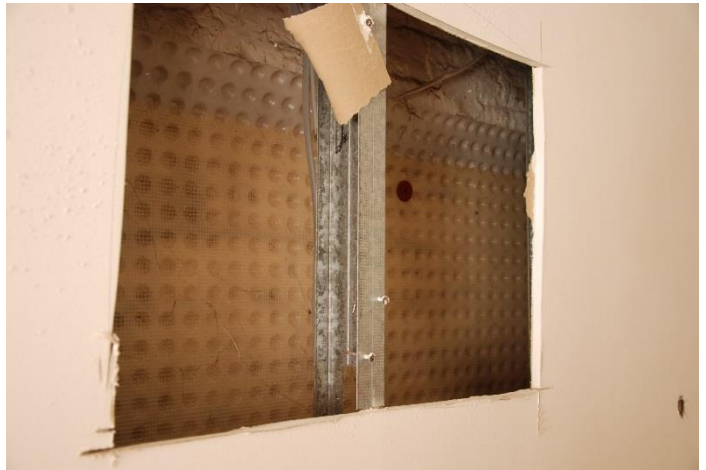
Due to the ground levels of the site it is believed that moisture is entering the structure in numerous ways including ground-borne moisture. There is an existing cavity membrane system installed at the property however trial pits have been created in the slab and there is no evidence of effective drainage. Cavity drainage membranes require drainage so that any water that enters into the structure is safely removed.

Photographs 8&9: Damp membrane/drylining and trapped moisture at slab level

Whilst there is evidence of previous works to eradicate moisture ingress from the fabric of the building these have been poorly designed/executed and ignored the fundamental issue of drainage.

A thorough overhaul, replacement and betterment of the waterproofing measures eradicating ground borne water ingress need to be taken, as well work to the above ground building fabric to ensure complete water tightness.

This will likely include the removal of all plastered faces/internal finishes, suitable tanking/chemical injection and the instatement of complete a vapour control membrane system to all external walls including suitable drainage, prior to the reinstatement of internal finishes.

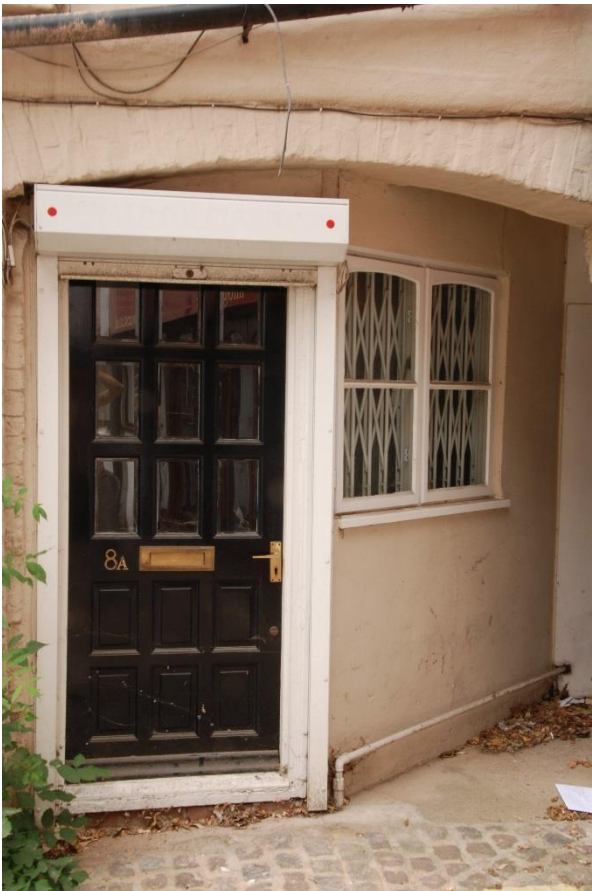
Photograph 10: Front door and security shutters

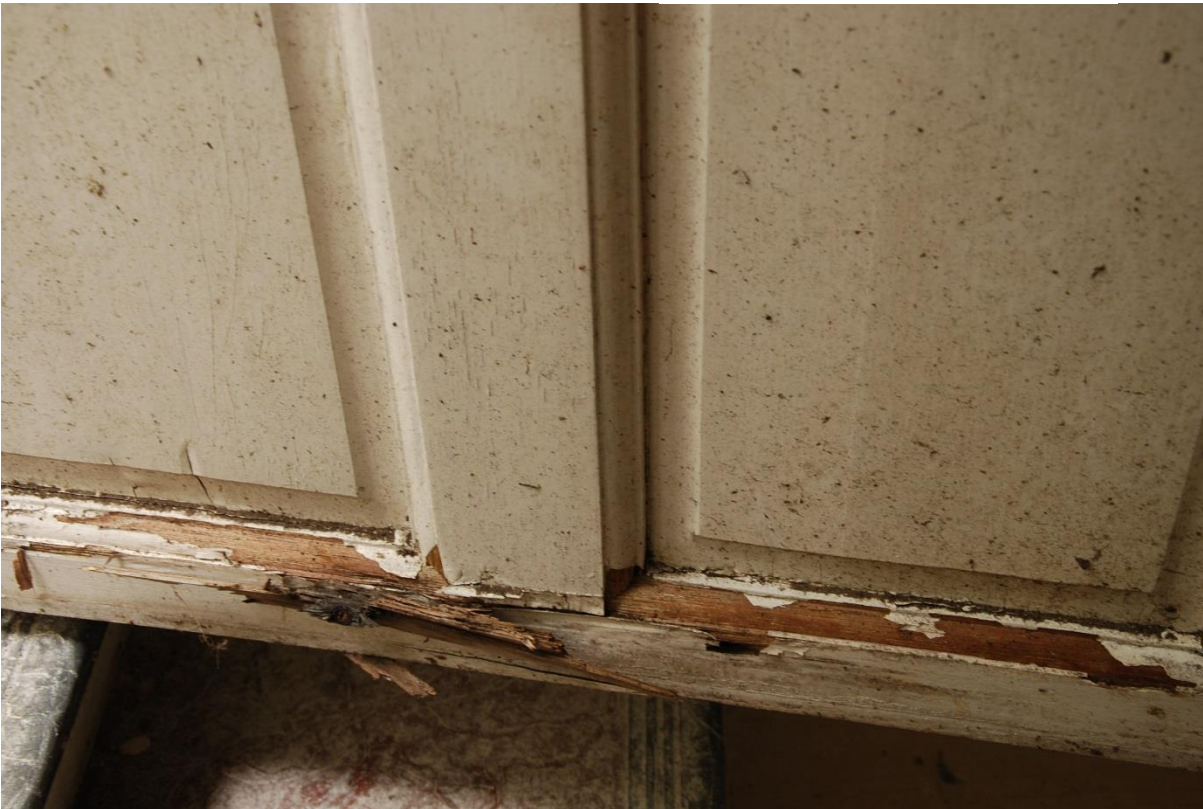
The windows and doors at the property are in a mixed condition. The front door is in a reasonable state but would benefit from cosmetic work; the rear door displays signs of damage and rotting and needs repair or replacement. The windows appear to be timber framed, double-glazed units and are in a reasonable state however would benefit from a cosmetic overhaul.

Photograph 13: Rear door

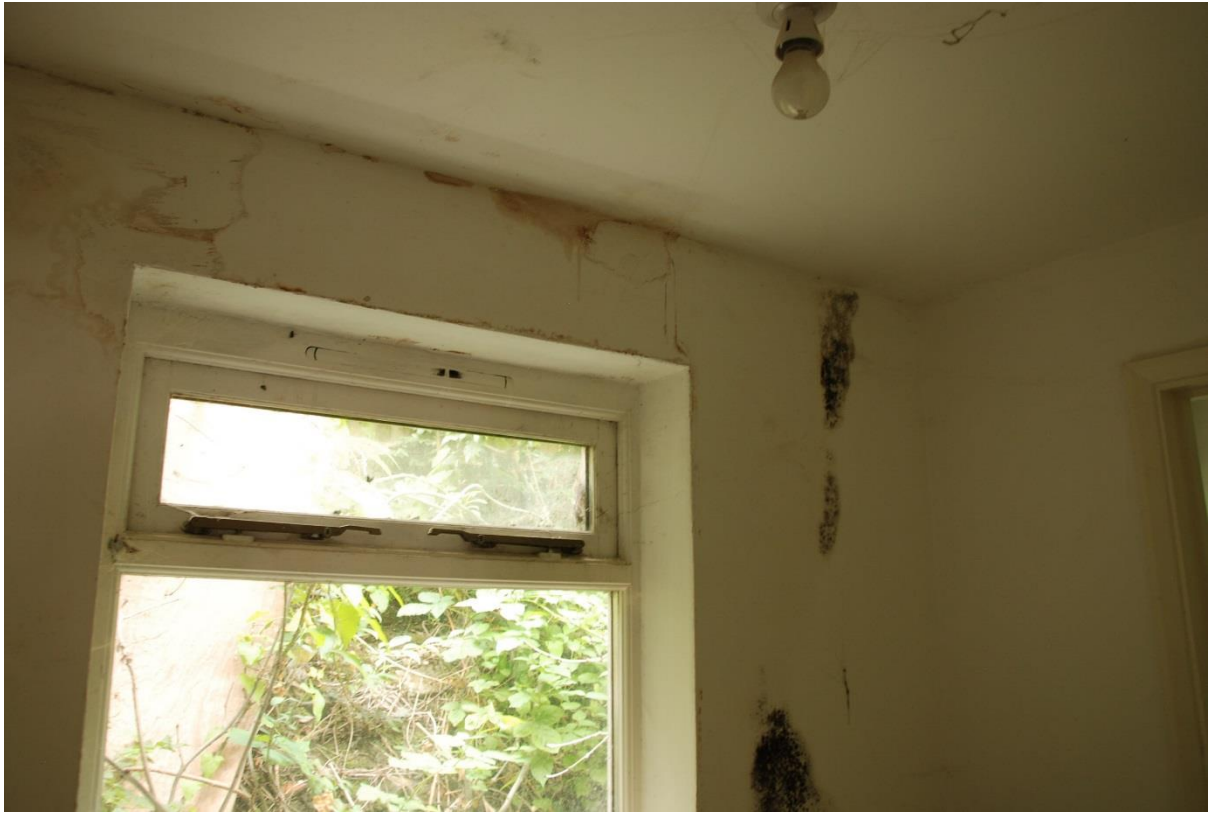
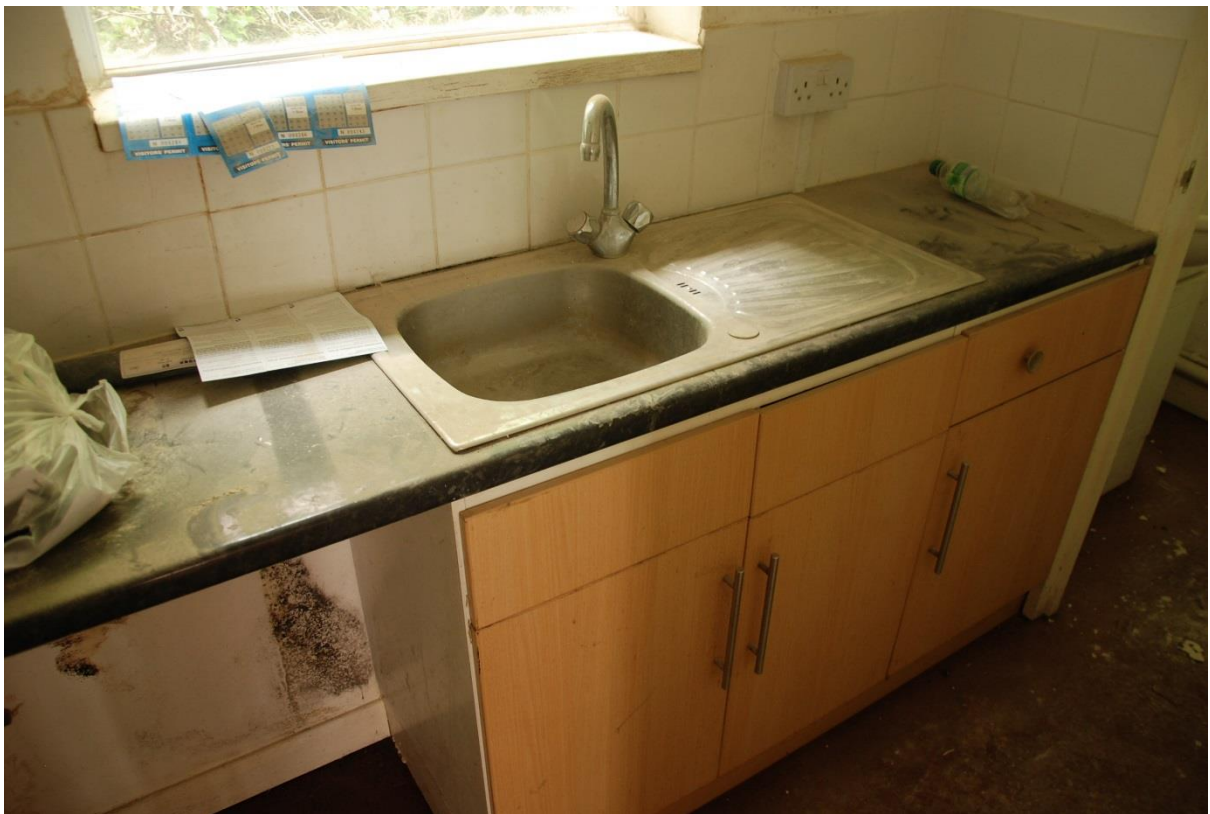
The small kitchenette facilities – such as they are – as well as the WC are in a poor condition and require complete refurbishment including fixtures and fittings, and decoration.

Photographs 14 & 15: Internal kitchenette

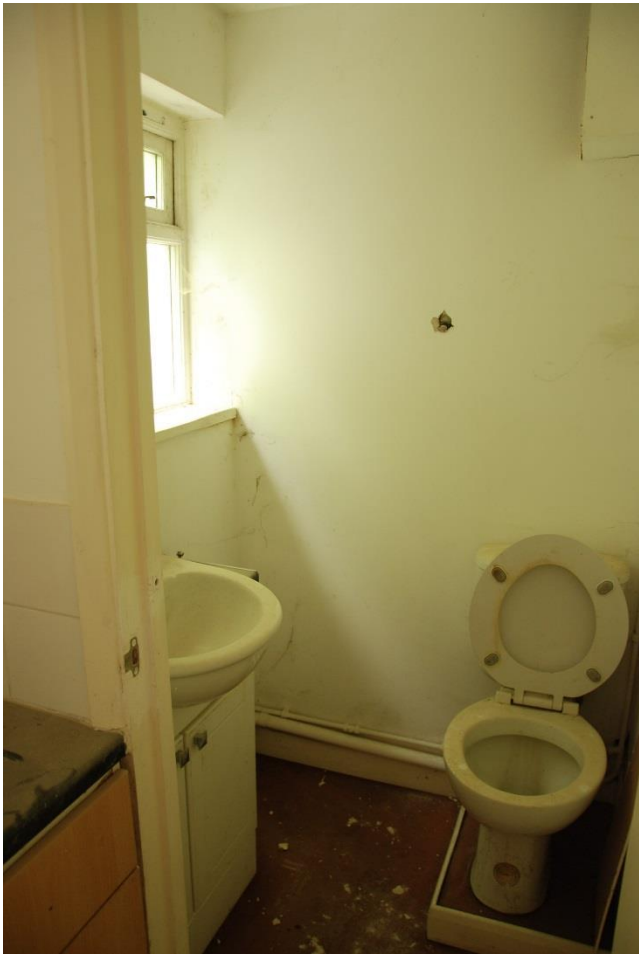
Photograph 16: WC

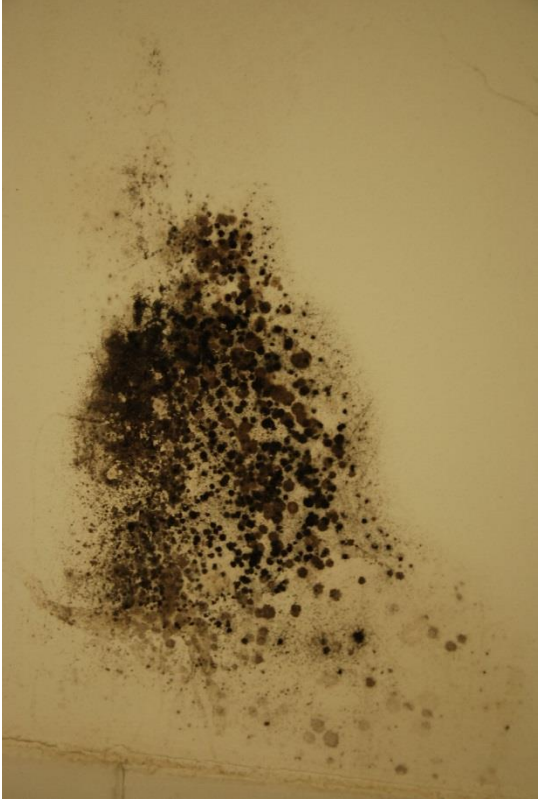
Of particular concern is the level of dampness evident throughout the property and areas of mould developing on internal faces.

Photograph 19: Mould in interior

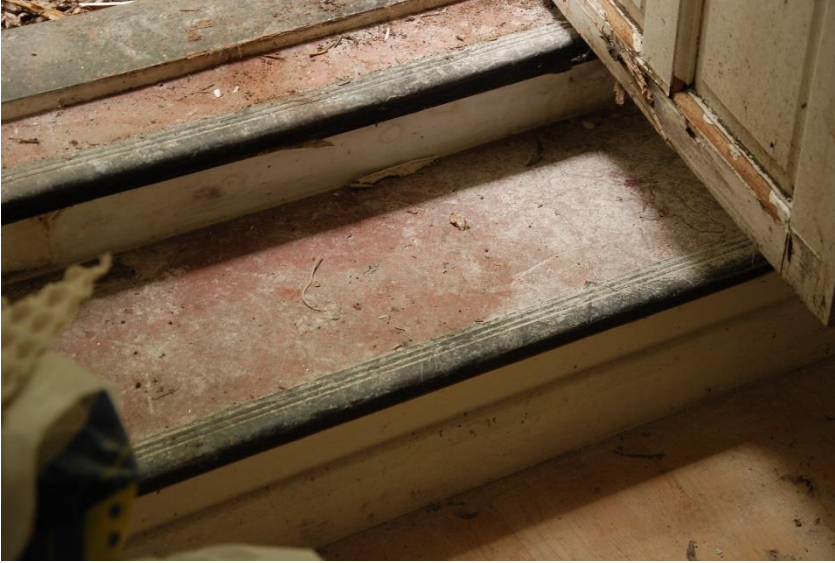
At minimum the rear garden requires a reasonable amount of 'standard maintenance' to control previous neglect and the shoring up of unstable fence panels to the rear; it would benefit further from works to the steps which are in an unstable condition.

Photograph 20: Rear steps

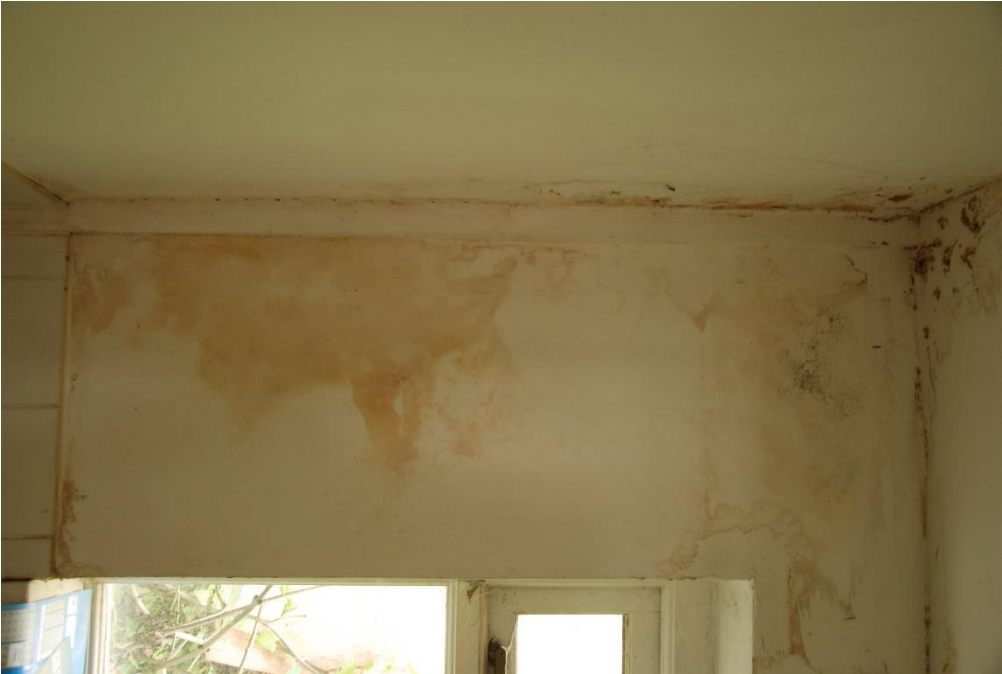
Photograph 21: Dampness to interior walls

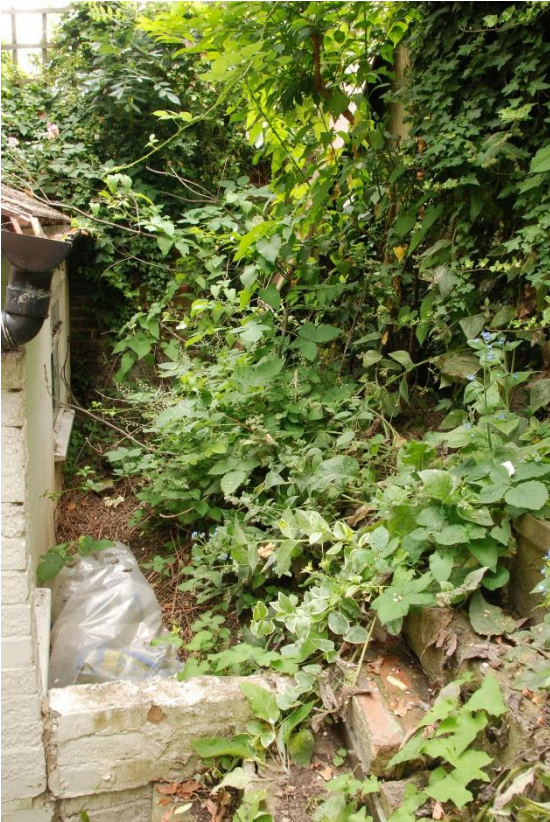
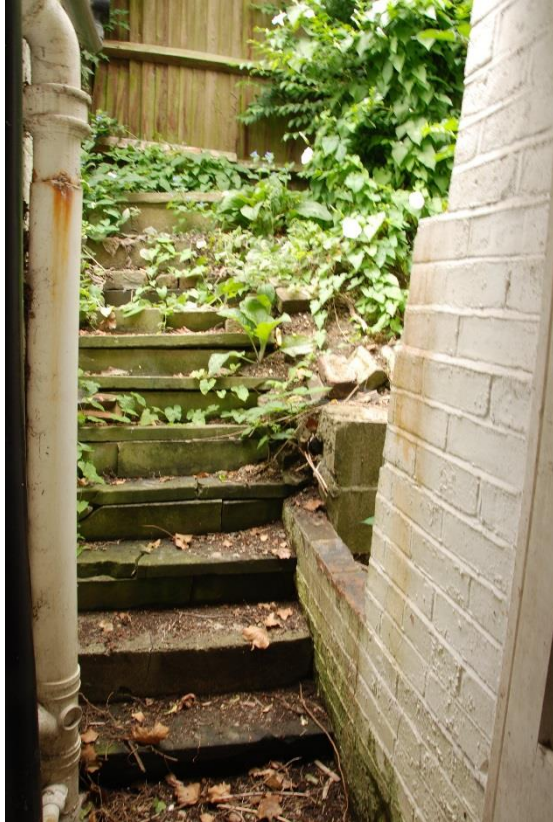
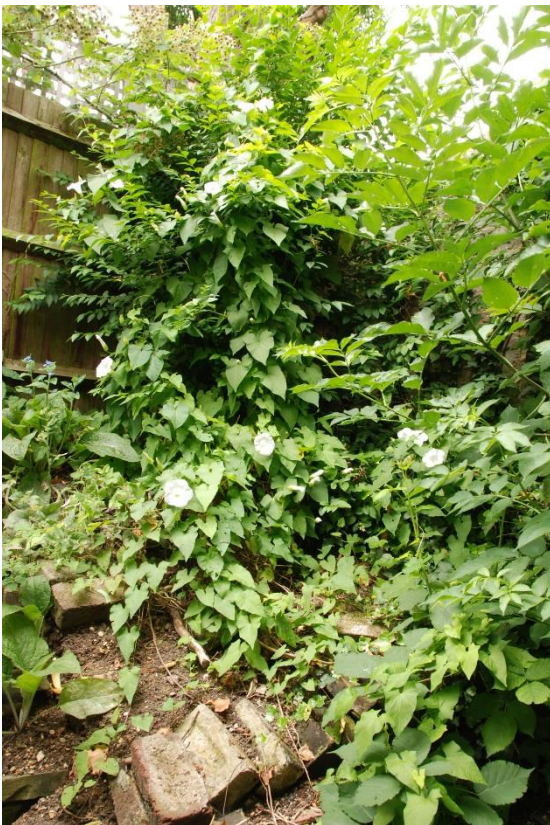
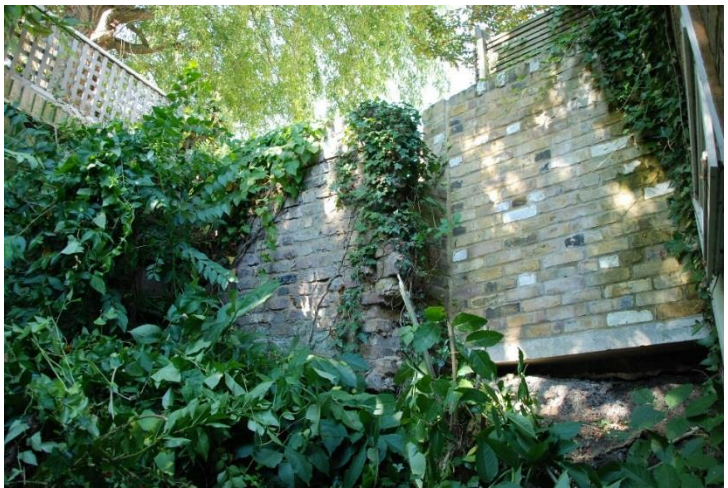
Photographs 22-25: Rear garden

Ivy should be cut back to prevent further damage to the building fabric.

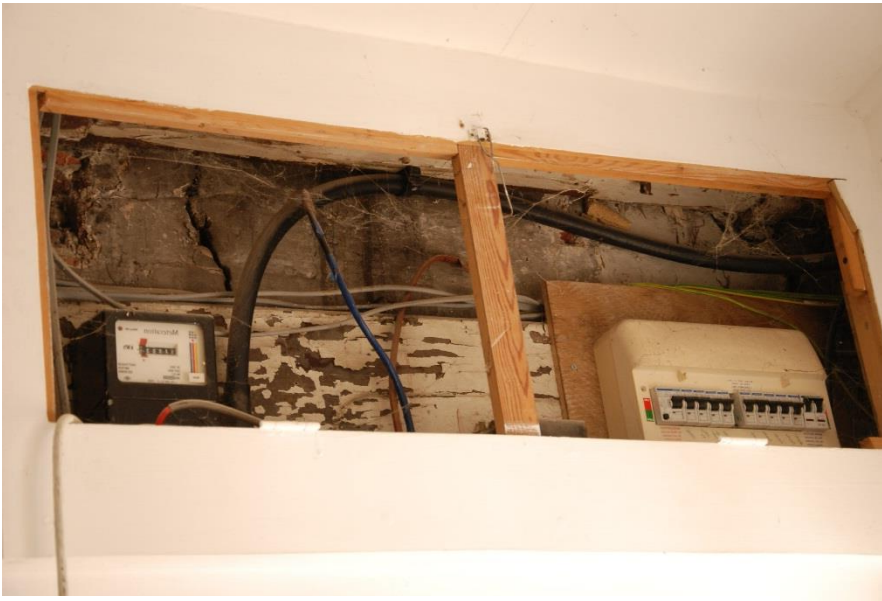
Photograph 26: Electric meter and fuse board

A comprehensive test of the existing electrical installation should be undertaken by a certified electrician. Given the estimated date of the light fittings in the property it is assumed that the electrical installation pre-dates current regulations and it would be a fair assumption that a complete new electrical installation should be undertaken as part of a comprehensive refurbishment and to bring the property in line with current regulations and standards.

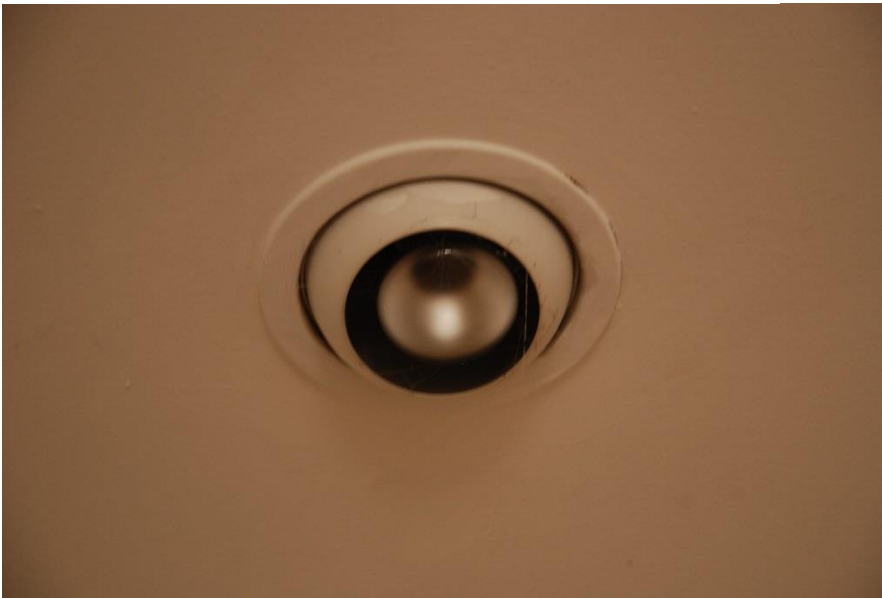
Photograph 27: Existing typical light fitting

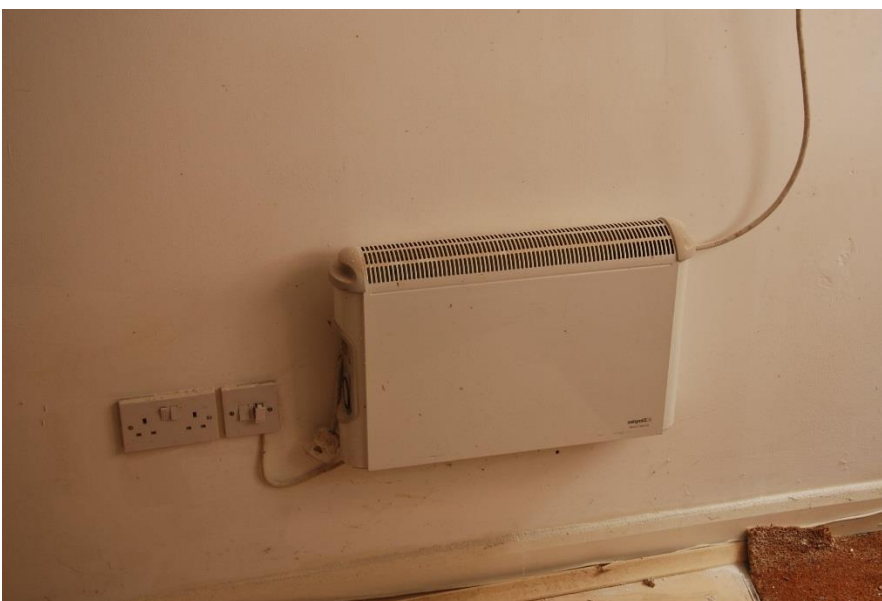
Photograph 28: Electric Dimplex heater

The property is currently served by electric Dimplex heaters. These should be tested for safety compliance but ideally would be replaced for radiators served from a gas boiler.
