# Appendix H

Intrusive investigations and site visit reports

## Arthur Stanley House – Site Visit Report No.01

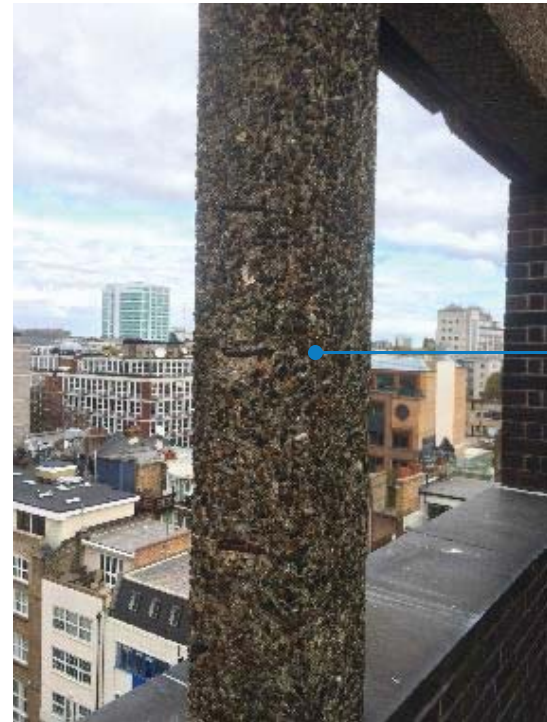
1.1 Piloti columns (expressed external RC frames) used for the roof extension with exposed aggregate finish on all faces.

Some reinforcement links on the side columns are clearly exposed by washed off cover. The reinforcement has corroded throughout its exposed surface.

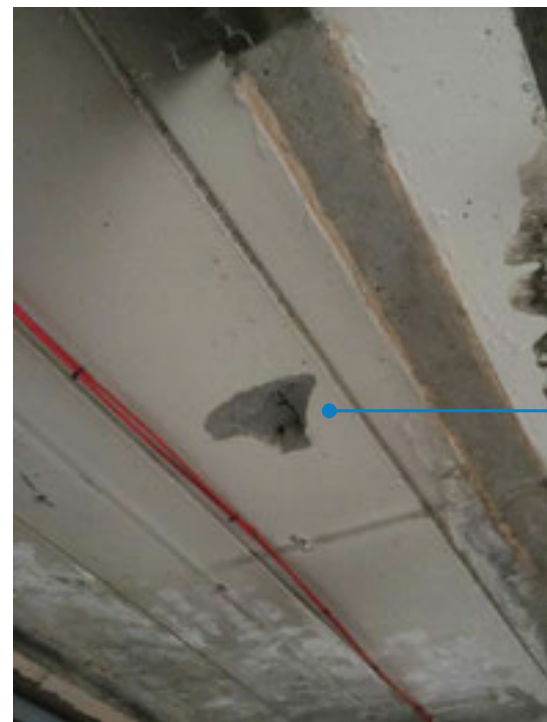
1.2 The roof level construction consist of autoclaved aerated concrete precast units.

The underside of a number of panels have lost some concrete areas leaving some of the reinforcement bars exposed.

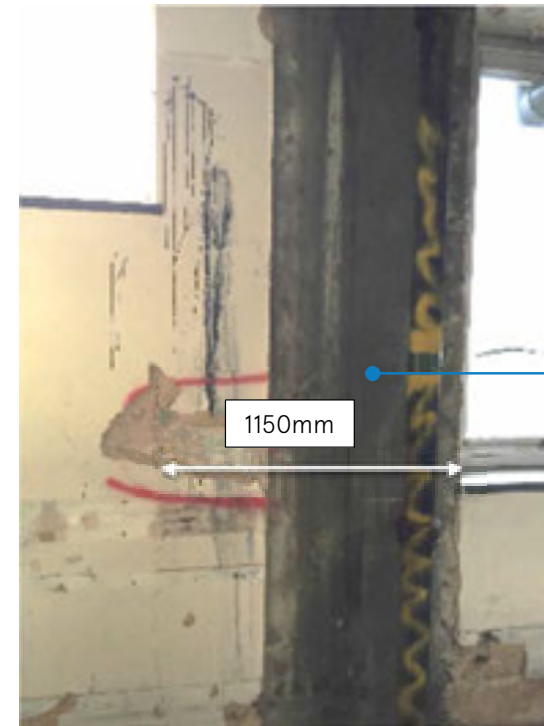
2.1 The column located at the end of the front façade that rises all the way up the building was identified as reinforced concrete. It was also measured from the inside to determine its overall width (see picture below).

2.2 The overall column width was measured to be 1150mm. Reinforcement bars and links are to be exposed and measured by HTS.

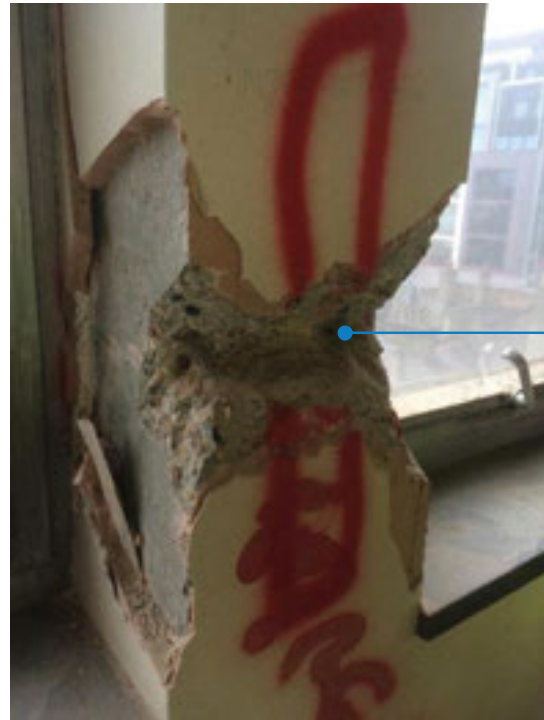
3.1 Some RC perimeter columns show exposed reinforcement and will be further exposed to reveal main reinforcement bars and shear links.

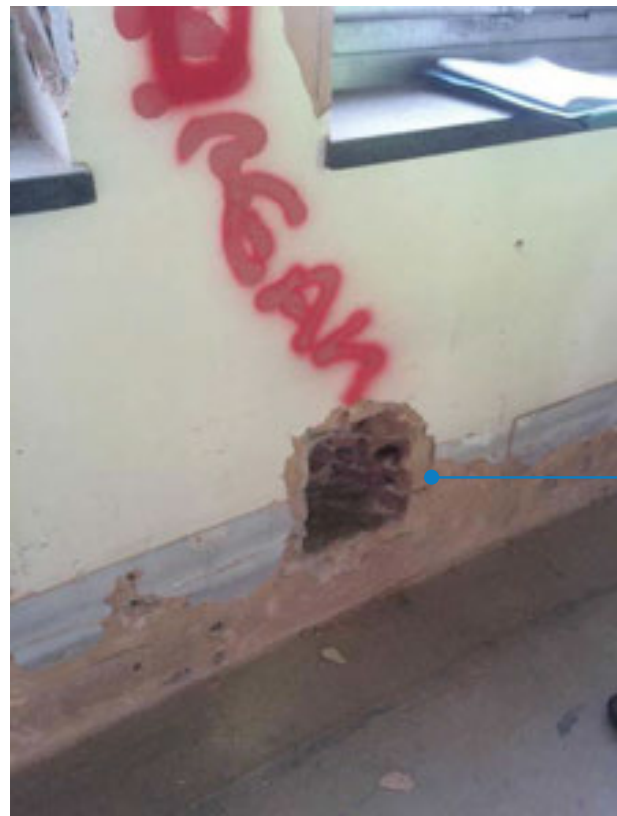
3.2 RC upstand on front façade was found exposed at 5<sup>th</sup> floor level. Reinforcement bars and shear links are to be exposed and measured.

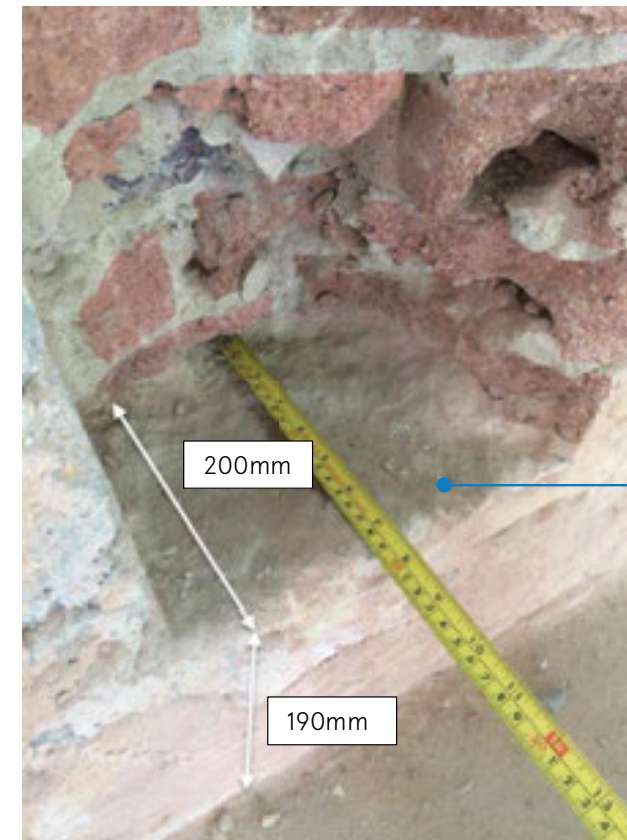
3.3 RC upstand was measured to be 190mm high from SSL and at least 200mm wide. These dimensions are TBC.

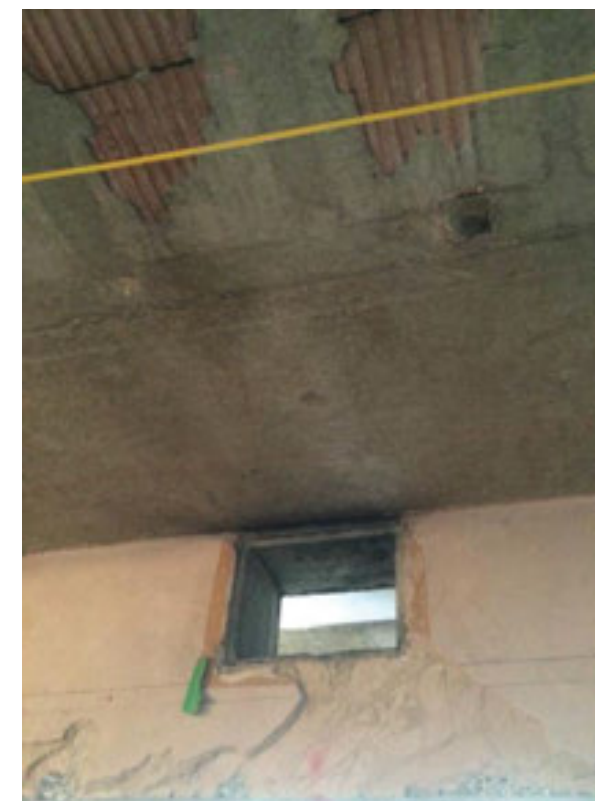
4.1 Services holes were present at the top of the spine beams at almost every level. These were pre-formed rather than post construction and formwork marks were identified on top and side edges.

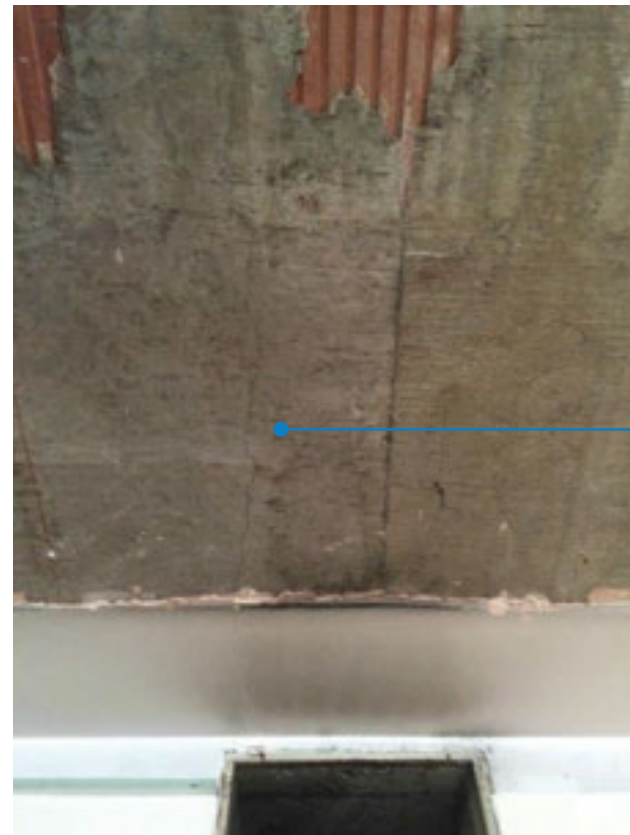
4.2 Cracks were identified above two service holes on the spine beam on the central bay. The cracks propagate to both sides of the spine beam.

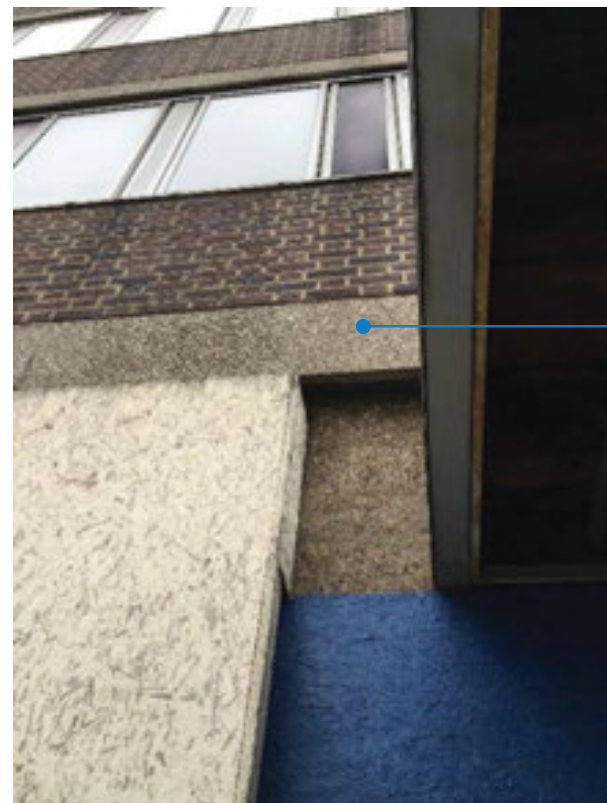
5.1 Front façade build up is to be investigated and measured on week commencing the 26<sup>th</sup> of October. HTS to measure and record wall build up.

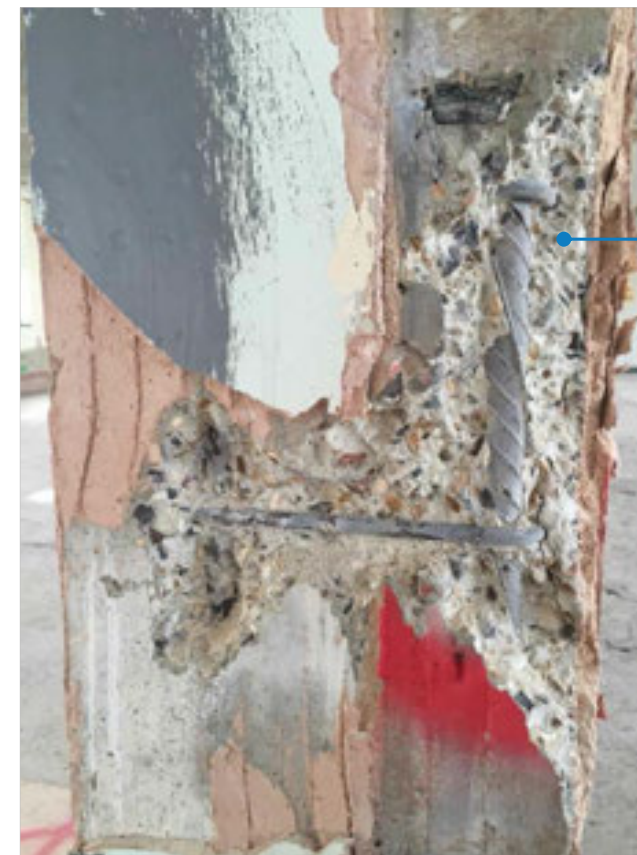
1.2 Cover of internal column was also removed to expose reinforcing bars.

Cover to reinforcement is more than nominal in some of the column faces. This is due to poor workmanship during construction.

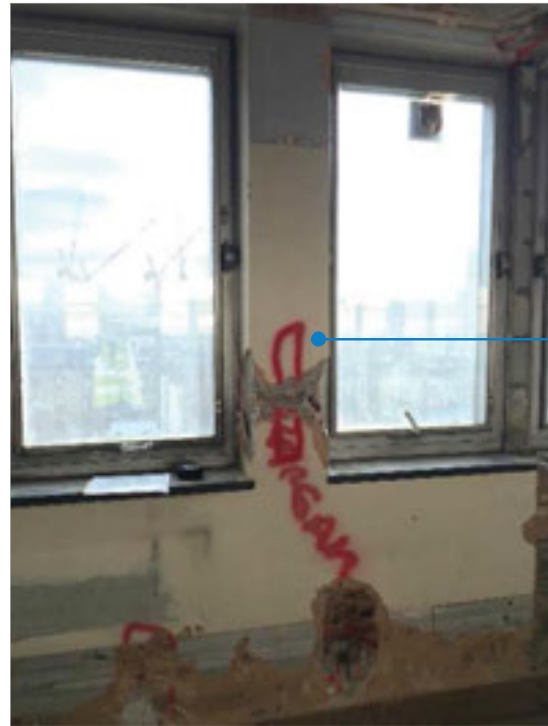
2.1 The column located at an inner bay in the front façade of the building has been heavily cored through in search of reinforcement bars.

This is not an ideal core since the column capacity is highly affected by loss of its section.

It is also important that column investigations are carried out about a third high from the base level.

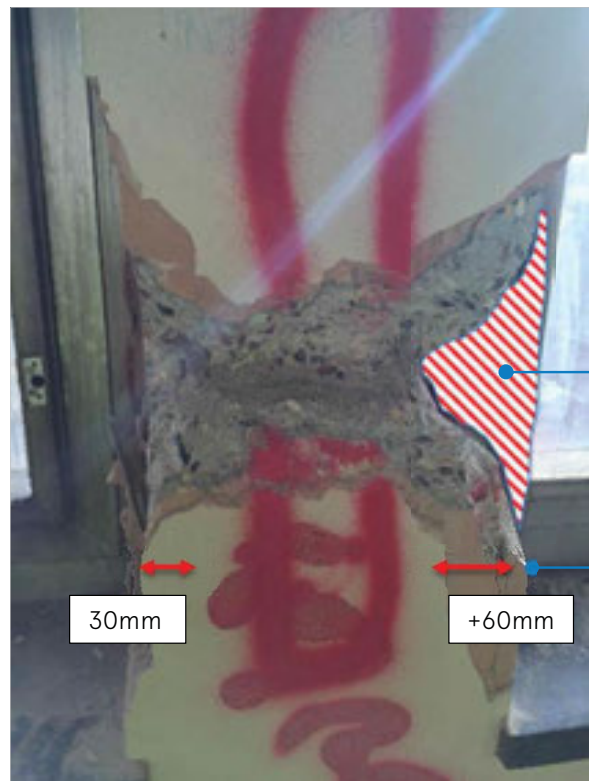
2.2 Loss of concrete around perimeter of the column which also extends towards top and bottom.

Cover to reinforcement varies between column faces. 30mm on one side and more than 60mm on the other.

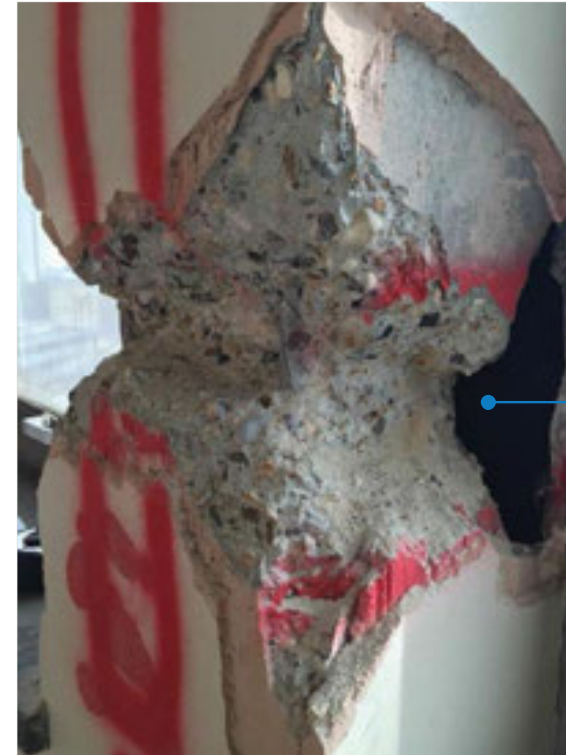
2.3 Column's strength capacity has been highly affected by material removal of most of its sectional area near mid height.

Column is to be repaired following HTS's column repair sequence. See sketch SK009-01.

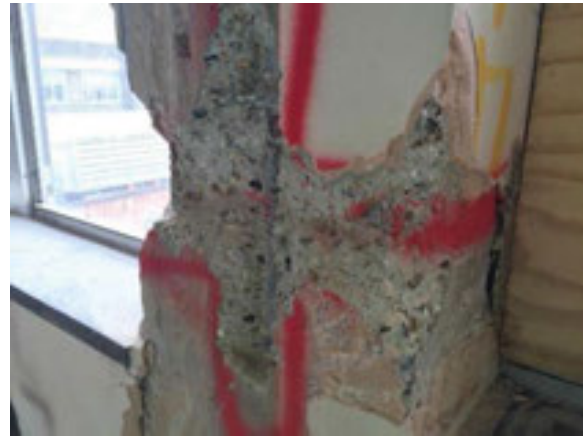
2.4 Column on second floor shows good practice example of cover removal and rebar exposure.

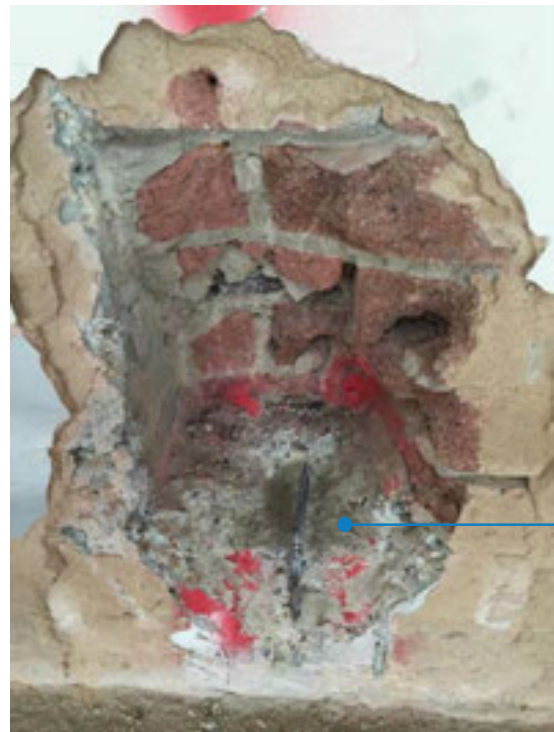
2.5 Reinforcement in internal façade upstand was exposed.

Shear links and longitudinal bars were identified close to the column edge.

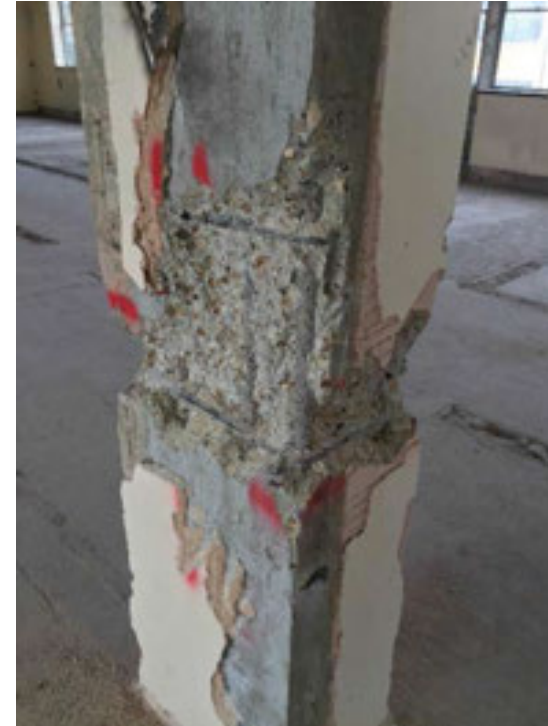
3.1 Internal and façade columns at second floor were exposed to show reinforcement arrangement.

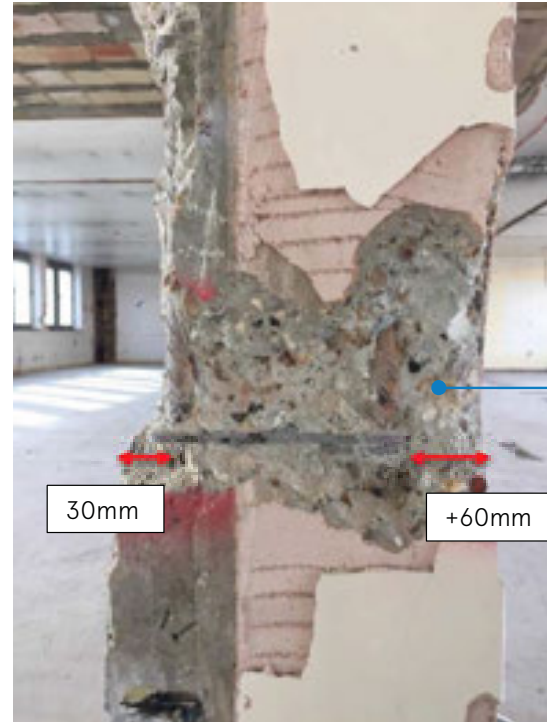
Cover to reinforcement varies significantly on column sides.  
This is due to poor workmanship during construction.

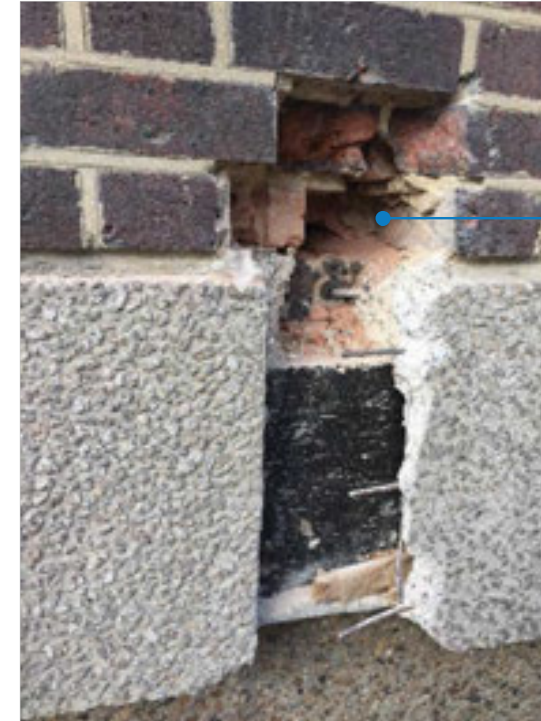
- 1.1 Façade wall investigation had been carried out from both inside and outside to determine the wall build-up, the upstand depth and width and the concrete fascia connection details.

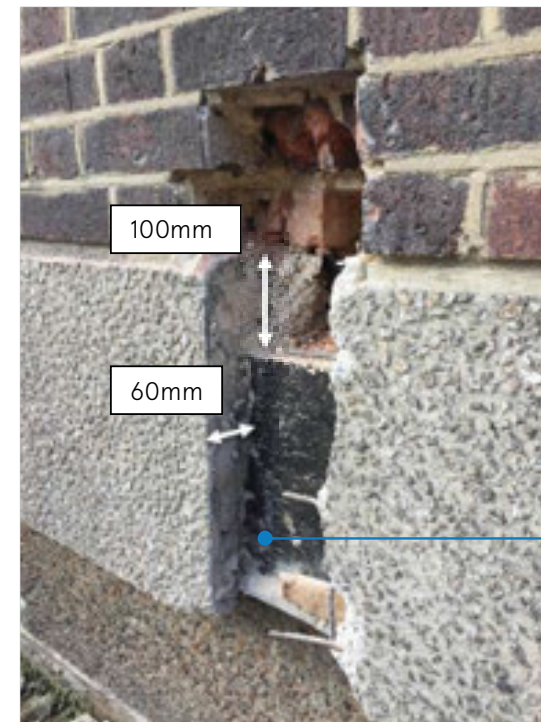
- 1.2 The precast concrete fascia is supported by a 100mm thick toe over the concrete edge and cast in metal brackets at the lower level.

There is a thin layer of mortar between the precast fascia and the concrete slab.

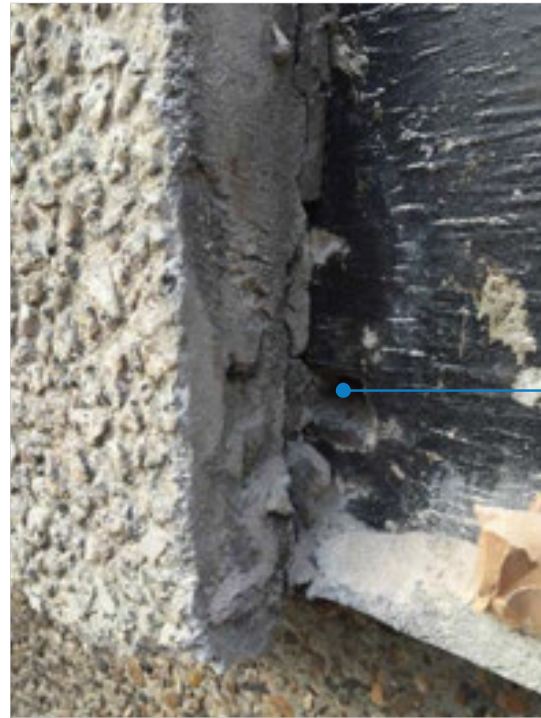
1.3 Cast in metal bracket connection into precast fascia.

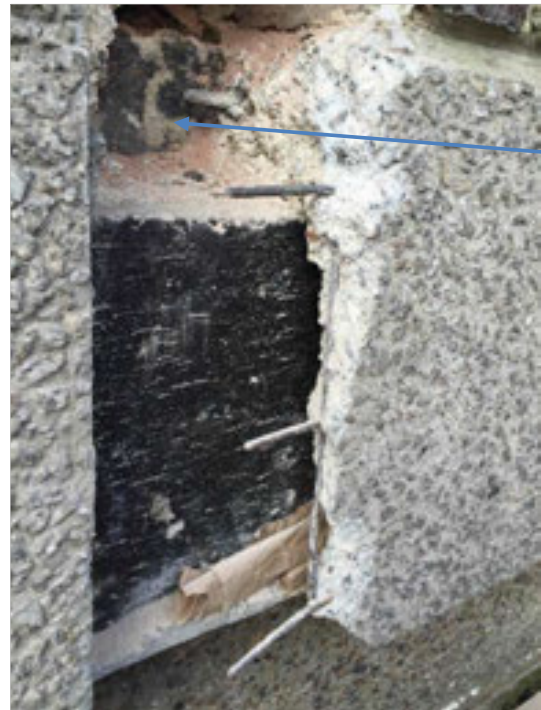
1.4 Rebars within fascia were identified as diameter 6mm plain bars in the downstand and ribbed diameter 6mm within the toe.  
Concrete upstand behind front face.

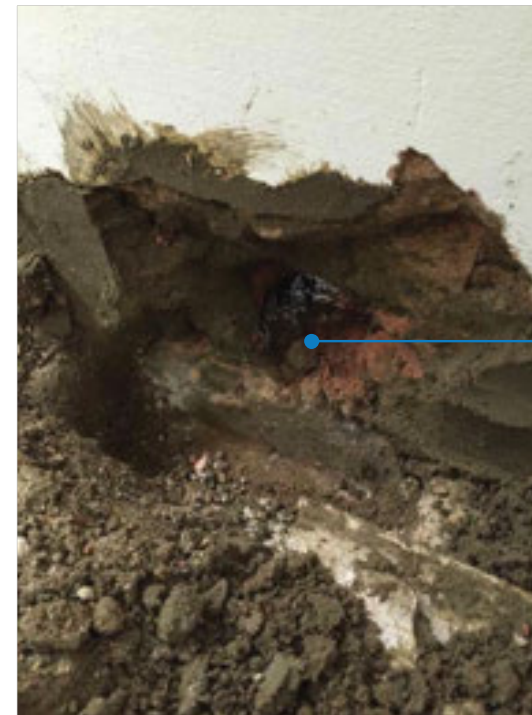
1.6 Upstand from inside was measured to be 60mm high from slab level.  
Refer to sketch 1431/SK010 for measured dimensions

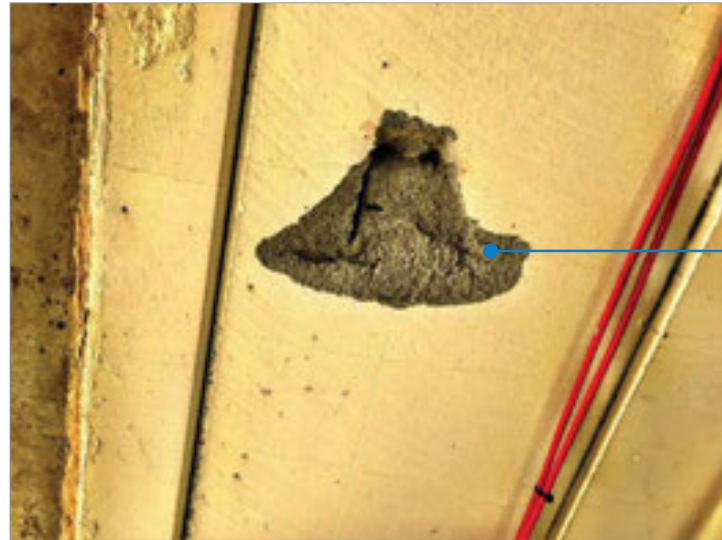
2.05 The existing precast concrete floor units appear to be formed from autoclaved aerated concrete, which has potential to contain radioactive gas and could therefore be a deleterious material.

HTS will highlight CDM risk on demolition drawings. Material to be tested by future contractor prior to any demolition.

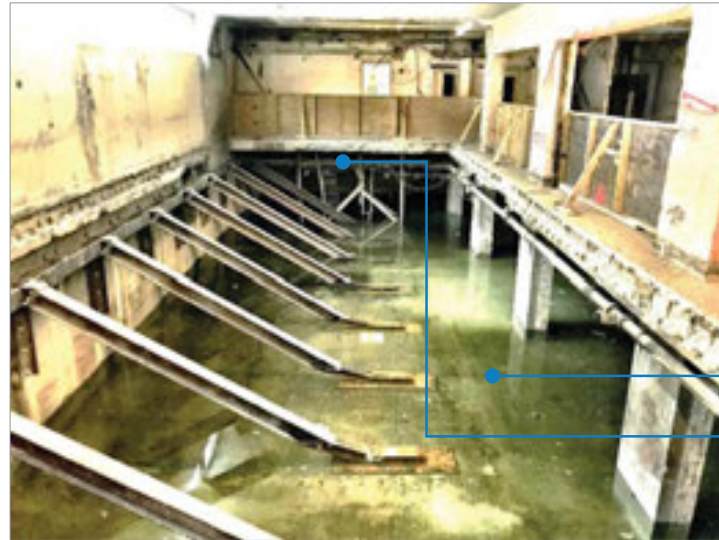
3.03 Basement is currently flooded. Water level appears to correspond to groundwater level determined in URS Ground Investigation Report. It therefore appears that existing basement box is not sealed against groundwater ingress.

HTS to visit site when water is pumped out to attempt to locate points of water ingress and rate. This will inform proposed basement waterproofing design.

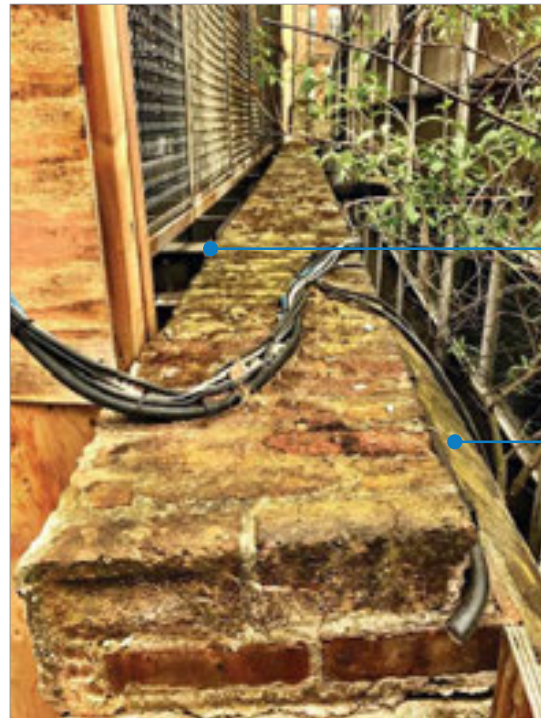
4.4 On western side of wall there is a steel frame. A gap between beam end plates and the wall suggest that the frame does not appear to provide any support to wall.

Buttress on the eastern side of the wall. This spans to ground level on the UCLH side of the wall and would appear to provide support to the wall.

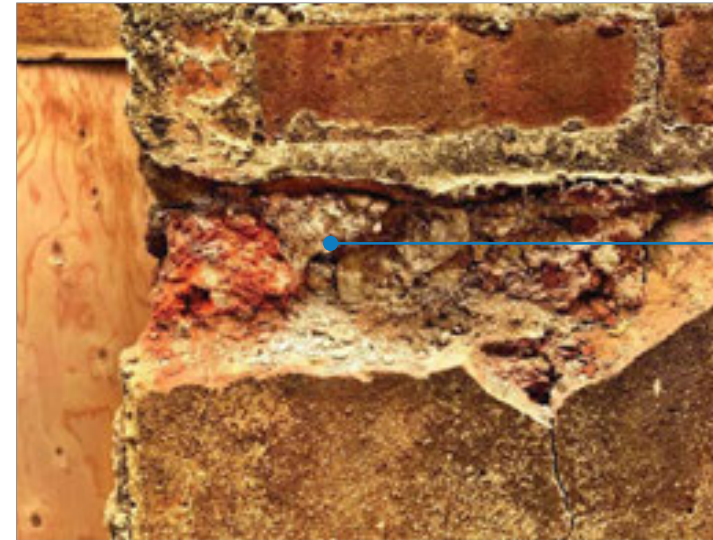
4.05 Snapped off stretcher bricks at the end of the wall. It would appear that the wall originally continued into the site to form a boundary wall between the two previous separate titles.

HTS to arrange for contractor to visit site to inspect wall and provide proposals to remove masonry above concrete upstand to boundary line.

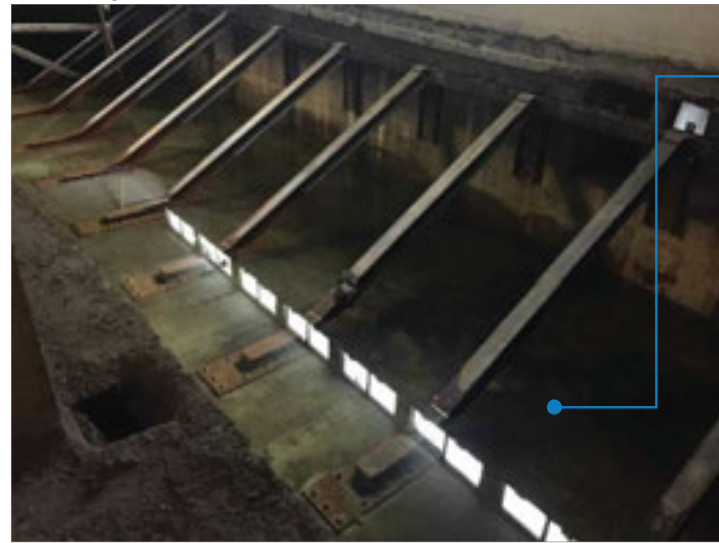
1.1 Basement is currently flooded.

Maintenance contractor has been dewatering the basement since Wednesday the 7<sup>th</sup> of July and water levels have now reached the water table determined by URs on the *Ground Investigation Report*.

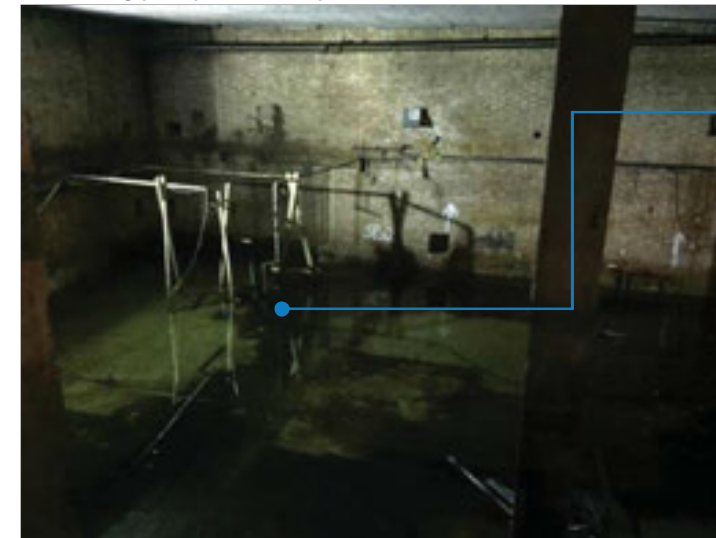
3.1 Maintenance contractor confirmed that once the basement level becomes accessible the previous pumps could be repaired or replaced.
