TECHNICAL REPORT ON A SUBSIDENCE CLAIM

Crawford Reference: SU1701142

**Mr Alan J Beadon
10 Shirlock Road
London
NW3 2HS**

SUBSIDENCE CLAIM

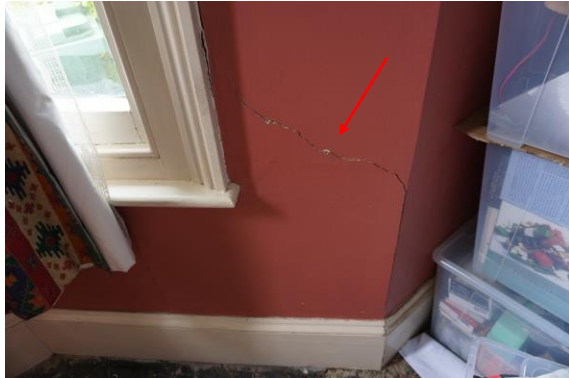
GF Front Bedroom – Diagonal Crack at Bay Junction

- Separation of front bay to left and right hand side - 2mm
- Vertical crack below bay - 2mm
- Vertical crack on rear wall - 2mm
- Cracking in ornate cornice to front - 2mm
- Separation in timber to front

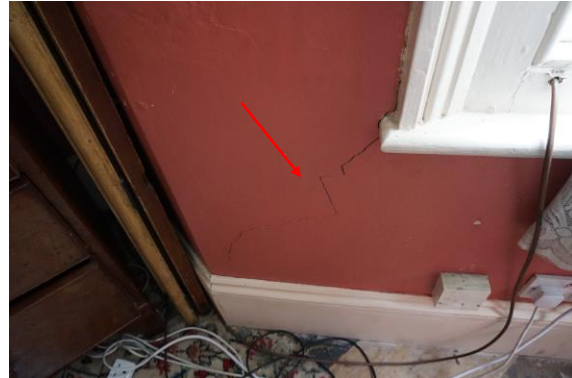
GF Front Bedroom – Diagonal Crack at Bay Junction

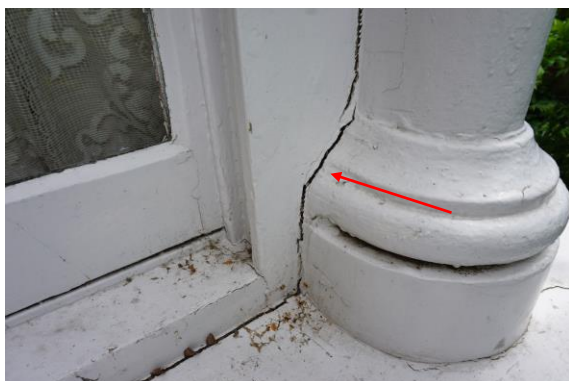
Front Bay – Stonework Separation

- Separation of left column from window - 3mm
- Stepped crack to left hand side - 2mm
- Separation of sill - 4mm

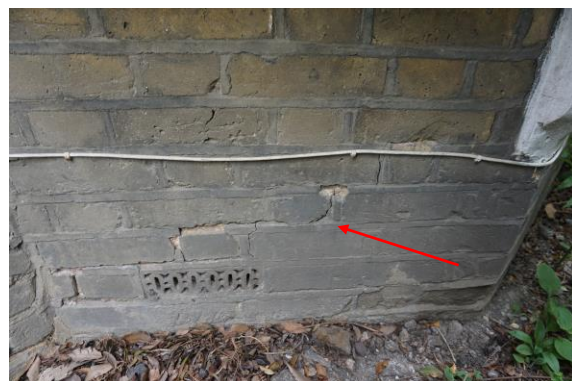
Front Bay – Stepped Cracking

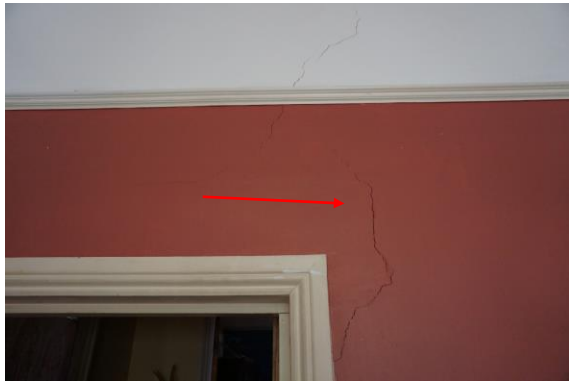
GF Front Bedroom – Vertical Crack Above Door to Lobby

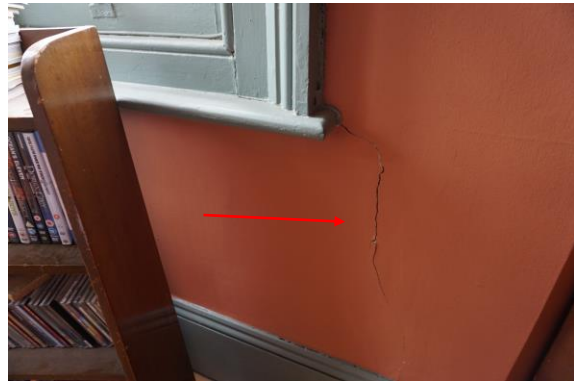
- Diagonal crack at junctions of bay - 2mm
- Cracks in cornice to front - 1mm

FF Front Bedroom – Diagonal Crack to Bay Junction

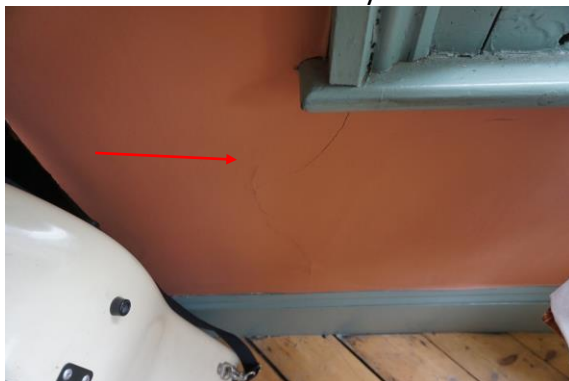
FF Front Bedroom – Diagonal Crack to Bay Junction

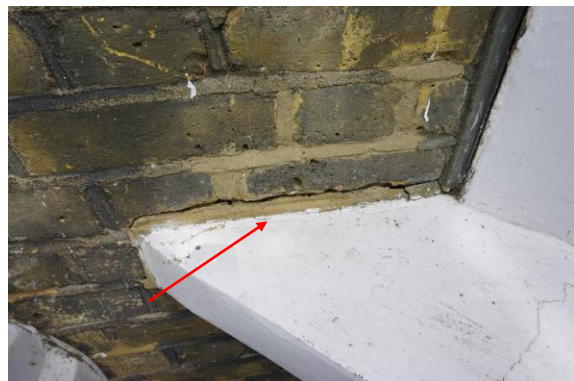
Front Bay – Separation of Sill from Main House

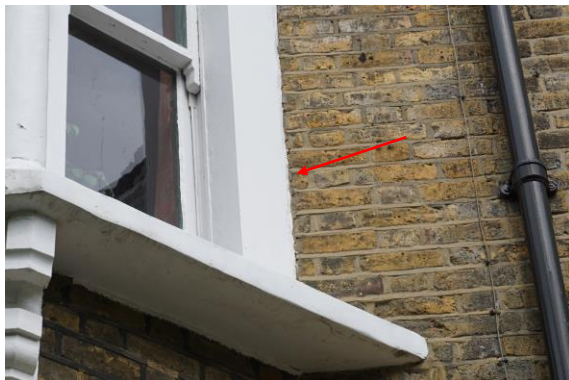
FF Bay – Separation at Junction to Main House

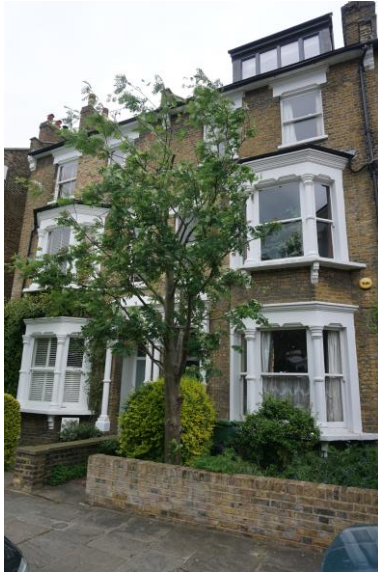
Rowan to Front

The timing of the event, the presence of shrinkable clay beneath the foundations and the proximity of vegetation where there is damage indicates the shrinkage to be root induced. This is a commonly encountered problem and probably accounts for around 70% of subsidence claims notified to insurers.

The cause of the movement needs to be dealt with first. We have completed a Soil Risk Analysis (VISCAT Assessment) and we are satisfied that your Rowan tree and shrub in front of the tree can be removed.

Please arrange removal of the Rowan and shrub at your earliest convenience.
