South Hampstead Synagogue Tree Condition Survey

Eight Associates have been instructed by Wates Group to carry out a tree condition survey in relation to a Tree of Heaven, *Ailanthus altissima* at South Hampstead Synagogue, 21-22 Eton Villas, London, NW3 4SG. The building on the site is currently being demolished to make way for a new synagogue. As part of the works undertaken, a wall was removed that constituted part of a planter structure containing the tree. This revealed the root structure of the tree and led to concerns over the stability of the tree.

Oliver Booth, an experienced arboriculturalist, carried out a tree condition survey on the 7th March 2017 to assess the tree's current status. This report describes the finding of the survey, and specifies mitigation in relation to works to enable the retention of the tree, which is categorised as an A category tree.

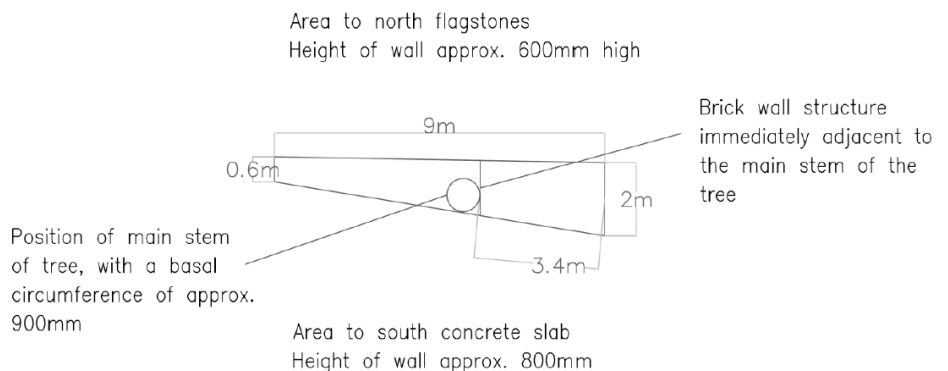
The *Ailanthus altissima* is situated within a planting structure the dimensions of which, and its position within, are given in the following diagram:
