ARBORICULTURAL IMPACT ASSESSMENT REPORT FOR:

9 St-Martins Almshouses
Bayham Street
London
NW1 0BD

Ref: MOX/9STM/AIA/01

Date: 19th April 2017

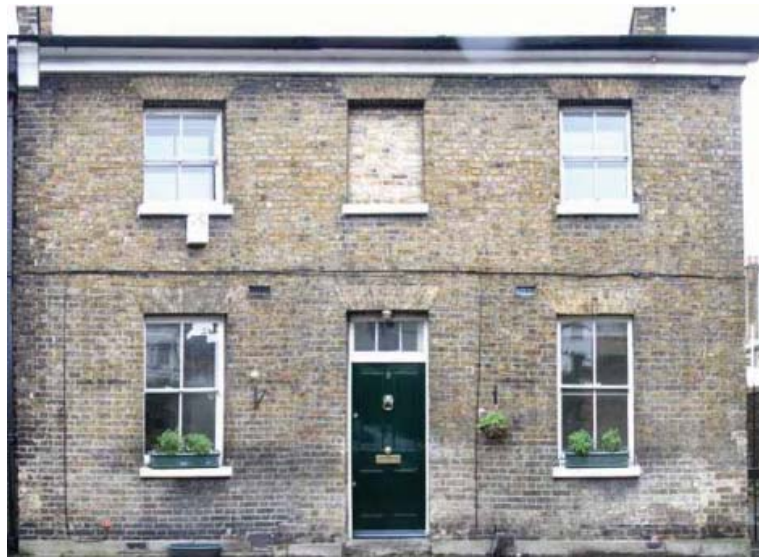
Photograph 1: 9 St-Martins Almshouses, Bayham Street, London NW1 0BD

- 3.1.1 The property is part of the St-Martin's Almshouses, a group of two storey houses built in 1818 by Henry Hake Seward. No. 9 is the end of terrace property located at the far right of the St Martins Almhouse development when viewed from Bayham Street.

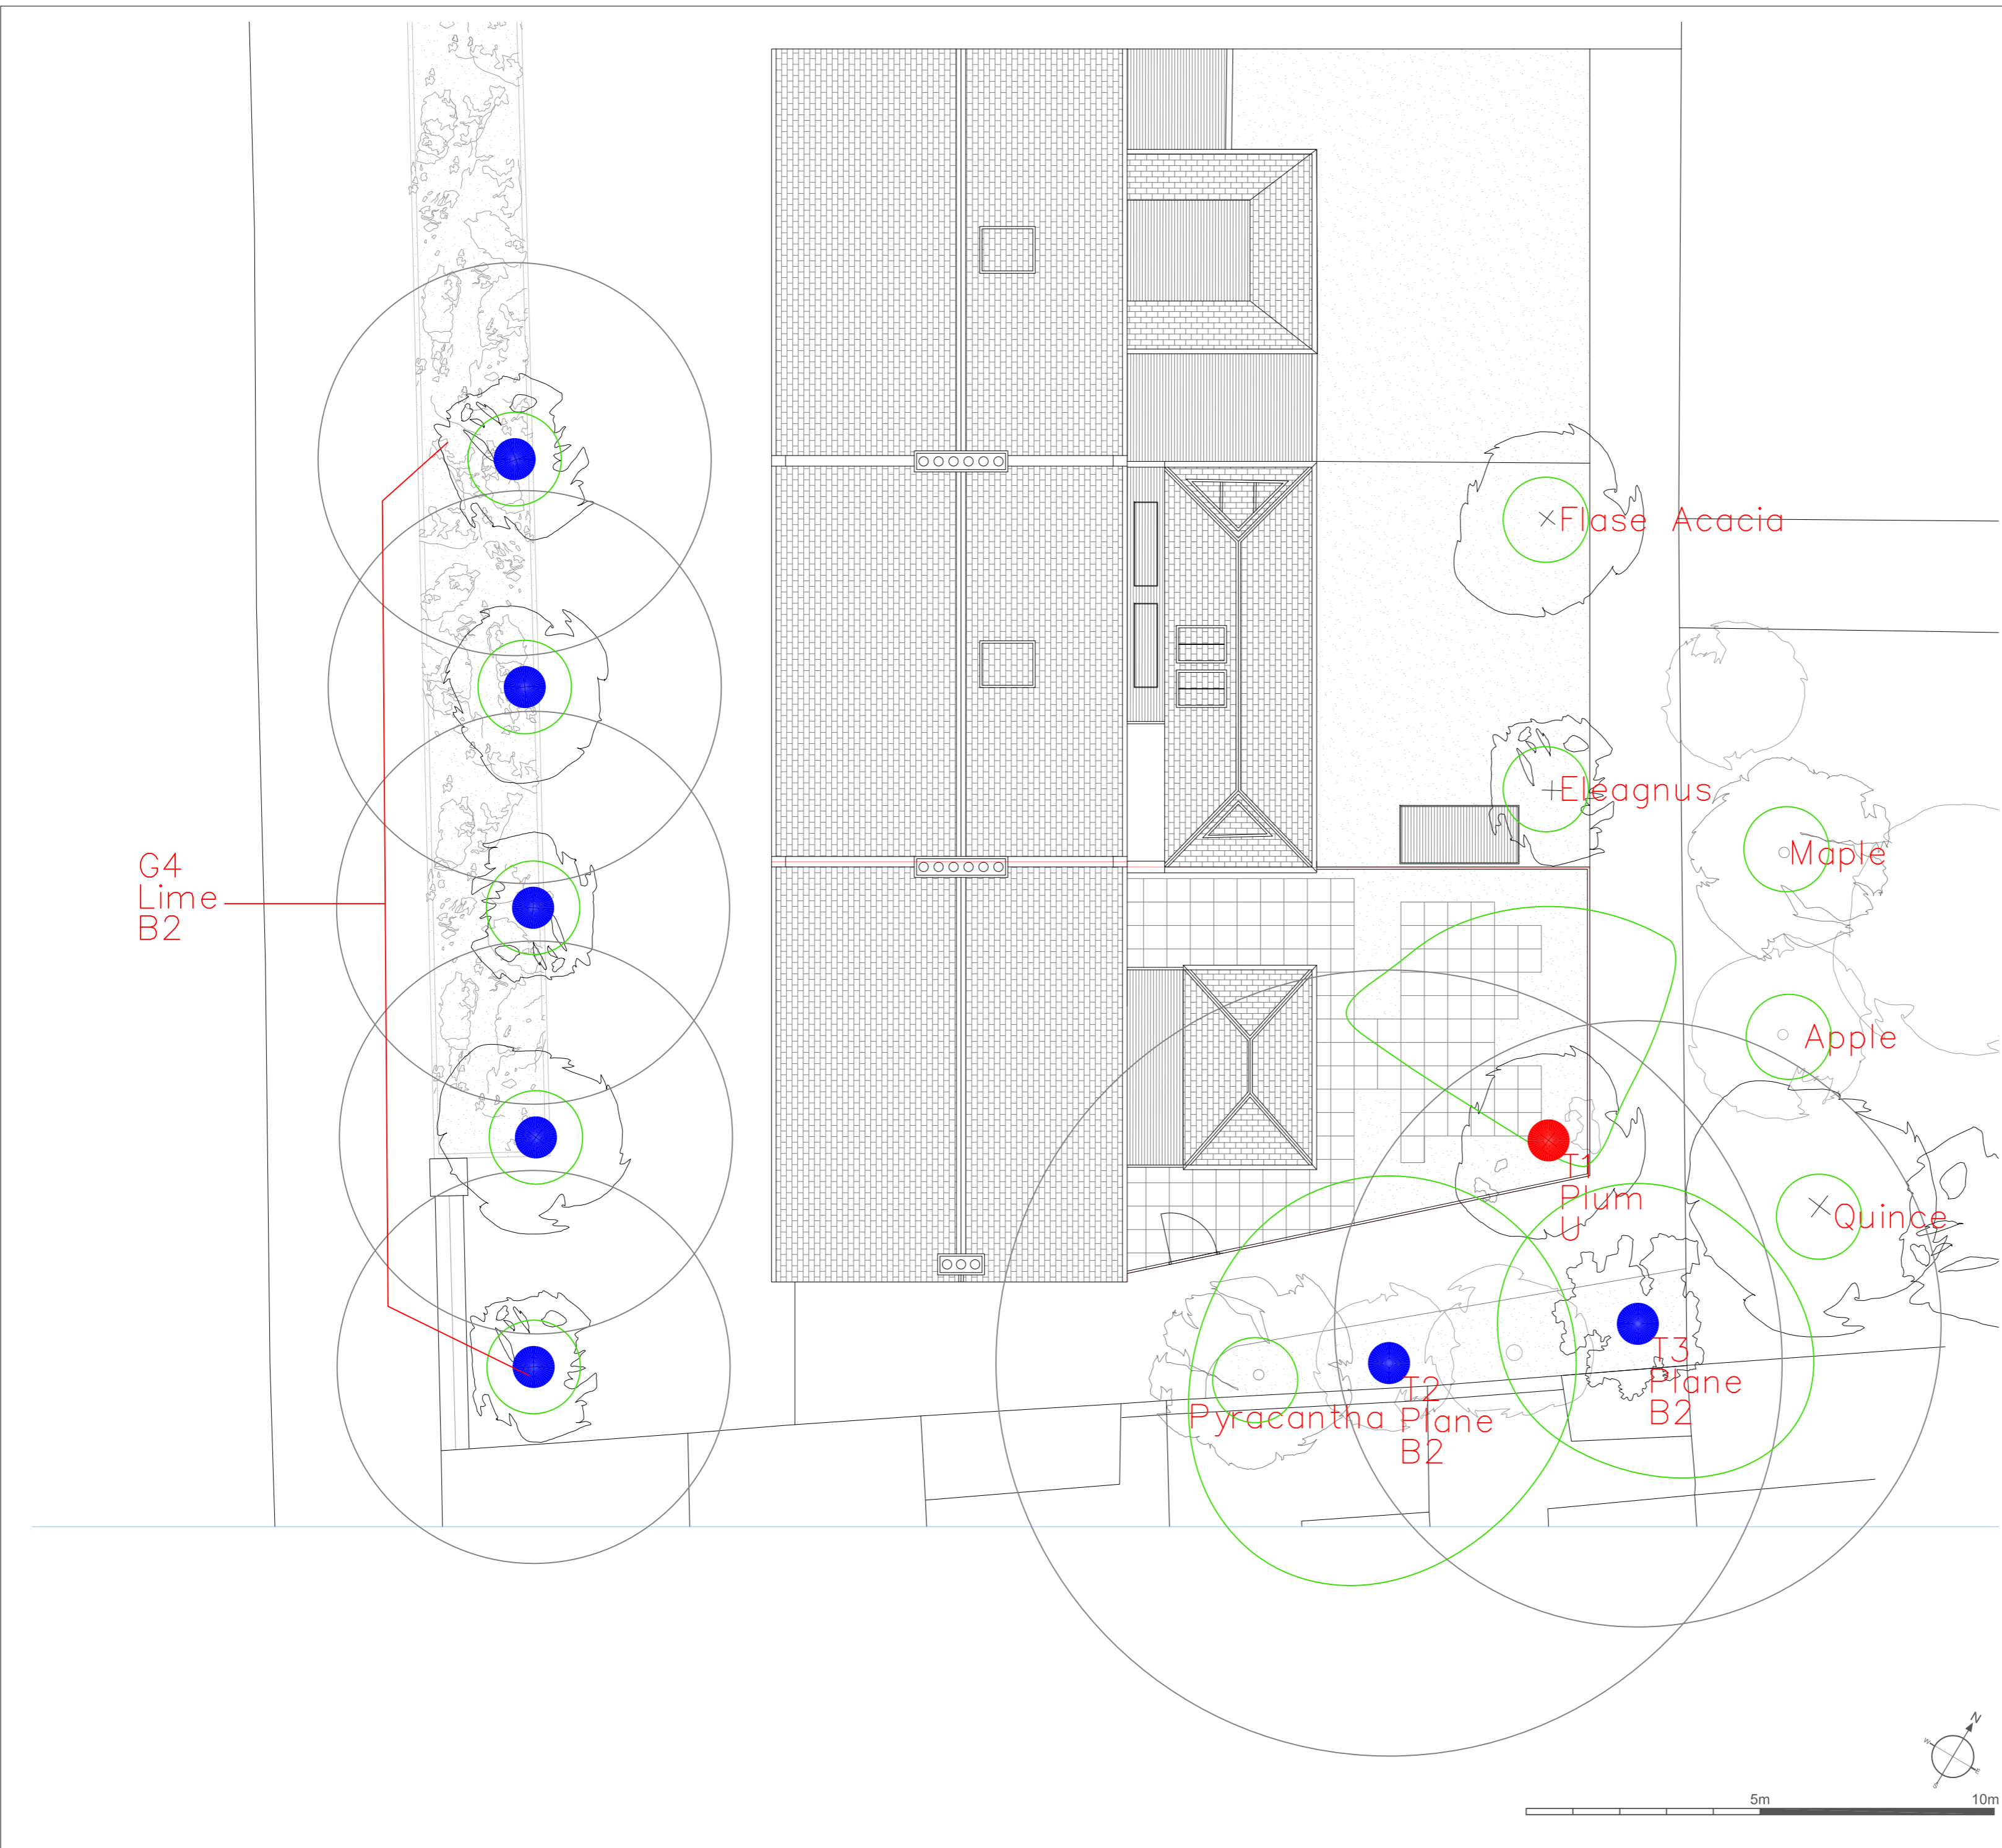
TREE CONSTRAINTS PLAN

4.1.8 In this instance, the only internal site tree is unsuitable for retention and therefore few significant primary constraints upon development, provided it will not be necessary to build right up to the boundaries.

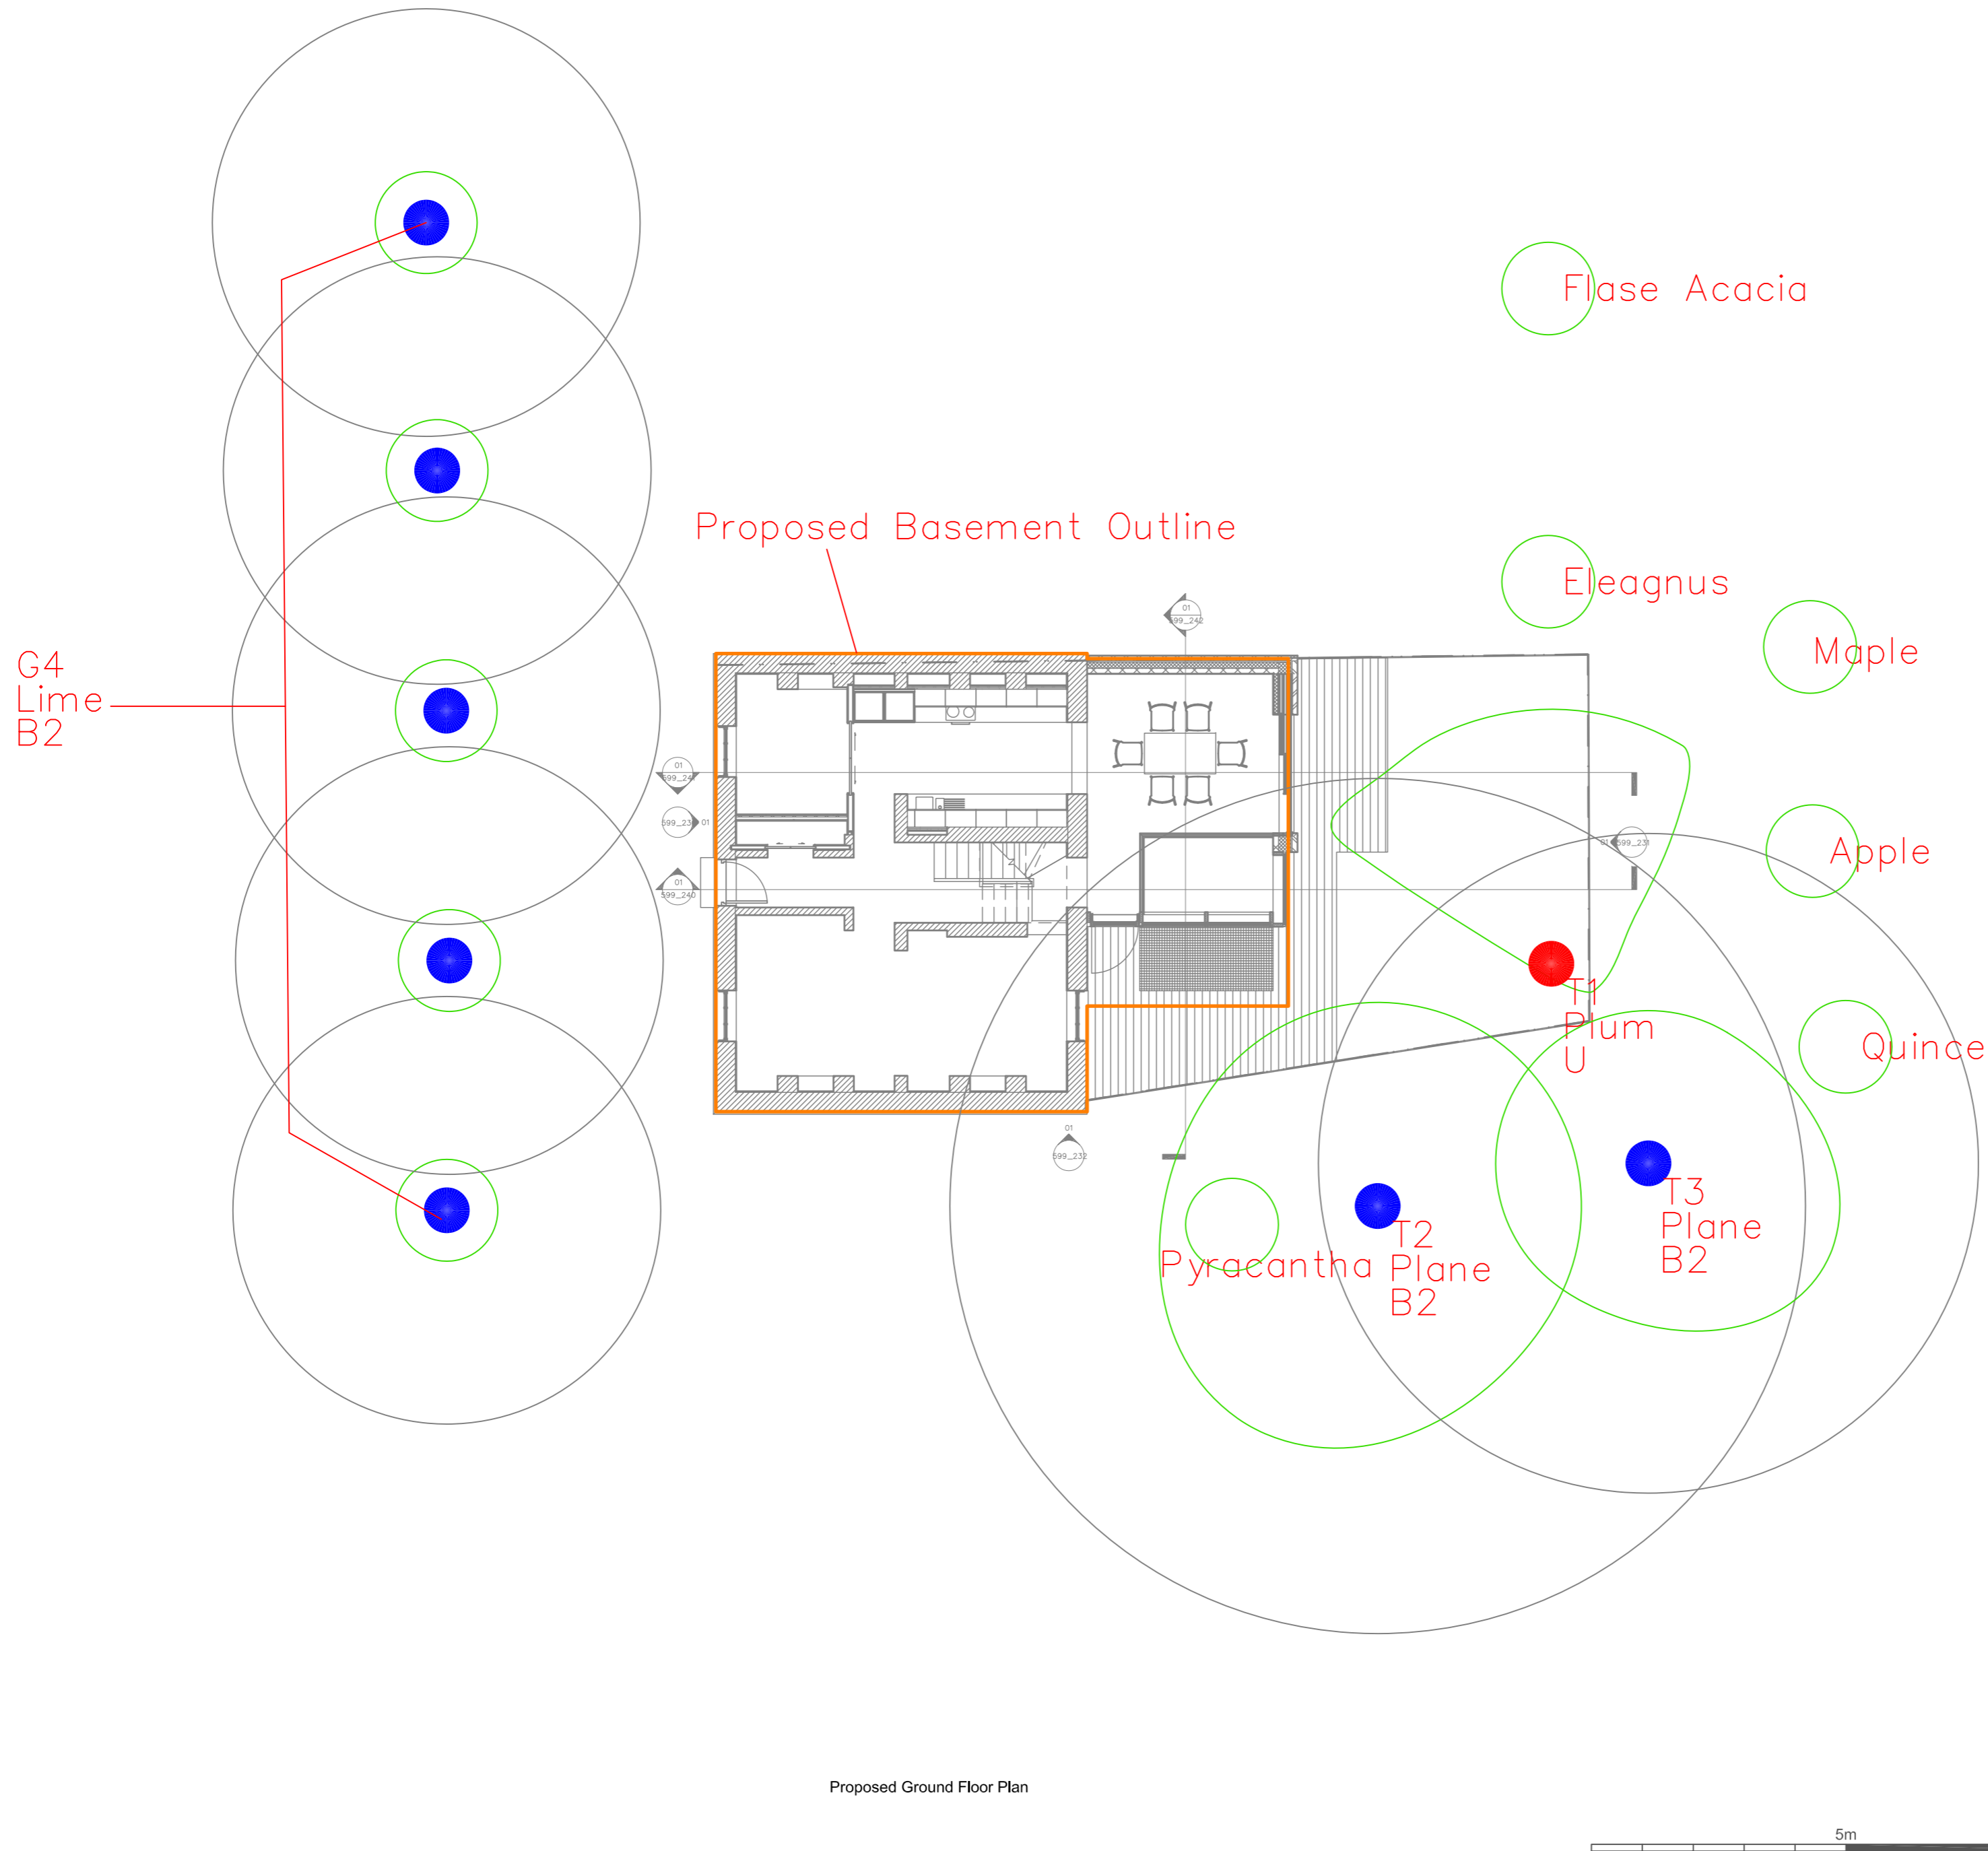
- i. Ground Floor

- 6.1.1 The principal impact in the current proposals comprises the encroachment of the theoretical RPA of T2 by the rear extension, particularly the basement extension. The new basement footprint occupies 20.4sqm of the RPA of T2, of which 7.2sqm is part of the existing basement leaving a new encroachment of some 13.2sqm or 5.95% of the total area. The likely impact of this is assessed as being low, although the presence of the existing foul water drain along the route indicated on the sketch below may well have deflected the passage of roots along its course which will reduce the likely impact. The proposed mitigation of manual excavation of the top 750mm of the basement line with pre-emptive root pruning will further reduce this impact to very low levels

- 6.1.2 Provided the mitigation detailed in paragraph 6.3.1 is adopted, the demolition of the rear extension will be of very low impact to T2.
- 6.1.3 Any replacement and remodelling of the hard landscaping within the RPAs of T2 and T3 will require a no-dig construction methodology and utilise a permeable finished surface.

6.3.1 All plant and vehicles engaged in demolition works should either operate outside the RPA, or should run on a temporary surface designed to protect the underlying soil structure. The demolition of the building should proceed inwards in a "pull down" fashion. Hard surfacing can be lifted with caution by a skilled machine operator again working away from the tree.

6.3.2 The path of foundations through RPAs will be manually excavated to 750mm depth under arboricultural supervision; any roots encountered within the trenches / pits will be cleanly pruned back to an appropriate junction with a sharp pruning saw or secateurs back to a junction. Roots larger than 25mm diameter may only be cut in consultation with an arboriculturalist.

6.3.3 The replacement paving/hard landscaping will require a no-dig construction technique, either using a cellular confinement system with no fines aggregate for the sub-base or simply building upon the existing sub-base without disturbing the ground below. Choice of construction method will initially depend upon root penetration within the existing sub-grade. The key principle is not to excavate in the presence of roots and to provide a porous surface to promote healthy soil water relations for future root growth. A further consideration in the use of a more expensive cellular confinement system or similar, may be the claimed reduction in risk of possible future slab / surface displacement by roots of trees growing in paved areas.
