**Project**  
Goodenough College  
47, Mecklenburgh Square, London  
WC1N 2AD

**Drawing Title**  
Existing Balcony Details

Drawing number 17023-CBP-XX-XX-DR-A-0002 P04  
Revision

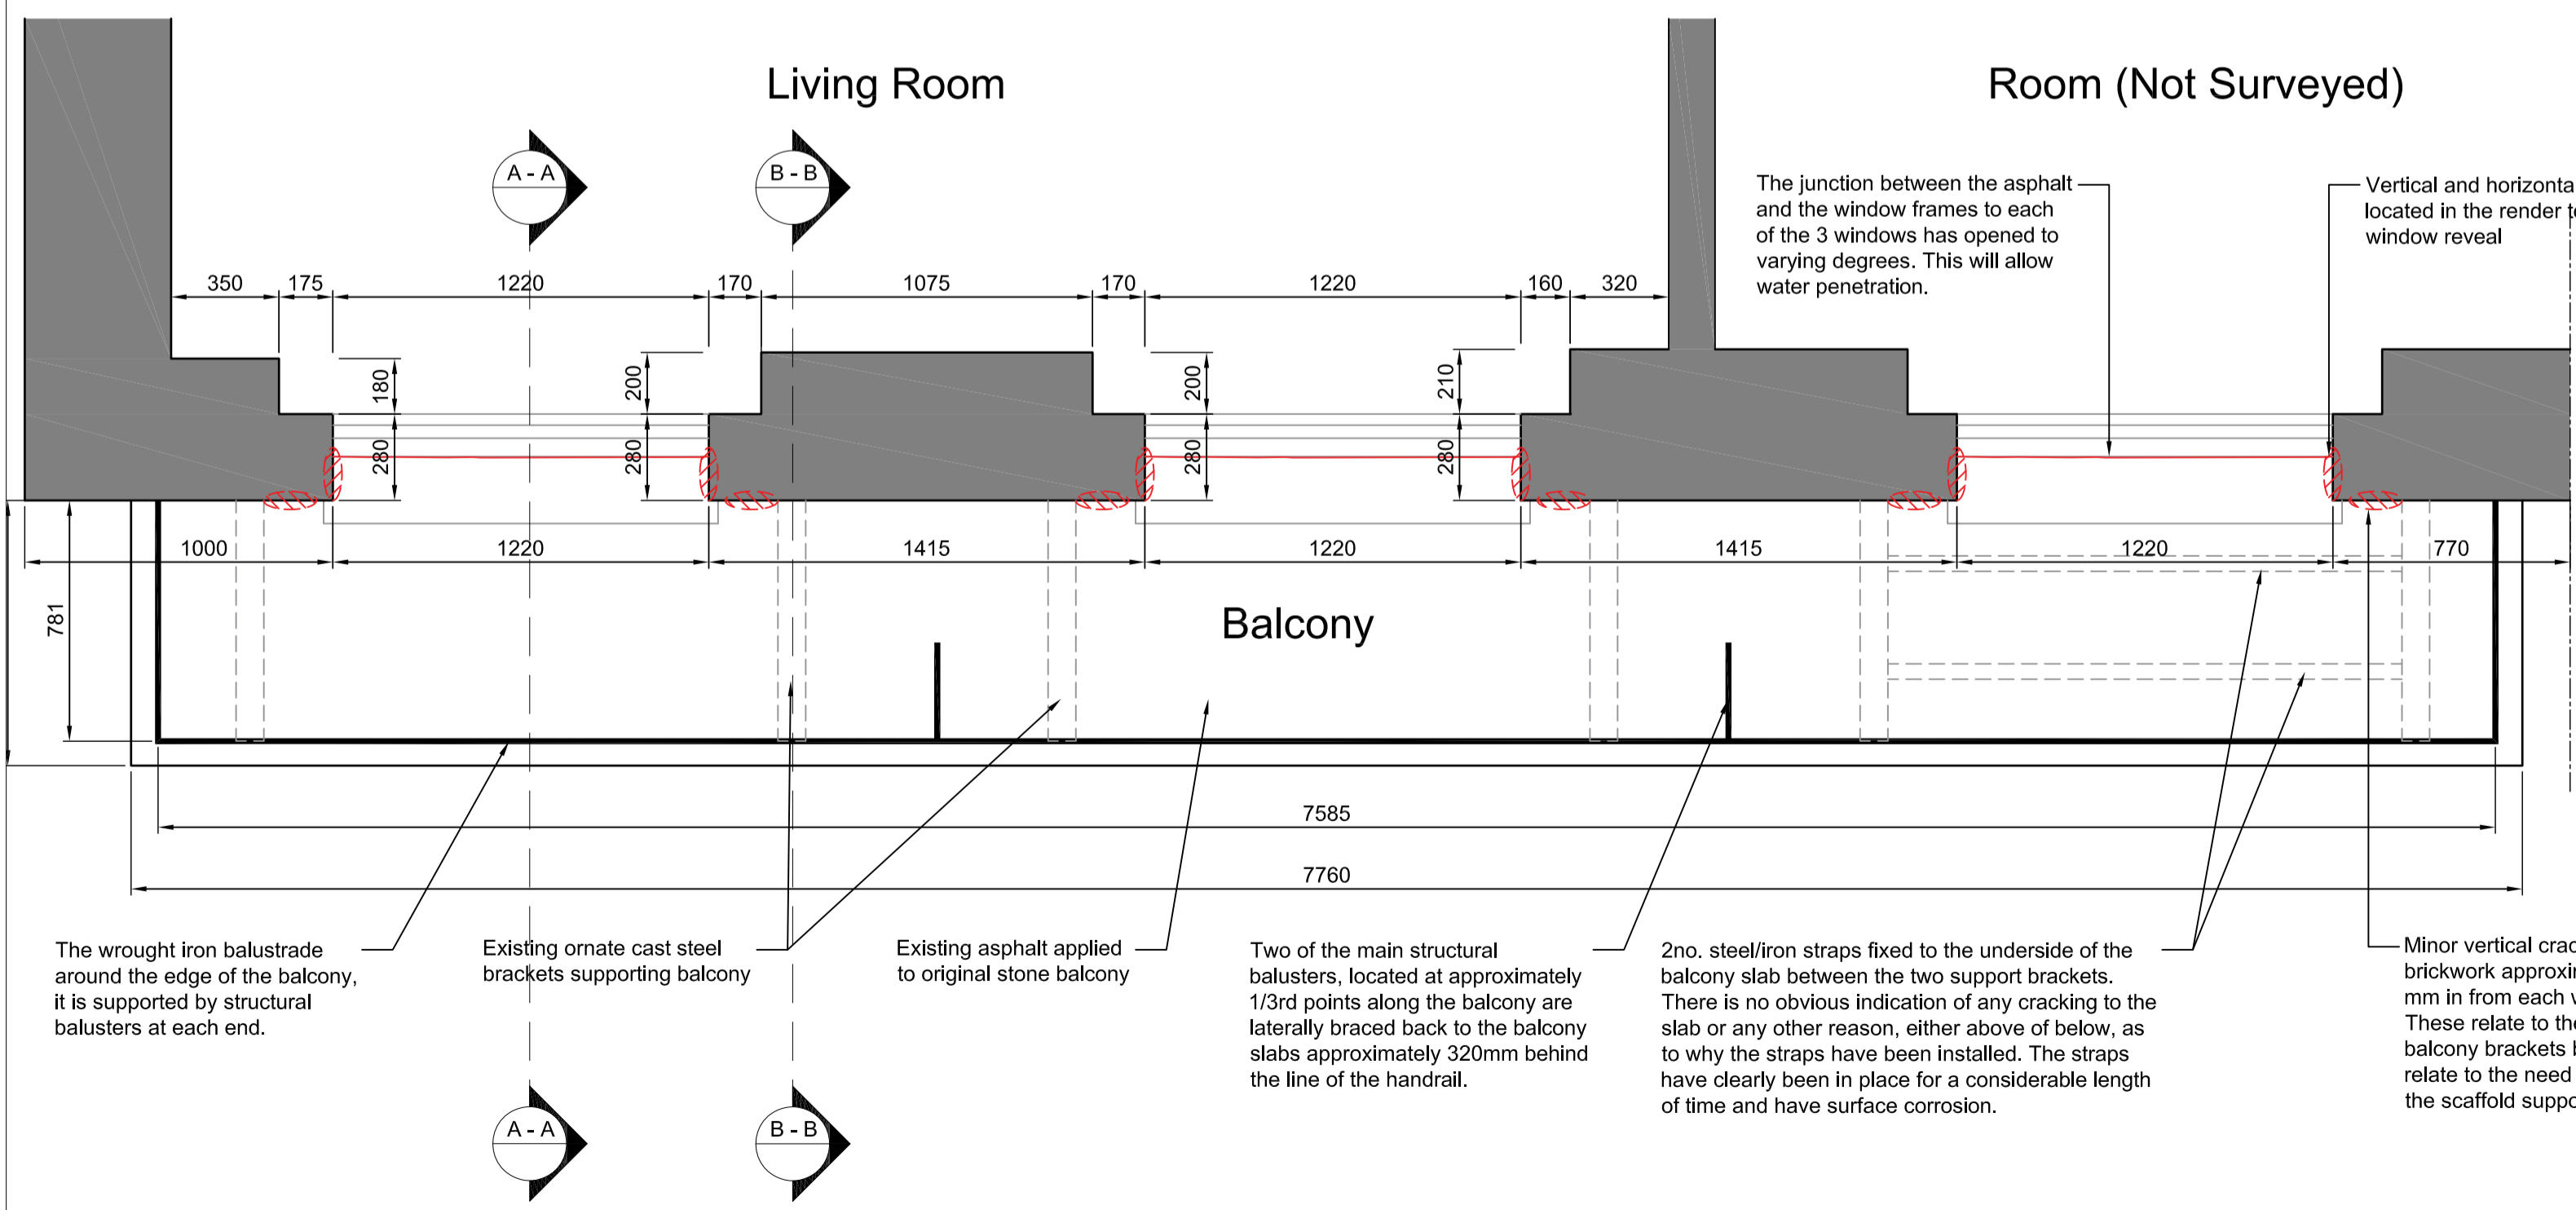
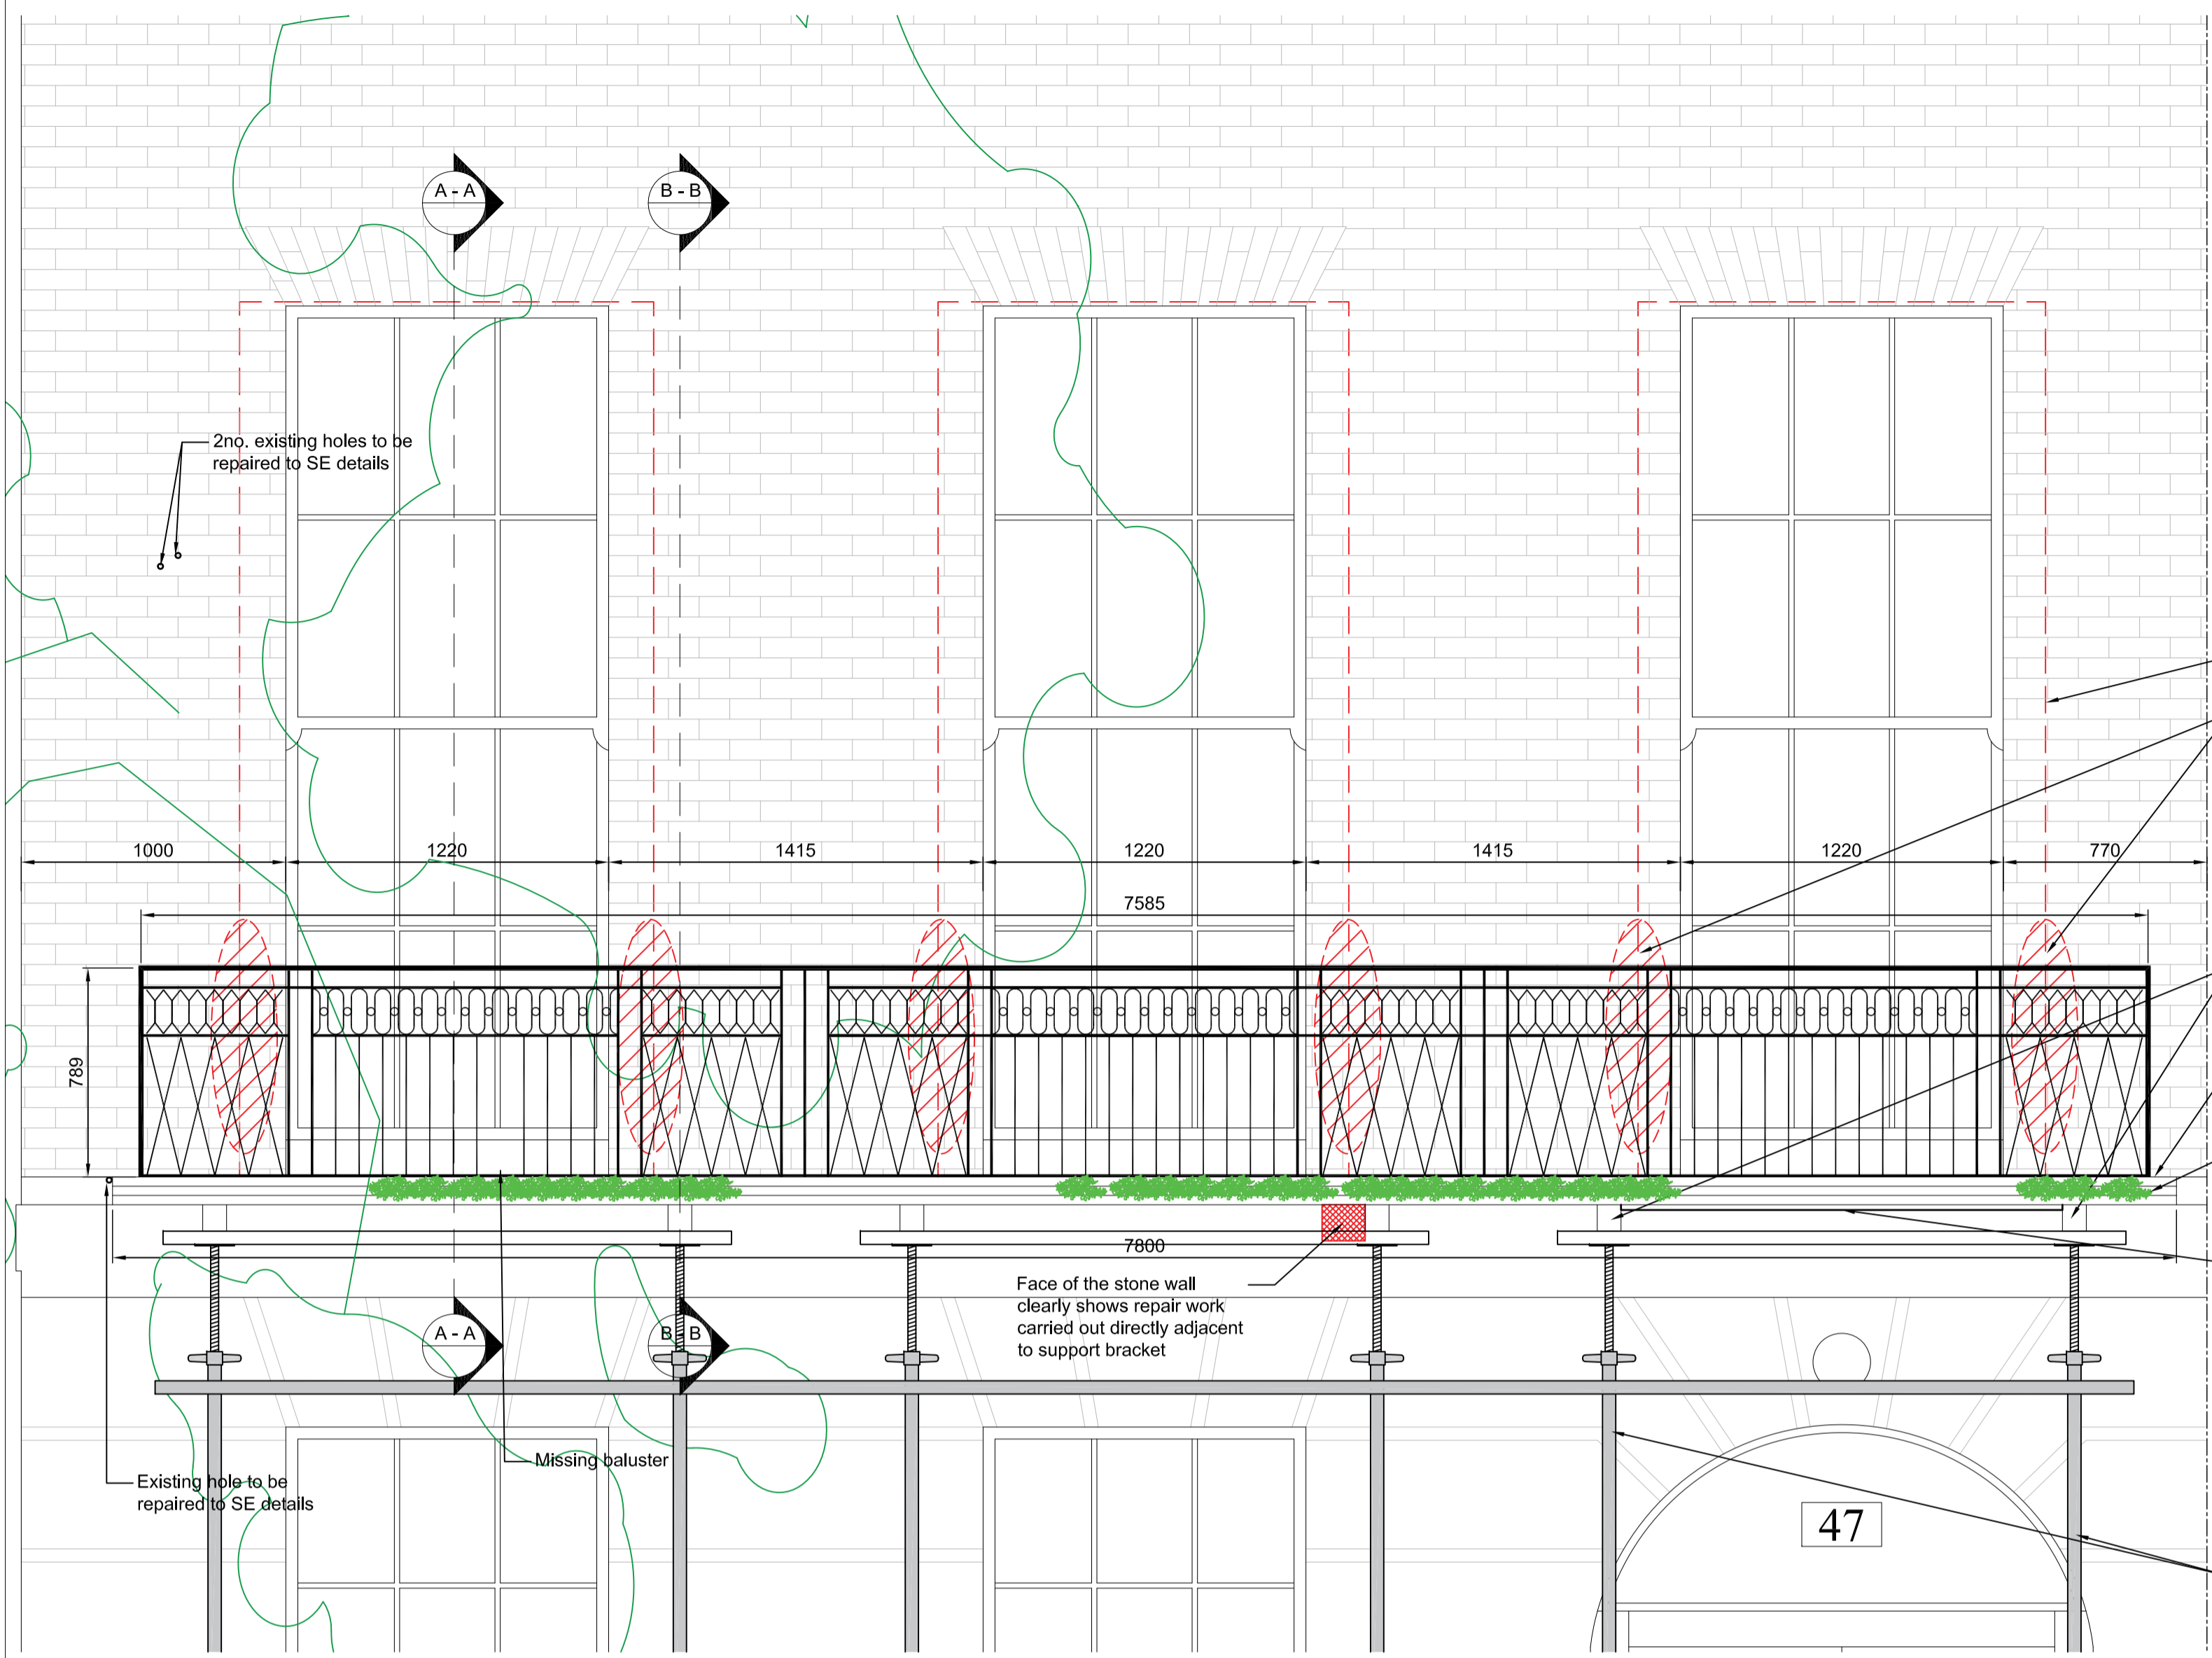
**EXISTING BALCONY DESCRIPTION**

**Cast Iron Brackets**  
6no. ornate cast iron cantilever brackets solidly built into the front wall. The brackets project approximately 780mm out from the wall and are built up to 50-60 mm back from the inner face of the brick wall. The inner face and outer face of the brackets have surface corrosion and sitting directly above the cast iron brackets internally is a timber bearer.

**Stone Slab**  
The brackets are arranged so that two brackets support a stone slab which spans between them and cantilever 385 - 440mm at each end, giving three stone slabs with two butt joints along the length of the balcony. The slabs are 90mm (approx.) thick. It is not clear how far they are embedded into the front wall of the property, but it could be up to 225mm.

**Balcony Finish**  
The slabs are currently finished with mastic asphalt although this is considered to be a later addition and not original. It presents minor cracking which may be allowing water penetration. Vegetation is growing around the edge of the stone slabs and the underside of the stone slabs have flaking and missing paintwork.

**Balustrade**  
The cast iron balustrade around the edge of the balcony is formed from small section balusters with infill decoration and top and bottom rails. These are supported by structural balusters at each end which in turn are embedded in the stone balcony slabs and also support the curved wrought iron handrail. Two of the main structural balusters, located at approximately 1/3rd points along the balcony are laterally braced back to the balcony slabs approximately 320mm behind the line of the handrail. The mastic asphalt prevents water run off at the edges.

**Handrail**  
The handrail is 790mm height therefore it does not comply with the current Building Regulations in terms of height (Building Regulations requires 1100mm for balconies). It is fixed into the top of the stone slabs with a little outward deflection when pressure is applied to the handrail.

**Front Wall**  
Is constructed using London common brick from first floor upwards, it is assumed to be formed by solid brickwork with no cavities, with ashlar stone facings at basement and ground floor levels. A prominent stone string course is located just below 3rd floor window level. There are existing historic windows repairs above the lintel head to the brickwork panel.

**Windows**  
Tall sash windows have an outer reveal in the facing brickwork which 280mm deep and an inner reveal that is approximately 200mm deep and set 160-175mm inside the outer reveal. The junction between the asphalt and the window frames presents a gap which will allow water penetration. Also the render to each window reveal has horizontal and vertical cracking.

**First Floor**  
The floor is formed by floor joists which span parallel to the external wall.
