**47, Mecklenburgh Square, London, WC1N 2AD**  
**Report on Structural Inspection of Existing 1<sup>st</sup> Floor Balcony**  
**26.04.2017**

**CBP Architects Ltd**

Document Reference: 47 Mecklenburgh Square – Balcony

Project Number: 17023-CBP-XX-XX-RP-A-0001

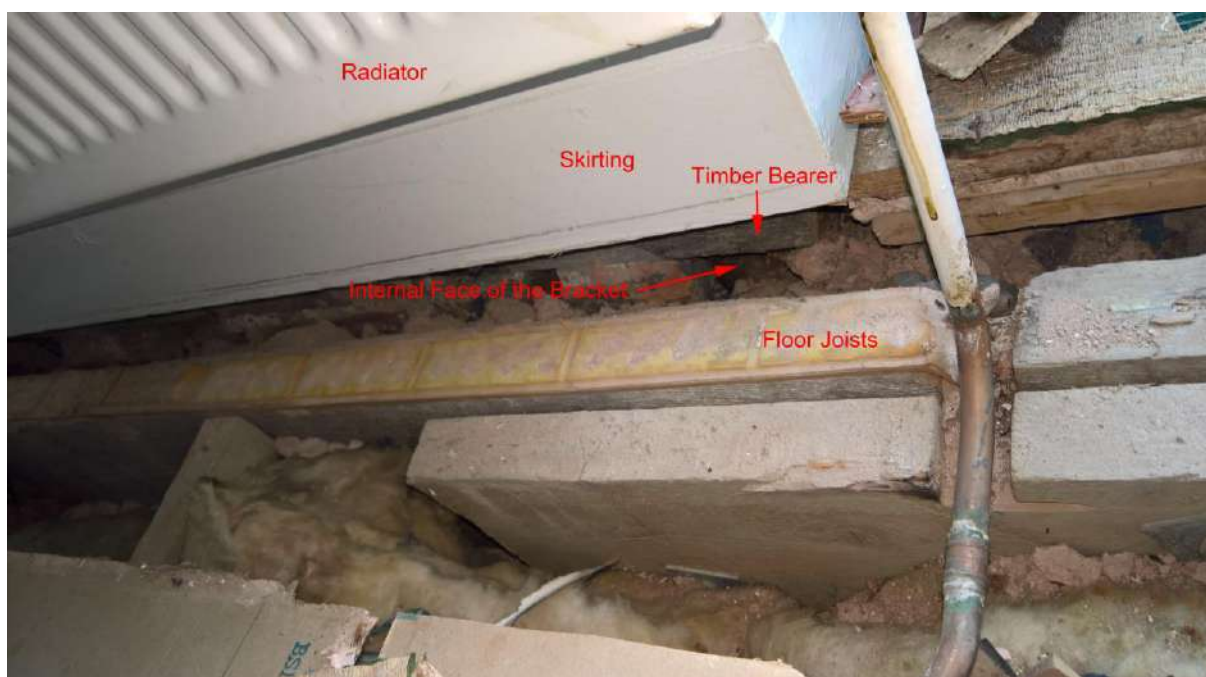
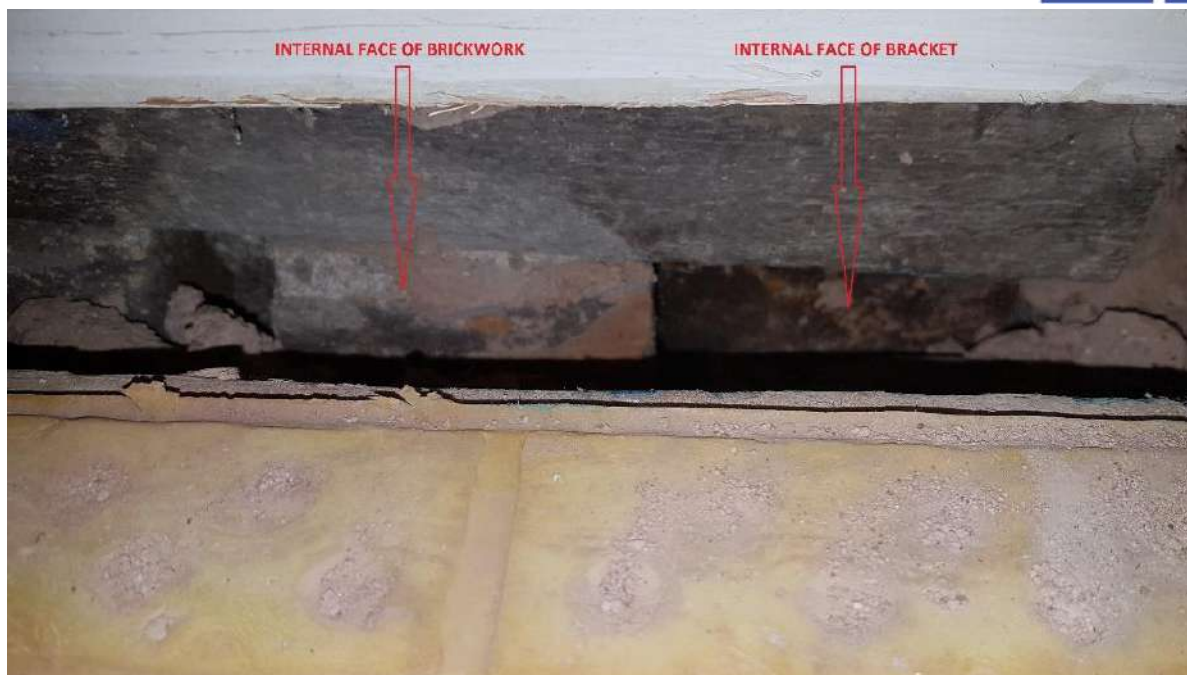
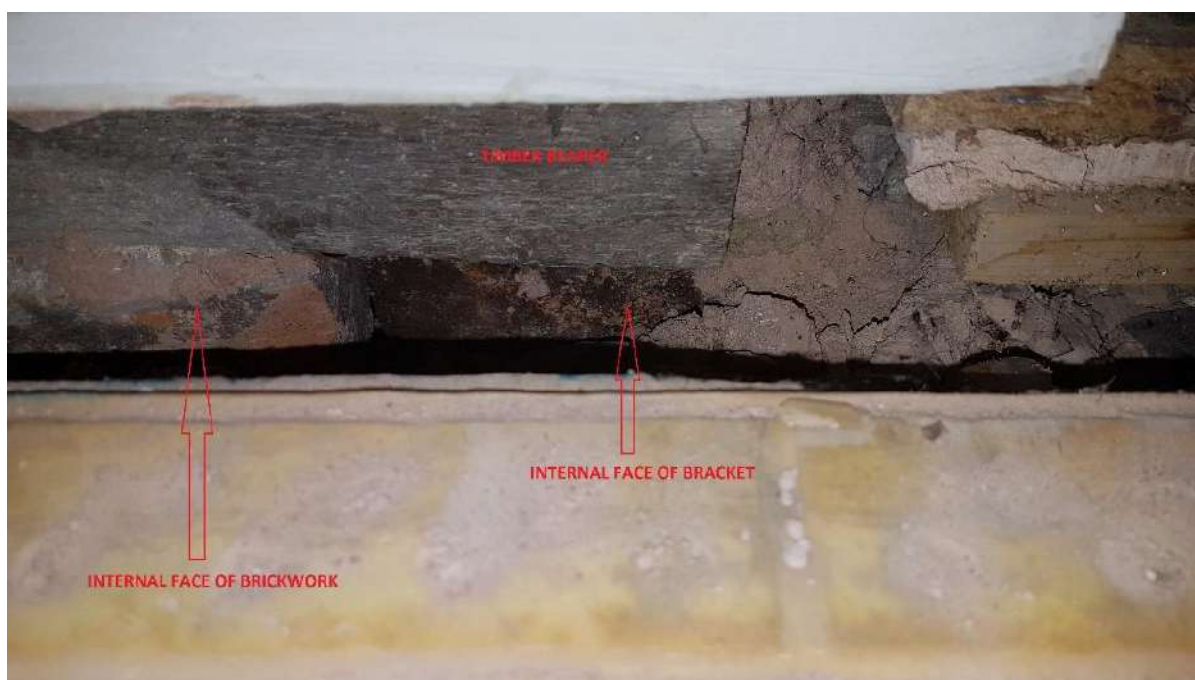
The cutting back of the internal flooring confirmed the rear of the support brackets project to approximately 50-60mm from the inner face of the brick wall. The floor joists span parallel to the external wall. The inner face of the brackets have surface corrosion only. Sitting directly above the cast iron brackets is a timber bearer spanning over the top of the bracket. See the following photographs. The stone slab of the balcony could not be viewed from the internal face.

View of inner face of brickwork and rear of bracket.

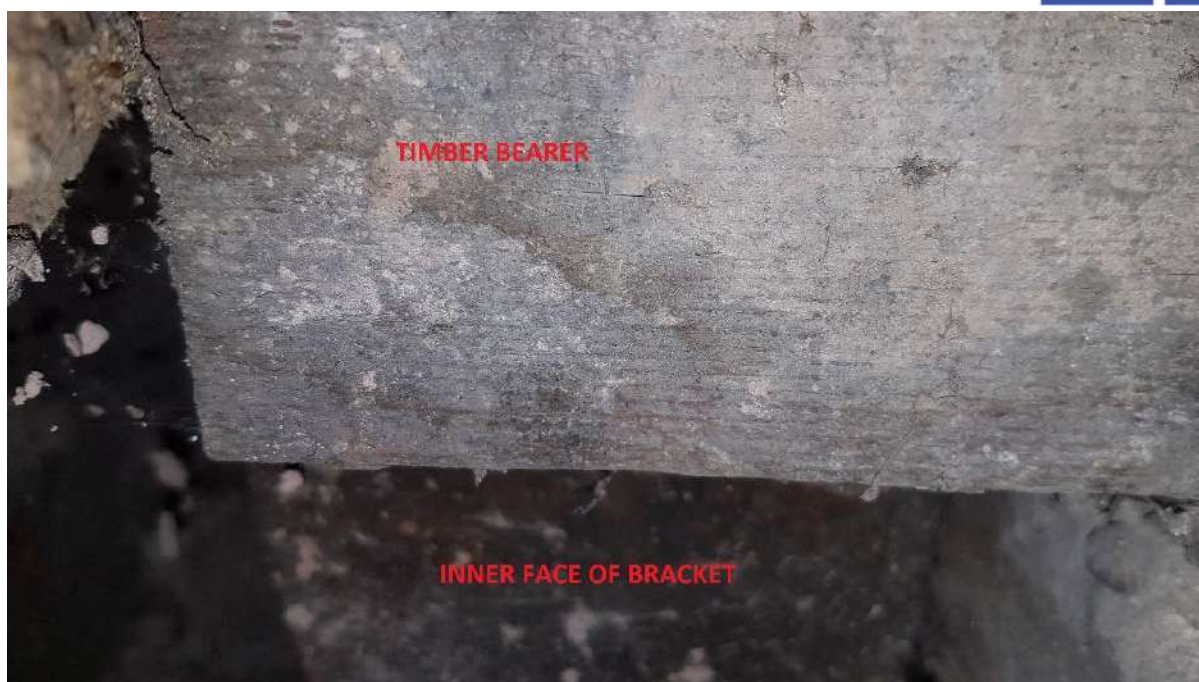
View of rear of bracket and timber bearer from opposite end of brick pier.

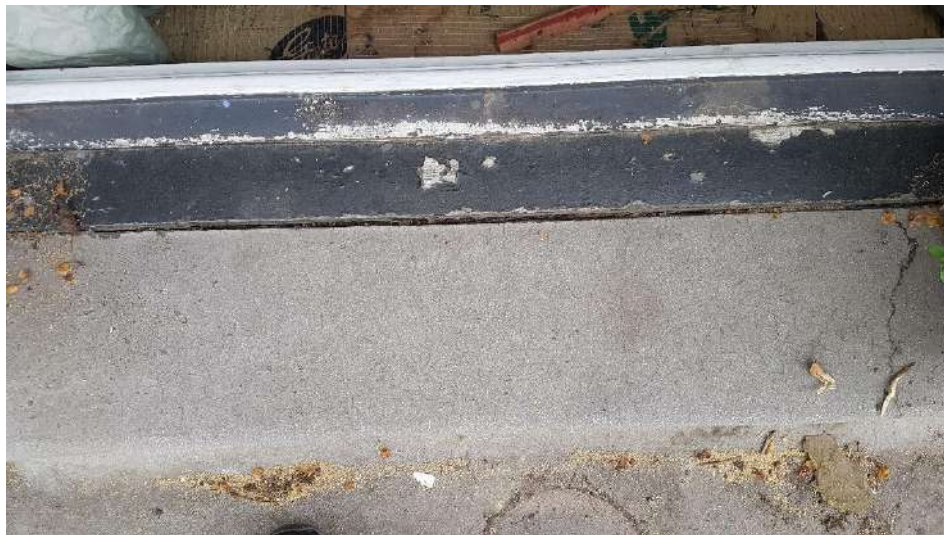
- The junction between the asphalt and the window frames to each of the 3 windows has opened to varying degrees. This will allow water penetration to the substrate.

View showing gap between back of asphalt and window frame

We would propose the removal in the mastic asphalt from the top surface of the balcony and replacement with either a new slip resistant breathable epoxy resin material that will allow water to drain from the top surface or a membrane type coating that is non-slip and bonded to the stone surface of the balcony slabs. When the mastic asphalt is removed the embedment of the balusters into the balcony deck can be checked. The replacement finish needs to be agreed with the local planning authority.

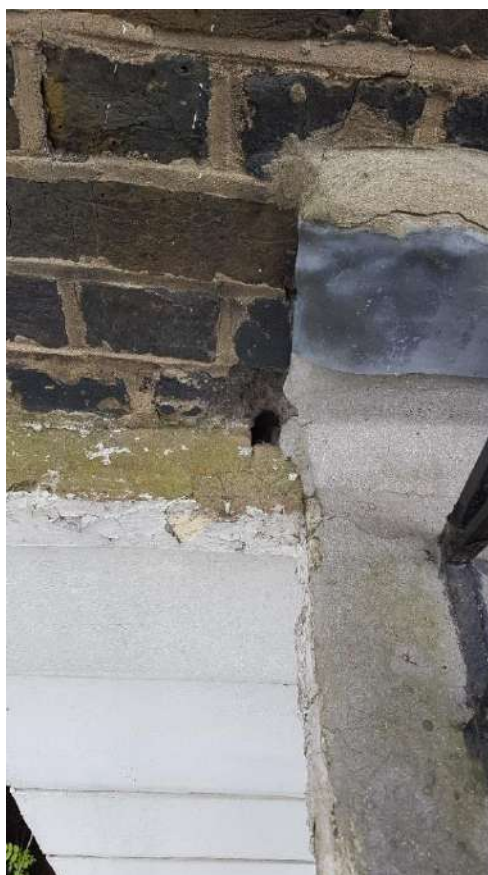
- There is a small hole in the main front wall at balcony level directly adjacent to the left hand end as viewed from the front, within the stone string course, this was approximately 60mm deep when penetrated with screwdriver.

View showing small hole in wall

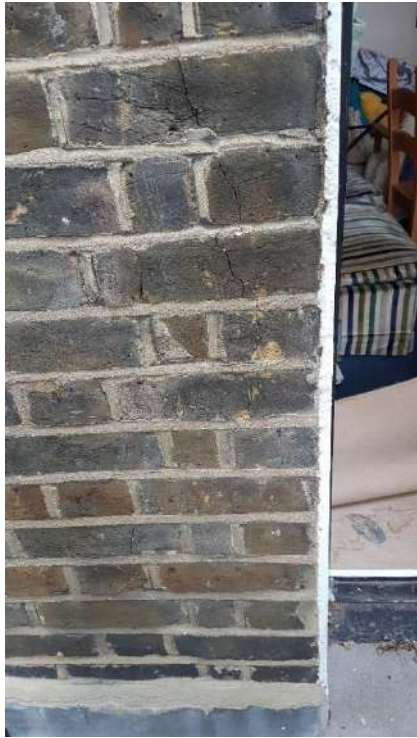
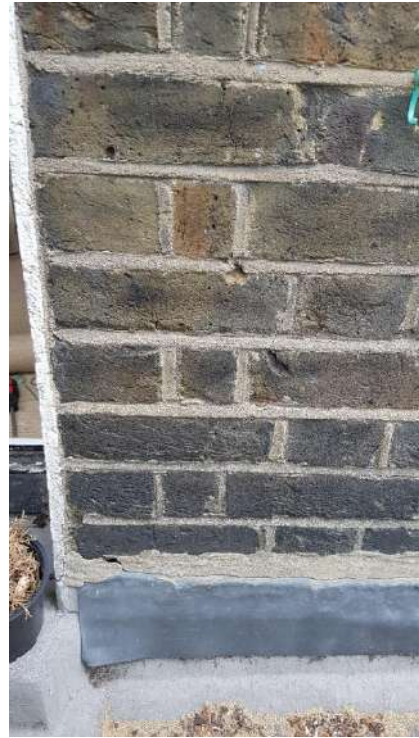
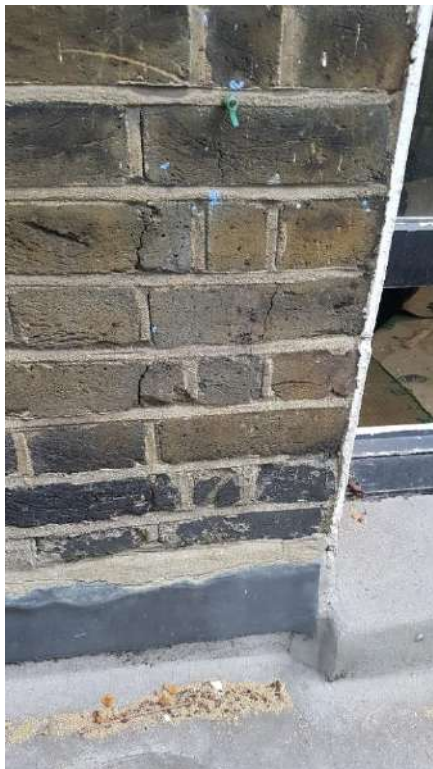
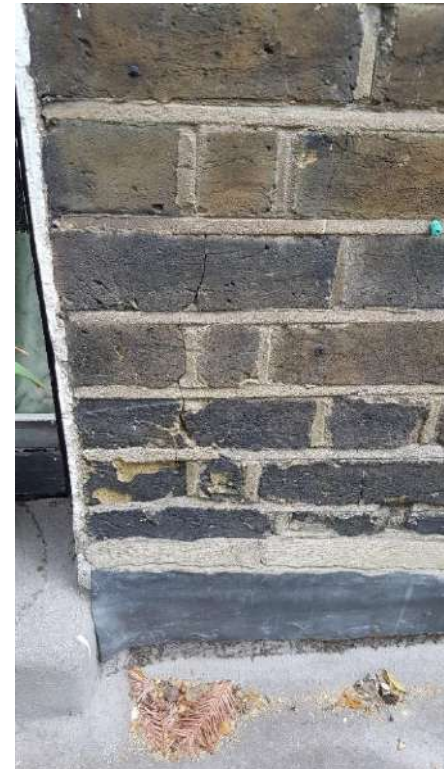
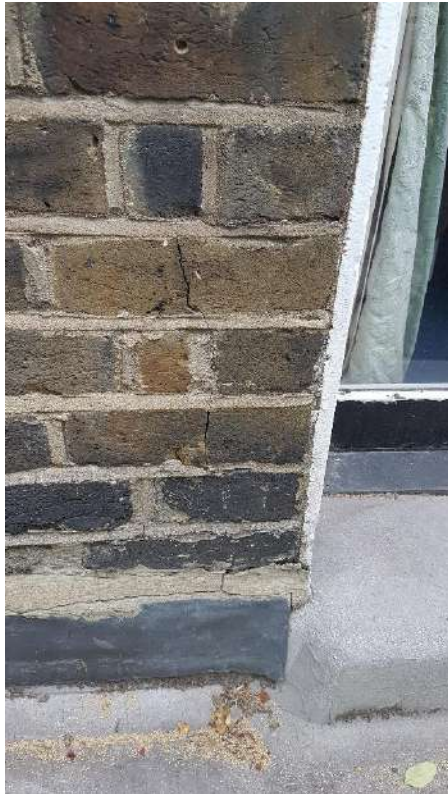
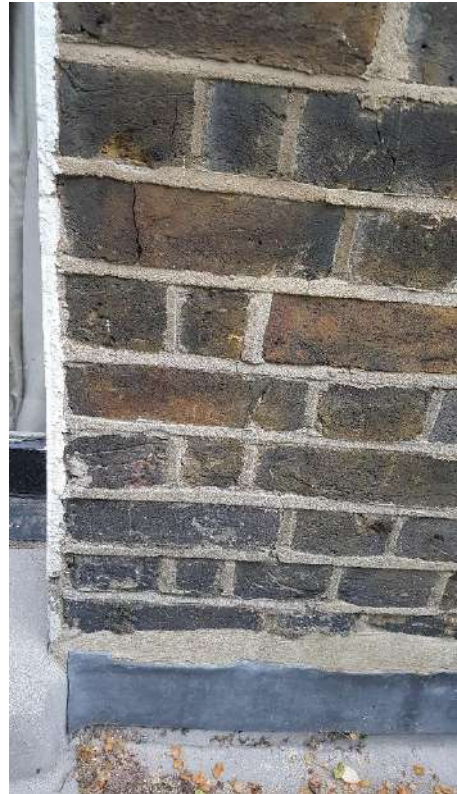
- There are minor vertical cracks in the facing brickwork approximately 100-150mm in from each window reveal. I believe these relate to the location of the balcony brackets below and may relate to the need for installation of the scaffold support.

The vertical cracking in the facing brickwork which is evident adjacent to each of the windows should be remediated using a low viscosity or thixotropic epoxy resin injection grout (Fosroc Nitofil LV/HV), applied under pressure as previously discussed.

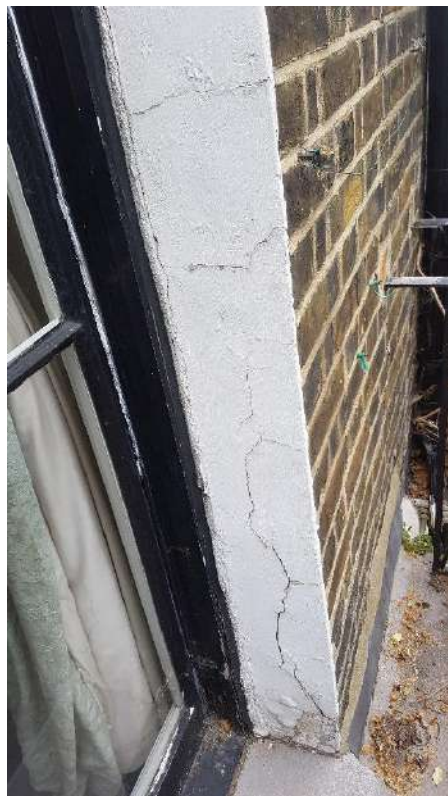
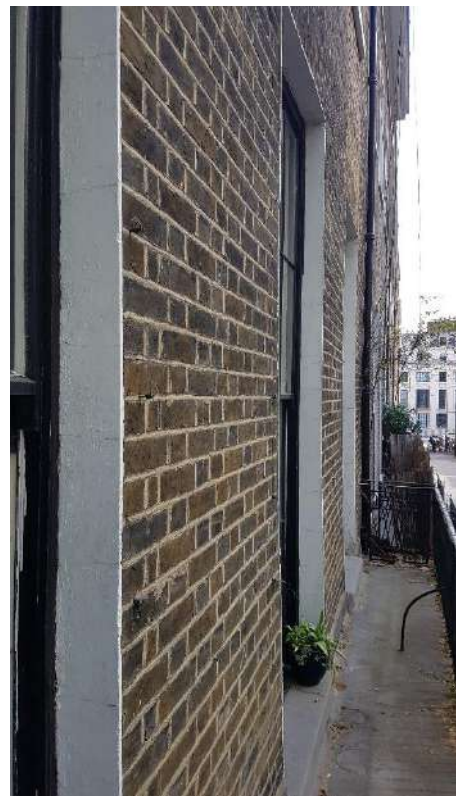
- The render to each window reveal has horizontal and vertical cracking.

Window reveal render cracking

The cracked render reveals to the windows should either be pointed or the render removed and replaced.

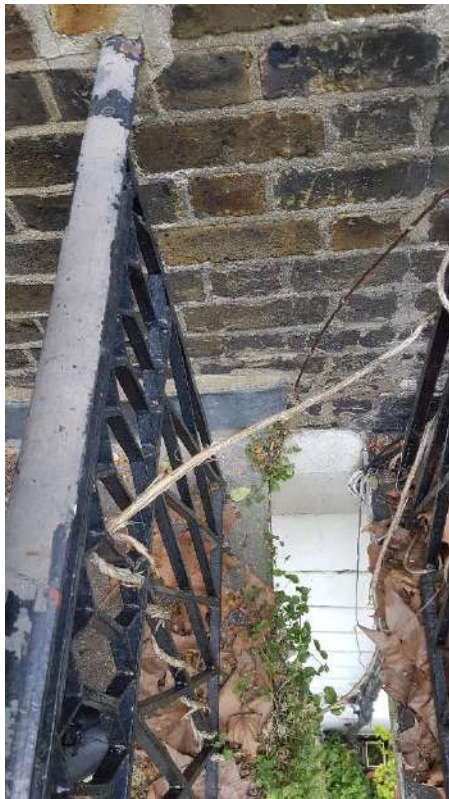
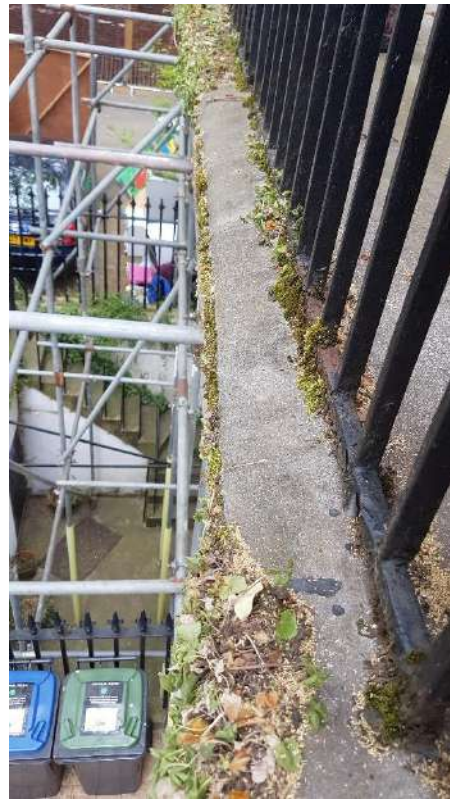
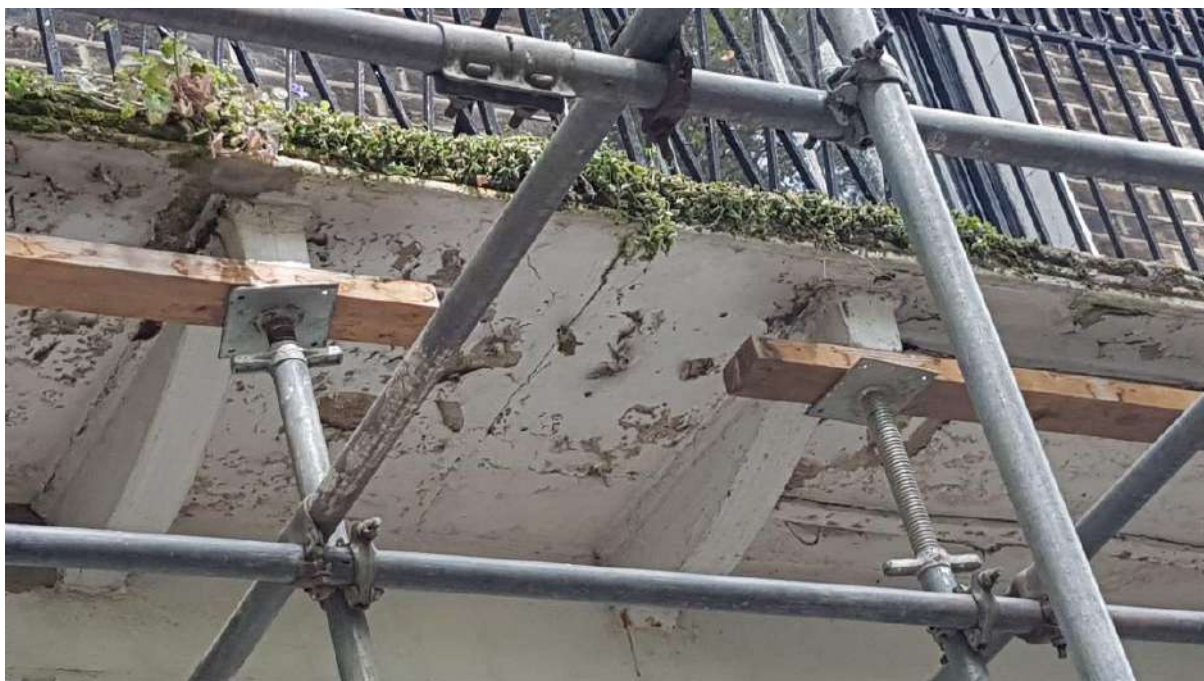
- Vegetation is growing around the edge of the balcony slabs.

Vegetation on edge of balcony

Vegetation on edge of balcony and collecting around bottom of the balustrade, trapping water

Vegetation on edge of balcony, balcony stone joint shown.

The vegetation growing on the edge of the balcony should be carefully removed and the stone inspected for localised stone repairs to be carried out.

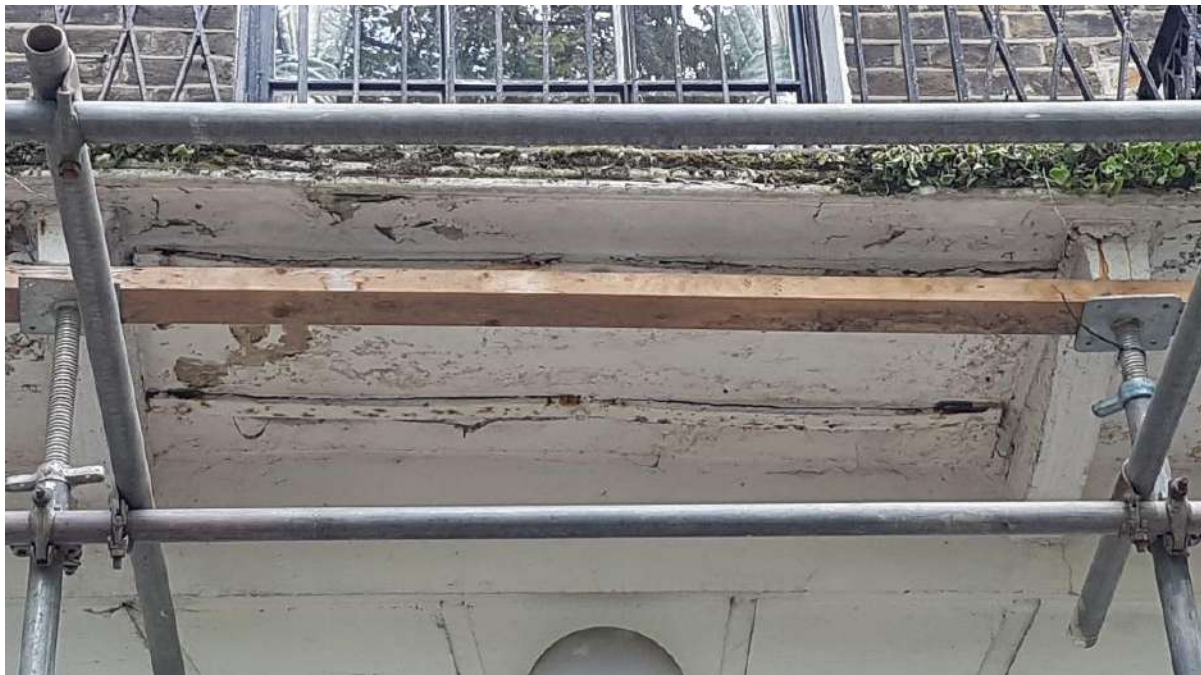
- There are 2 steel/iron straps that have been fixed to the underside of the balcony slab between the two support brackets either side of the right hand window over the front door/ entrance steps. There is no obvious indication of any cracking to the slab or any other reason, either above or below, as to why the straps have been installed. We speculate that as they are located above the main entrance door, they may have supported a light or ornamental decoration previously or may have been fixed there as part of the 2<sup>nd</sup> WW bomb repairs. The straps have clearly been in place for a considerable length of time and have surface corrosion. After the intrusive site visit 1<sup>st</sup> June 2017 identified that the steel straps are also located to the upper level and span over the steel support brackets of the balcony stone slab, with fixings through the slab to the underside metal straps.

View indicating steel/iron support straps – surface degradation – brackets require replacement with new treated steel straps above and below, fixed through the stone slab.

- The existing metal straps fitted to the soffit of the stone, and bolted through to the top straps, should be fully exposed, and the fixings reinforced/ or replaced with galvanised steel, with new fixings with required ties over the cast steel brackets to Structural Engineers details.

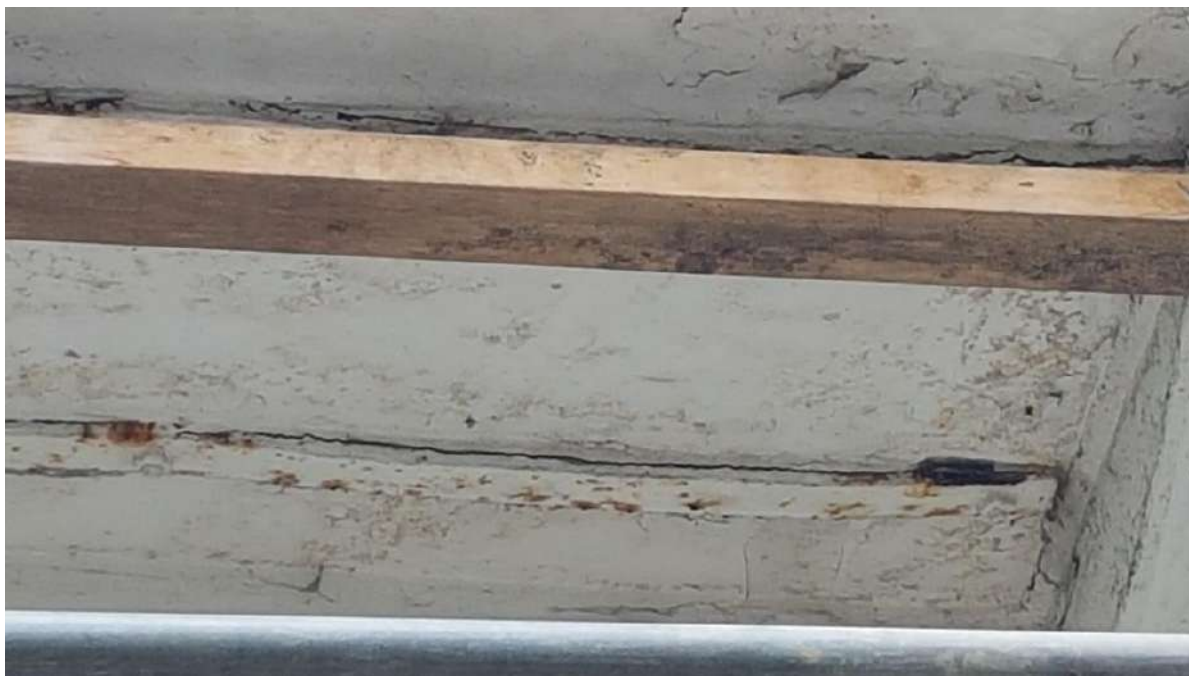
View indicating steel/iron support straps – note corrosion

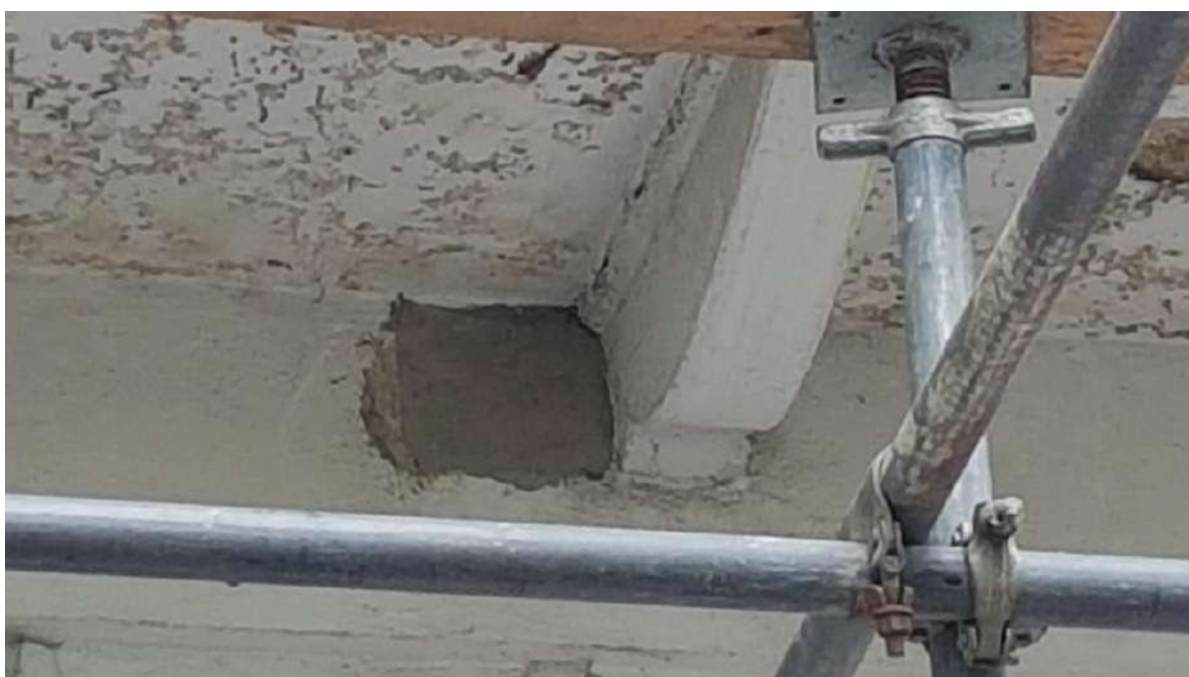
- The face of the stucco has clearly undergone repair work directly adjacent to the support bracket located to the right of the middle window.

View showing the repair

It is clear that a repair has been undertaken directly adjacent to one of the brackets. The satisfactory support of each bracket is dependent on solid and stable support within the full extent of the wall. Closer inspection of each individual bracket where it embeds in the wall should be undertaken on site at construction stage. As a precautionary measure and to ensure there are no voids around the fixing brackets it would be prudent to drill small diameter holes into the stone, approximately 30mm from the face of the bracket and at 75mm centres. These holes should extend to within 75mm of the inner face of the wall. They should then be filled with a low viscosity or thixotropic epoxy resin injection grout (Fosroc Nitofil LV/HV), applied under pressure to ensure any minor cracks and voids located within

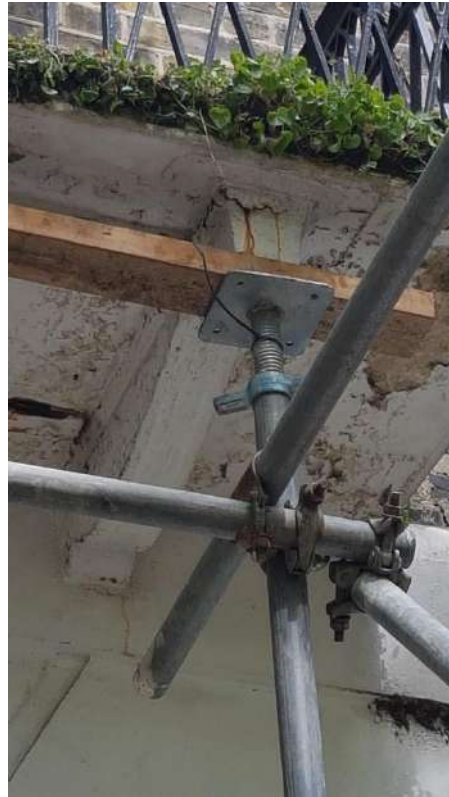
- The cast iron support brackets are showing signs of surface corrosion.

Bracket surface corrosion

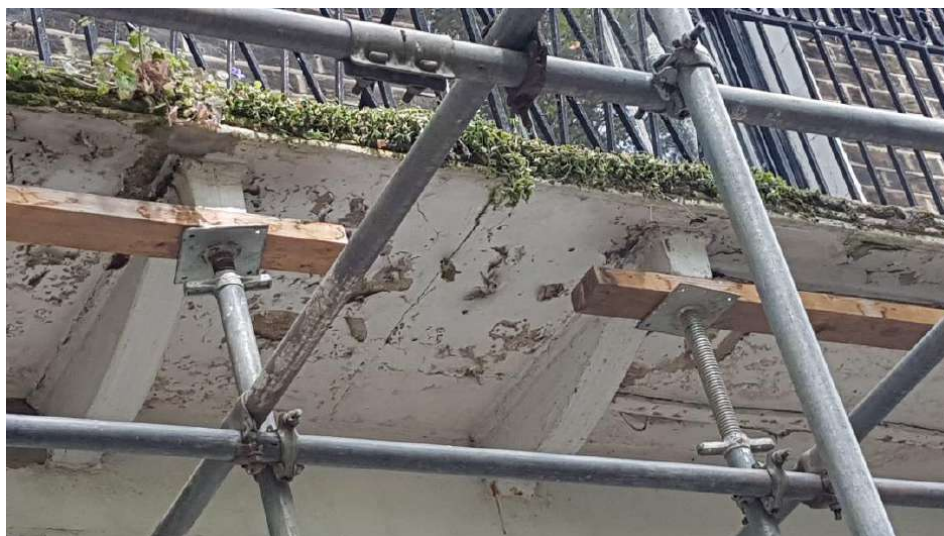
- The underside of the balcony slabs have flaking and missing paintwork.

Flaking and missing paintwork – stone abutment shown between brackets

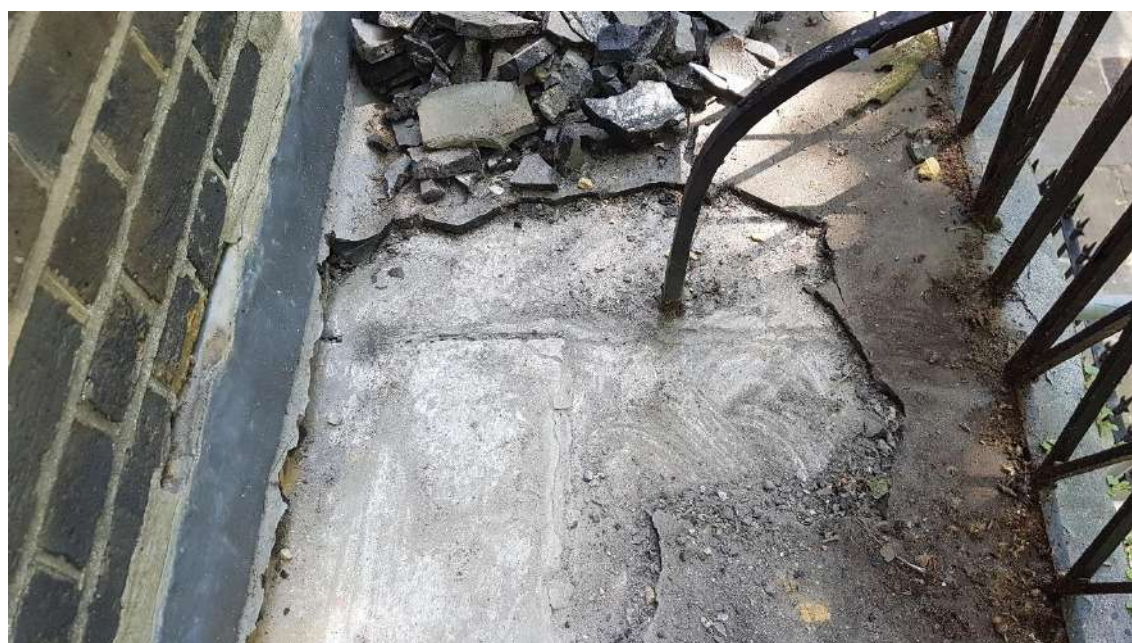
Removal from the Western Joint - Asphalt approximate 20/25mm thick on cementitious repair

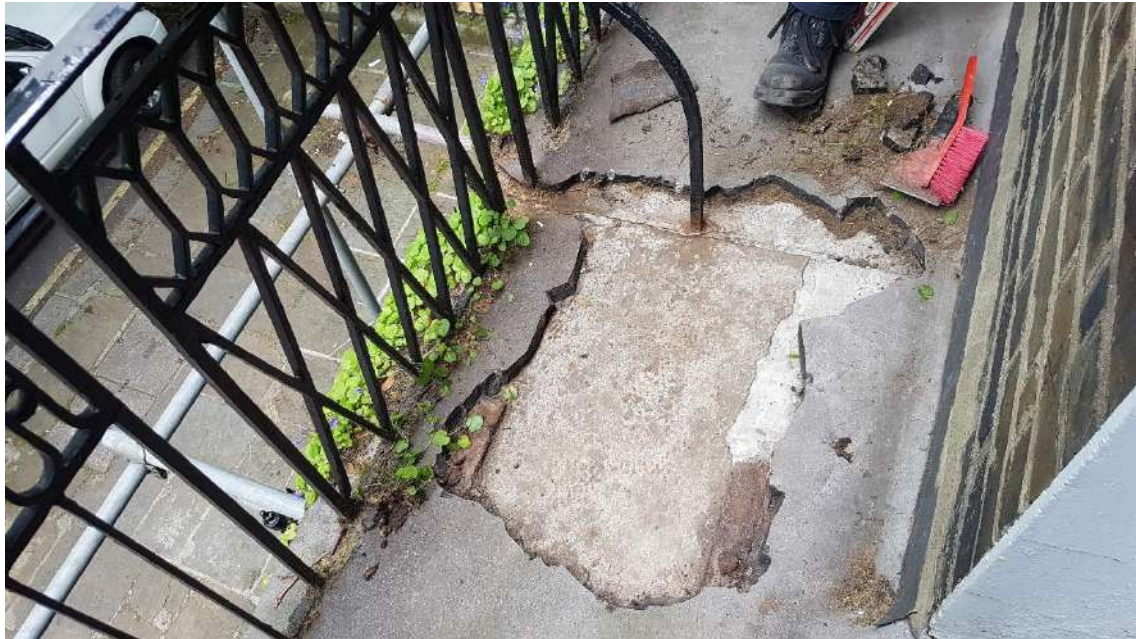
Removal from the Eastern Joint over the front door, showing the reinforcing steel and fixings, Asphalt 50-60 mm thick

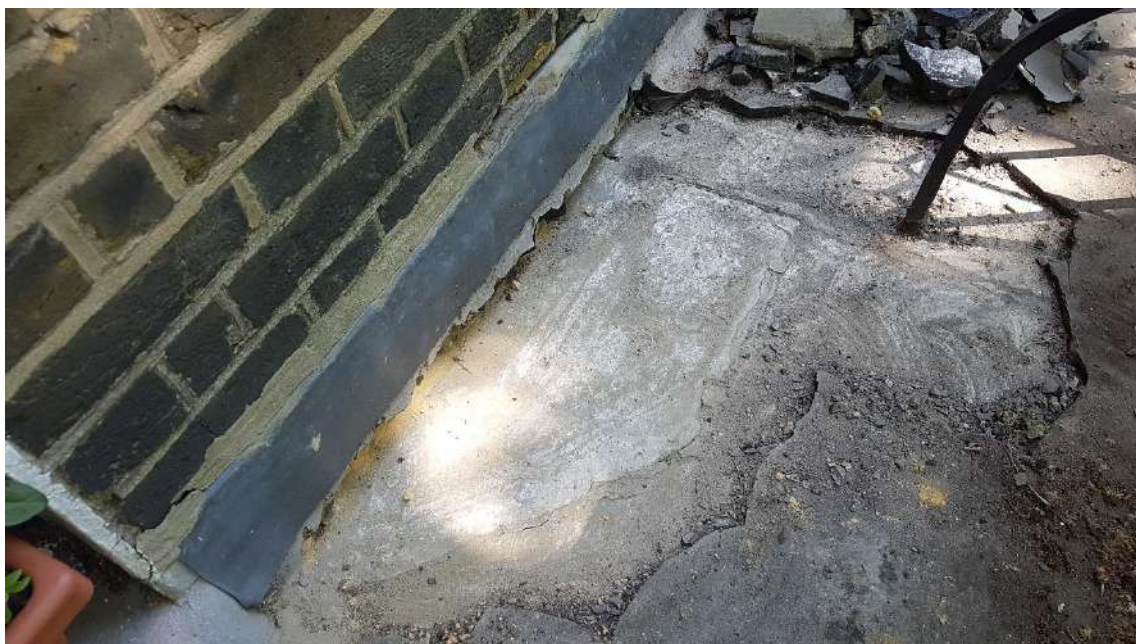
The Western mastic removal revealed a build-up over the stone slab of approximately 25mm of a cementitious screed with approximately 25mm of mastic asphalt. The screed to the Western slab has not been laid in one operation, with a section directly adjacent to the main wall laid separately to the remainder, as indicated below.

Western Joint - Detail of differing screeds. Note the screed that tapers out to the main wall.

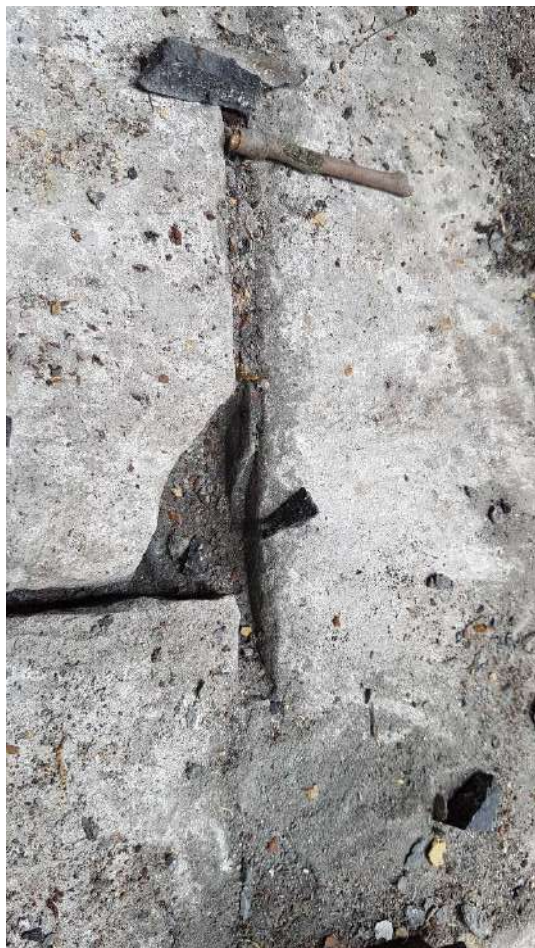
A corner section of the screed against the main wall was cracked and was removed to reveal the screed thickness and the stone slab directly beneath. There appears to be an inverted T lead flashing running along the joint between stone slabs and under the screed.

Western Joint - Corner of screed removed with the inverted T shown between the joint.

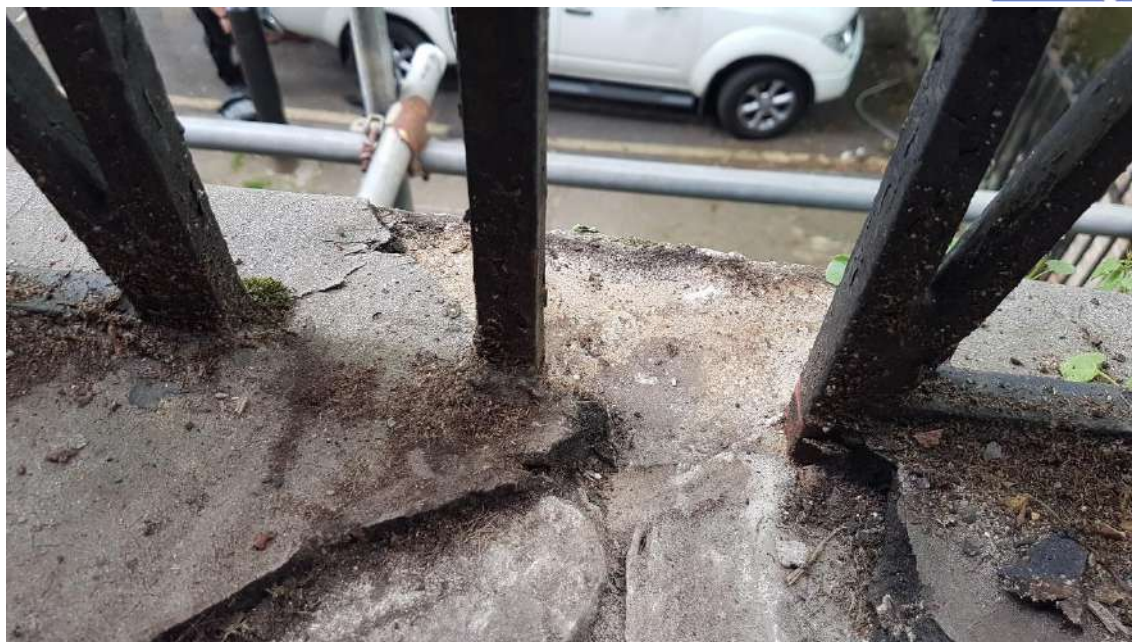
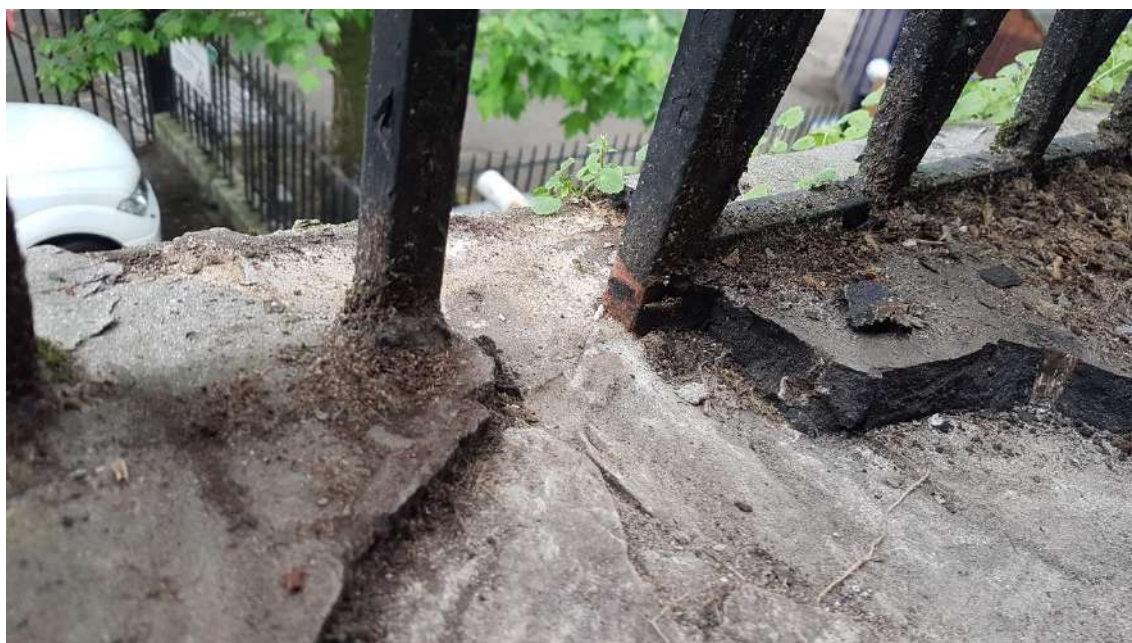
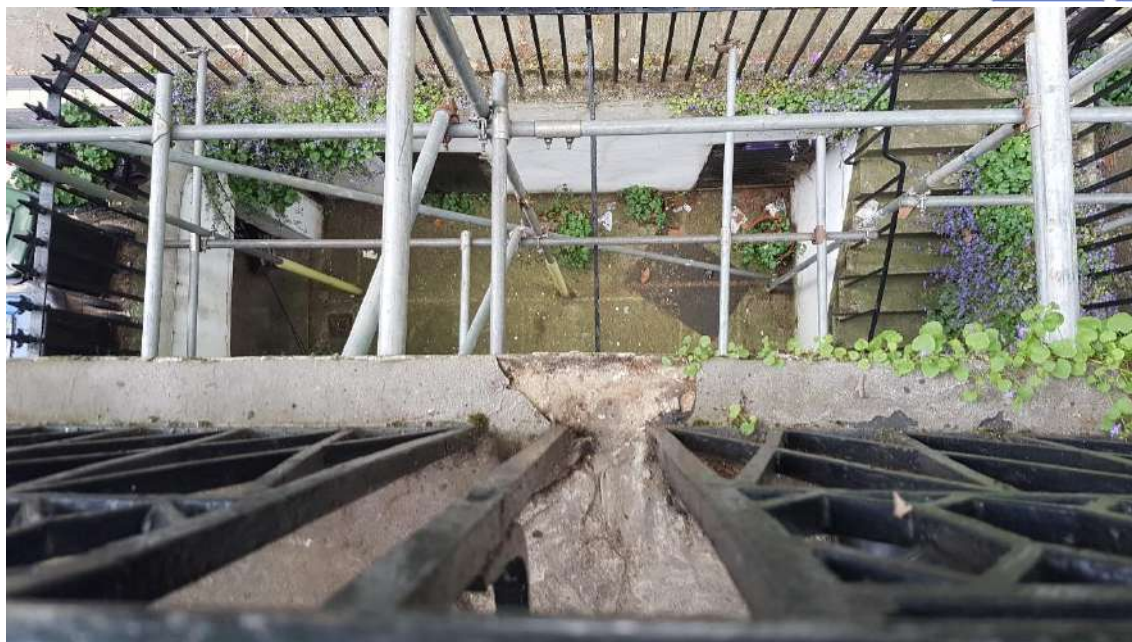
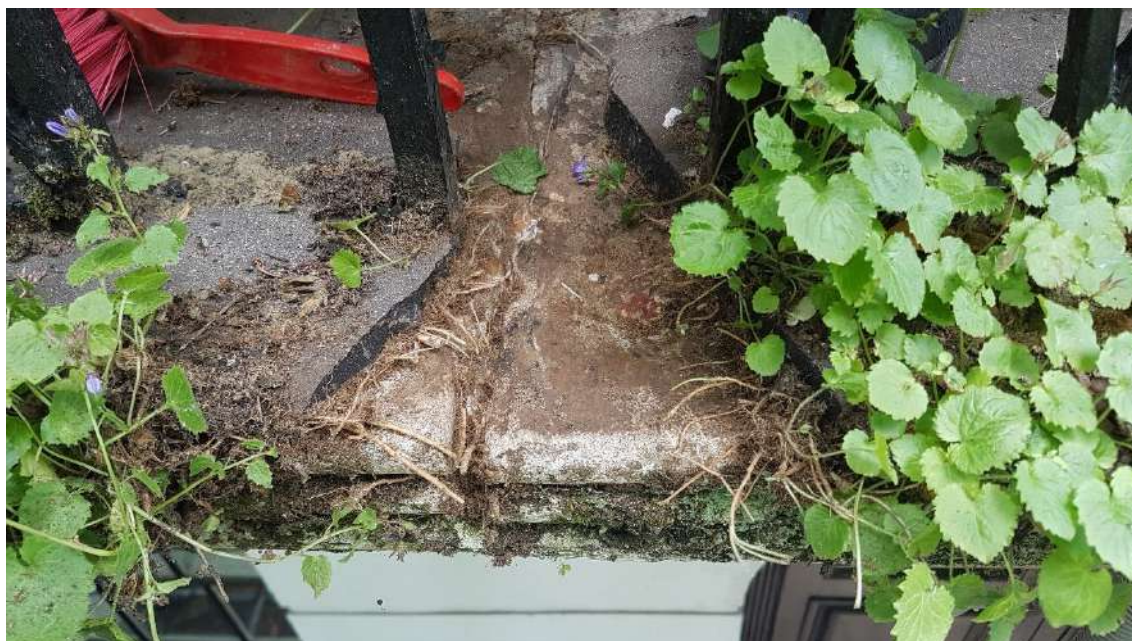
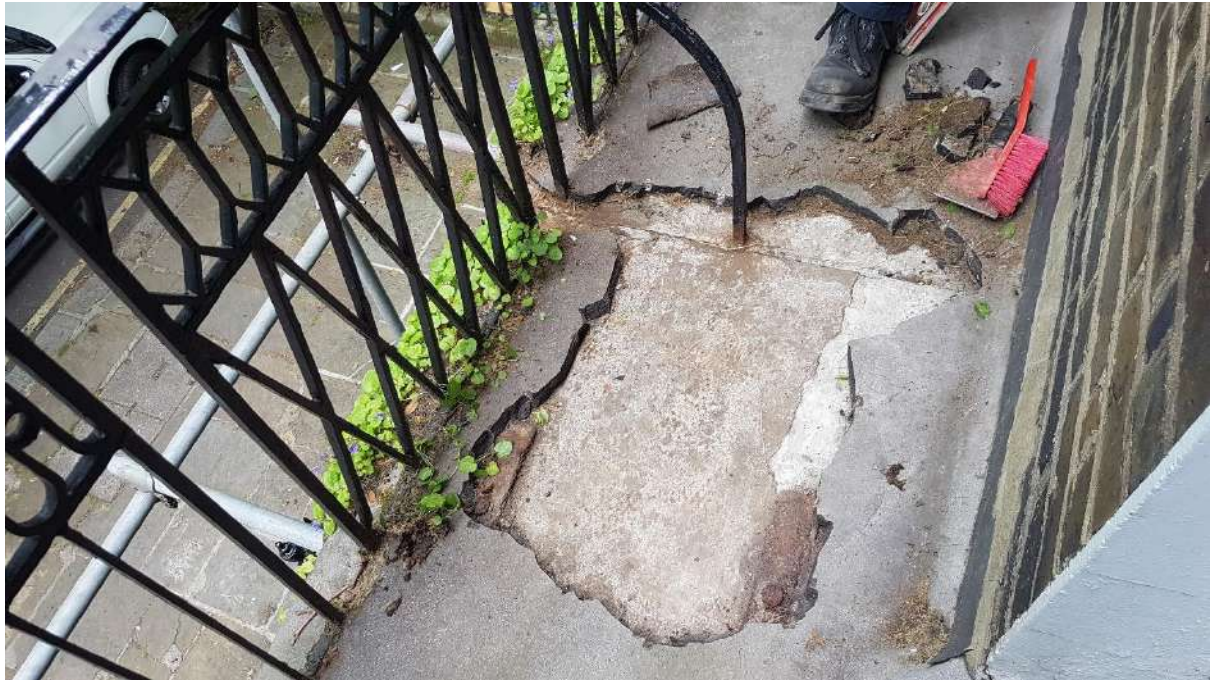
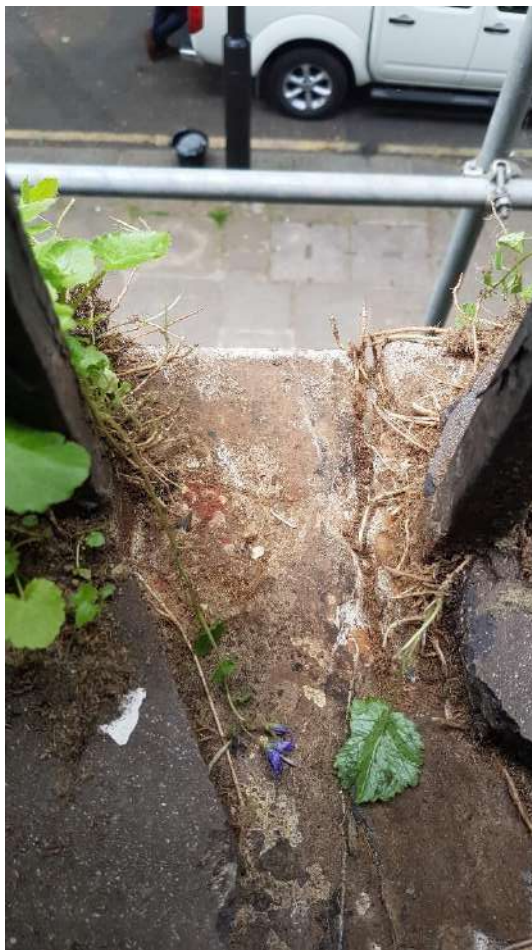
The mastic asphalt was removed from both locations to the outer edge of the slabs. This revealed a thickness of existing stone slab similar to that of the neighbouring property – approximately 70mm thick.

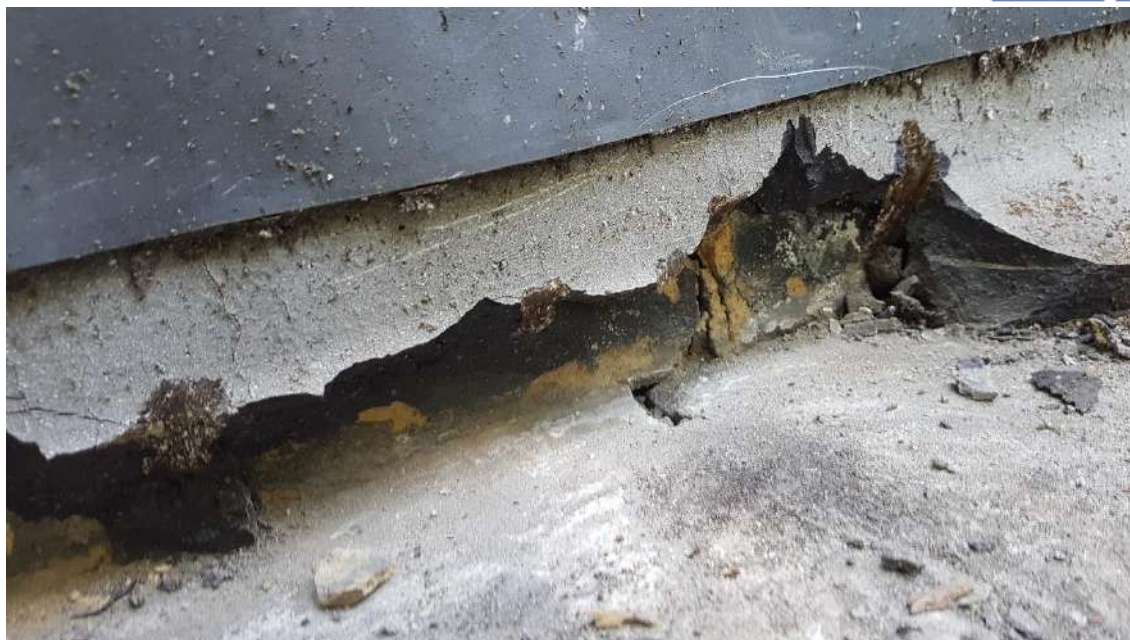
The Western asphalt was removed right back against the main wall. The screed does not appear to have been taken into the existing wall construction.

Western end with asphalt removed up to wall.
