**47, Mecklenburgh Square, London, WC1N 2AD**  
**Report on Structural Inspection of Existing 1<sup>st</sup> Floor Balcony**  
**26.04.2017**

**CBP Architects Ltd**

Document Reference: 47 Mecklenburgh Square – Balcony

Project Number: 17023-CBP-XX-XX-RP-A-0001

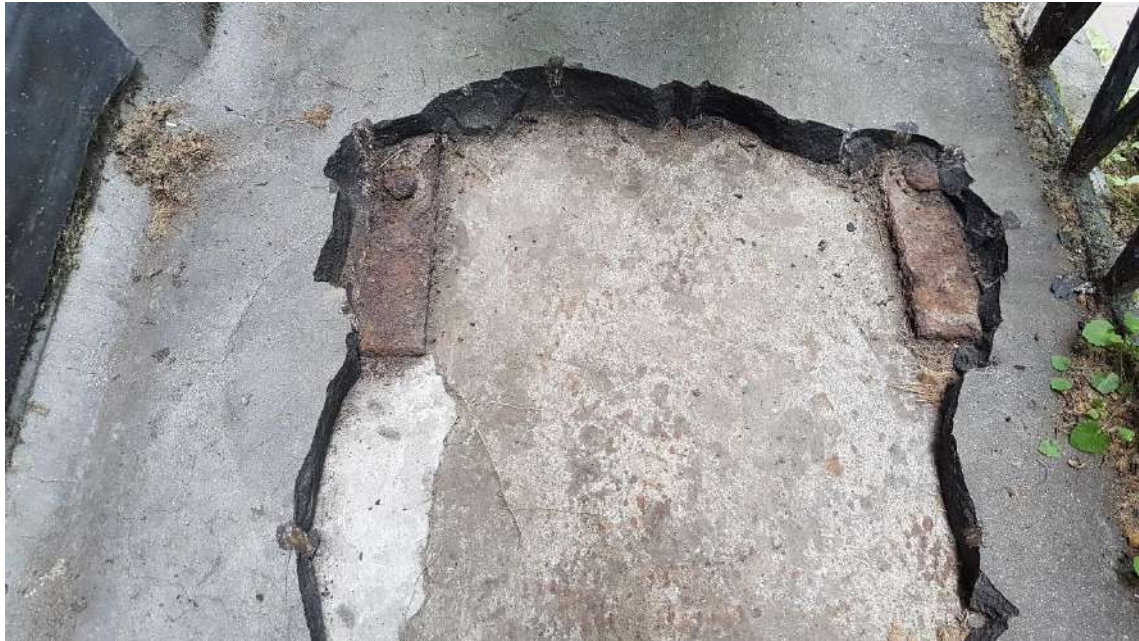
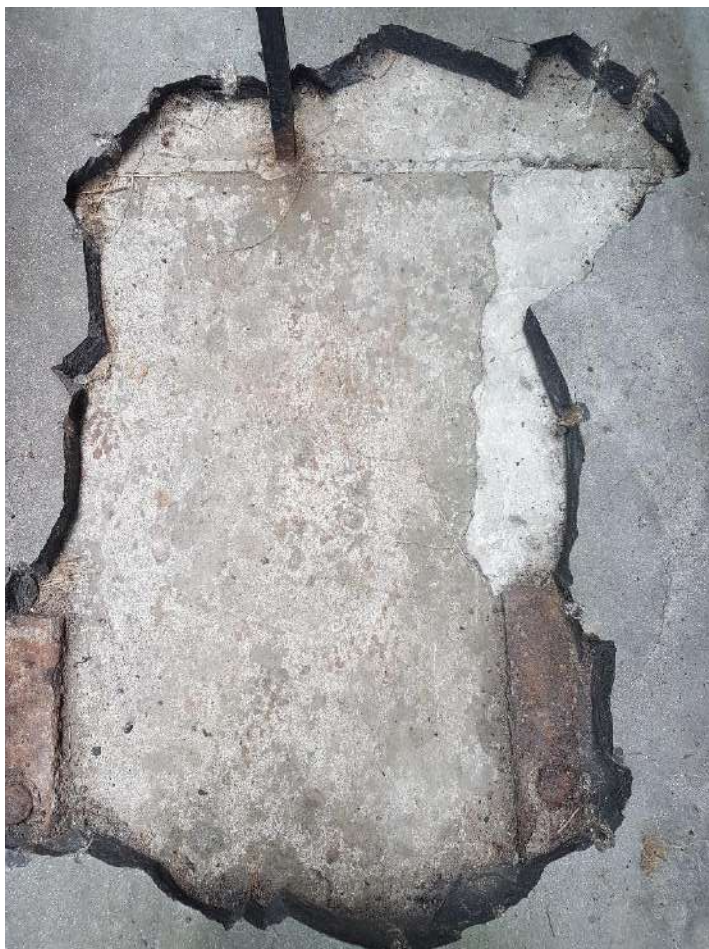
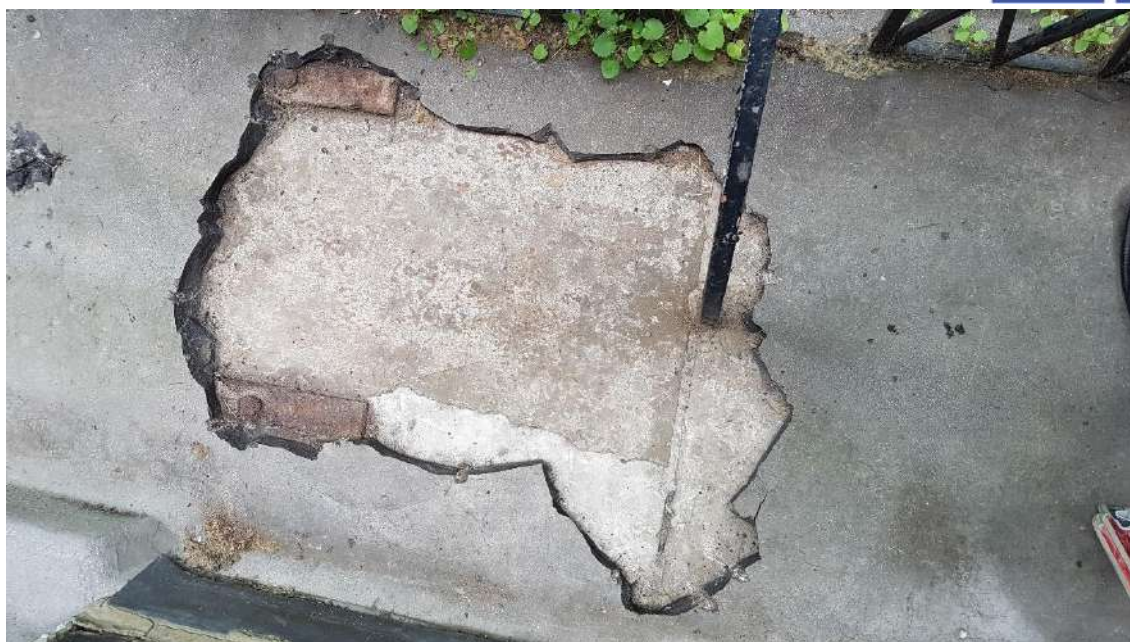
The Eastern end mastic asphalt removal revealed two steel straps that align with the straps on the underside, suggesting they have been installed later as a strengthening measure. The top strap extends further than the bottom one, carrying over the existing brackets to the balcony soffit.

View of steel straps from top require replacement and renewal to detail

View of steel straps from top, require replacement and renewal to detail

- The existing metal straps fitted to the soffit of the stone, and bolted through to the top straps, should be fully exposed, and the fixings reinforced/ or replaced with galvanised steel, with new fixings with required ties over the cast steel brackets to Structural Engineers details.
