# GRENVILLE STREET

EXISTING OFFICES MARKETING STATEMENT  
FOR PLANNING APPLICATION

**STRUCTURAL SURVEY**

**11-12 GRENVILLE STREET  
LONDON  
WC1N 1LZ**

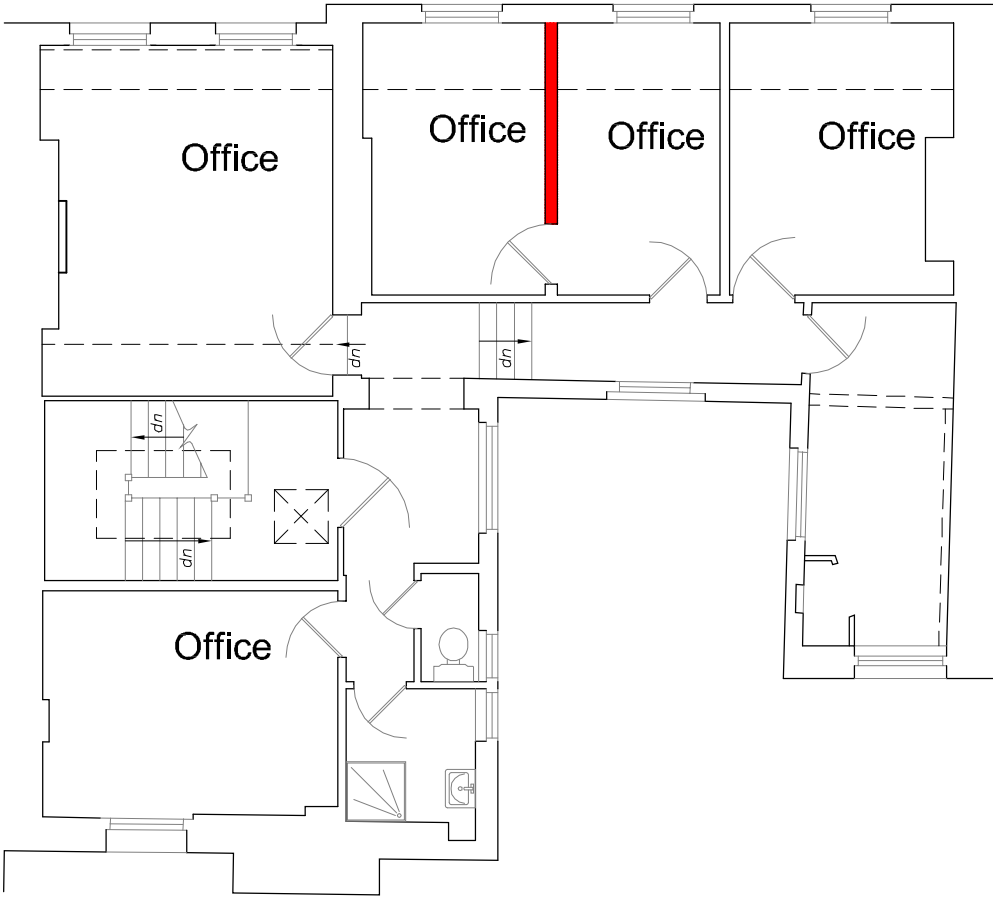
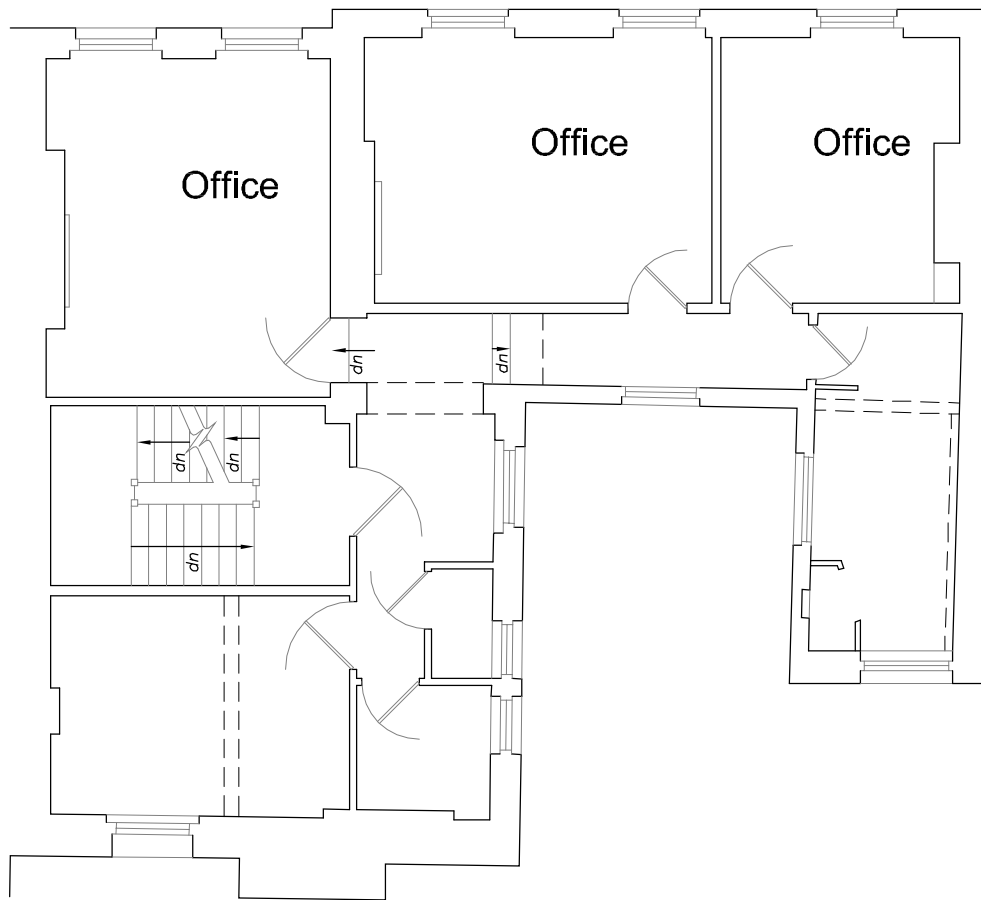
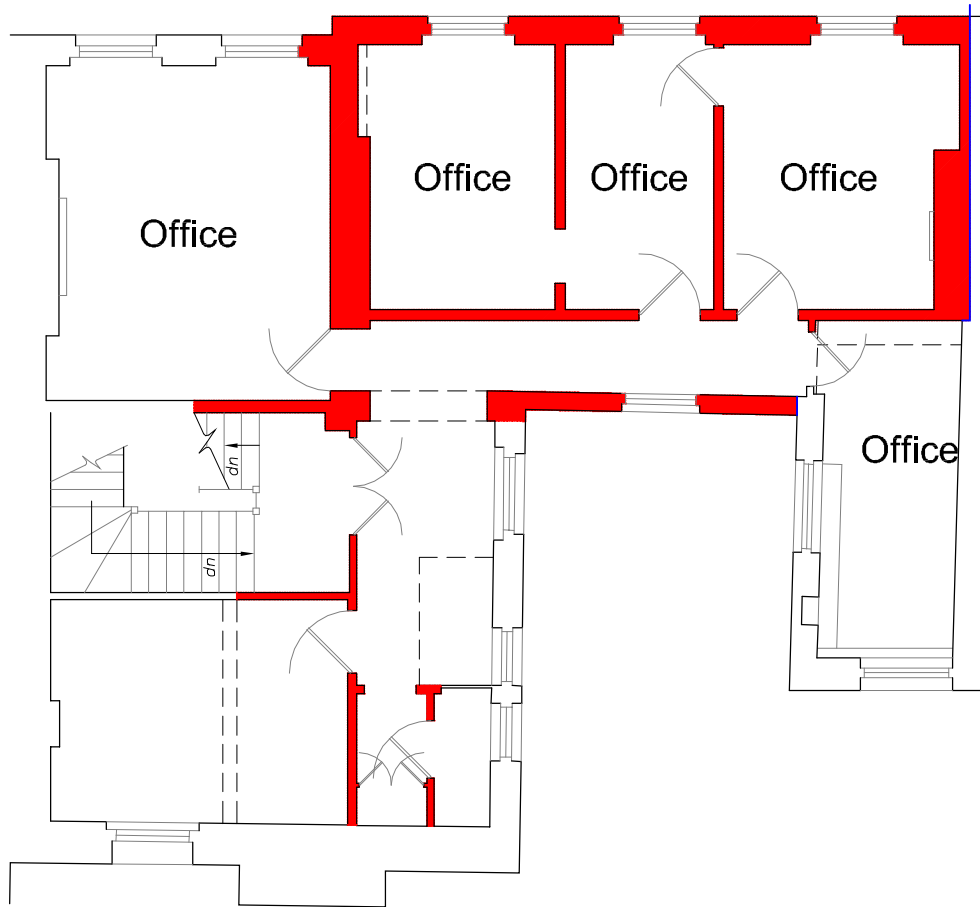
EXISTING FLOOR PLANS HIGHLIGHTING DISCONTINUITY  
OF STRUCTURE BELOW AND VULNERABILITY OF  
KEY ELEMENTS TO VEHICULAR DAMAGE

- 6.10 There was some discontinuity of internal walls which requires investigation as regards adequacy of supporting structure, particularly where potentially exposed to moisture ingress, as the first floor mews beams and those forming the cafe open areas.

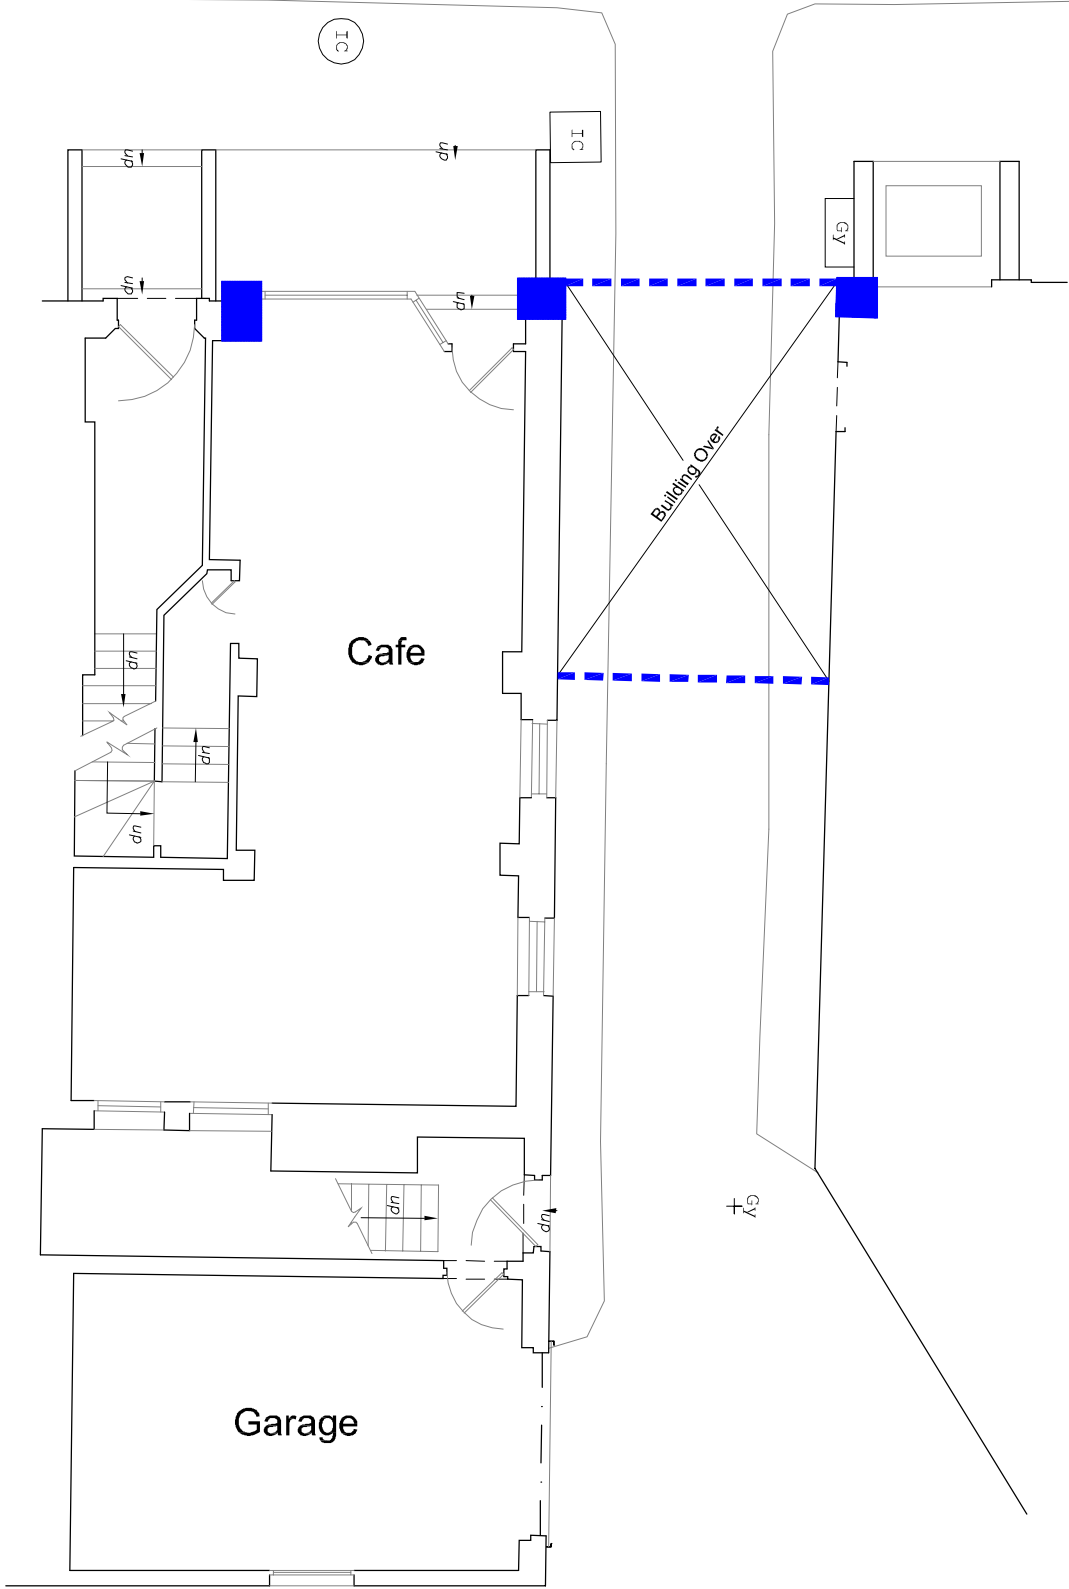
Ground Floor

- 6.11 The building does not comply with current regulations regarding disproportionate collapse. This is exacerbated by the ground floor mews access which increases the possibility of disproportionate damage due to vehicular impact.

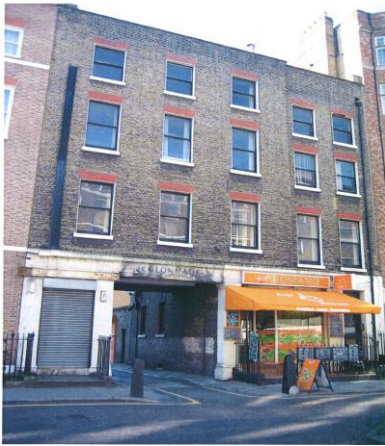
Photograph No. 1	Front elevation. Note structural ties to left hand side, lack of ground floor structure with regard to lateral stability, vulnerability of key elements of structure to vehicular impact.
Photograph No. 2	Rear elevation.
Photograph No. 3	Low level roof areas.
Photograph No. 4, 5, 6, 7 & 8	High level roof areas.
Photograph No. 9	Internal timber floor.
Photograph No. 10	Missing section of plaster lath ceiling.
Photograph No. 11	Internal damp ingress.
Photograph No. 12 & 13	Internal cracking and internal tie rod.
Photograph No. 14	Internal cracking.

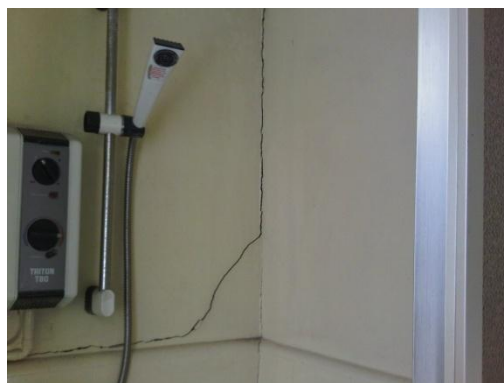
Photograph No. 14

- 6.09 There were a number of internal cracks indicative of some structural movement, some of which may be due to dissimilar materials but others, particularly as associated with the tie rods present to the left hand side of the building – refer to photograph no. 1 – are indicative of some historic instability commonly associated with terrace properties which, as this, have been substantially opened up at ground floor level and where internal walls lack the necessary continuity to provide lateral and longitudinal stiffness.
