Re - Proposed Basement Impact assessment at 41 Howitt Road London

1.0 Brief and scope of this Report

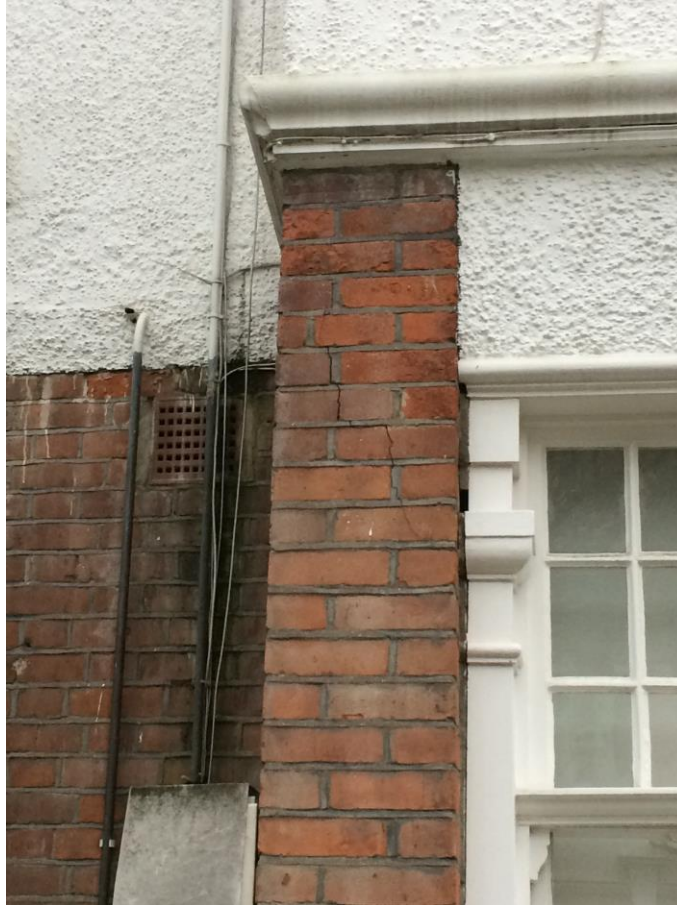
Photograph 1

The front elevation is constructed of brick masonry, which appears to be in good condition; the wall appeared to be vertical with no signs of bowing observed. Generally no cracking was observed except some minor historic, "slight" to "very slight" cracking noted on the ground floor window pier. The reason for the cracking isn't clear, but it does not show signs of any recent movement nor do the cracks appear to propagate into any adjacent structure. *See Photograph 1*

- 4.1 We would classify the damage evident during our inspections to be category 1 (BRE Digest 251 - Assessment of damage in low rise buildings.) This kind of minor damage only usually requires filling and aesthetic repair.
- 4.2 We did not notice any signs to suggest any progressive or ongoing movement is occurring. Our inspections undertaken in 2015 and 2017 have found no increase evident in the magnitude, extent or severity of the damage. We therefore conclude that the damage evident is due to historic movement.

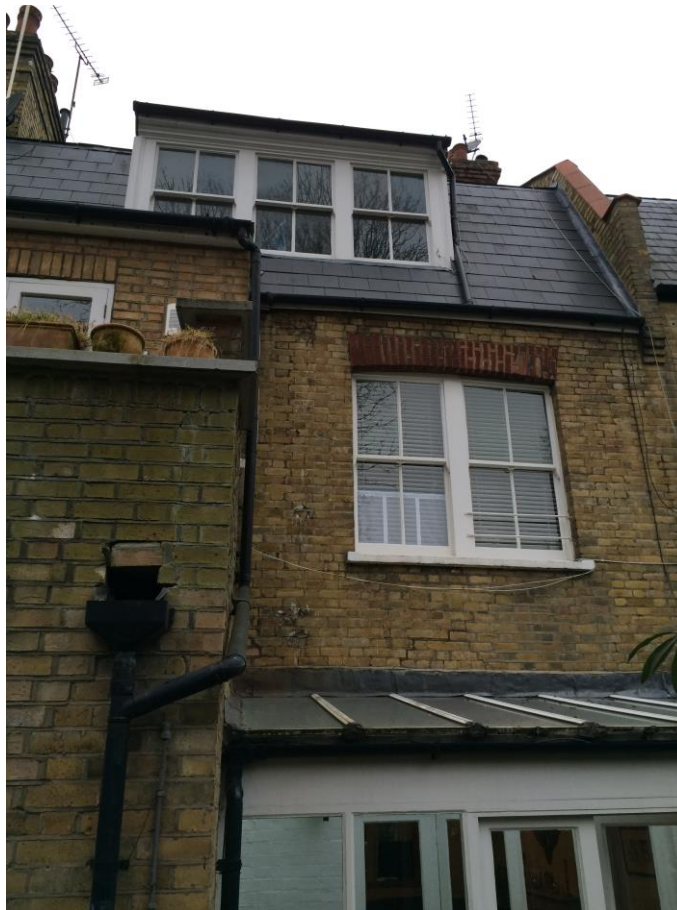
Photograph 2

The rear of the property is of brick masonry, and appeared to be in good condition for the age of the building; the masonry appeared to be vertical with signs of bowing. Generally no cracking was observed in the masonry except for localised “slight” cracks above the lintel to the rear conservatory. The cracking is likely to be a result of deflection of the lintel across the opening created to construct the non-original conservatory, at some time after its construction, but there is no evidence that the cracks increasing. ***See Photograph 2***

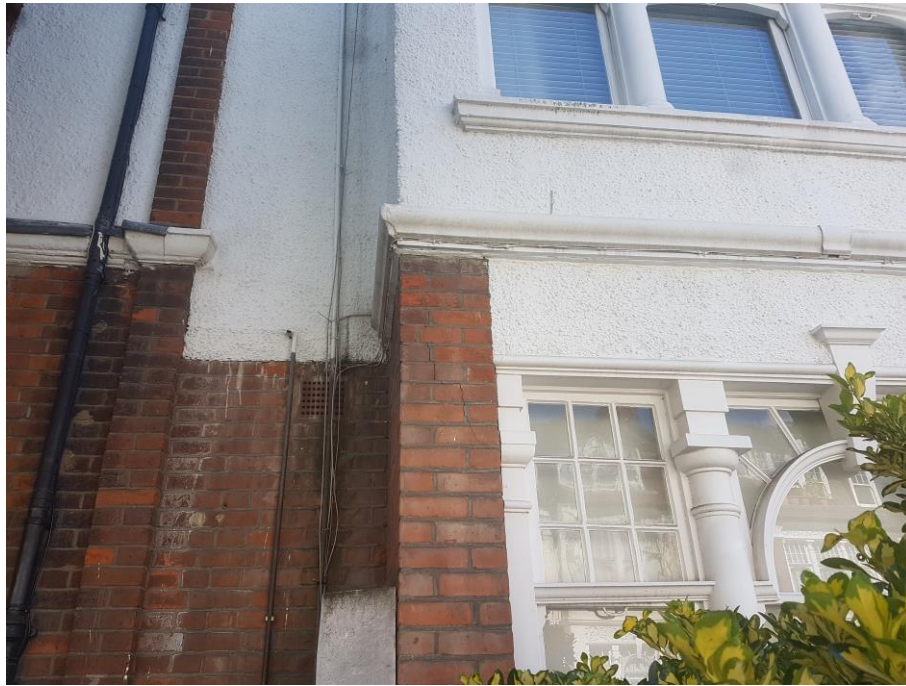
Photograph 3

The damage evident previously to the front and rear elevations, as shown in photographs 1 & 2 did not appear to have worsened. ***See Photographs 3 & 4 taken on the 13th June 2017 in comparison to Photographs 1 & 2***
