Our ref: 1-38-4417

31st August 2017

Re: 31 Lyndhurst Road, London, NW3 5PB

BACKGROUND

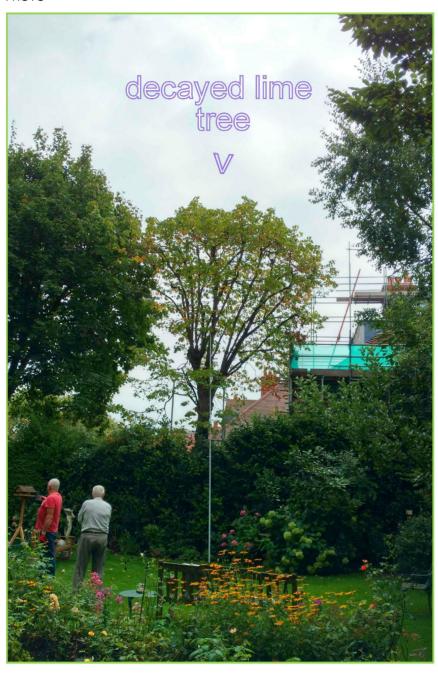
РНОТО

TREE DATA					ſ
Tree number	Tree type	Height	Stem diameters	Comments	Urgency
i	common lime	9	450	A tap test (for sonority) indicated a severely decayed base and lower trunk from about ground level to 1.5m above ground level. The basal condition was confirmed by 'Resi' (trace appended). Severe root loss is suspected to have occurred on the 2, Akenside Road side. No access possible: it is a fair observation that the reported basement construction which adjoins the boundary very tightly has occupied all potential rooting space for the tree that may have been ramified by its roots. There is a change of level with an historic retaining wall marking a drop to the 2 Akenside Road site of perhaps 1m. The tree has previously been pollarded. The foliar condition of the tree is in my view in excess of what might be expected of allocation of photosynthetic resource to containment of decay and does likely relate to root loss. Accordingly the tree is considered to be both unstable and increasingly prone to failure in the lower trunk due to decay which has been present for maybe	High

Remove the tree and treat the stump to prevent growth. It may be possible to retain the tree as a low pollard for a limited period of time. If this is done, the tree will require very regular and frequent re-inspection (annual) for safety reasons.
