ENGINEERS REPORT

**Interested Underwriters per
Equity Claims
V93684/09/83852**

The Lodge, 17 Acol Road, London, NW6 3AD

Date: 8th December 2009

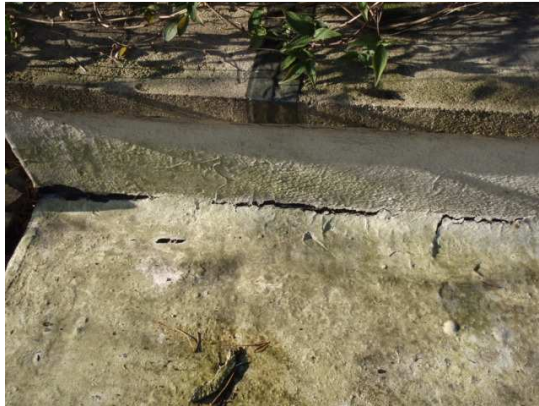
This photograph shows the cracking within the flat roof at its junction with the right hand flank wall. This cracking has significantly increased in magnitude during the recent months.

Following a general appraisal of the single storey flat roof we noted that the overall condition was in a relatively good state of repair. However, at the rear right hand corner there is significant cracking at its junction with the right hand elevation wall. This appears to be quite fresh and is also indicative of movement having taking place within the right hand elevation of the property.

To the single storey flat roof, we noted a considerable amount of cracking to the rear right hand corner, this resulting in water ingress and damp staining which was noted internally within the dining room.

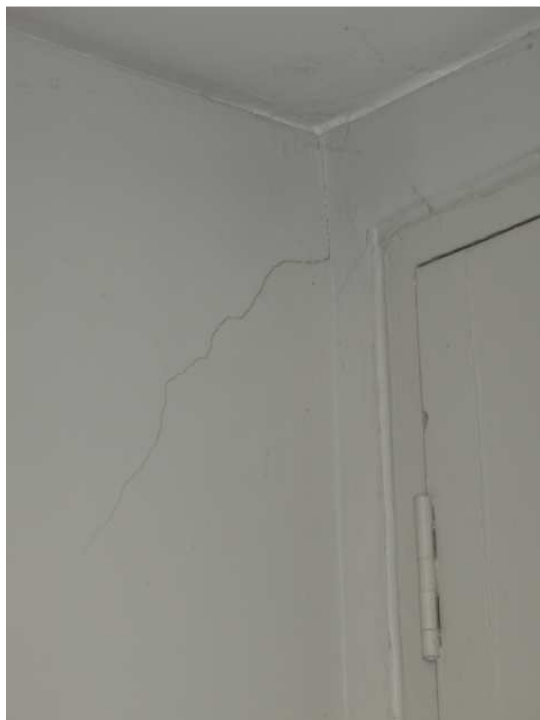
This photograph shows the cracking within the plaster finish at the rear left hand corner of the sitting room.

In this room we noted areas of cracking to the wall and ceiling finish which are considered to be as a result of plaster shrinkage exacerbated by thermal movements between differing building materials.

The damage within the structure is detailed under Section 5.00 of this report and where this is located within the internal fabric of the building, it is considered that its cause is primarily related to thermal movements between differing building materials, together with a small amount of plaster shrinkage which was noted to the rear left hand corner of the first floor sitting room.
