Stair - Survey Review

Basement Stairs: 22, 23 Mecklenburgh Square

Goodenough College

September 2017

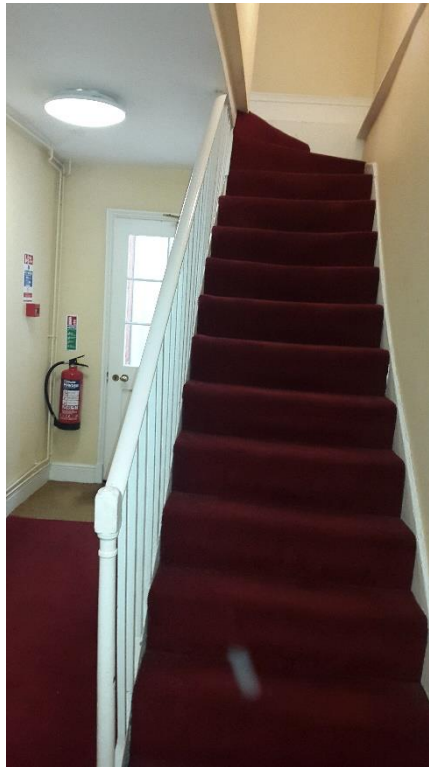
Handrails: Unstable and moves under pressure. Appears handrail to be original. Balusters require checking for structural integrity and solid fixing, and require to be reinforced.

Height of Bulkhead from stair string measured 1940mm approx. noted that warning signs are installed. This reduced dimension and limited reduced tread may cause an issue for users negotiating the stairs at this point.

Handrail height from string measures approximately 760mm being lower than the required dimension of 900mm. as the current Building Regulations.

1. Reinforce handrail/ balustrade / make consistent level treads.

Bottom and top treads require strengthening.

Handrail, Balustrade and Newel Post requires to be strengthened

Bottom/ intermediate treads require adjustment and reinforcement to accommodate consistent rise height over the whole flight.

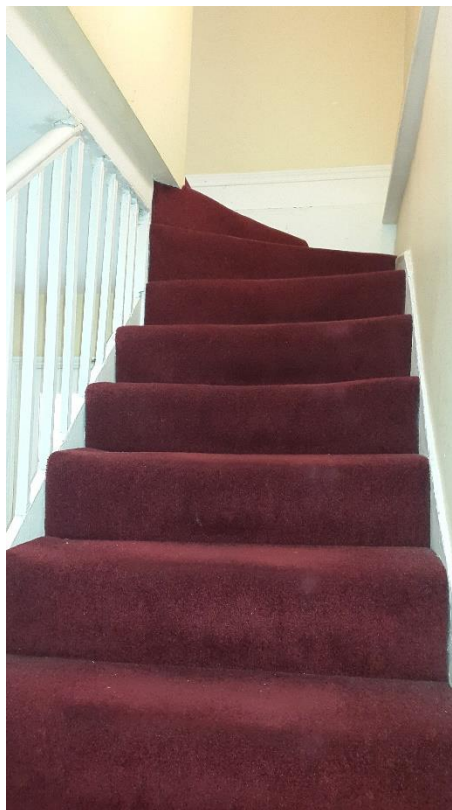
2. Tread and handrails require reinforcement/ repair/ consistent height.
Introduction of additional handrail to wall side.

Observations: Propose an additional feature handrail installed at the upper area of the stair, and to wall elevation at 900mm above string, consider reduced width and escape capacity.

Consider removal of thick carpet, and introduction of a thinner but suitable material to allow more tread depth.

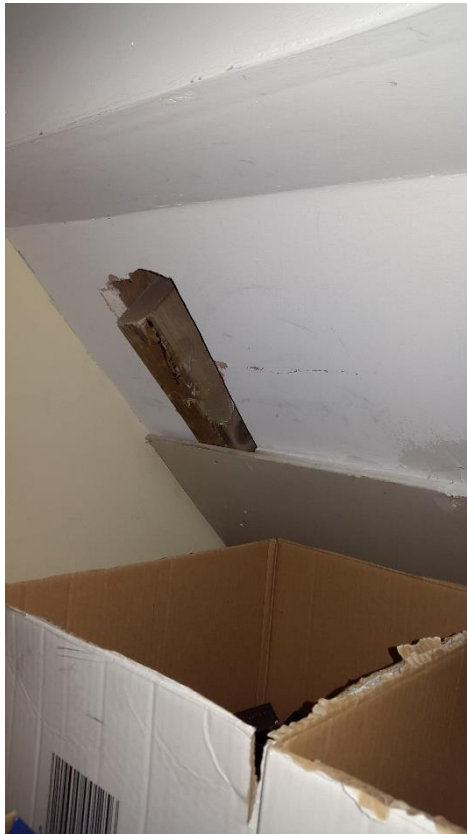
Store under stairs, plasterboard soffit requires to be repaired to maintain the required fire resistance to the store and protect the soffit of the stairs.

3. Make good to under stair soffit, to maintain fire resistance integrity.

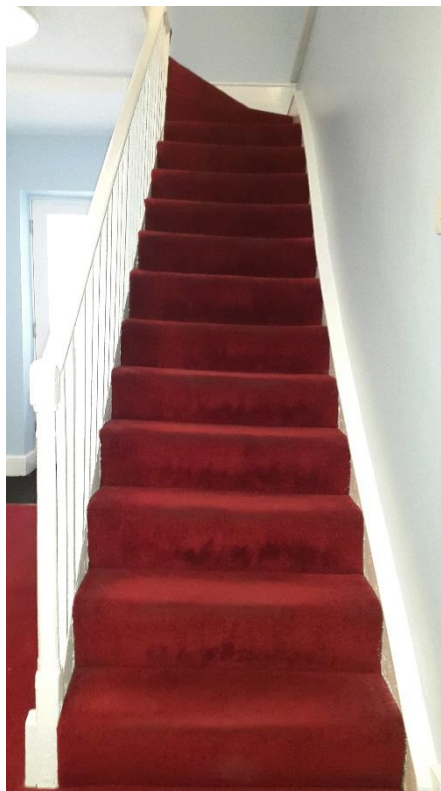
Handrail and newel posts requires to be strengthened, particularly the Newel Post to the bottom of the stairs which has had a temporary previous repair but requires to be reinforced. The Newel Post is also slightly out of plumb.

Treads 4,5,8,9,10,11 are loose, irregular and unsafe, require repair, level adjustment and reinforcement to accommodate consistent rise height over the whole flight.

4. Tread and handrails requires reinforcement/ repair. Introduction of additional feature wall handrail. Newel post is loose/ requires reinforcement.

Observations: Lower and intermediate tread requires reinforcement.

Propose an additional feature handrail installed at the upper area of the stair, and to wall elevation at 900mm above string, consider reduced width.
