Summary Of Structural Assessment And Strengthening Works Required

project name		9 Denmark Street	
sketch title		Proposed Structural Details	
date		15.09.2017	
project no	sketch no	rev	by
879	Z3-S-100.0	-	RK

project name		9 Denmark Street	
sketch title		Proposed Structural Details	
project no		879	
sketch no		Z3-S-100.1	
date		25.08.2017	
rev		-	
by		RK

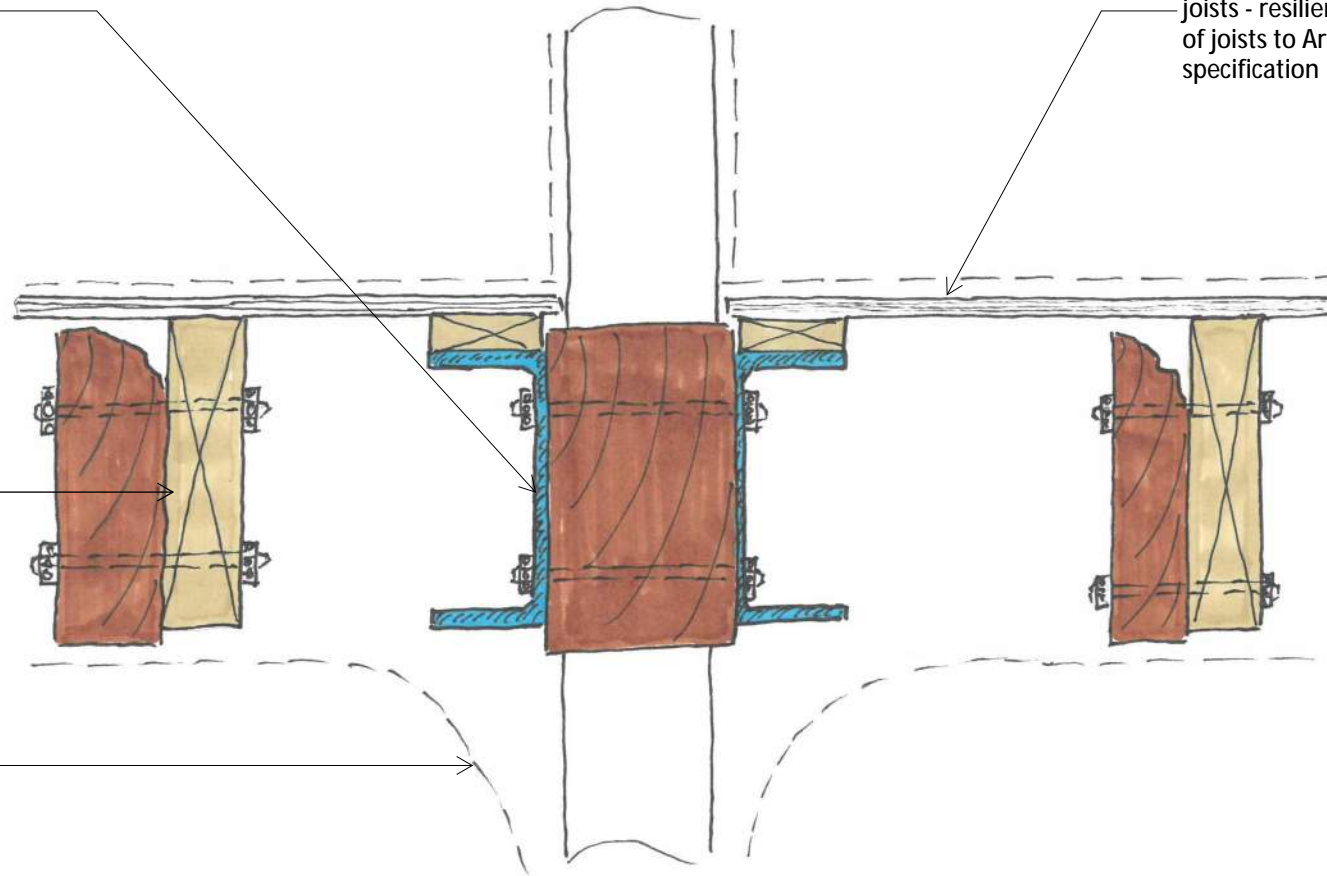
Detail 1: Spine Beam & Joist Strengthening Requirements, 1:10
Option A

- This option provides the required strengthening to the existing spine beam while minimising impact on the historic finishes.
- This option does require the existing floor beams to be trimmed and re-supported on the new steelwork
- Option A is considered to have the least impact on the historic building fabric while achieving the required structural strengthening

Proposed spine beam strengthening allows for finishes to remain largely undisturbed

Existing timber spine wall beams to be strengthened with pairs of PFC steel beams - through bolted to spine beam with pairs of bolts at 600mm c/c

New plywood sheathing fixed down to new timber joists - resilient bars to tops of joists to Architects specification

Existing joists to be strengthened with 200x50 C24 timber joists - bolted together at 400mm staggered c/c

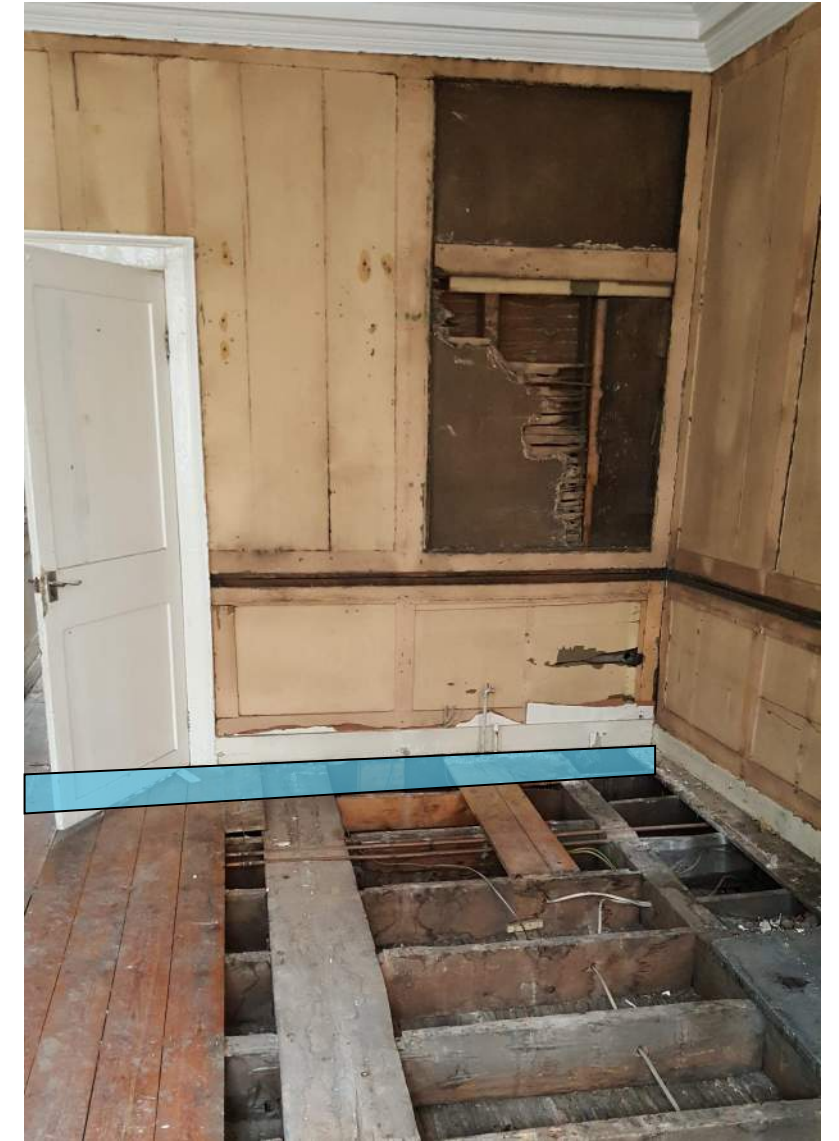
Figure 1, Spine Wall Strengthening Location

- The existing spine wall beam can not be justified to support the required residential loadings to current standards therefore strengthening is required.
- The existing floor joists require strengthening due to comply with current standards and allow for levelling of existing floors
- Generally all structural strengthening proposed will reduce deflections and movements within the building to protect the historic structure and materials from further damage
- Steel beams to bear onto padstones in masonry party walls

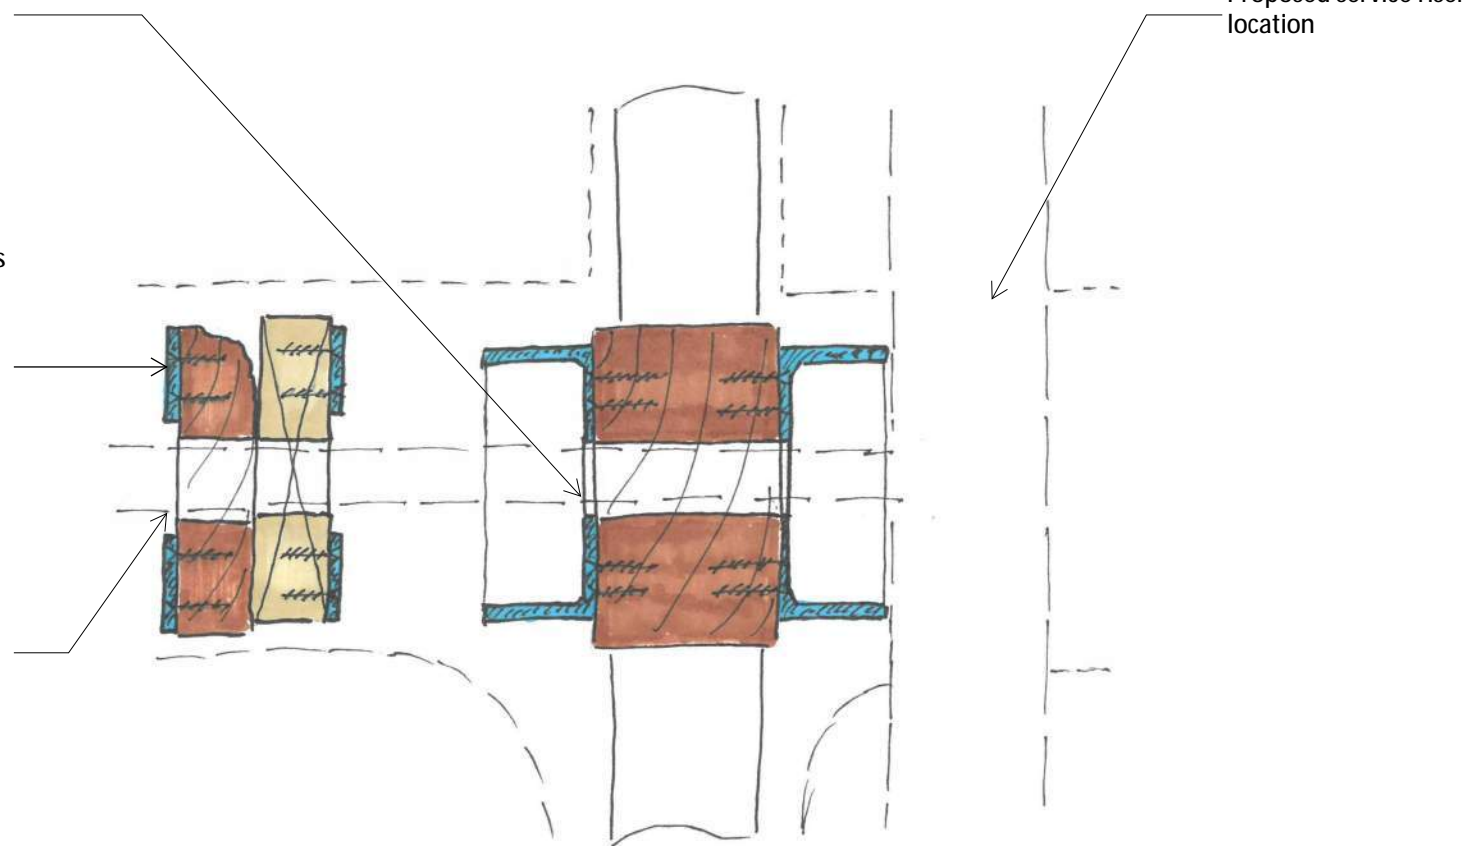
Detail 3: Spine Beam & Joist Service Penetration, 1:10

- The strengthening is required to allow the waste pipe from the proposed kitchen island unit to run through the floor zone. The island unit is required to avoid any damage to historic wall finishes
- The service run for the kitchen waste pipe will effect a maximum of 3 joists and the spine beam at each level

Strengthening steel beams to existing timber spine wall beams allow for kitchen waste pipe to run through to riser beyond - steel beams to be strengthened locally around penetration

Existing and proposed joists to be strengthened locally with steel plates to allow for kitchen waste pipe to run within floor zone - plates to be screw fixed to joists

Service penetration to mid depth of joists

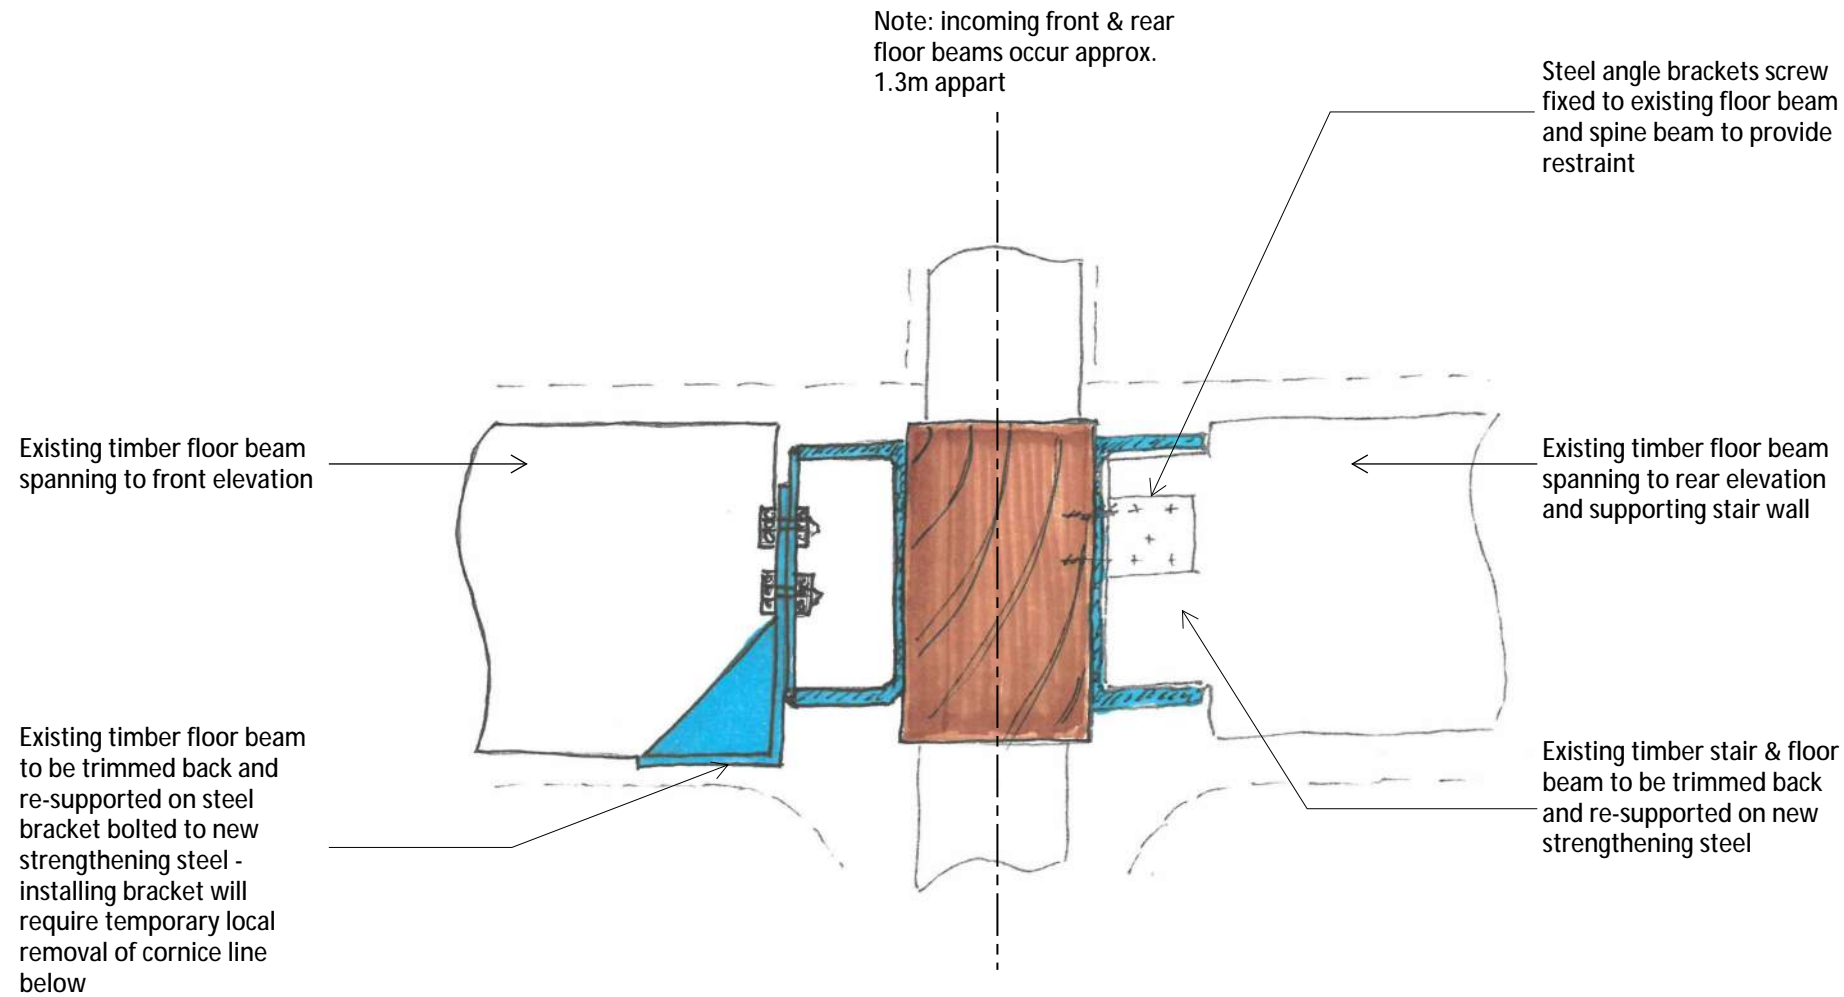
Detail 4: Floor Beam To Be Re-supported, 1:10

- The strengthening is required to the bearing of the floor beams to justify the connection for required residential loadings to current standards

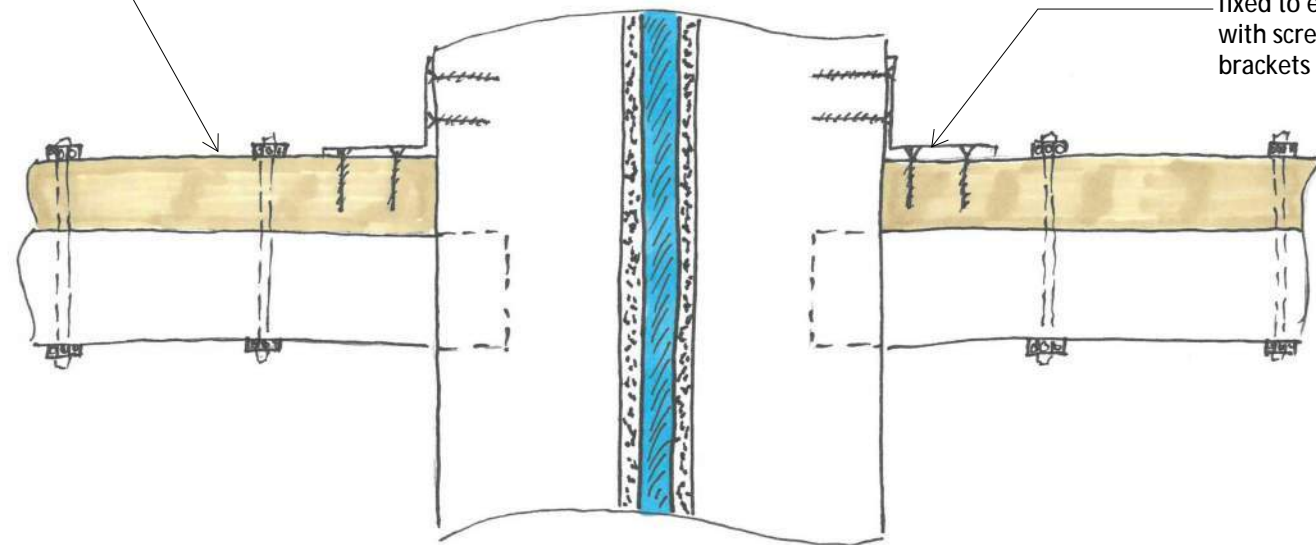
Detail 6: Plan of Front Floor Beam To Be Strengthened, 1:10 Option A

Bending Stresses @ 110% capacity => strengthening required
 Deflection @ 200% limit => strengthening required

- The existing timber floor beam can not be justified for the required residential loadings to current standards and requires strengthening
- This solution offers the least impact to the existing floor joists

Existing joists to be strengthened with 200x50 C24 timber joists - bolted together at 400mm staggered c/c

New timber joists to be fixed to existing floor beam with screw fixed angle brackets

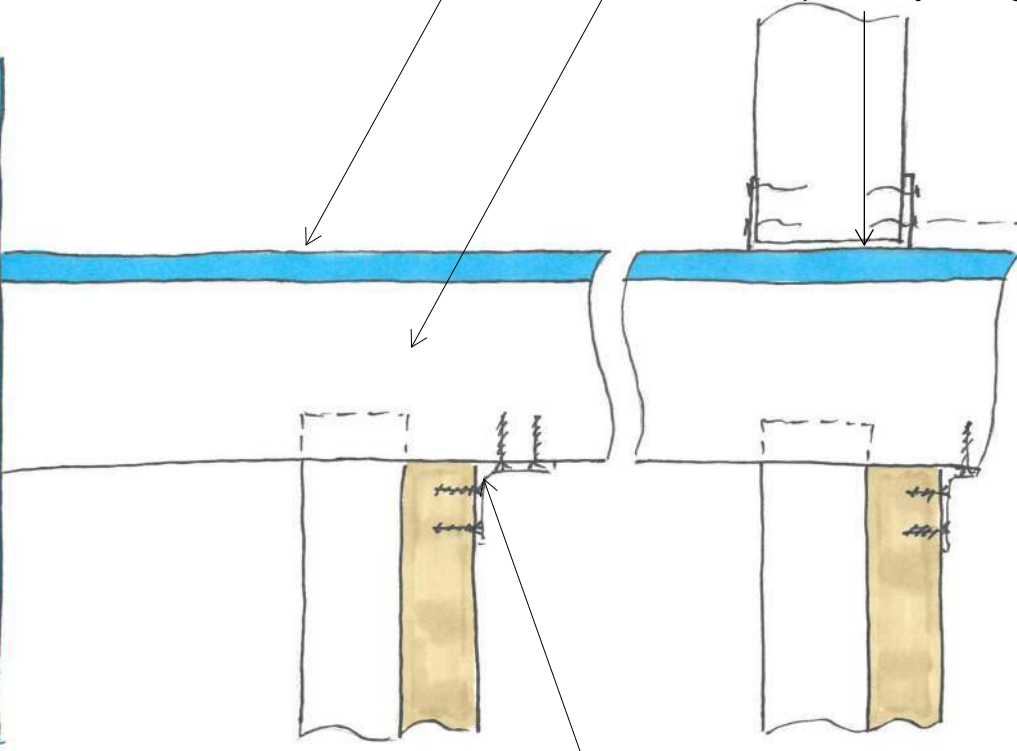
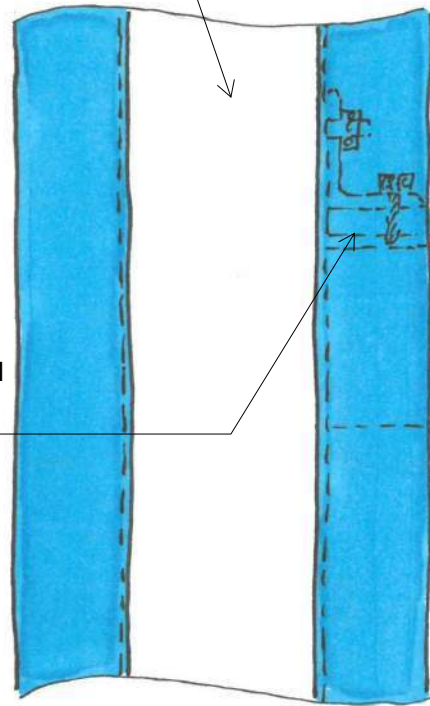
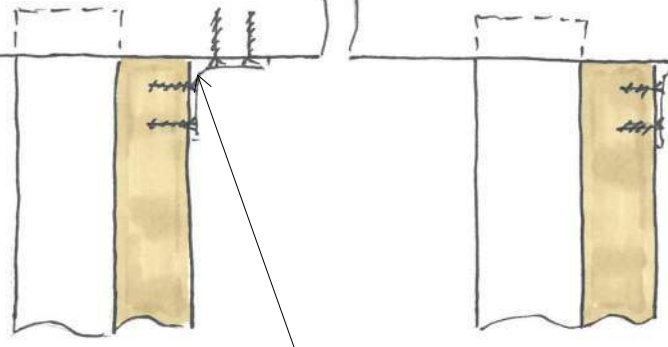
Detail 9: Plan of Rear Floor/Stair Beam To Be Strengthened, 1:10

Bending Stresses @ 140% capacity => strengthening required
 Deflection @ 200% limit => strengthening required

- The existing timber floor beam can not be justified for the required residential loadings to current standards and requires strengthening
- The staircase shows signs of settlement due to the movement of the stair wall and the supporting beam line needs to be stabilised at each level
- The proposed solution offers the least impact to the existing floor structure as the floor joists will not require cutting back and re-supporting

Existing timber spine wall beams to be strengthened with pairs of PFC steel beams - through bolted to spine beam with pairs of bolts at 600mm c/c

Steel plate to be supported on new steel beam - fixed with bolted angle connection

New steel plate bolted to stair side face of existing timber beam - existing finishes to be carefully removed to allow for plate to be installed

Existing stair trimmer beam to be re-supported in steel plate with joist hanger

New timber joists to be fixed to existing floor beam with screw fixed angle brackets

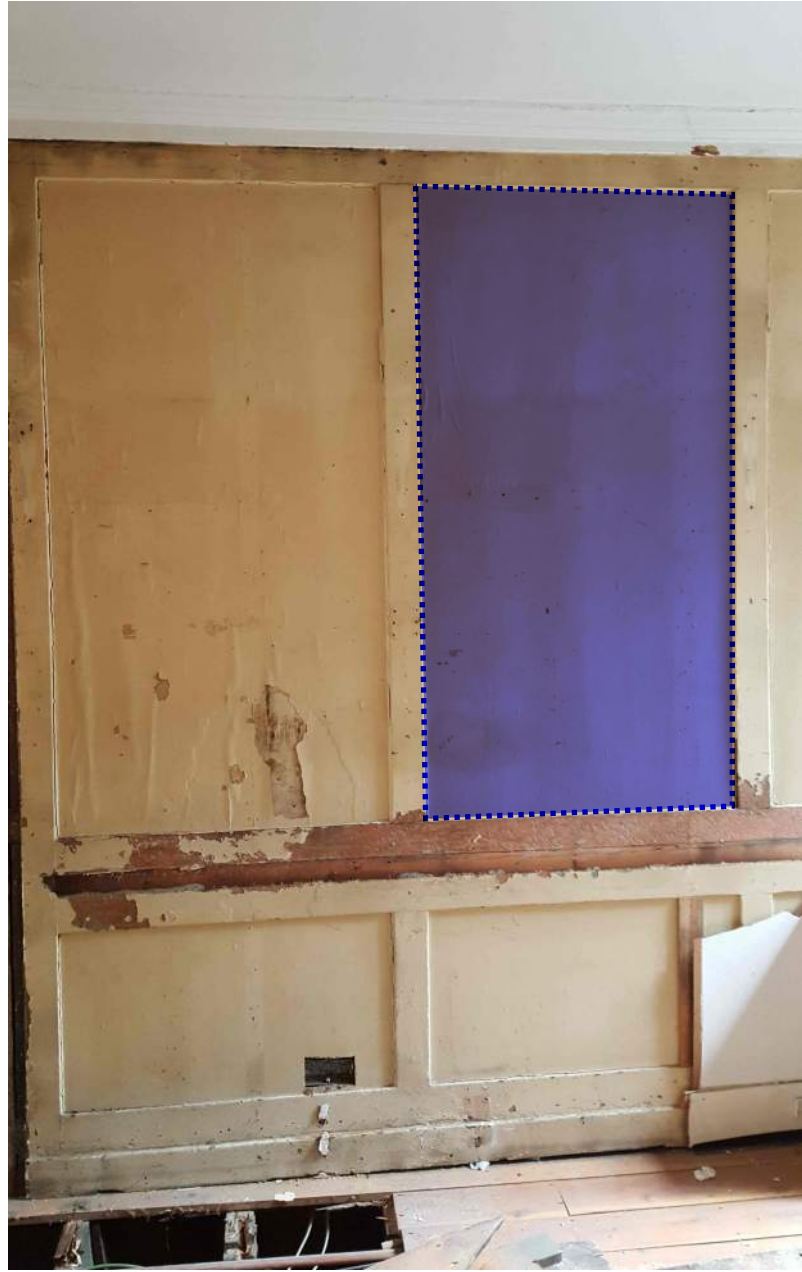
Figure 10, Location Of Panelling To Be Removed - Second Floor Stair Wall

- The existing staircase has settled significantly and we need to inspect the connection of the staircase to the stair wall and assess whether additional strengthening is required

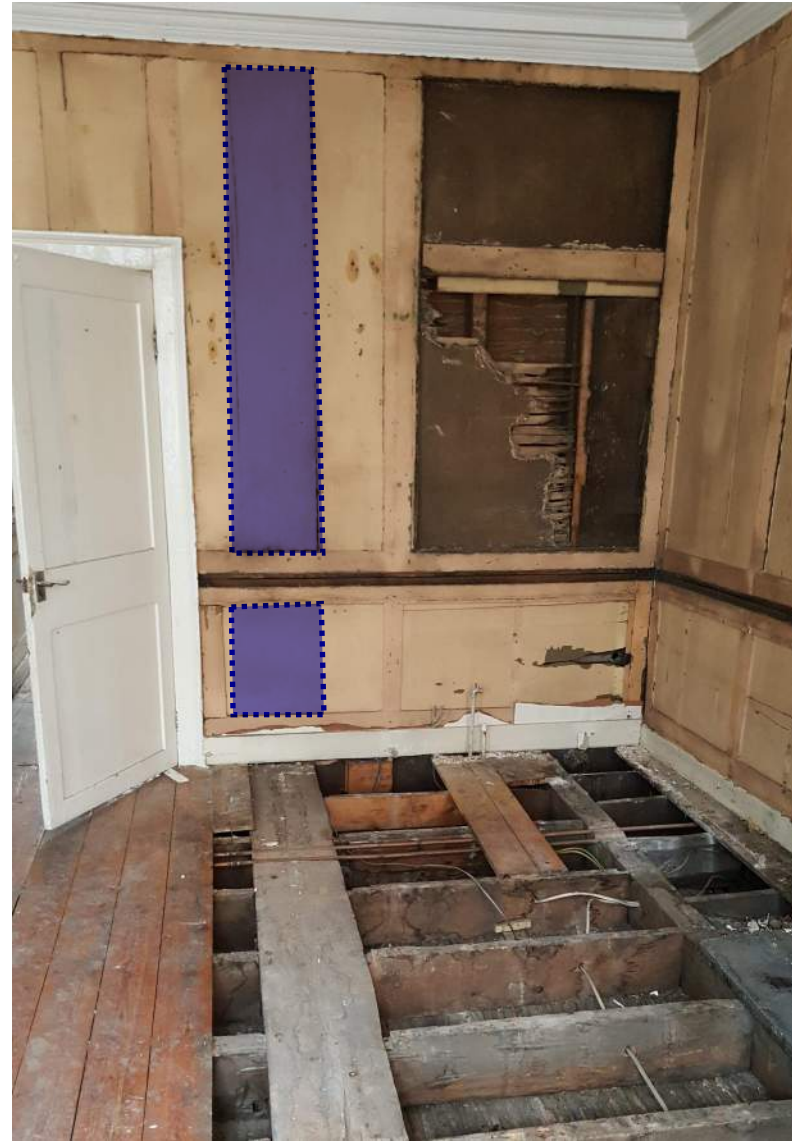
Figure 11, Location Of Panelling To Be Removed - Second Floor Spine Wall

- The base and head of the existing timber stud wall needs to be inspected to confirm whether any remedial works are required

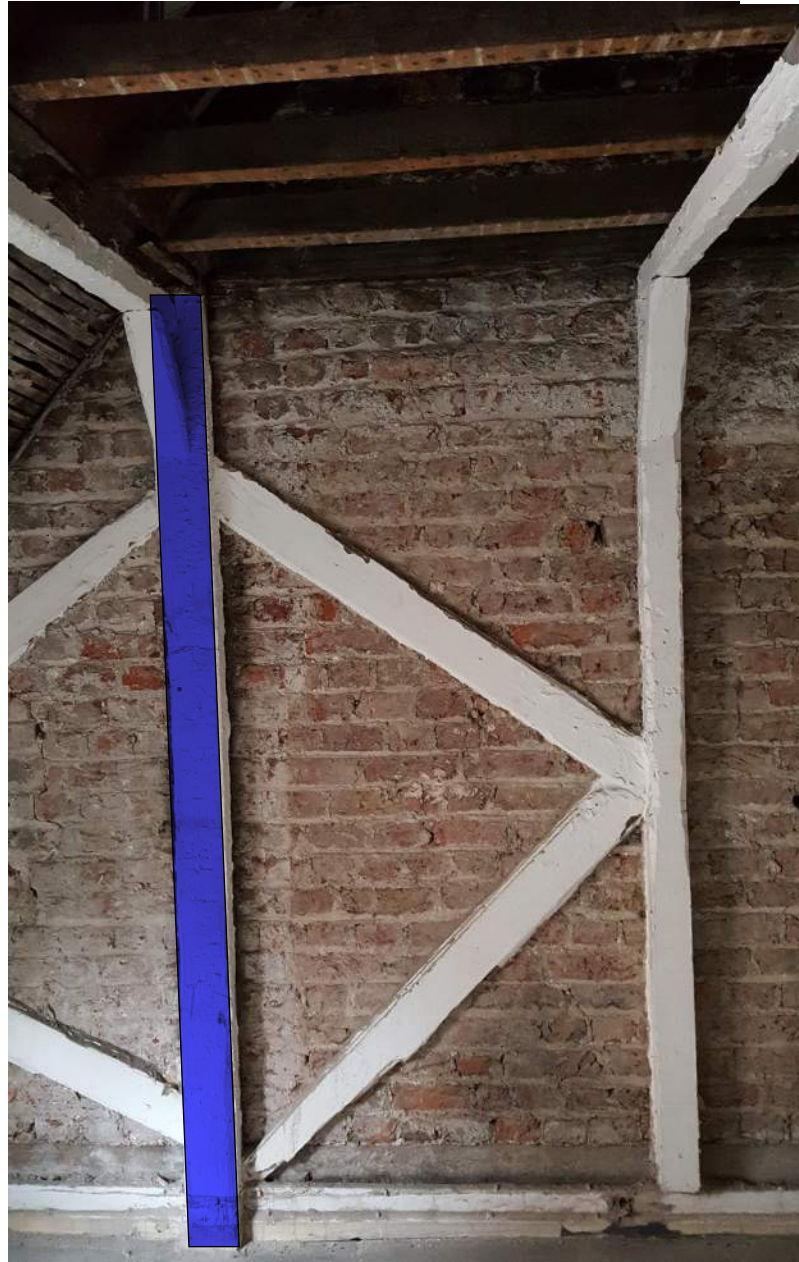
Figure 12, Third Floor Non-Structural Additions

- By inspection it is apparent that almost all of the white painted timber joinery inside the plaster finish line is a decorative add-on and non-structural in nature. As such this can be removed.
- The only exception are the posts supporting each end of the roof beam high lighted above.

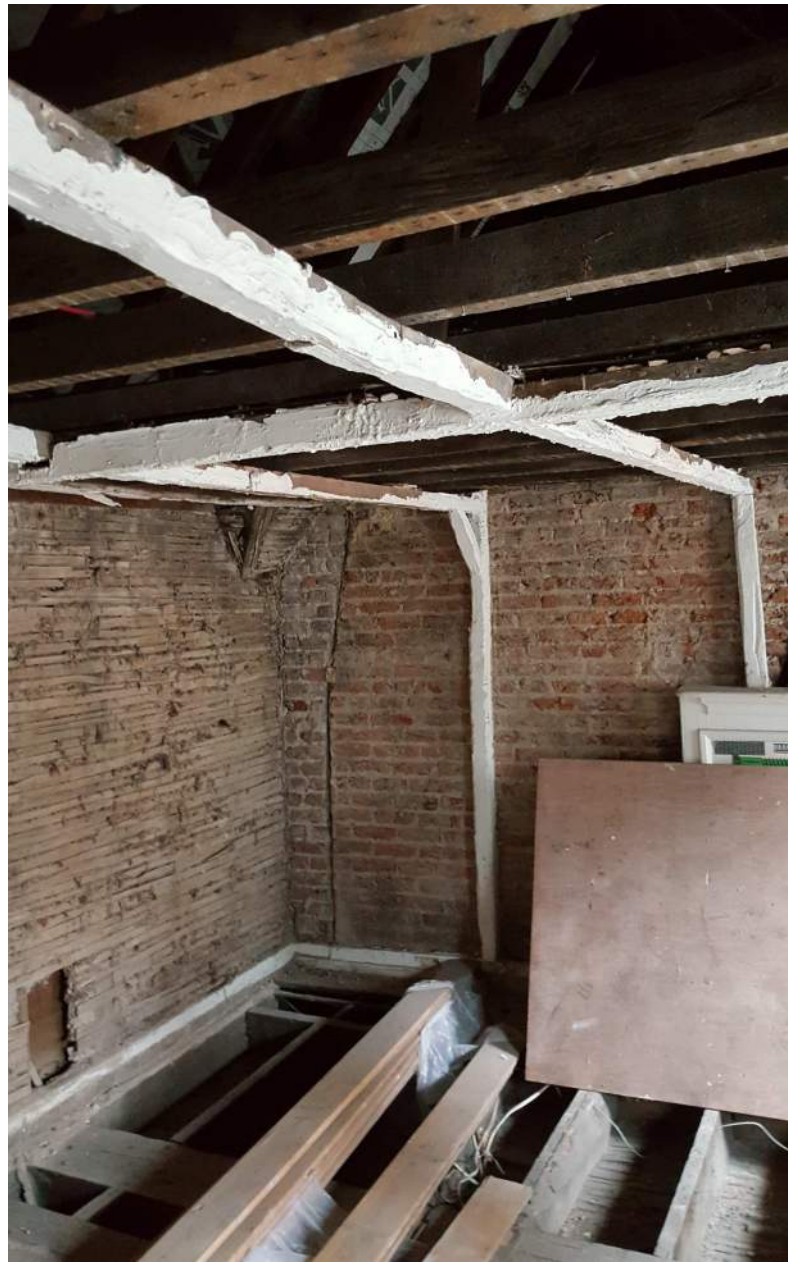
Figure 13, Third Floor Non-Structural Additions

- The white timber work to the ceiling has splice joints which have rotated and are not designed to be load-bearing

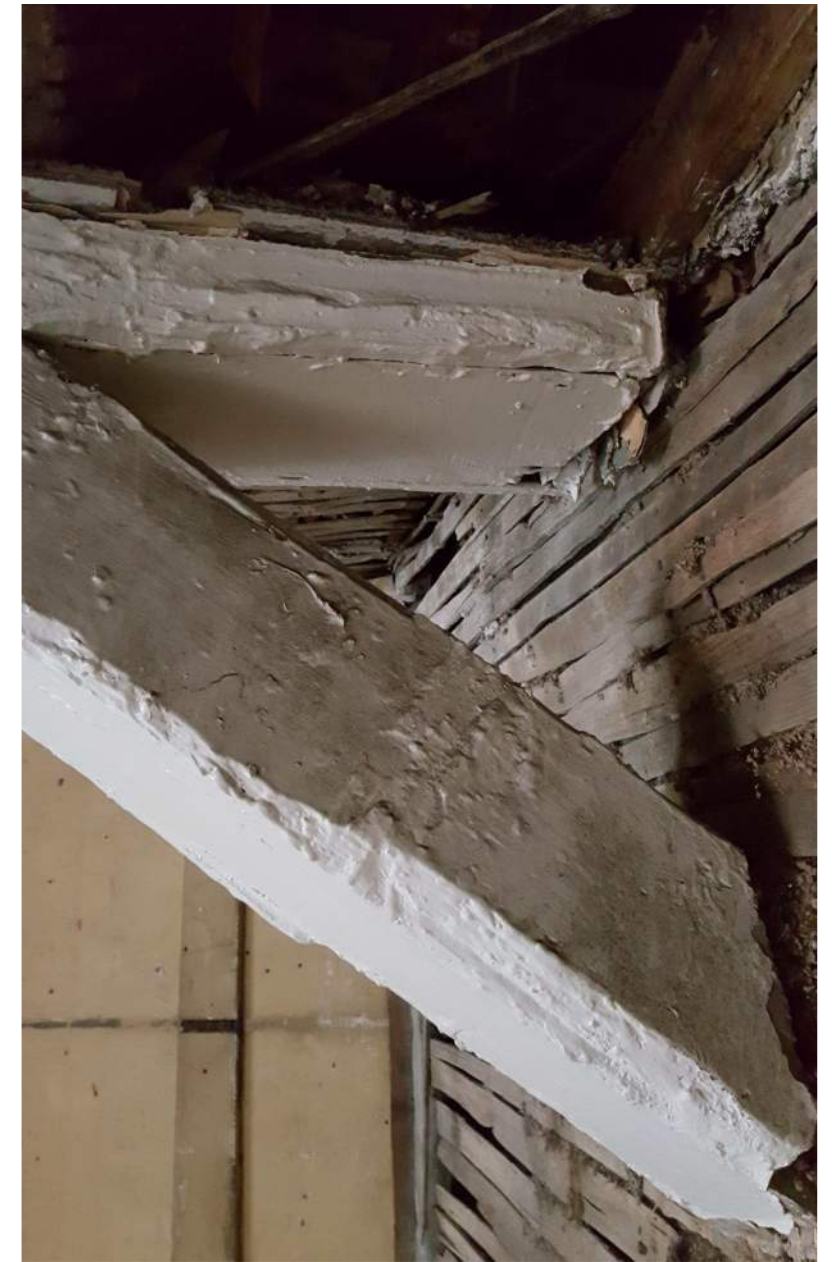
Figure 14, Third Floor Non-Structural Additions

- The apparent main white timber beam to the underside of the ceiling is formed of timber sheets and is hollow, by inspection this element is non-structural
