Arboricultural Appraisal Report

Subsidence Damage Investigation at:

Flat 2, Gilling Court
Belsize Grove
Hampstead
London
NW3 4UY

CLIENT:	Crawford & Company
CLIENT REF:	SU1604808
MWA REF:	SUB170818-1673
MWA CONSULTANT:	Andy Clark
REPORT DATE:	30-08-2017

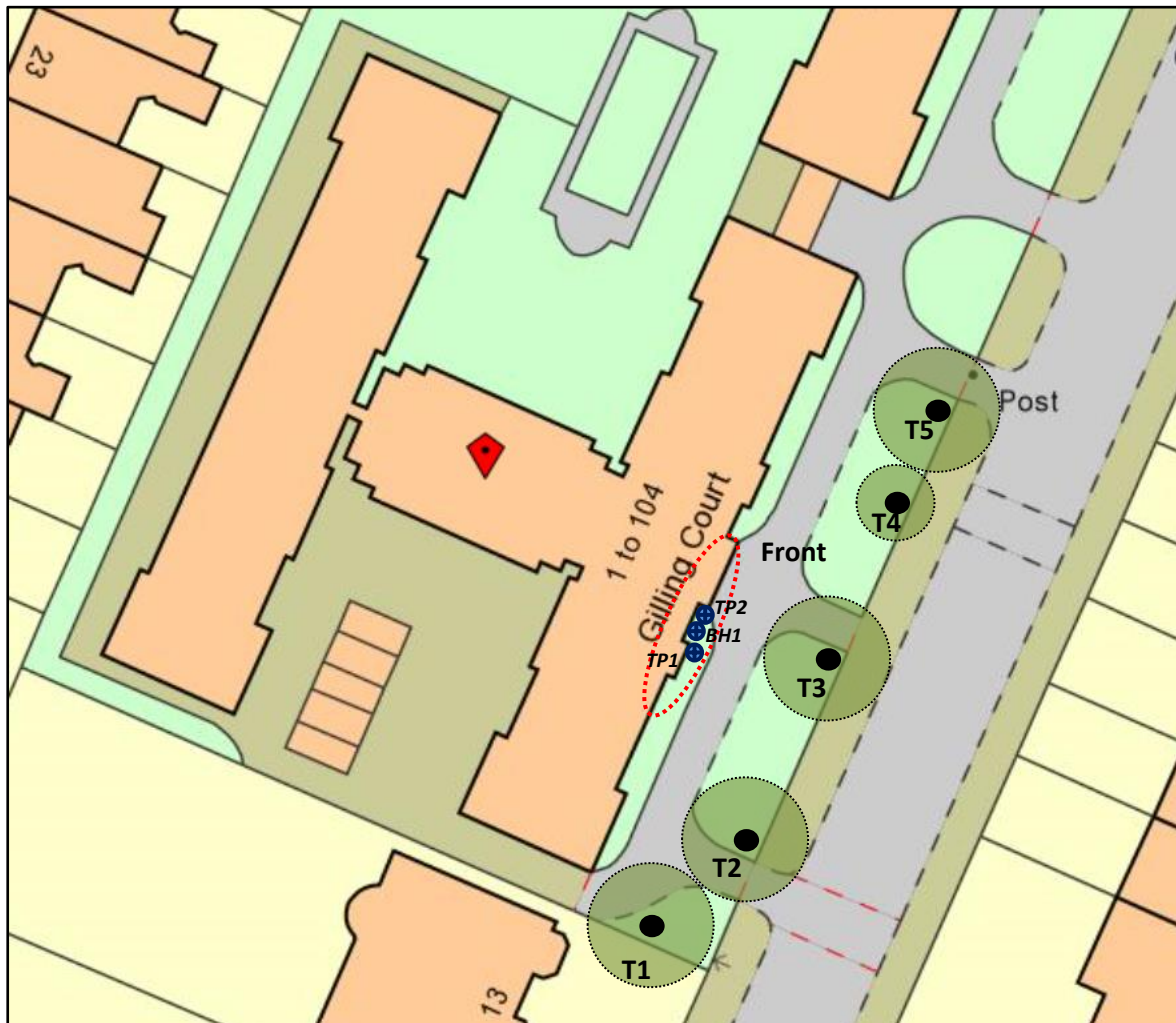
SITE PLAN

Approximate areas of damage

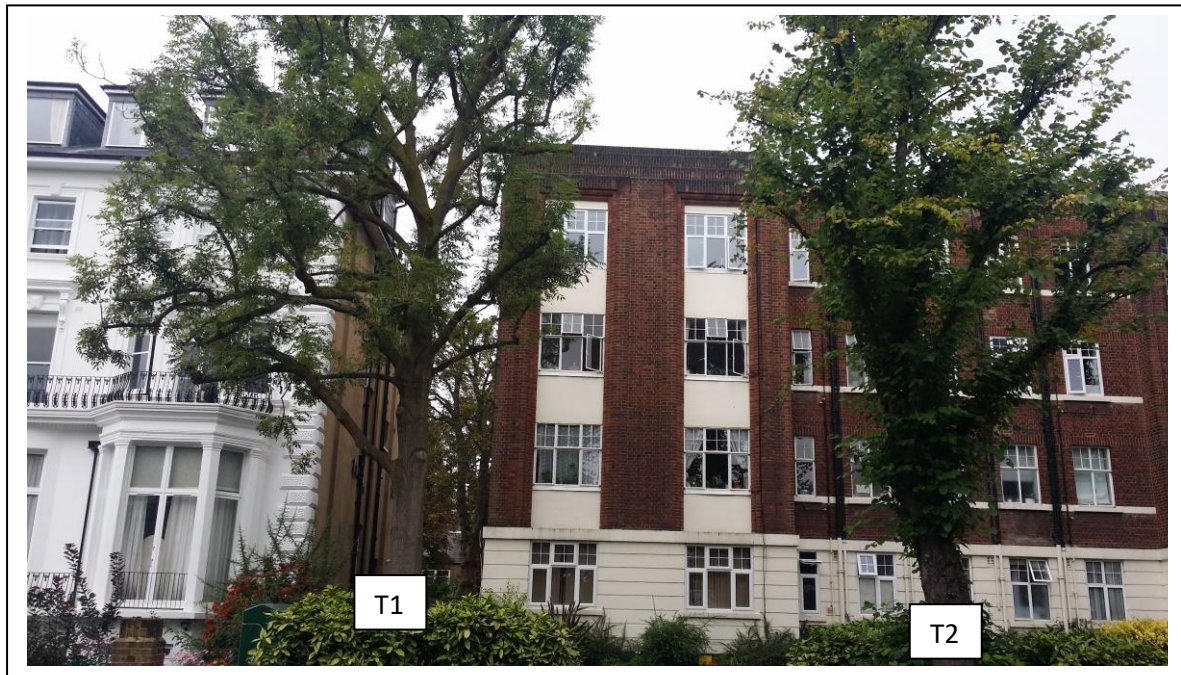
View of T1 Ash and T2 Lime

Tree No.	Species	Ht (m)	Dia (mm)	Crown Spread (m)	Dist. to building (m)	Age Classification	Ownership
T2	Lime	14.5	600	7.0	10.4	Younger than property	Policy Holder
Management history		Crown reduced in recent past – regrowth appears <1yr Moderate basal and epicormic growth					
Recommendation		Fell to ground level and treat stump to inhibit regrowth					
T3	Lime	20.5	Ms [x4] 400	14.0	11.1	Younger than property	Policy Holder
Management history		Pollarded in past @ approx. 15m – regrowth appears <10yrs Included unions @ main stem fork cluster					
Recommendation		Fell to ground level and treat stumps to inhibit re-growth

Tree No.	Species	Ht (m)	Dia (mm)	Crown Spread (m)	Dist. to building (m)	Age Classification	Ownership
T1	Ash	15.5	530	7.5	6.8	Younger than property	Policy Holder
Management history		Crown reduced in recent past – regrowth appears <1yr					
Recommendation		Fell to ground level and treat stumps to inhibit re-growth. The tree is too close and is an inappropriate species for its location.					
T4	Cherry	12.5	350	3.5	11.2	Younger than property	Policy Holder
Management history		Leaning stem and asymmetrical crown growth habit Crown reduced in recent past – regrowth appears <1yr					
Recommendation		Do not allow to exceed current dimensions through a programme of regular [triennial] pruning					
T5	Horse Chestnut	13.5	870	11.0	11.4	Younger than property	Policy Holder
Management history		Pollarded in past @ approx. 5.5m – regrowth appears 10> yrs Moderate stem decay at old pollard points					
Recommendation		Do not allow to exceed current dimensions through a programme of regular [triennial] pruning

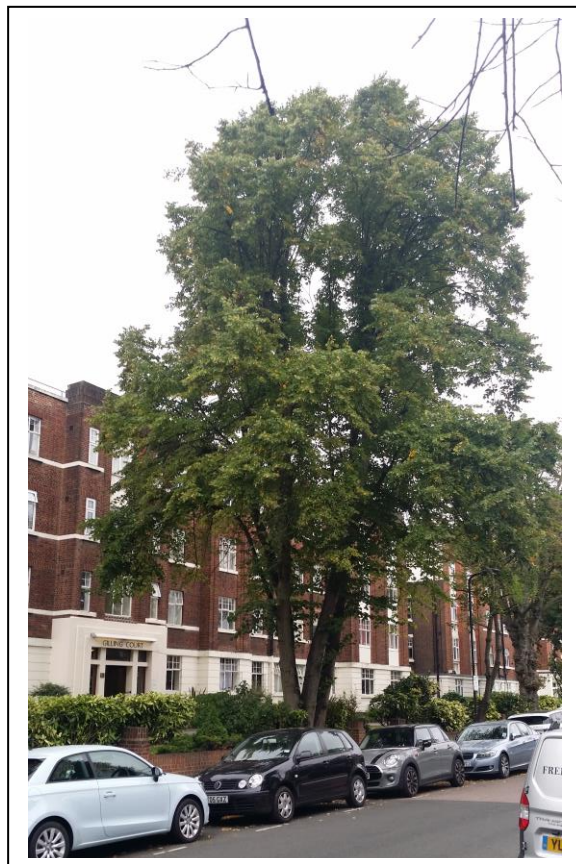
Roots were observed to a depth of 4.0m bgl in BH1 and recovered samples have been positively identified (using anatomical analysis) as *Tillia* spp. and *Berberis* or *Mahonia* spp., the origin of which, given their relative proximity to the property, will be T3 Lime, confirming the influence of this trees on the soils below the foundations. The recorded *Berberis* or *Mahonia* spp. roots will relate to small nearby shrubs which are not considered to be relevant. Irrespective of the root identification however, the roots of T1, T2, T4 and T5 are also likely to have a significant presence below the foundations of the property given their size and relative proximity to the structure.

View of T3 Lime

Based on the technical reports currently available, engineering opinion and our own site assessment we conclude the damage is consistent with shrinkage of the clay subsoil related to moisture abstraction by vegetation. Having considered the available information, it is our opinion that T3 Lime is the principal cause of the current subsidence damage with T2 Lime also being contributory. If an arboricultural solution is to be implemented to mitigate the current damage and allow the soils beneath the property to recover to a position such that an effective repair solution can be implemented we recommend that T2 and T3 are removed.

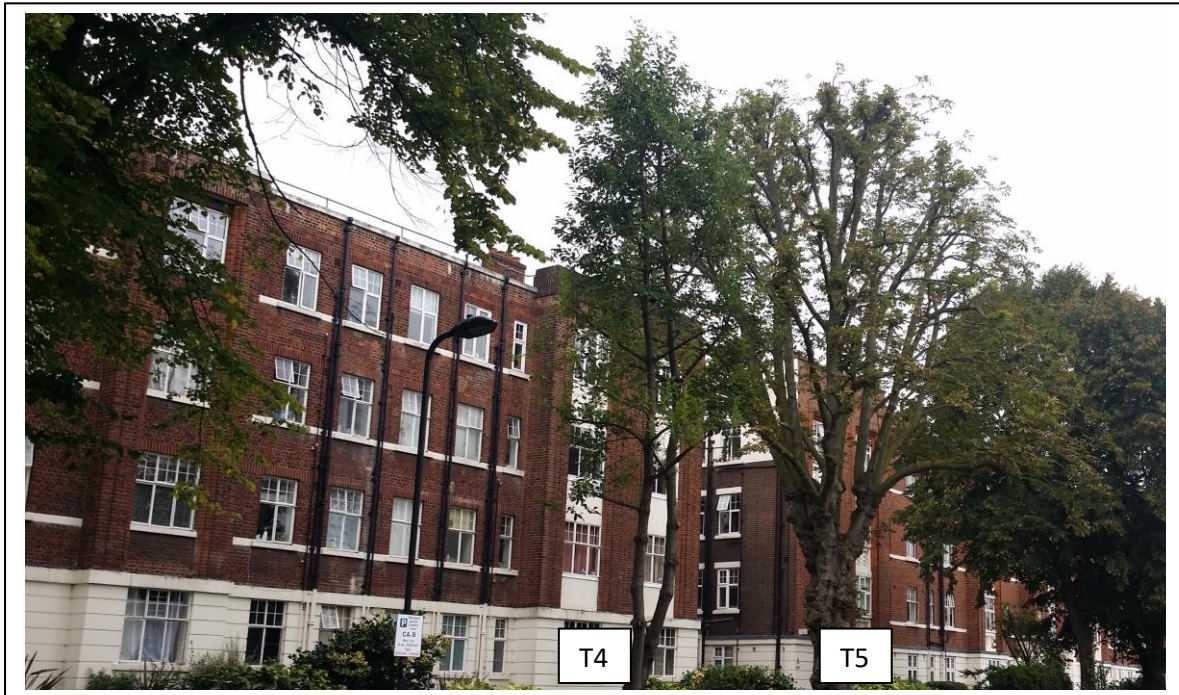
View of T4 Cherry and T5 Horse Chestnut
