Arboricultural Appraisal Report

Subsidence Damage Investigation at:

Garden Flat
37 Redington Road
London
NW3 7QY

CLIENT:	Pyle Consulting
CLIENT REF:	BRC/sp/8356
MWA REF:	SUB170724-1616
MWA CONSULTANT:	Andy Clark
REPORT DATE:	11-08-2017

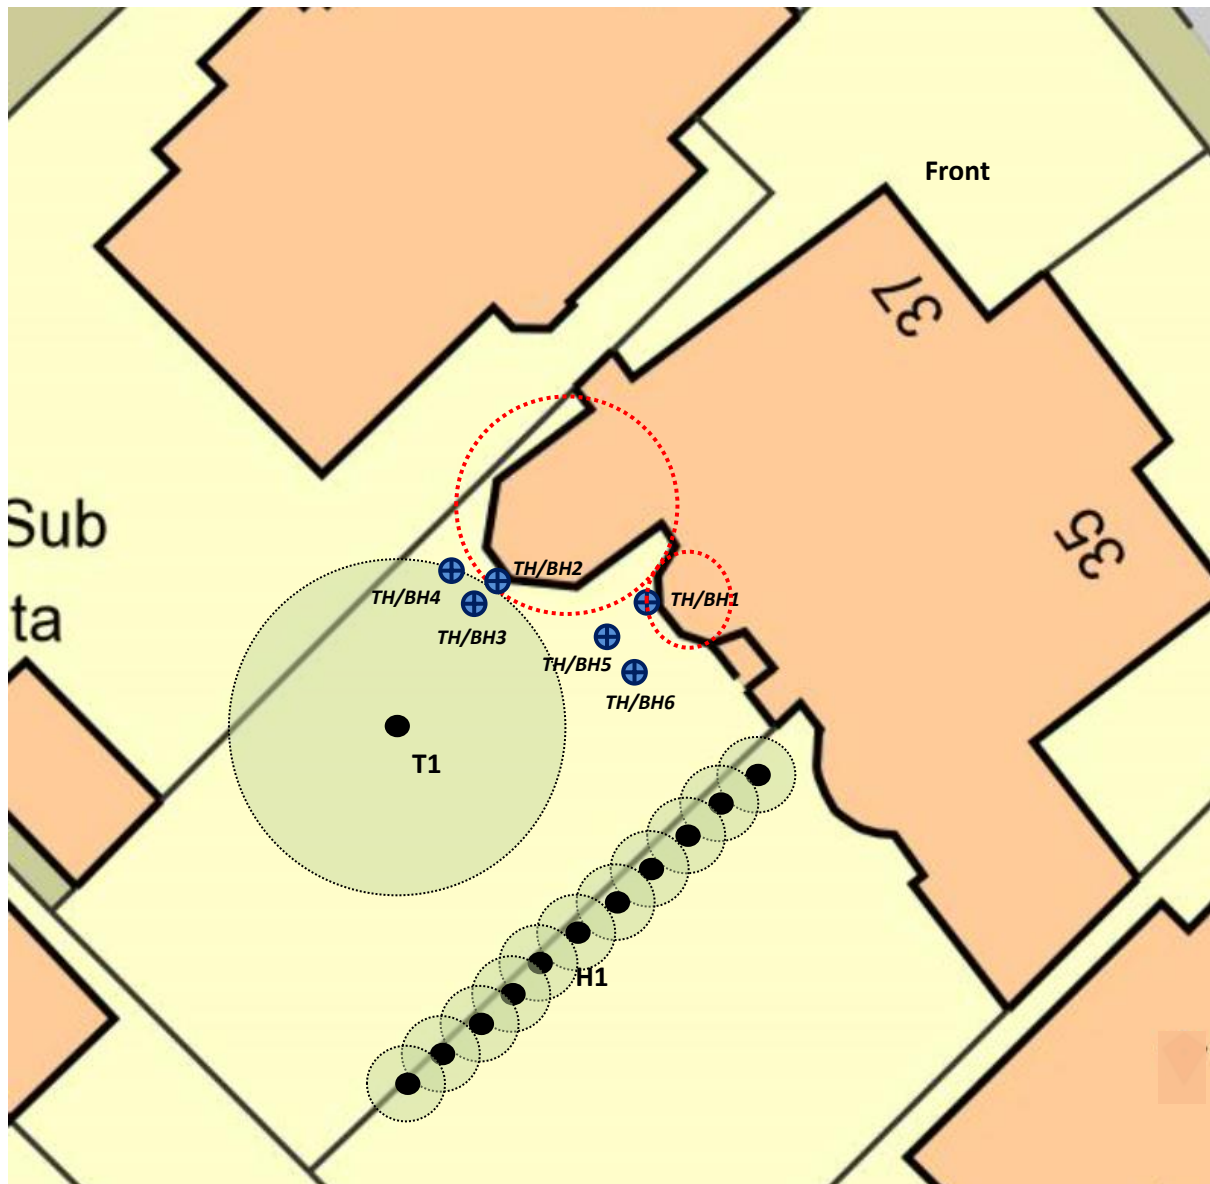
SITE PLAN

Approximate areas of damage

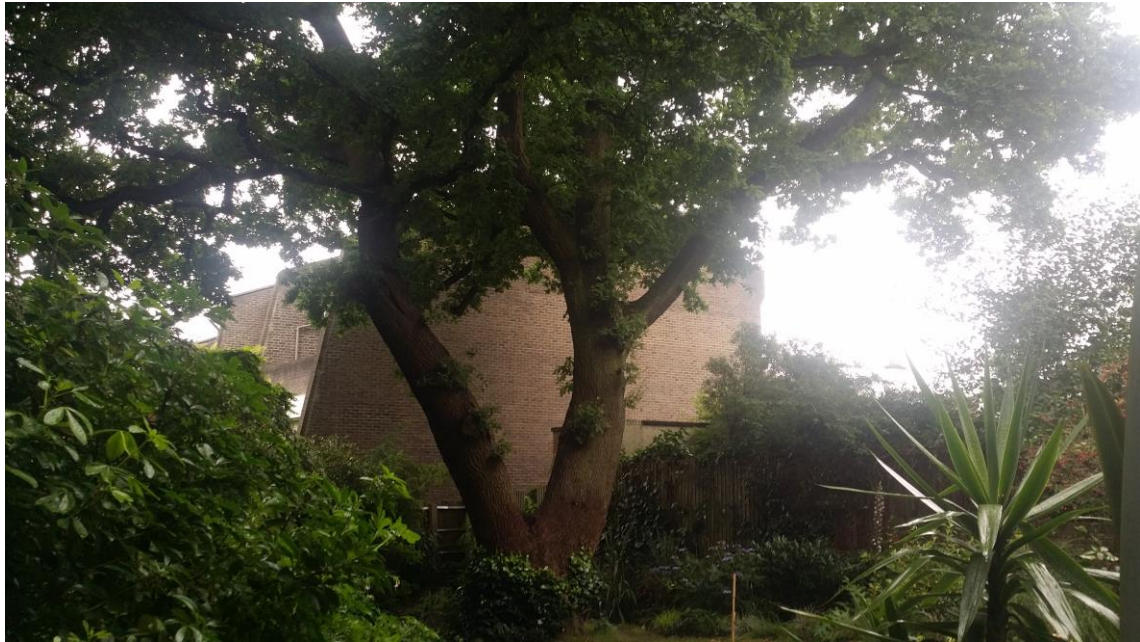
Based on the technical reports currently available, engineering opinion and our own site assessment we conclude the damage is consistent with shrinkage of the clay subsoil related to moisture abstraction by vegetation and that T1 Oak is the principle cause, with the addition that H1, 3rd party Leyland Cypress hedge, is a potential contributory factor based on size and proximity.

View of T1 Oak

Given that removal of the tree has the potential to result in heave and lead to further damage to the property, if an arboricultural solution is to be implemented to help mitigate the current damage and allow the soils beneath the property to recover to a position such that an effective repair solution can be implemented we believe that T1 Oak can undergo a crown reduction of approximately 50% volume.

Tree No.	Species	Ht (m)	Dia (mm)	Crown Spread (m)	Dist. to building (m)	Age Classification	Ownership
T1	Oak	16.0*	1290	15.0	8.4	Older than property	Policy Holder
Management history		Twin stemmed growth habit with main fork @ approx. 1.5m Large longitudinal decay column in south-eastern stem Moderate basal decay pocket to south side of main stem No signs of significant past management however understood to have been crown reduced C.2015					
Recommendation		Reduce in height to suitable growth points at approx. 11m and reduce lateral limbs by approx. 3.5m radius to balance crown - ensure inner crown growth is retained. Do not allow to exceed new dimensions by a program of regular (triennial) re-pruning.

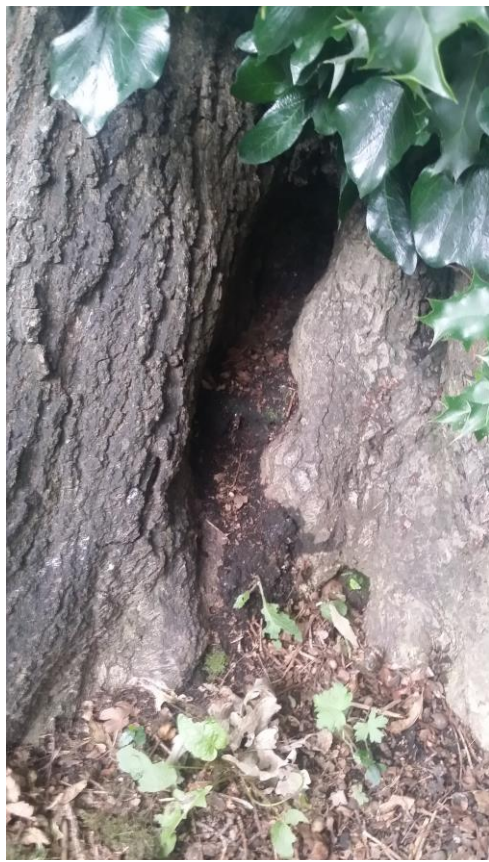
View of T1 Oak - basal decay pocket to south side of main stem

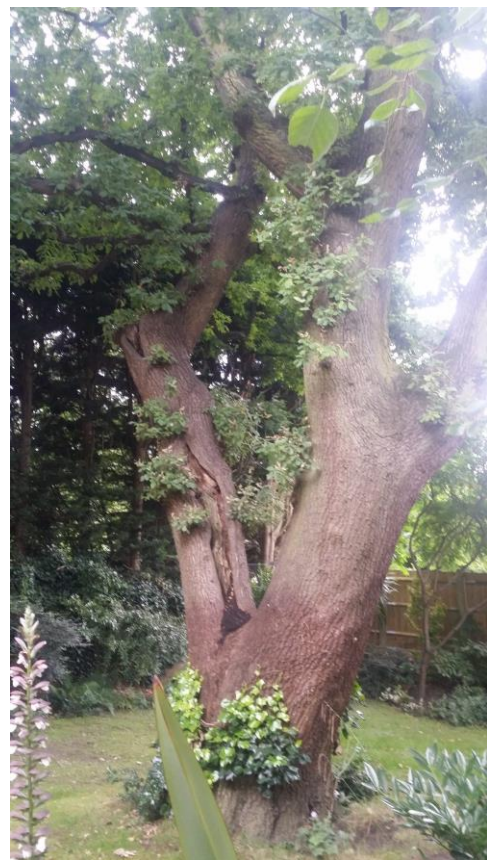
View of T1 Oak – longitudinal decay column in south-eastern stem

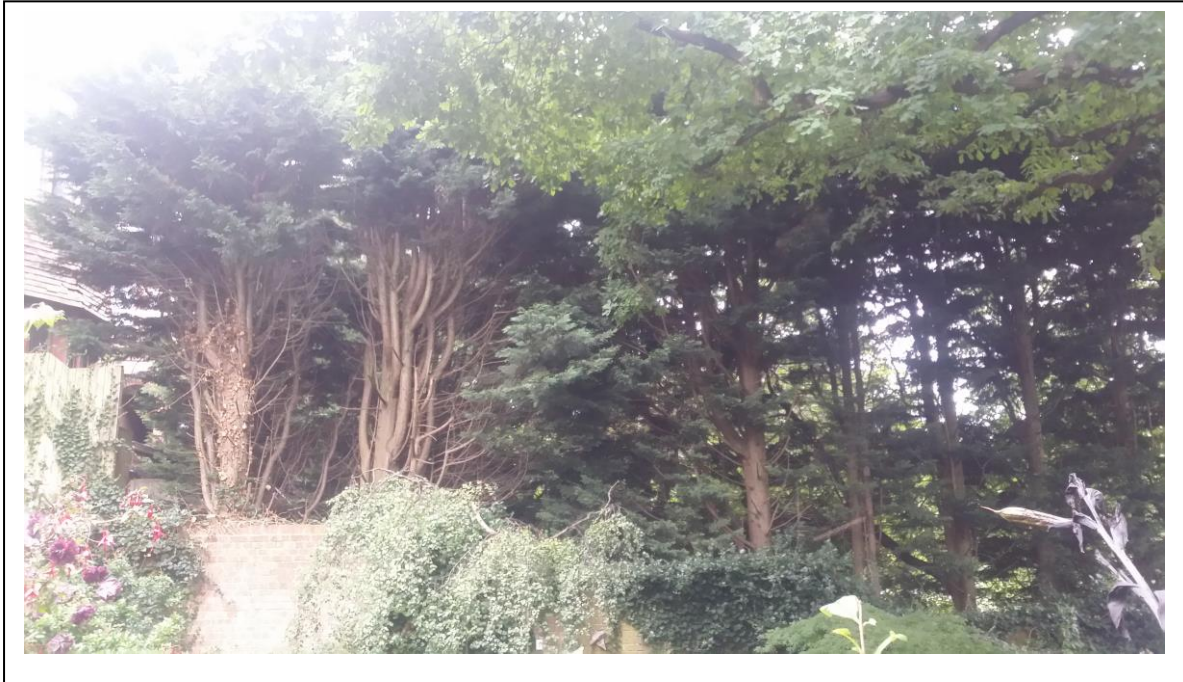
View of H1 – Leyland Cypress Hedge

Tree No.	Species	Ht (m)	Dia (mm)	Crown Spread (m)	Dist. to building (m)	Age Classification	Ownership
H1	Leyland Cypress hedge	11.0	250*	5.0	8.8 [closest stem]	Younger than property	3rd Party:- 35 Redington Road, NW3
Management history		Topped in past @ approx. 10m – regrowth appears <5yrs					
Recommendation		Reduce in height to 5m Do not allow to exceed new dimensions by a program of regular (annual) trimming
