**SUPPORTING INFORMATION FOR**  
**15 GLOUCESTER AVENUE REAR BALCONY, LONDON, NW1**

**1 Introduction**

This information is provided in support of the original Listed Building Application 2017/4254/L following the on-site meeting with Nick Baxter on 21st August 2017.

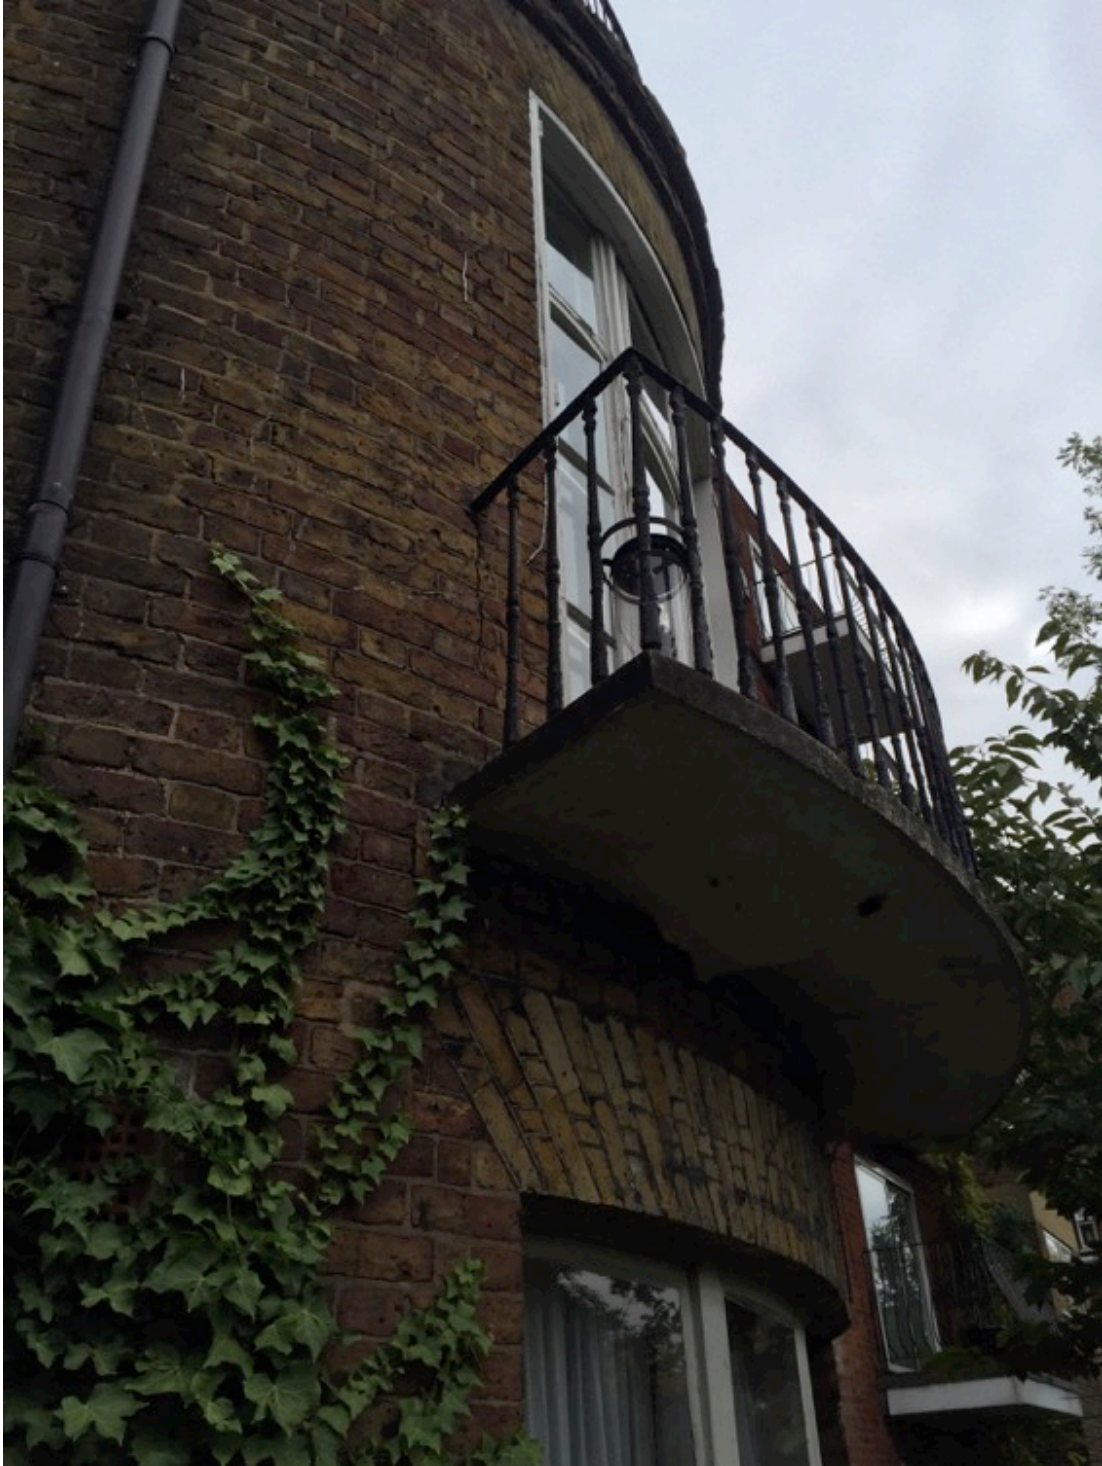
Photograph 1 – Balcony in disrepair

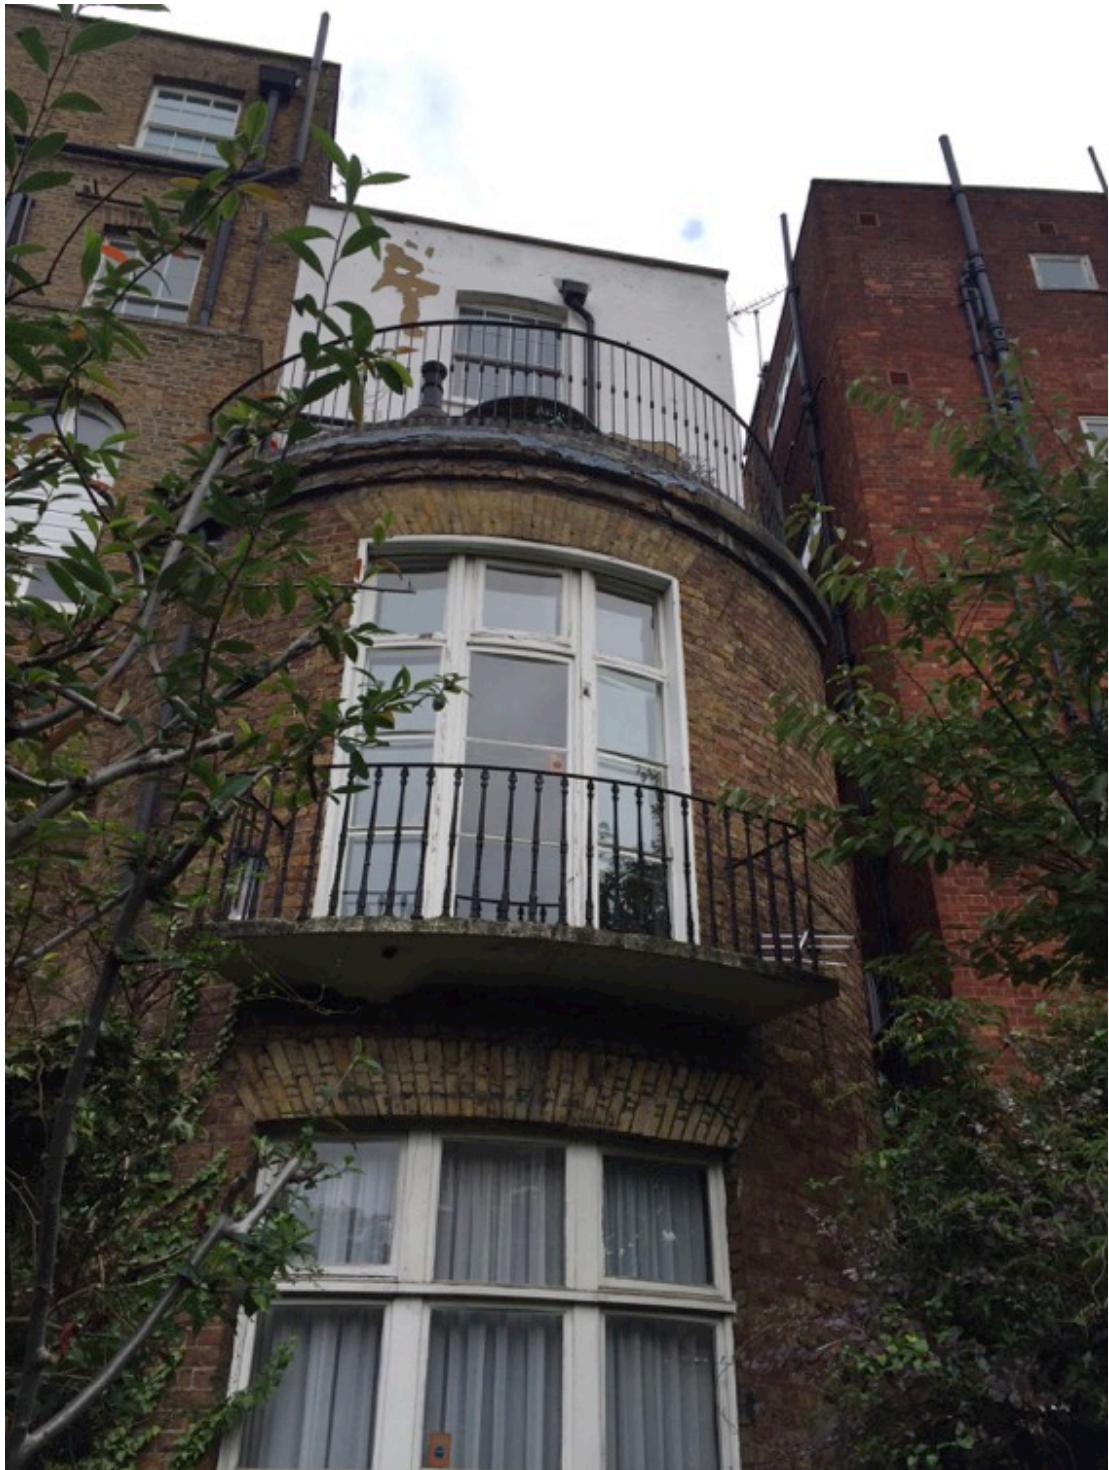
Both reports concluded that the balcony was not safe and repairing the existing balcony was not a safe or feasible option.

Photograph 2 – The balcony as deemed unsafe

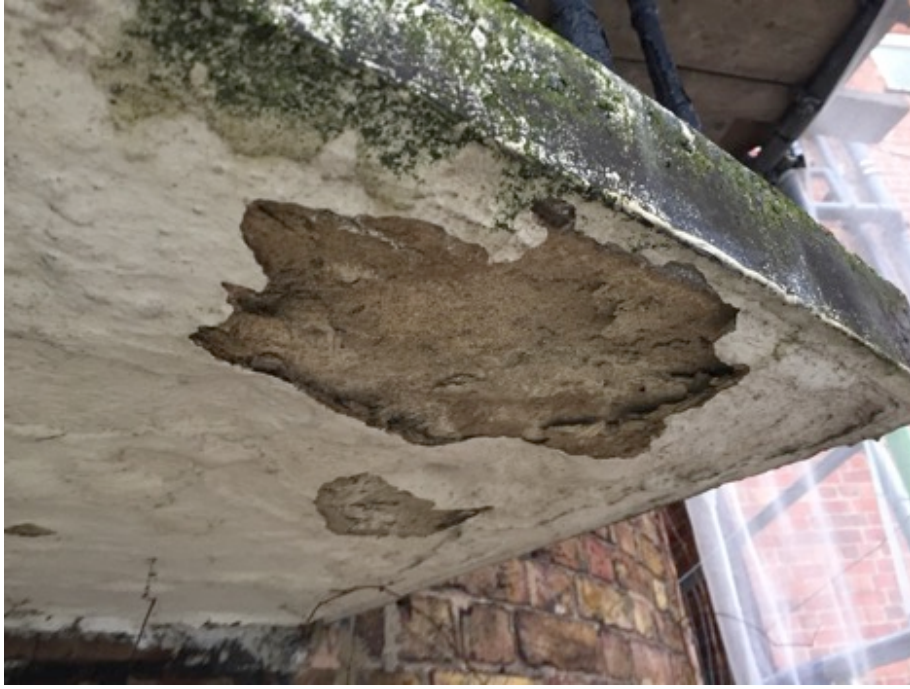
Photograph 3 – Large section of the underside of balcony fallen off

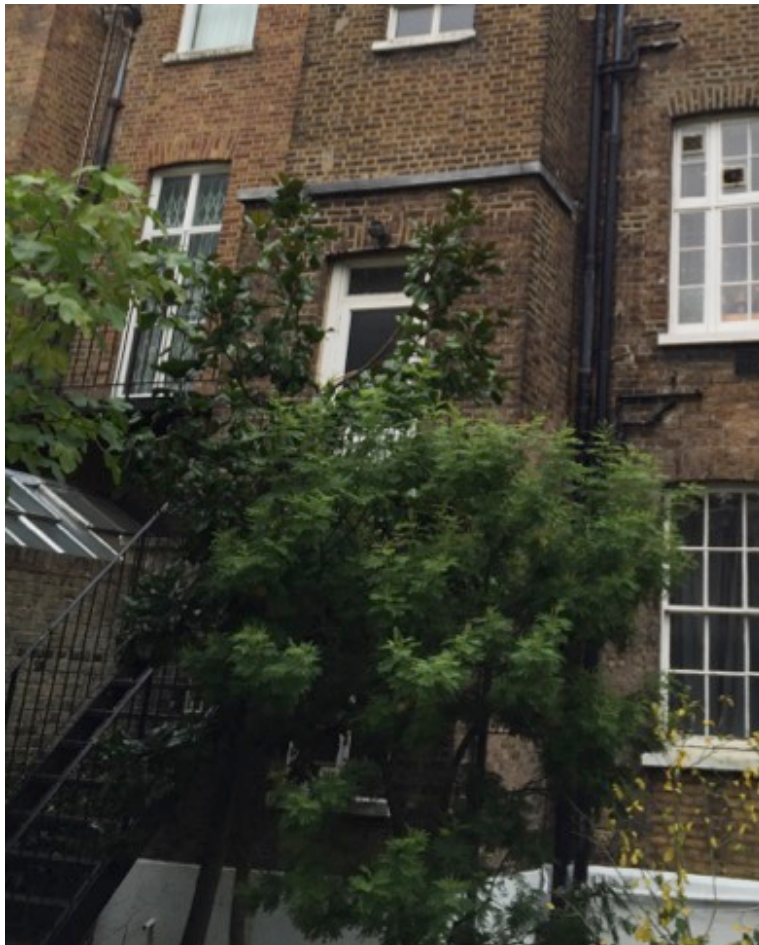
During the on-site meeting with Mr Baxter, it was evident looking at the rear facade of Gloucester Avenue that no other stone or concrete had been used for the construction of balconies. They are all of metal/ironwork construction and therefore the proposed metal balcony would not be out of context with the rear façade.

Photograph 4 – Full metal balcony and railings to rear facade (LHS of picture)

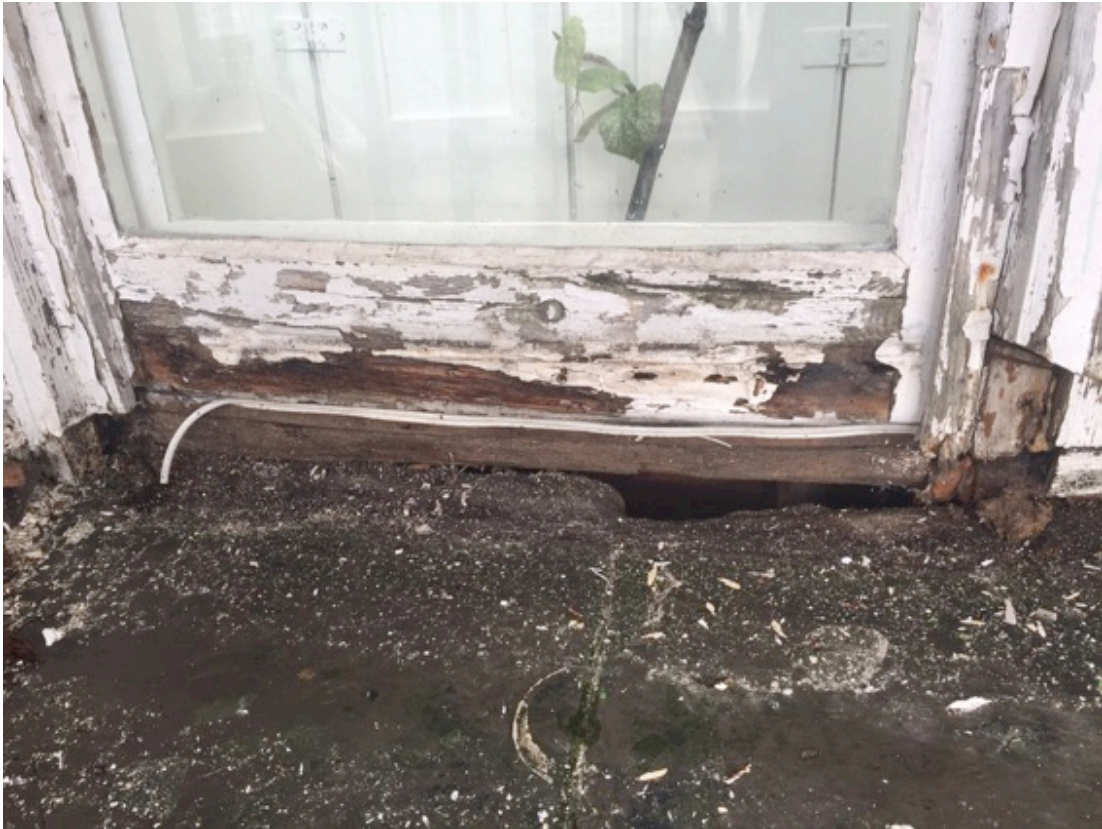
The first engineer to inspect the balcony suggested that the steel curved plate sections behind the single skin facing brick arch was supporting the balcony and presumed a cantilever structure. However, through further inspection, the second engineer concluded that the balcony was held in place simply by the brick wall and the balustrade, resulting in a balcony with very little restraint, i.e. not cantilevered.

Photograph 5 – Gap between the balcony and main building indication it was not a cantilever design.

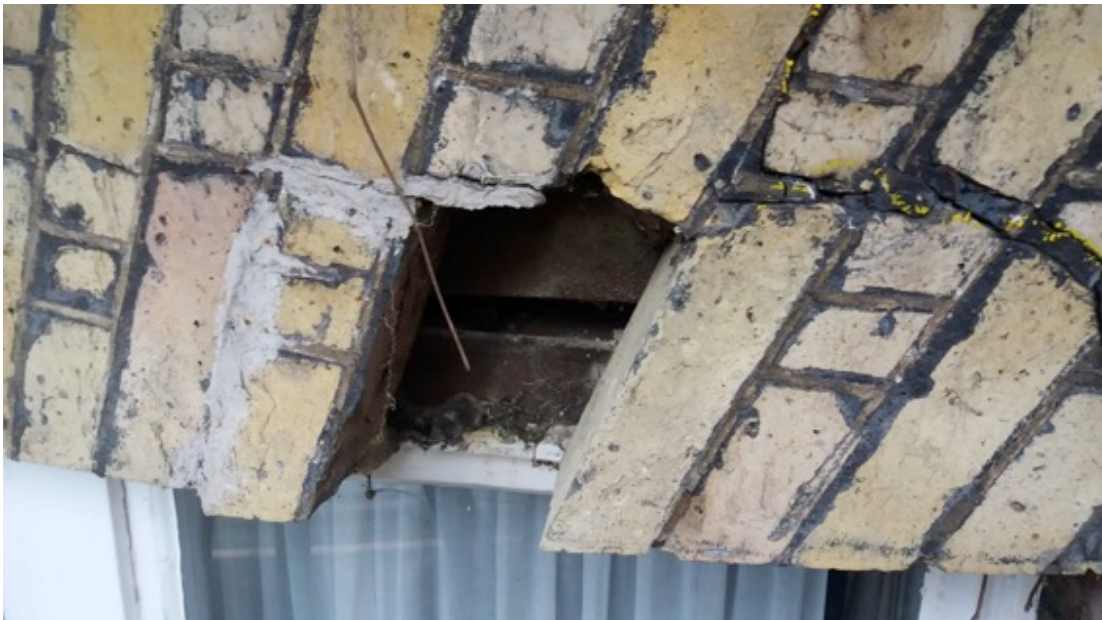
Photograph 6 – Curved steel support below the balcony.
