ARBORICULTURAL ASSESSMENT REPORT

Arborist Name:	Dave O'Connell		
Title:	Senior Arborist	Date:	30/11/2016

Location:	24 Rochester Square, London, NW1 9SA
Job Ref.:	69194
Survey Date:	30 th November 2016
By OCA Limited	
Crown copyright 2016. License number 100043594

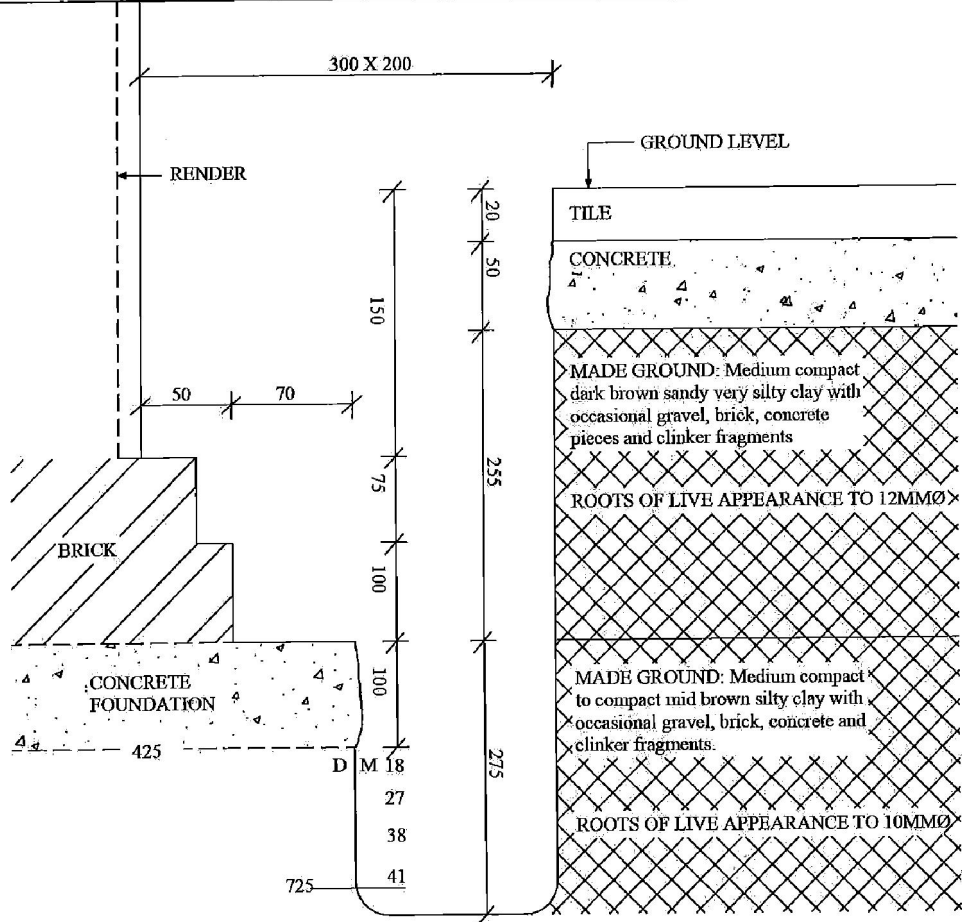
Trial Pit No: 1	Sheet: 1 of 1	Site: 24 Rochester Square, NW1
	Job No: 383693	
Hand Tools	Drawn by: SL	Work carried out for: Cunningham Lindsey
Weather: DRY	Ground Level mOD:

Remarks: All measurements in millimetres. Small trial pit dug due to services in area, no mac probes done underside sample.	Key:	D Small disturbed sample	J Jar sample
	B Bulk disturbed sample	V Pilcon Vane (kPa)	
	W Water sample	M Mackintosh probe	
	TDTD Too dense to drive
