Arboricultural Appraisal Report

Subsidence Damage Investigation at:

52 West End Lane
 London
 NW6 2NE

CLIENT: Crawford & Company
 CLIENT REF: SU1700120
 MWA REF: SUB170621-1526
 MWA CONSULTANT: Andy Clark
 REPORT DATE: 17-07-2017

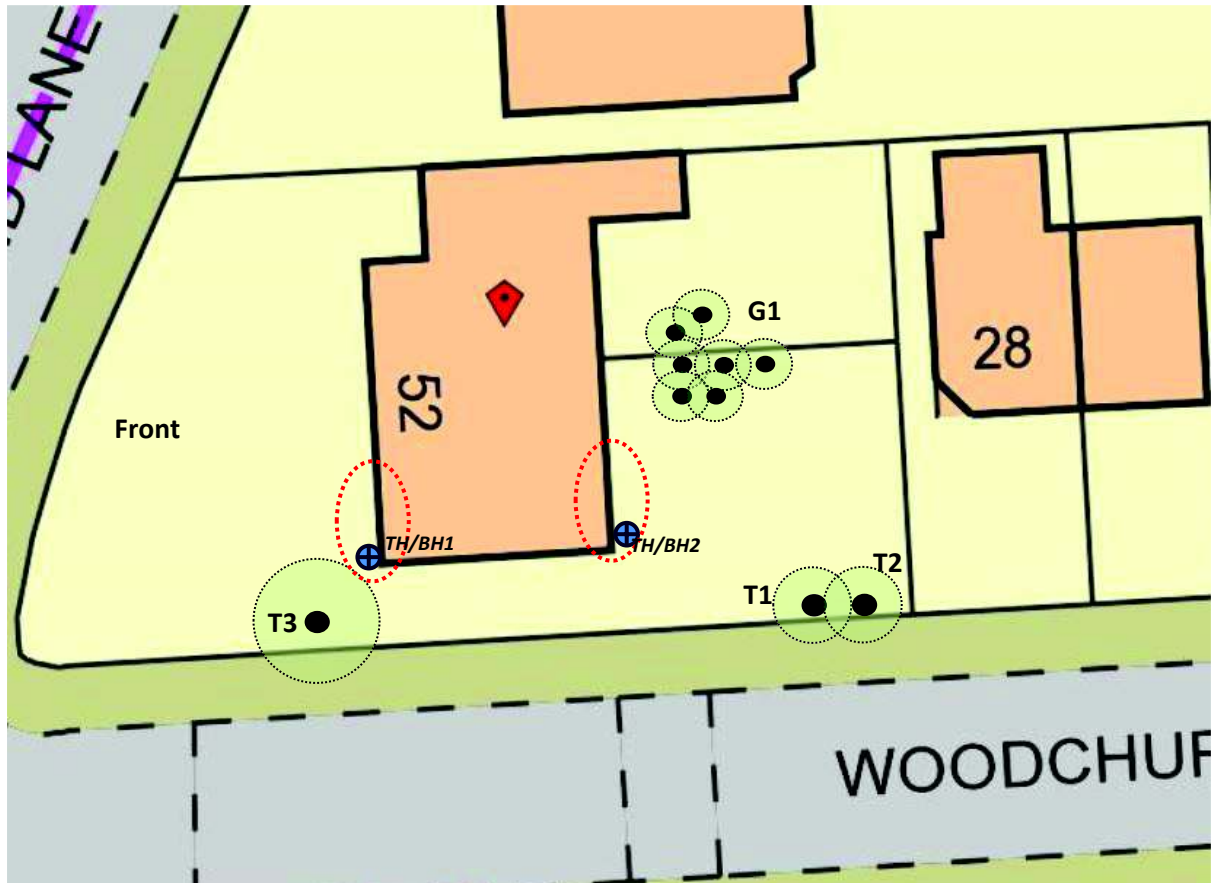
SITE PLAN

Approximate areas of damage

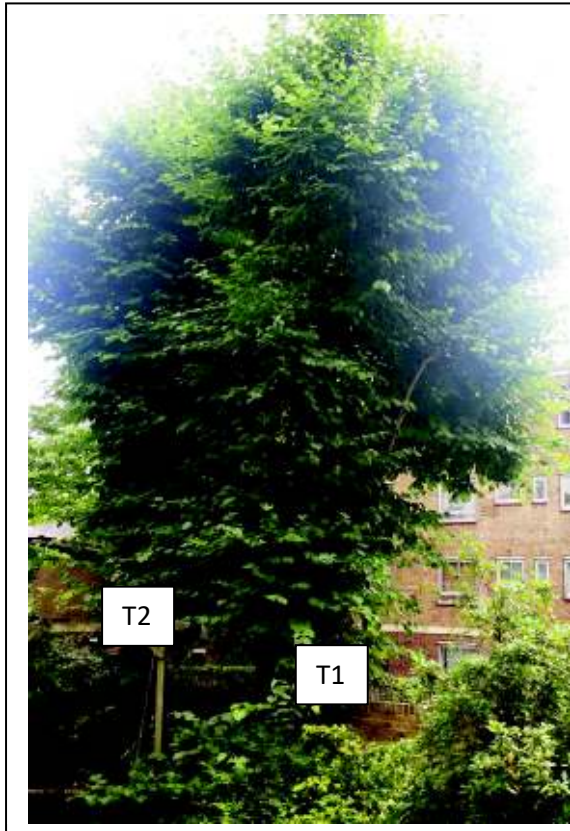
Live roots were observed to a depth of 1.7m bgl in TP/BH2 and recovered samples have been positively identified (using anatomical analysis) as *Salix* spp. and *Tilia* spp., the origin of the *Tilia* will be T1 and T2 Lime, confirming the influence of these trees on the soils below the foundations. On investigation of the property no *Salix* spp. [Willow] trees were evident. Irrespective of the root identification, the roots of T3 False Acacia and G1 Mixed spp. shrub group are also likely to be present below the foundations based on their size and proximity.

View of T1 Lime and T2 Lime

Based on the technical reports currently available, engineering opinion and our own site assessment we conclude the damage is consistent with shrinkage of the clay subsoil related to moisture abstraction by vegetation. Having considered the available information, it is our opinion that T1, T2 and T3 are the principal cause of the current subsidence damage. If an arboricultural solution is to be implemented to mitigate the current damage and allow the soils beneath the property to recover to a position such that an effective repair solution can be implemented we recommend that these trees and shrubs are removed.

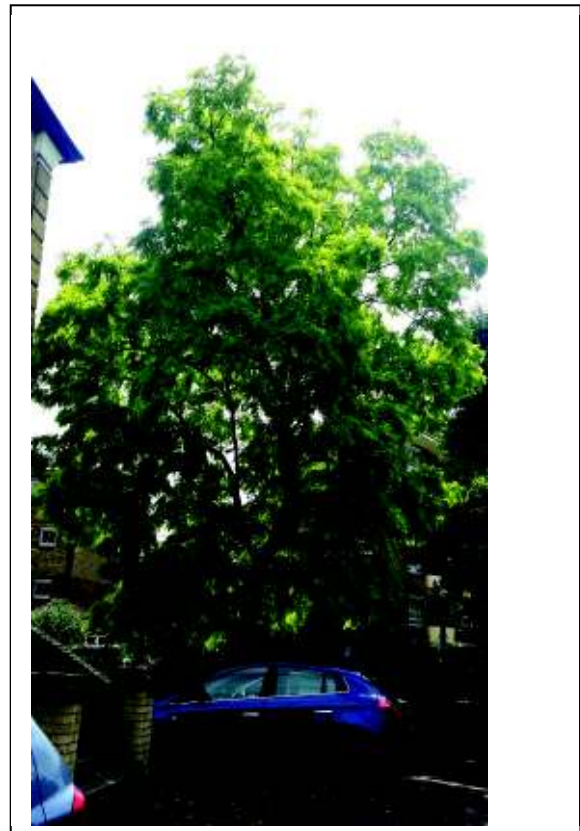
View of T3 False Acacia

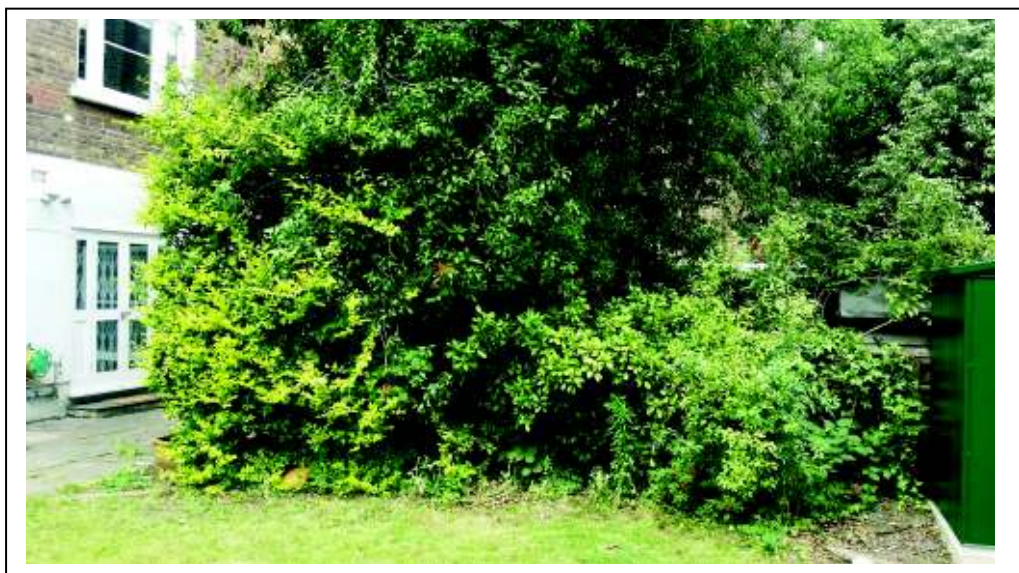
View of G1 Mixed spp. shrub group

Tree No.	Species	Ht (m)	Dia (mm)	Crown Spread (m)	Dist. to building (m)	Age Classification	Ownership
G1	Mixed spp. group consisting Rhododendron, Photinia, Pittosporum and Elaeagnus	3.5	Ms 100	7.0	4.5	Younger than property	Policy Holder
Management history		No signs of significant past management					
Recommendation		Reduce height by 50% and trim annually to retain at reduced dimensions.
