**14 Rochester Road,
London, NW1 9JH**

Circumstances

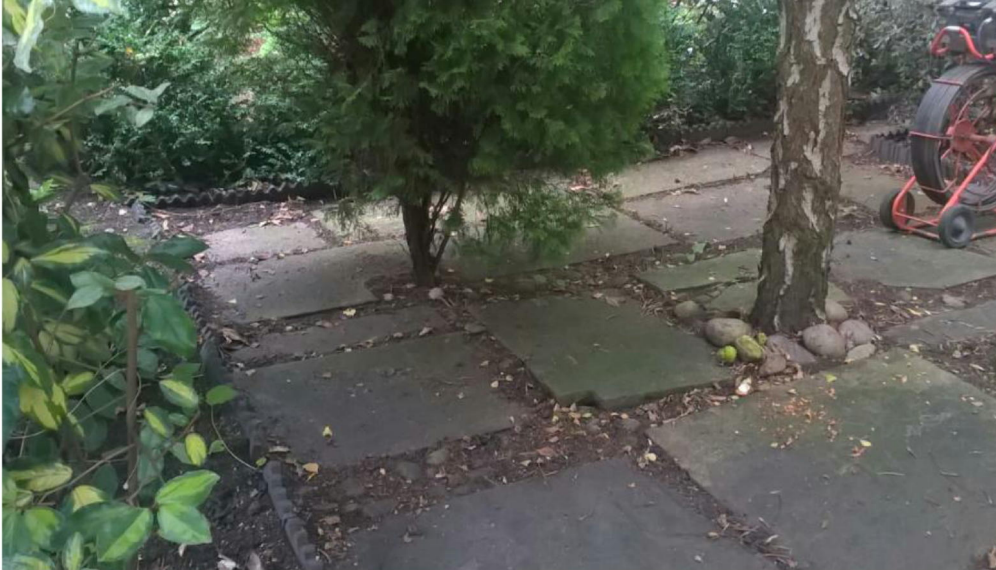
It is now our belief that the pipework has a large root intrusions at around 5.5-6 meters downstream.

In highly possible that the root intrusion has caused the pipework to collapse at this distance and due to the jetting unit only getting to 8 meters there is a second collapse which would be out of boundary.

Trees to be removed – area of excavation is below shrub in centre of picture.

- Excavate to a depth of up to 3 meters at 5.6 meters downstream FMH1 using a digger.
- Excavation will require trench support/shoring to comply with health and safety requirements.
- Remove section of pipe and CCTV downstream to ascertain pipe condition.
- Call from site with findings
- Backfill and reinstate as per current ground conditions (slabing)
- Remove all spoil and waste from site as required.

Please note before the excavation can be completed an arbour culturist will be required to remove trees/shrubbery so the repair can be completed.
