CCTV REPORT

CLIENT	RANDALL SURVEYS LLP
LOCATION	CAMLEY STREET
DATE	26/05/2017
REF	071082
DVD No	001

071082 CAMLEY STREET LONDON - CCTV Survey Report : 28/05/17

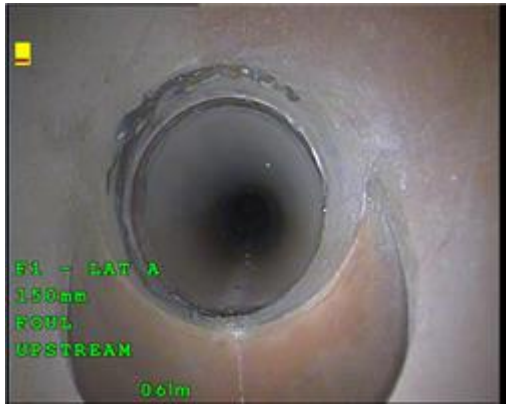
Pos	Code	Description	Image
00.00m	MH	Start node type, manhole F1	
00.00m	WL	Water level: 0% Height/Diameter	
00.61m	JN	Junction at 6 o'clock: 150mm Diameter BACKDROP	<p>Image Provided - Ref: 0_2</p>

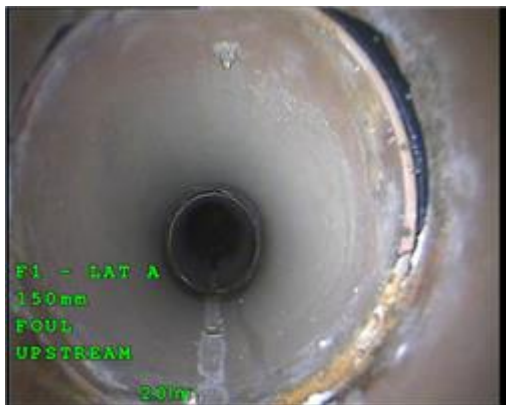
02.01m	OJM	Open joint medium - Grade 2	<p>Image Provided - Ref: 0_3</p>

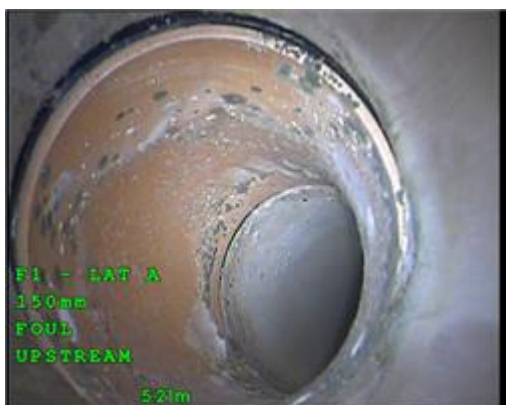
05.21m	OJM	Open joint medium - Grade 2	<p>Image Provided - Ref: 0_4</p>

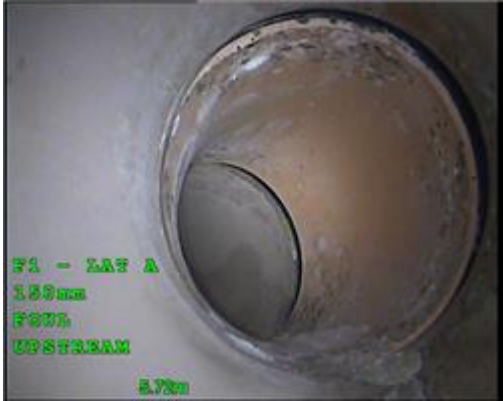
Pos	Code	Description	Image
05.72m	OJM	Open joint medium - Grade 2	<p>Image Provided - Ref: 0_6</p>

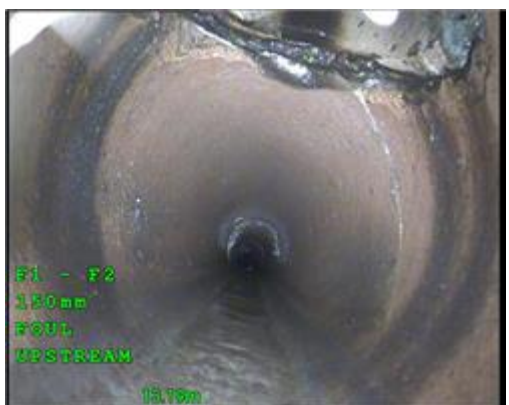
13.19m	CC	Crack, circumferential from 1 o'clock to 5 o'clock - Grade 2	<p>Image Provided - Ref: 1_4</p>

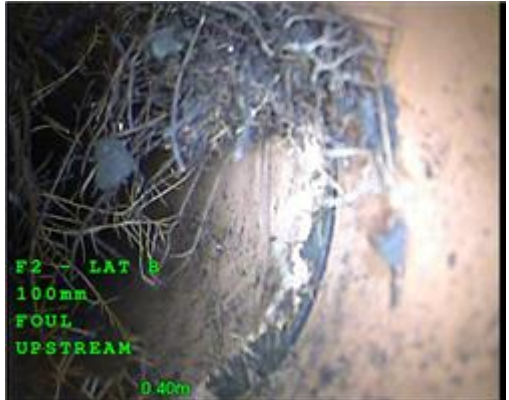
Pos	Code	Description	Image
00.00m	MH	Start node type, manhole F2	
00.00m	WL	Water level: 0% Height/Diameter	
00.40m	LLH	Line of drain/sewer deviates left [half]	
00.40m	R	Roots - Grade 2 MASS ROOTS AT JOINT 30%	<p>Image Provided - Ref: 4_3</p>

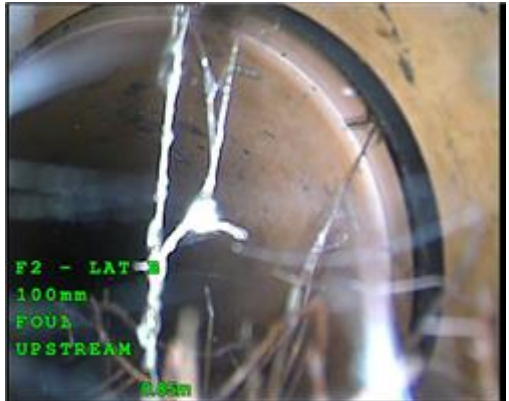
00.85m	JDL	Joint displaced large - Grade 3	<p>Image Provided - Ref: 4_4</p>

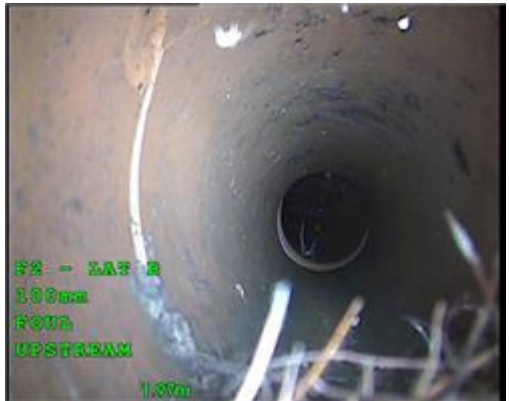
01.97m	FC	Fracture circumferential from 6 o'clock to 12 o'clock - Grade 3	<p>Image Provided - Ref: 4_5</p>

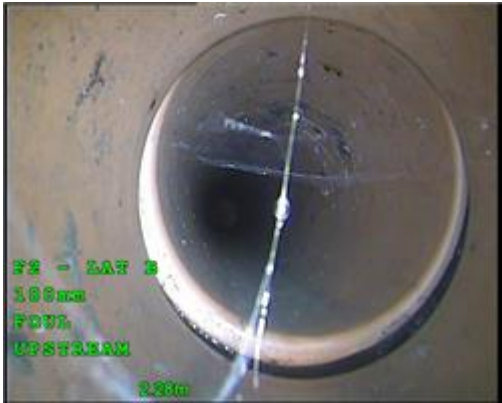
Pos	Code	Description	Image
02.28m	JDL	Joint displaced large - Grade 3	<p>Image Provided - Ref: 4_6</p>

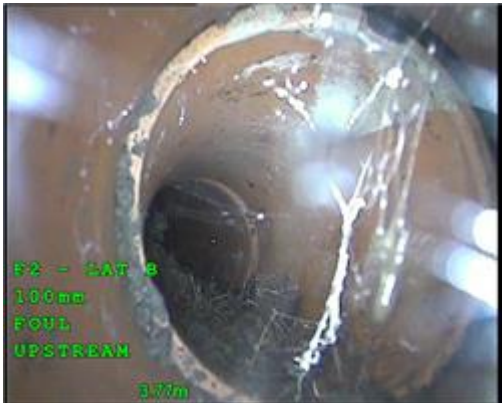
03.77m	JDL	Joint displaced large - Grade 3	<p>Image Provided - Ref: 4_7</p>

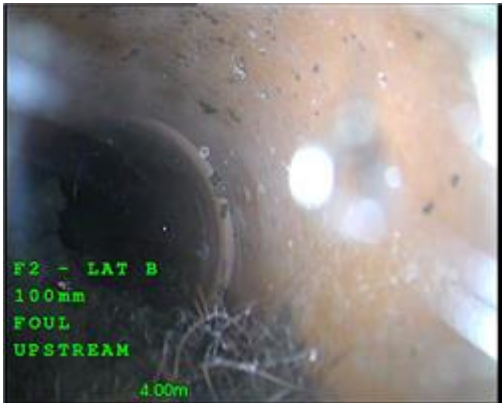
03.90m	LLQ	Line of drain/sewer deviates left [quarter]	
04.00m	S1 R	Roots4m - 5.95m - Grade 2 MASS ROOTS 40%	<p>Image Provided - Ref: 4_9</p>

05.95m	F1 R	RootsDefect End - Grade 2 MASS ROOTS 40%

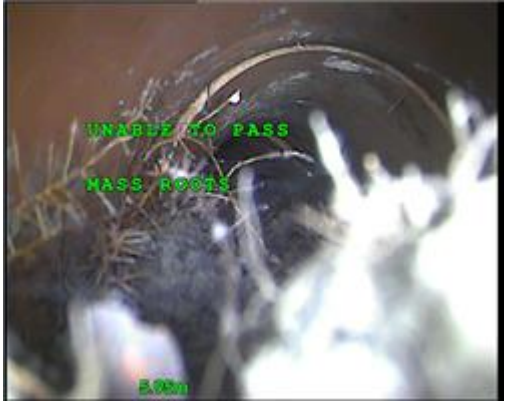
Pos	Code	Description	Image
05.95m	SA	Survey abandoned UNABLE TO PASS MASS ROOTS	<p>Image Provided - Ref: 4_9999</p>

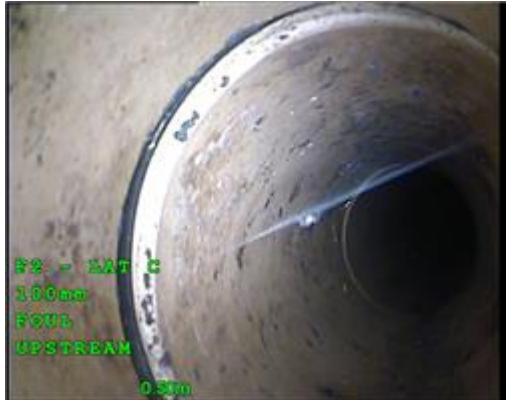
Pos	Code	Description	Image
00.00m	MH	Start node type, manhole F2	
00.00m	WL	Water level: 0% Height/Diameter	
00.50m	LRQ	Line of drain/sewer deviates right [quarter]	
00.50m	JDM	Joint displaced medium - Grade 2	<p>Image Provided - Ref: 5_3</p>

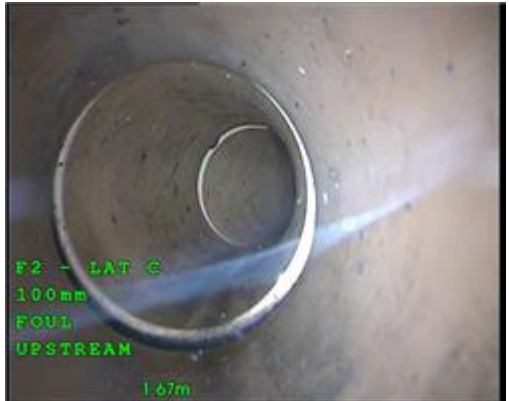
01.67m	JDM	Joint displaced medium - Grade 2	<p>Image Provided - Ref: 5_4</p>

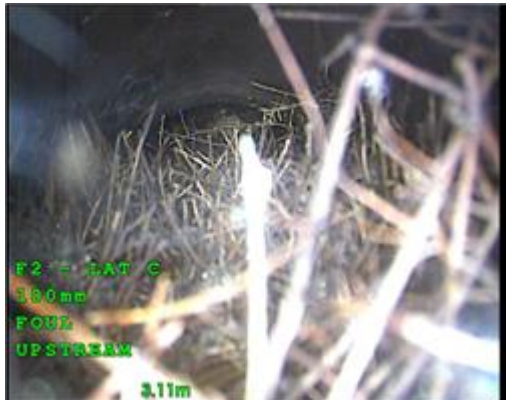
01.70m	LRQ	Line of drain/sewer deviates right [quarter]	
03.11m	R	Roots - Grade 2 MASS ROOTS 70%	<p>Image Provided - Ref: 5_6</p>

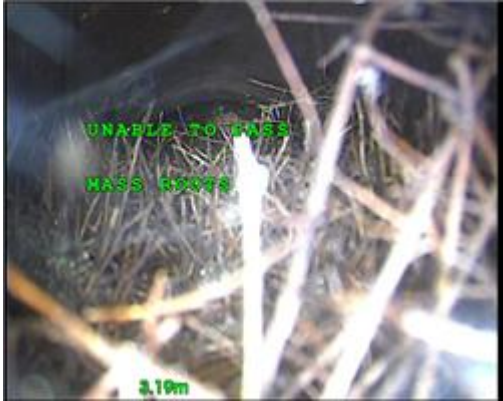
Pos	Code	Description	Image
03.19m	SA	Survey abandoned UNABLE TO PASS MASS ROOTS	<p>Image Provided - Ref: 5_9999</p>

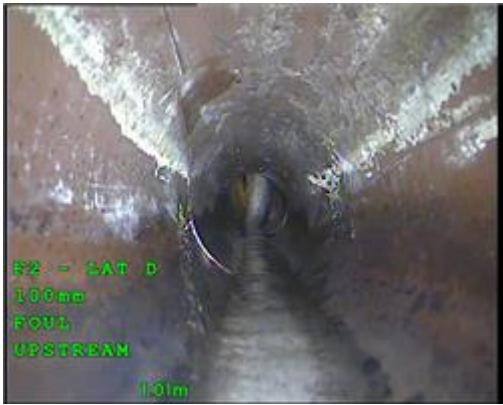
Pos	Code	Description	Image
00.00m	MH	Start node type, manhole F2	
00.00m	WL	Water level: 5% Height/Diameter	
01.00m	CL	Crack, longitudinal at 11 o'clock - Grade 2	<p>Image Provided - Ref: 6_2</p>
