# Simon Pryce Arboriculture

## Report

**Site:** 9 North End, London, NW3 7HH

**Subject:** Safety inspection of copper beech

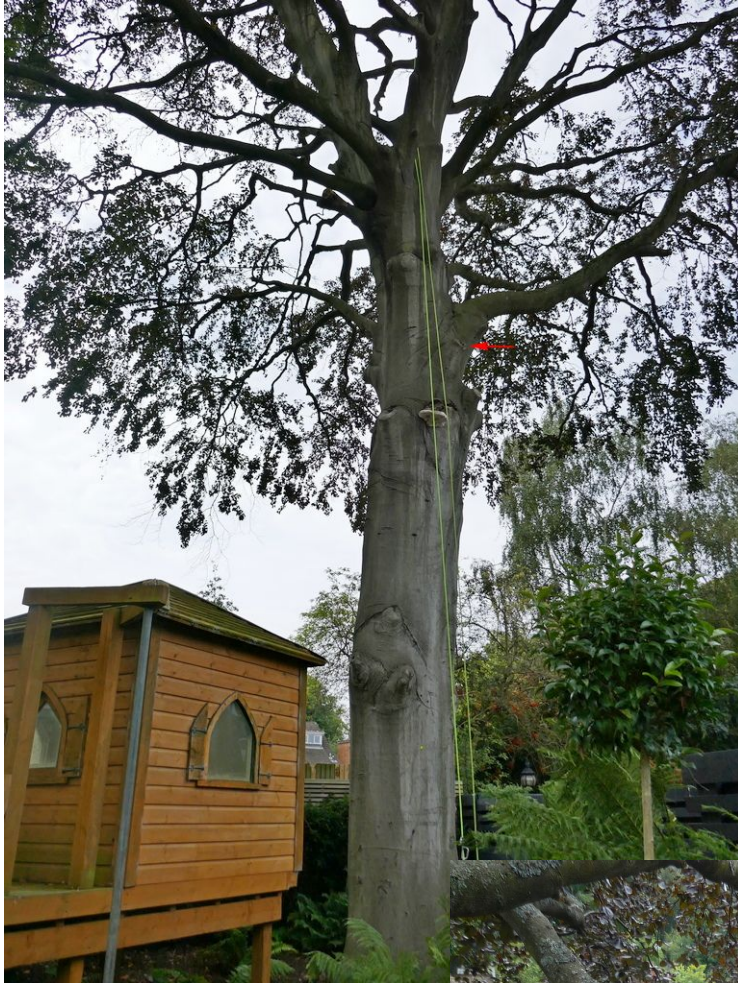
- 1.1 This report has been prepared for Mr Tony Herbert of 129 North End, London, NW3 7HH.
- 1.2 I have been asked to inspect a mature copper beech growing in the rear garden, to assess its condition and to recommend any necessary or appropriate work. This was prompted by the appearance of a large bracket fungus on the trunk, shown in photo 1.

- 3.1 The bracket fungus that caused the initial concern is growing on the north east side of the trunk on an old pruning cut at about 6m and is *Ganoderma applanatum*, a widespread species that causes decay in beech and various other broadleaved trees. The bracket is about 300mm across and woody, with the typical semi circular shape of this species, and has a pale margin indicating that it is growing actively. *Ganoderma* brackets are perennial and this one is growing beneath the remains of other smaller ones, which date back at least five years.

1) Tree from the garden showing the white fungal bracket at 6m, with the red arrow showing the cavity where the other bracket is growing. Sparse and dying foliage is also apparent.

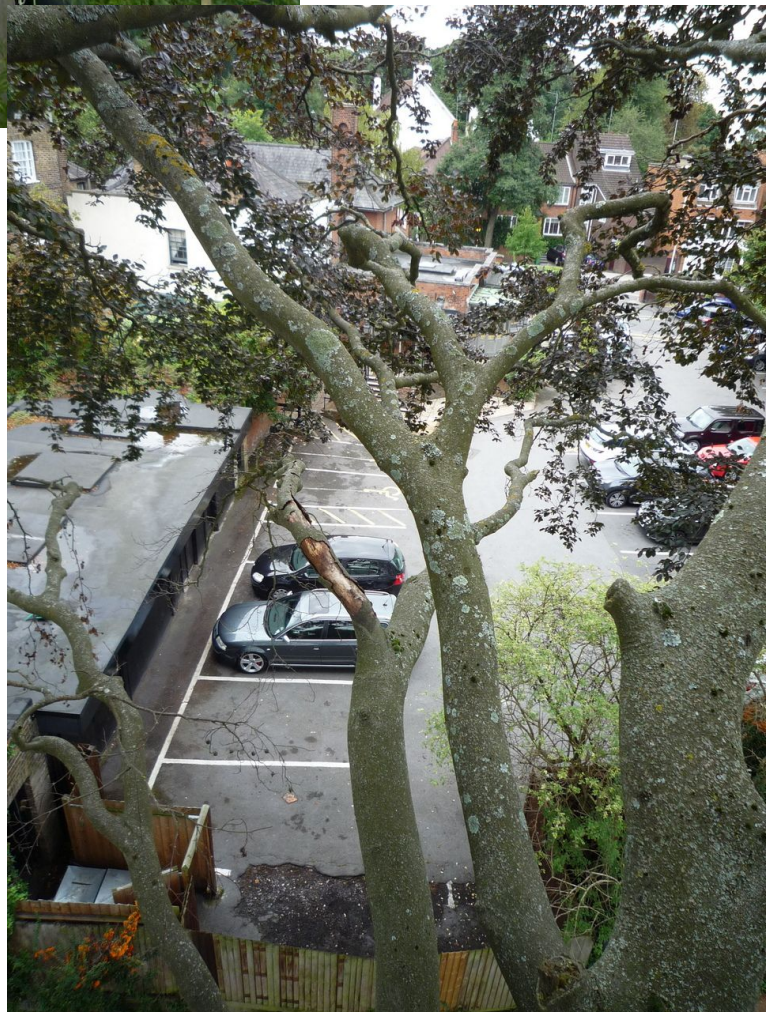
- 2.3 The foliage is unevenly distributed, very sparse in places and the branch ends are dying back, particularly on the north and west sides where it overhangs the pub car park. Some of the large branches have died completely, probably some time ago, as they are losing bark. At a rough estimate the tree has less than 30% of the foliage cover that would be expected in a fully healthy tree. (photo 2)
- 2.4 The tree has produced a fairly heavy crop of seed pods this year.

2) View in the crown showing sparse foliage and major dead branches.

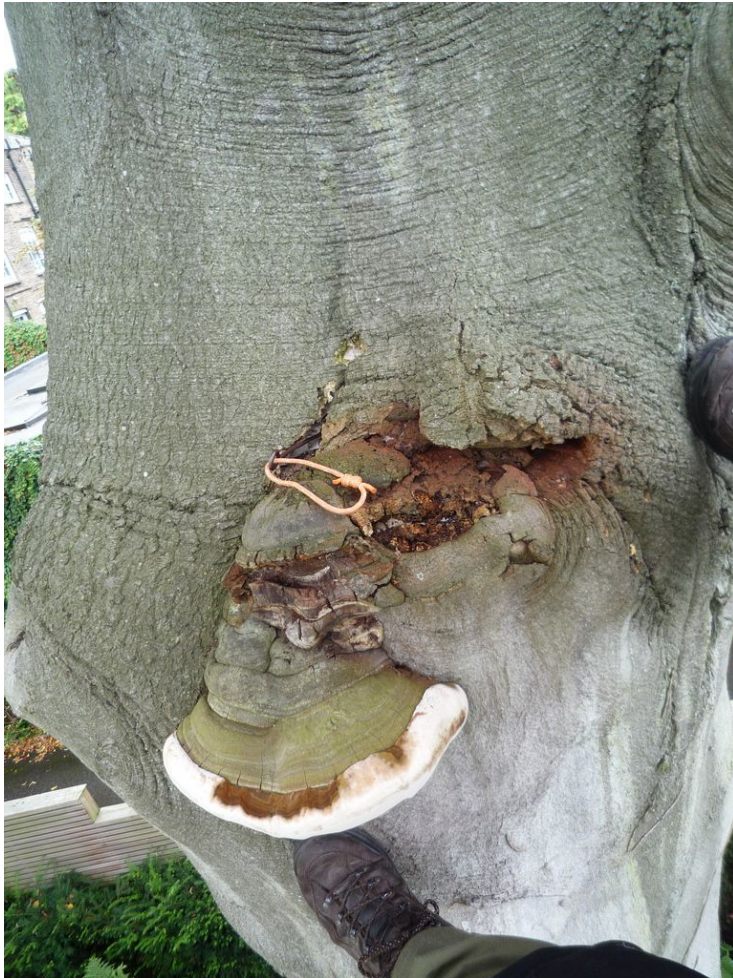
- 3.2 Just above the bracket is an open horizontal wound that has partly callused, but has visible decay and white fungal tissue within it. This looks like marshmallow and it was possible to push a blunt steel probe 400mm long into it for the full depth with little effort. (photo 2)

3) Ganoderma bracket at 6m, below smaller, older brackets. Note large open wound and the end of a 400mm long probe with orange loop.

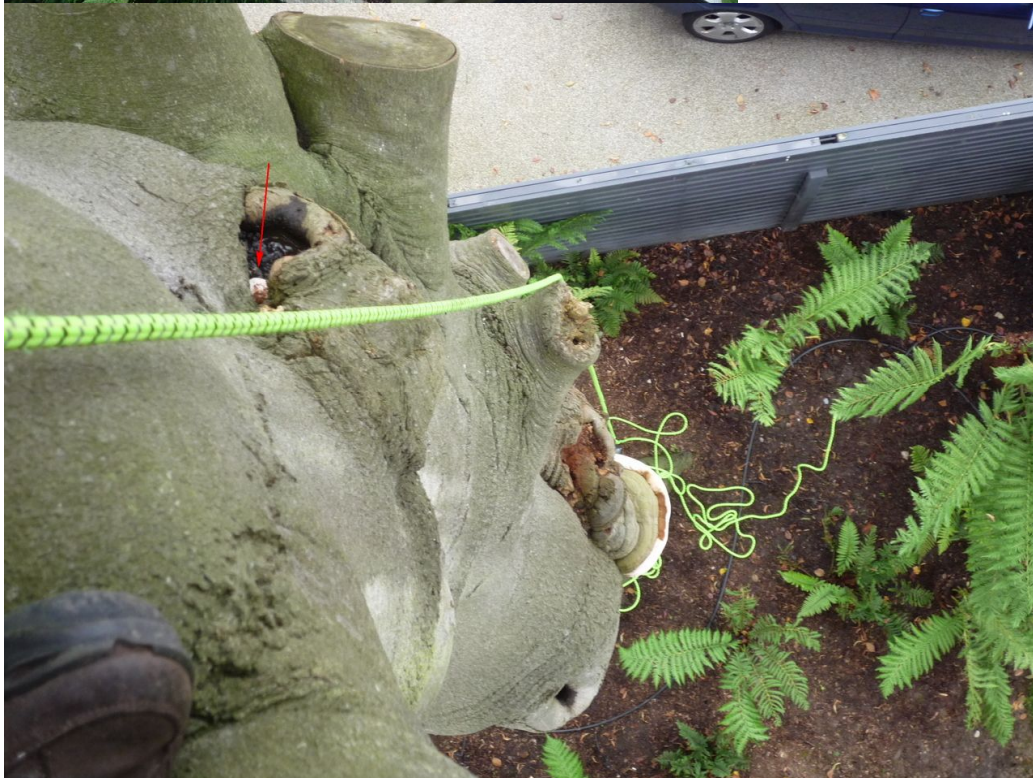
- 3.3 There is also an immature *Ganoderma* bracket starting to appear in a small cut 2m - 2.5m higher up the trunk on the same side and it was possible to insert the probe about 250mm into the decayed material with little effort.

View down the trunk, red arrow shows smaller bracket about 2.5m above the larger one visible below.

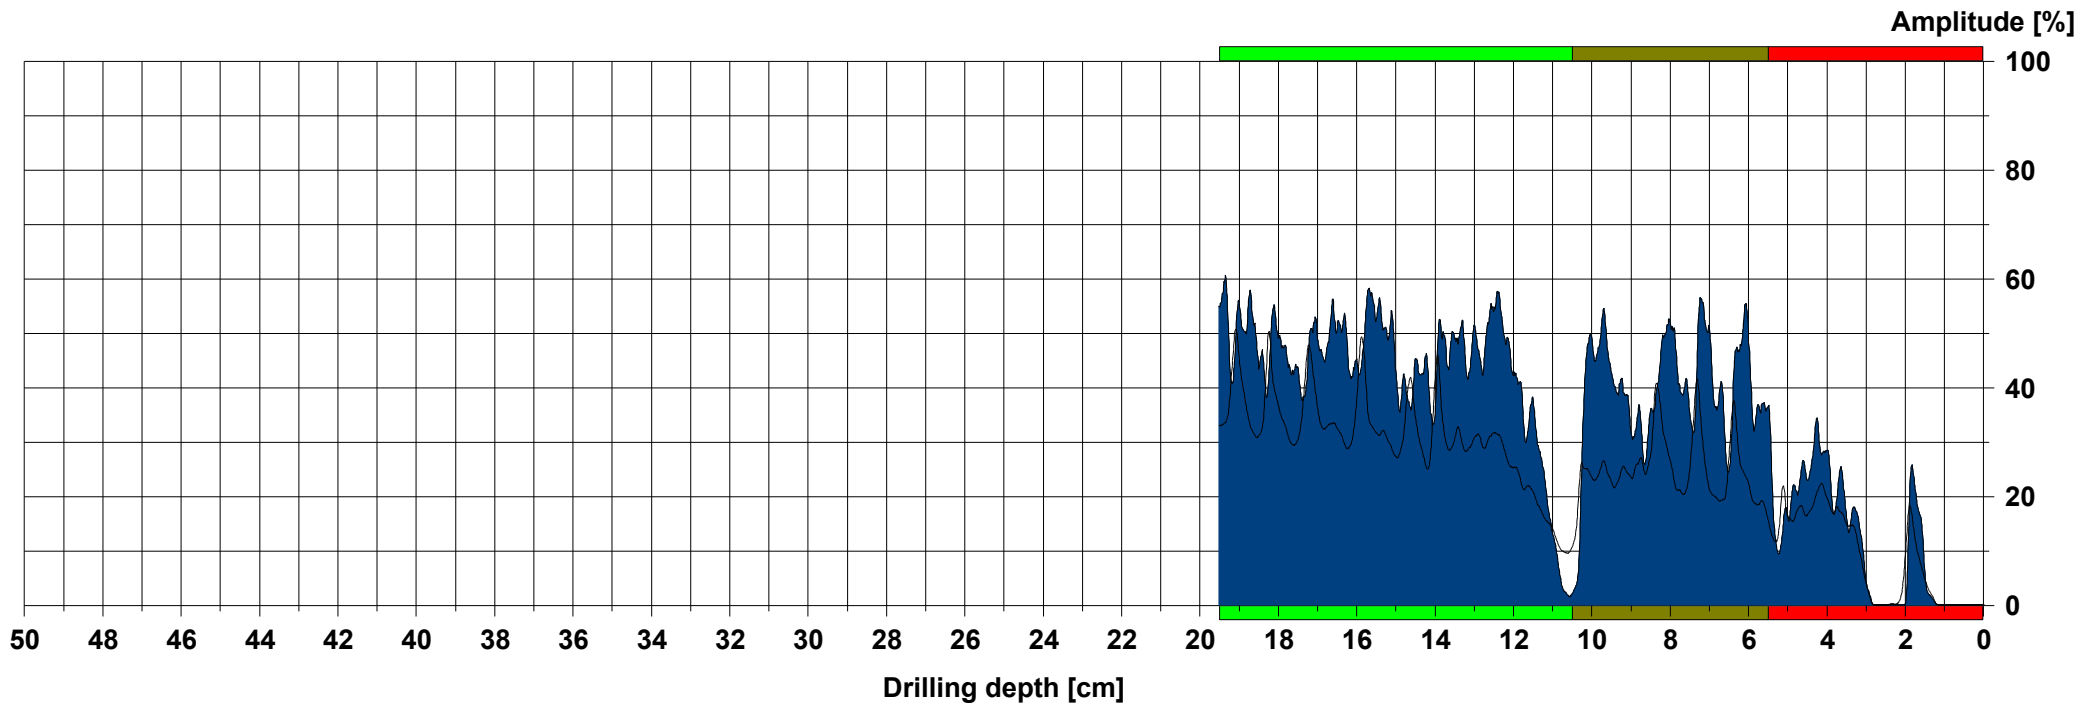
- 3.5 Test drilling the large wound on the west side of the lower trunk confirmed that the decay there is localised and structurally significant, although it is at the base where the leverage from the tree's weight and wind pressure on it are highest.

<span style="color: red;">■</span>	From 0,0 cm to 5,5 cm : Decay
<span style="color: olive;">■</span>	From 5,5 cm to 10,5 cm : Suspected decay
<span style="color: green;">■</span>	From 10,5 cm to 19,5 cm : Sound wood
<span style="border: 1px solid black; display: inline-block; width: 10px; height: 10px;"></span>	From 0,0 cm to 0,0 cm :
<span style="border: 1px solid black; display: inline-block; width: 10px; height: 10px;"></span>	From 0,0 cm to 0,0 cm :
<span style="border: 1px solid black; display: inline-block; width: 10px; height: 10px;"></span>	From 0,0 cm to 0,0 cm :

From SW into cavity. Some decay but is localised with sound wood beyond. Drill stopped at 19.5 due to high resistance. Serrated pattern is due to the grain texture and indicates sound wood

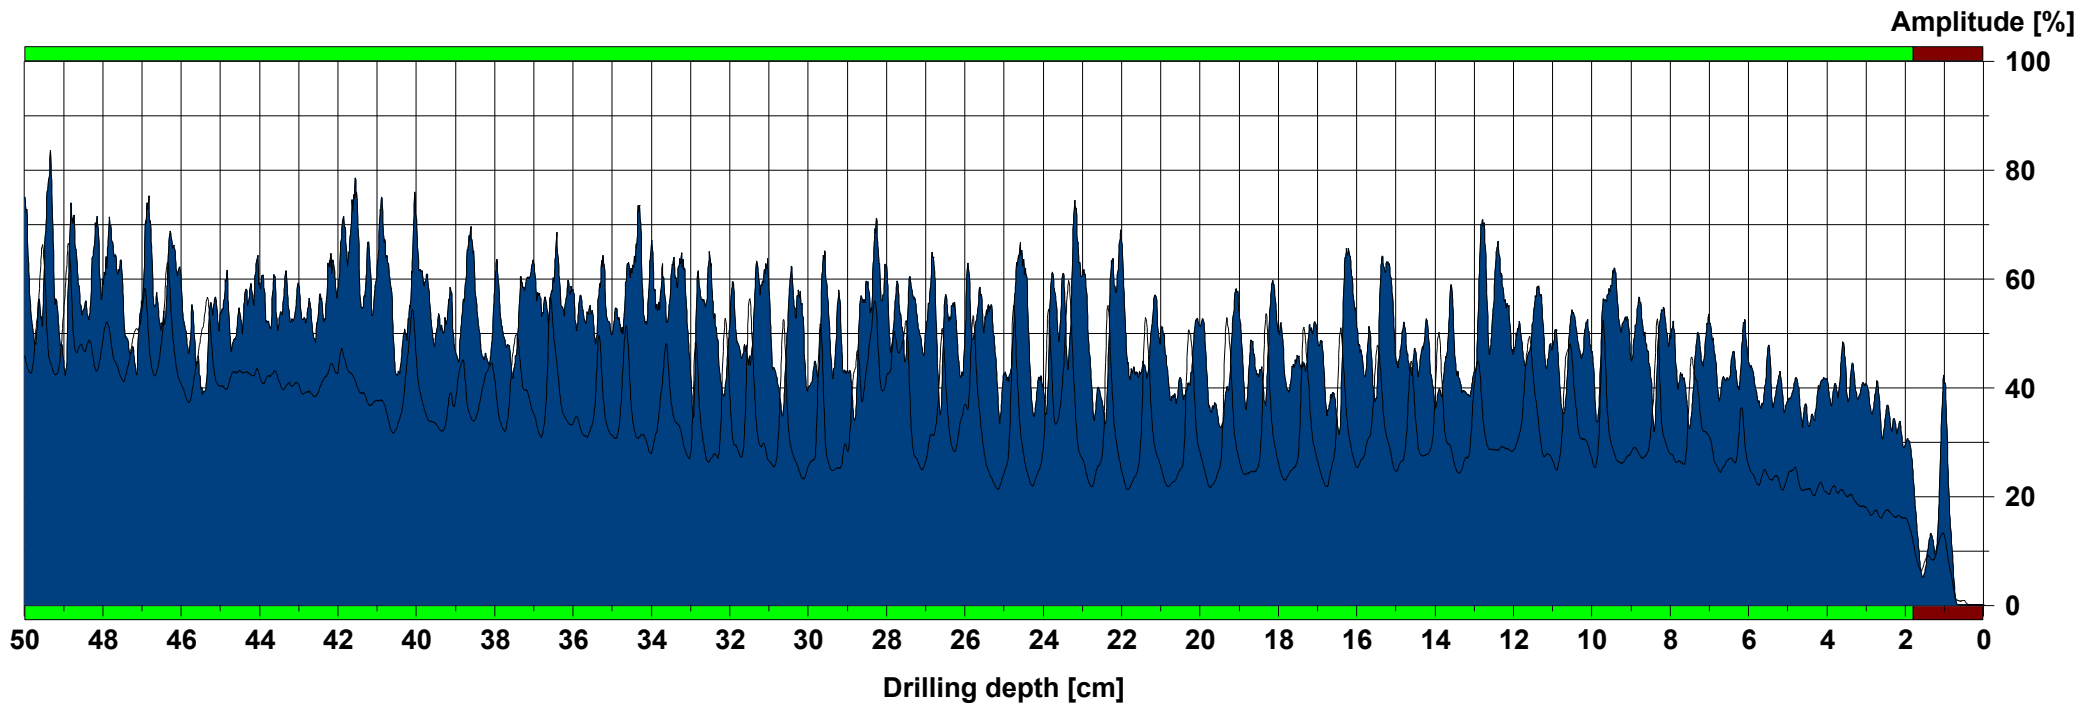
<span style="display:inline-block; width:10px; height:10px; background-color:darkred; border:1px solid black;"></span>	From 0,0 cm to 1,8 cm : Bark
<span style="display:inline-block; width:10px; height:10px; background-color:limegreen; border:1px solid black;"></span>	From 1,8 cm to 50,0 cm : Sound wood
<span style="display:inline-block; width:10px; height:10px; background-color:white; border:1px solid black;"></span>	From 0,0 cm to 0,0 cm :
<span style="display:inline-block; width:10px; height:10px; background-color:white; border:1px solid black;"></span>	From 0,0 cm to 0,0 cm :
<span style="display:inline-block; width:10px; height:10px; background-color:white; border:1px solid black;"></span>	From 0,0 cm to 0,0 cm :
<span style="display:inline-block; width:10px; height:10px; background-color:white; border:1px solid black;"></span>	From 0,0 cm to 0,0 cm :

From NW across the rear of the wound. No internal decay detected

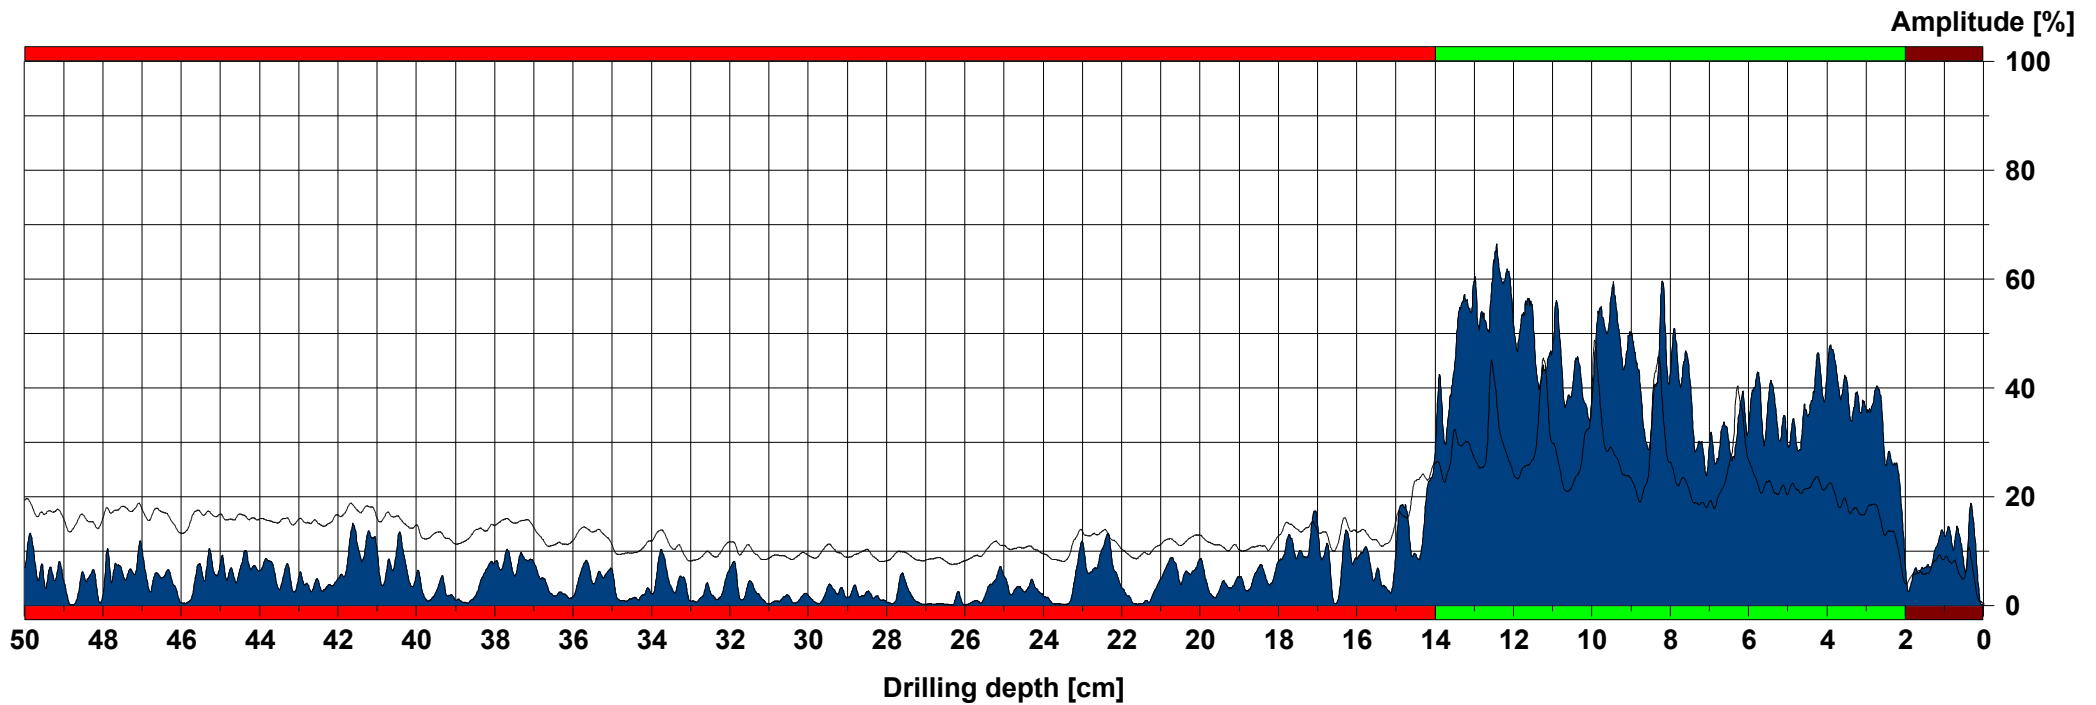
- 3.6 The tree was test drilled in three locations at about 6m, once each side of the bracket and slightly higher, and once just below it. The decay below the bracket was not quite as severe as at each side, but in all three locations there was a thin shell of sound wood 40 - 120mm thick over decay that extended for the full 500mm depth of the drill, i.e. well past the centre of the trunk.

<span style="display:inline-block; width:10px; height:10px; background-color:darkred; border:1px solid black;"></span>	From	0,0 cm	to	2,0 cm	:	Bark
<span style="display:inline-block; width:10px; height:10px; background-color:limegreen; border:1px solid black;"></span>	From	2,0 cm	to	14,0 cm	:	Sound wood
<span style="display:inline-block; width:10px; height:10px; background-color:red; border:1px solid black;"></span>	From	14,0 cm	to	50,0 cm	:	Decay
<span style="display:inline-block; width:10px; height:10px; background-color:white; border:1px solid black;"></span>	From	0,0 cm	to	0,0 cm	:	
<span style="display:inline-block; width:10px; height:10px; background-color:white; border:1px solid black;"></span>	From	0,0 cm	to	0,0 cm	:	
<span style="display:inline-block; width:10px; height:10px; background-color:white; border:1px solid black;"></span>	From	0,0 cm	to	0,0 cm	:

From NE above and left of bracket. Thin shell of sound wood over very severe decay extending well beyond the centre of the tree

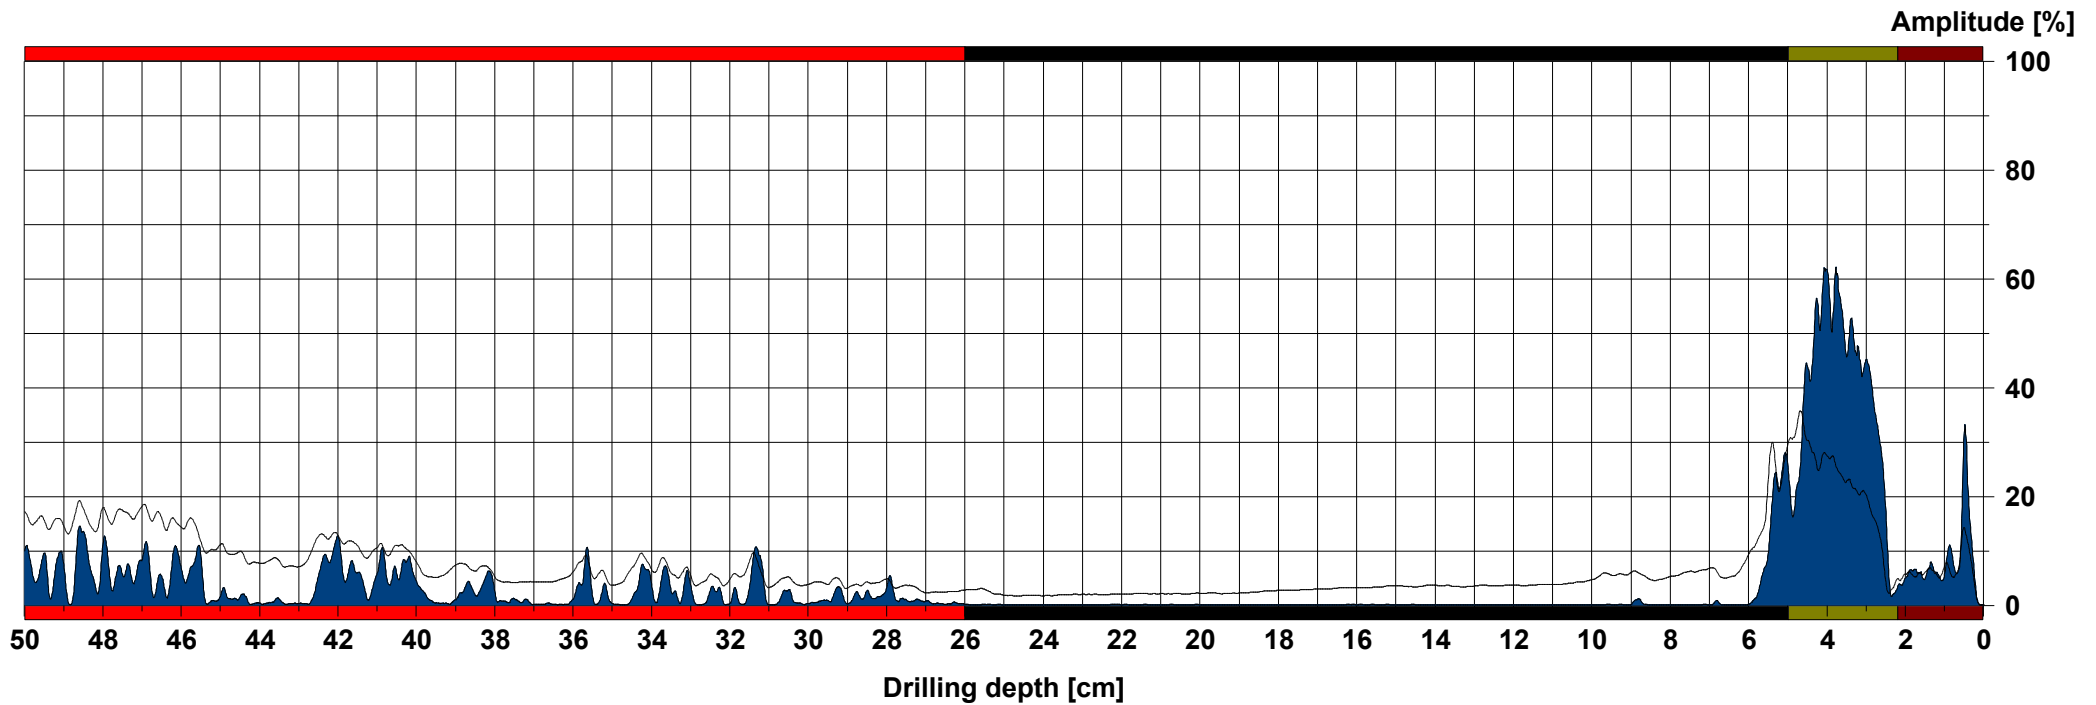
<span style="display:inline-block; width:10px; height:10px; background-color:darkred; border:1px solid black;"></span>	From	0,0 cm	to	2,2 cm	: Bark
<span style="display:inline-block; width:10px; height:10px; background-color:olive; border:1px solid black;"></span>	From	2,2 cm	to	5,0 cm	: Suspected decay
<span style="display:inline-block; width:10px; height:10px; background-color:black; border:1px solid black;"></span>	From	5,0 cm	to	26,0 cm	: Cavity
<span style="display:inline-block; width:10px; height:10px; background-color:red; border:1px solid black;"></span>	From	26,0 cm	to	50,0 cm	: Decay
<span style="display:inline-block; width:10px; height:10px; background-color:white; border:1px solid black;"></span>	From	0,0 cm	to	0,0 cm	:
<span style="display:inline-block; width:10px; height:10px; background-color:white; border:1px solid black;"></span>	From	0,0 cm	to	0,0 cm	:

NE above and right of bracket. Thin shell of wood over cavity or very advanced decay

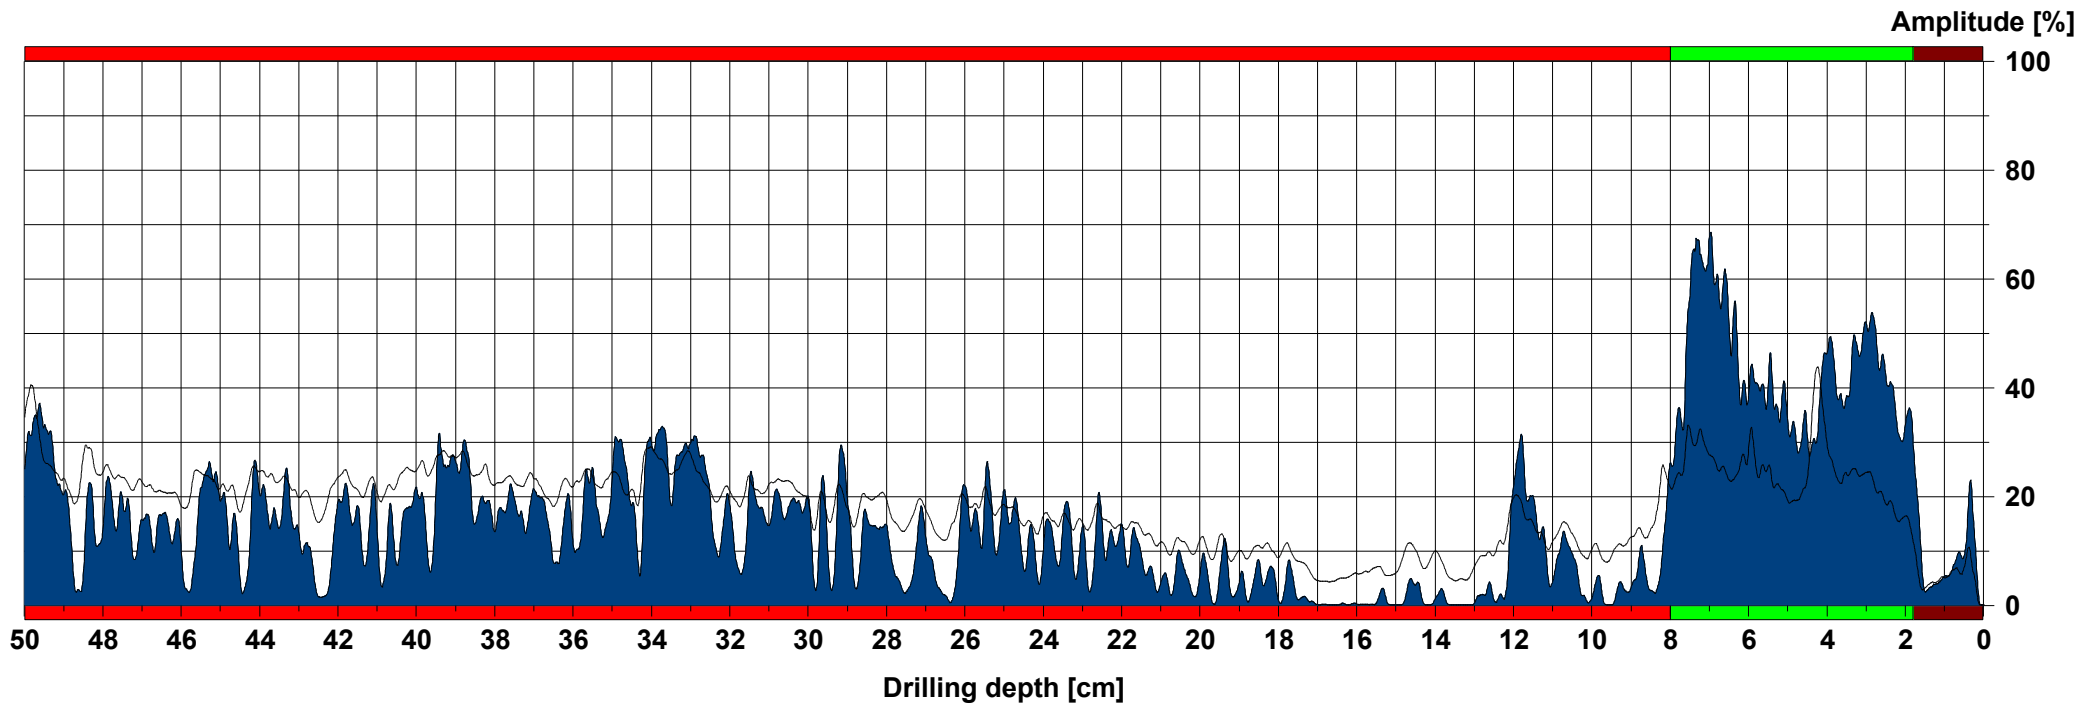
<span style="color: red;">■</span>	From 0,0 cm to 1,8 cm : Bark
<span style="color: green;">■</span>	From 1,8 cm to 8,0 cm : Sound wood
<span style="color: red;">■</span>	From 8,0 cm to 50,0 cm : Decay
<span style="color: white;">■</span>	From 0,0 cm to 0,0 cm :
<span style="color: white;">■</span>	From 0,0 cm to 0,0 cm :
<span style="color: white;">■</span>	From 0,0 cm to 0,0 cm :

From NE below the bracket. Decay not quite as severe as level with the bracket, but still extends beyond the centre of the trunk and there is no significant strength left in the affected timber
