# TECHNICAL REPORT ON A SUBSIDENCE CLAIM

Crawford Reference: SU1701605

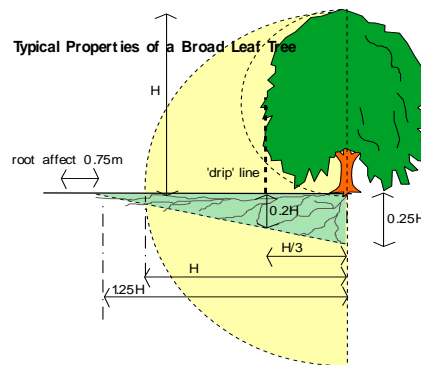
Typical proportions of a broadleaf tree. Note the potential root zone. It must be noted that every tree is different, and the root zone will vary with soil type, health of the tree and climatic conditions.

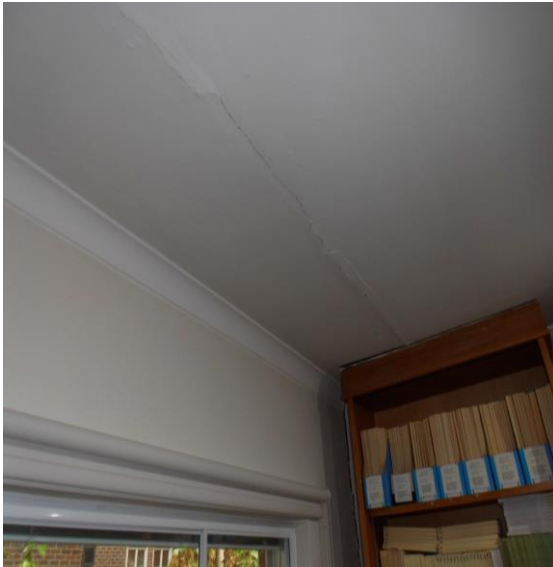
Library ceiling crack to rear of room

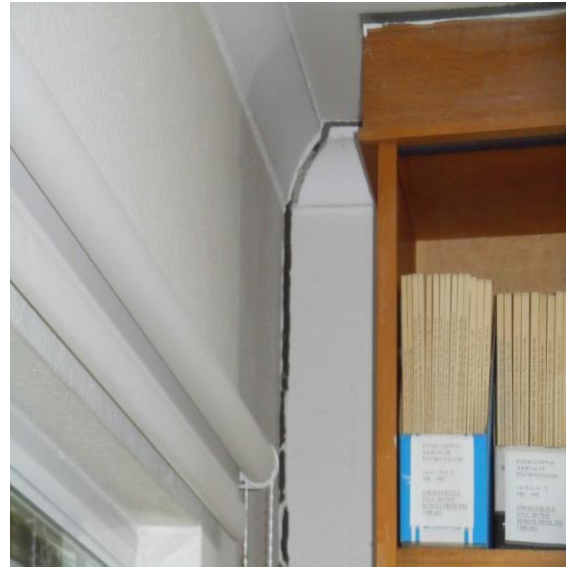
Close up of crack to right of window in the library

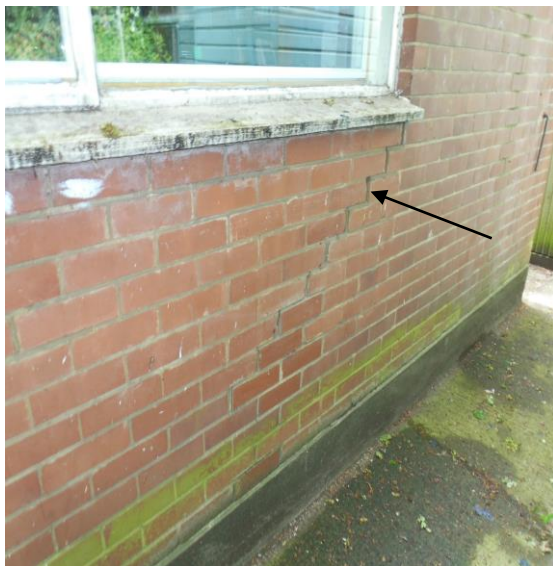
~Stepped diagonal crack below window along flank wall to library

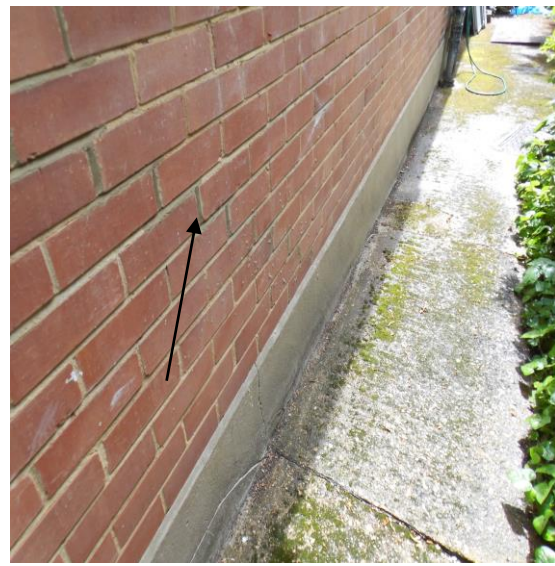
Evidence of previous repairs to rear elevation of single storey extension

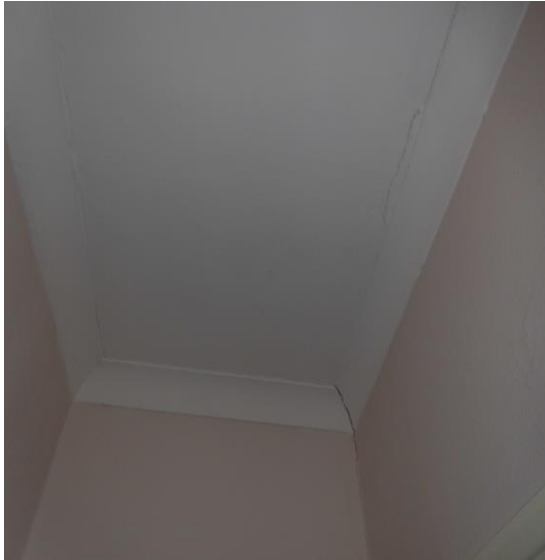
Ceiling crack in corridor near library

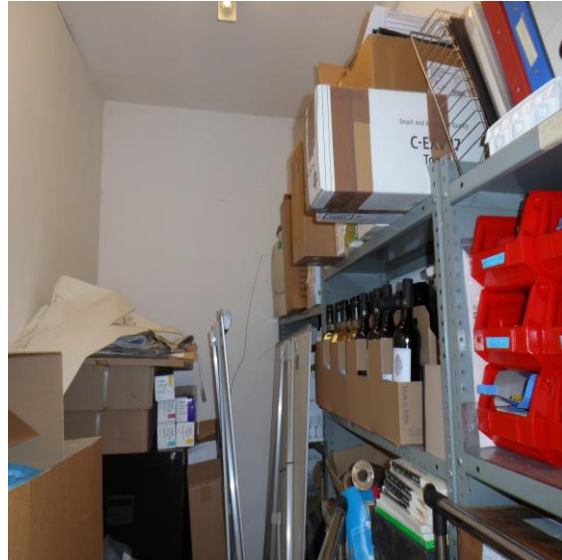
Fracture to partition wall to cupboard no. 23

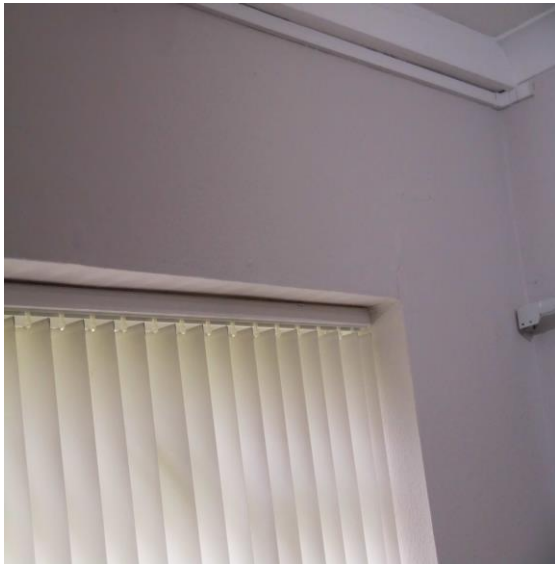
Rear meeting room crack above right of window

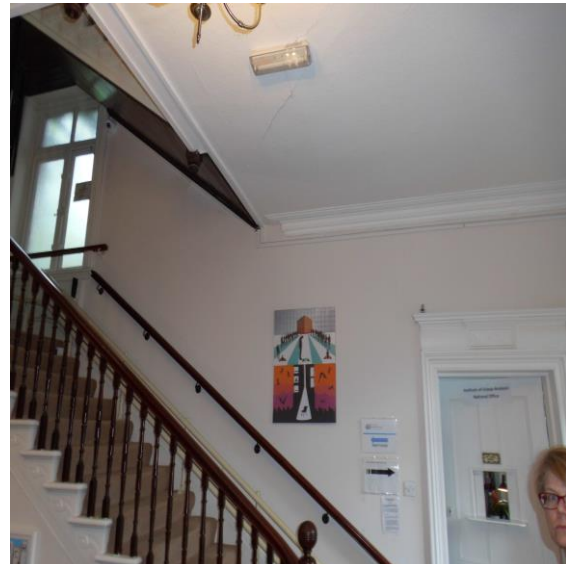
Ceiling crack in hallway

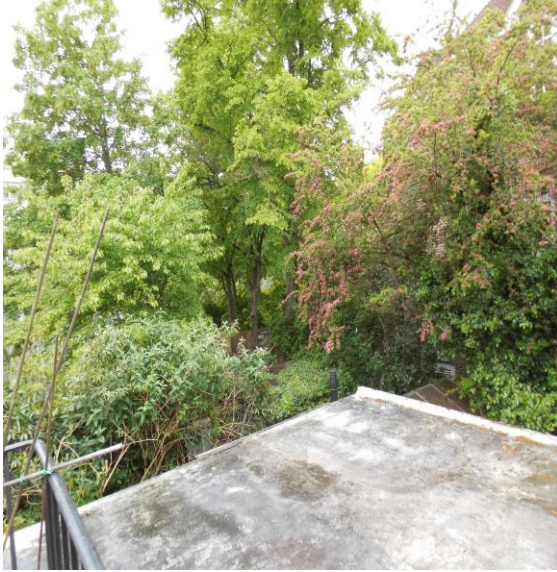
Flat roof to rear extension

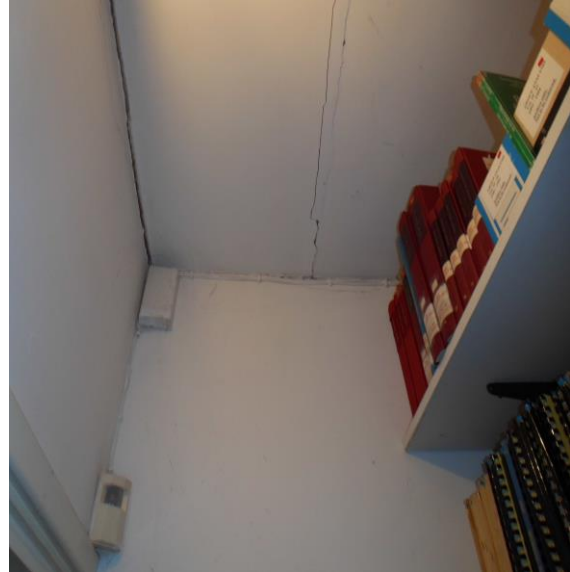
Ceiling crack to library cupboard
